11 February 2013

Document Ref. 2013-0007AC

**RE: GEOTECHNICAL SITE INSPECTION AND REVIEW OF STABILITY ANALYSIS,  
OPAL VALE LANDFILL, CHITTY ROAD, TOODYAY, WA**

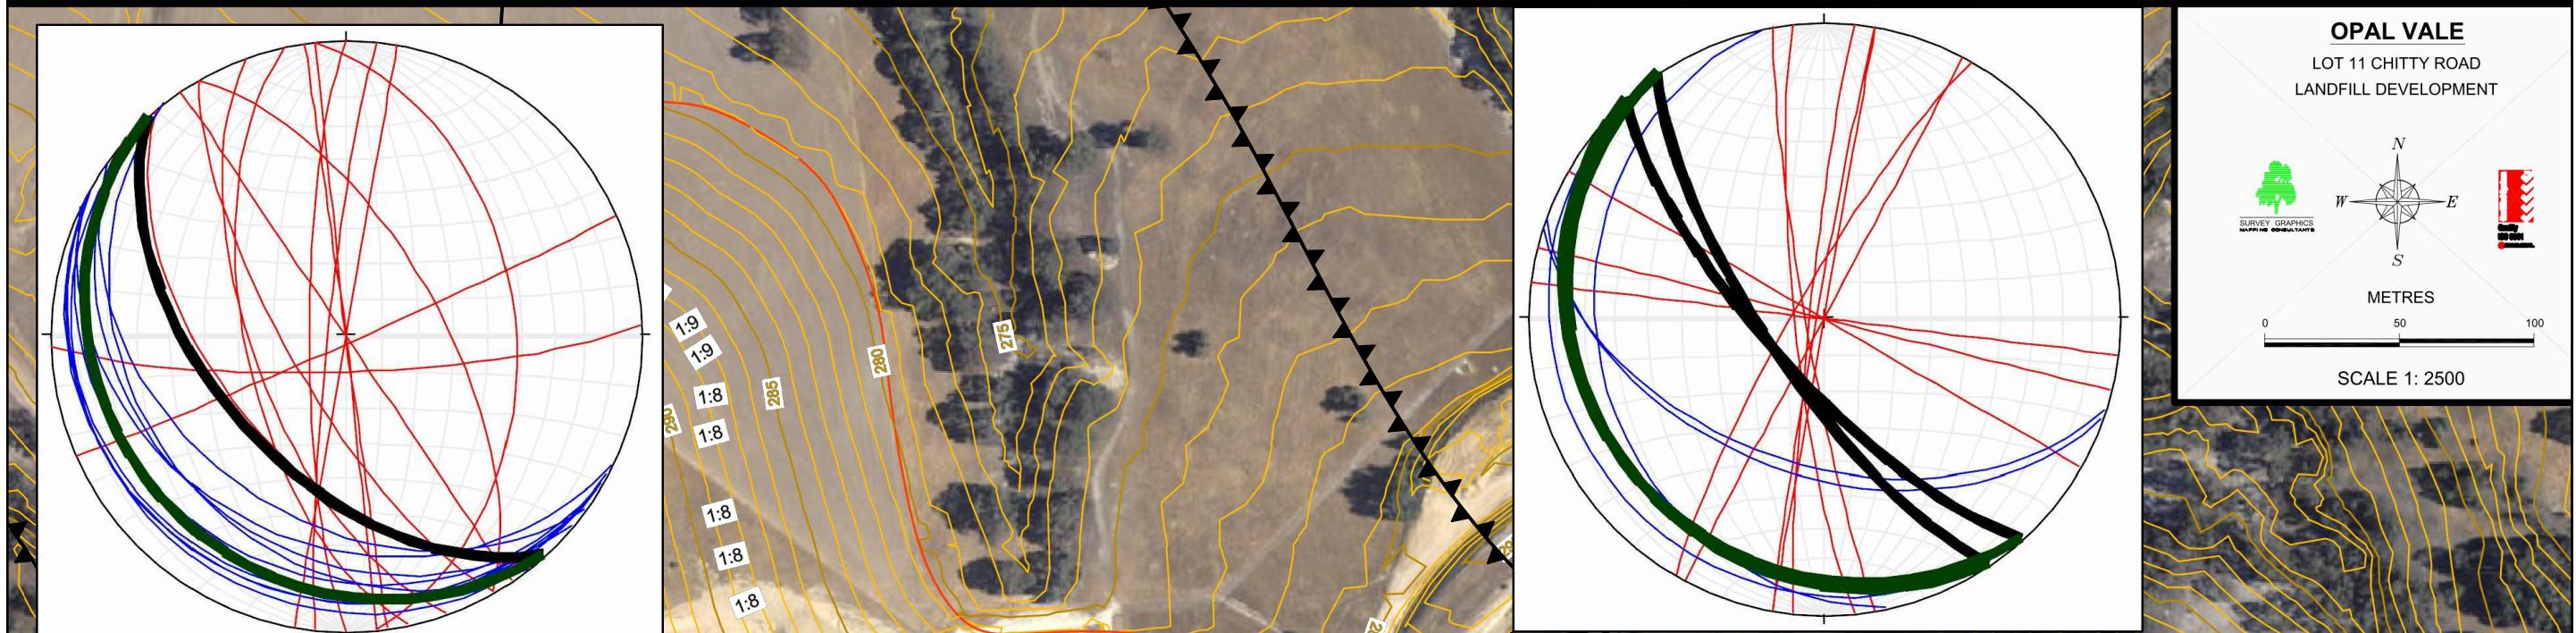
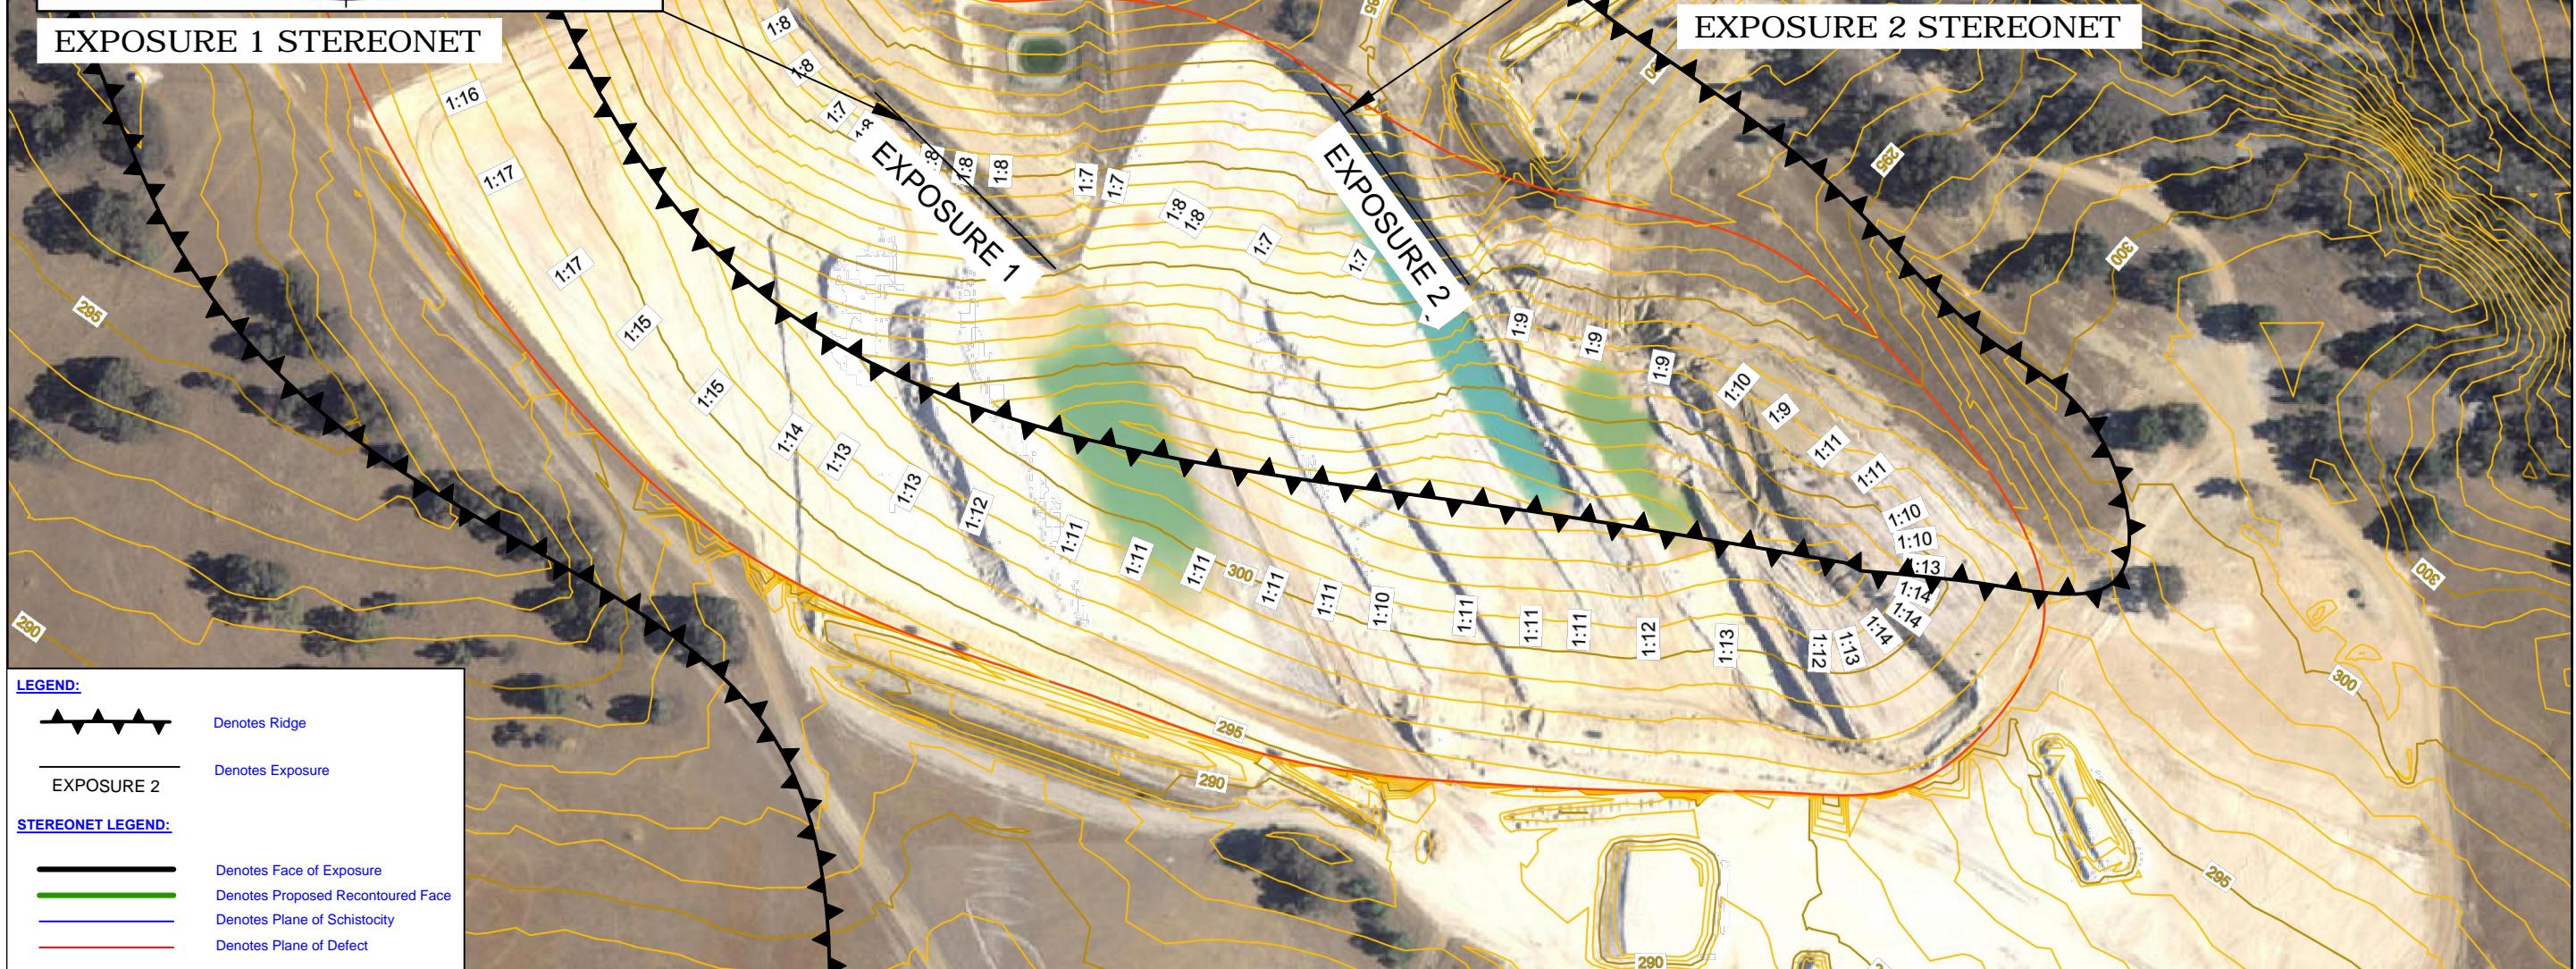
The majority of the pit walls have been reworked to reduce slope angles and during the time of our inspection were typically covered with track compacted fill materials (Plate 1). Large quantities of fill has been placed in the eastern portion of the site covering the near vertical cut slopes, which are visible in the aerial photograph provided (Figure 1 and Plate 2). However, two steep cut slopes in the northern portion of the site (marked on Figure 1 as Exposure 1 and 2) exposed the subsurface profiles which were logged during our time onsite.

A stereographic projection of the dominant defects measured in the field is presented in Figure 1. Based on our interpretation of the stereograph and the observed quality of the defects, the following can be concluded about the potential for rock slope type failures at the location of Exposure 1:

A stereographic projection of the dominant defects measured in the field is presented in Figure 1. Based on our interpretation of the stereograph and the observed quality of the defects, the following can be concluded about the potential for rock slope type failures at the location of Exposure 2:

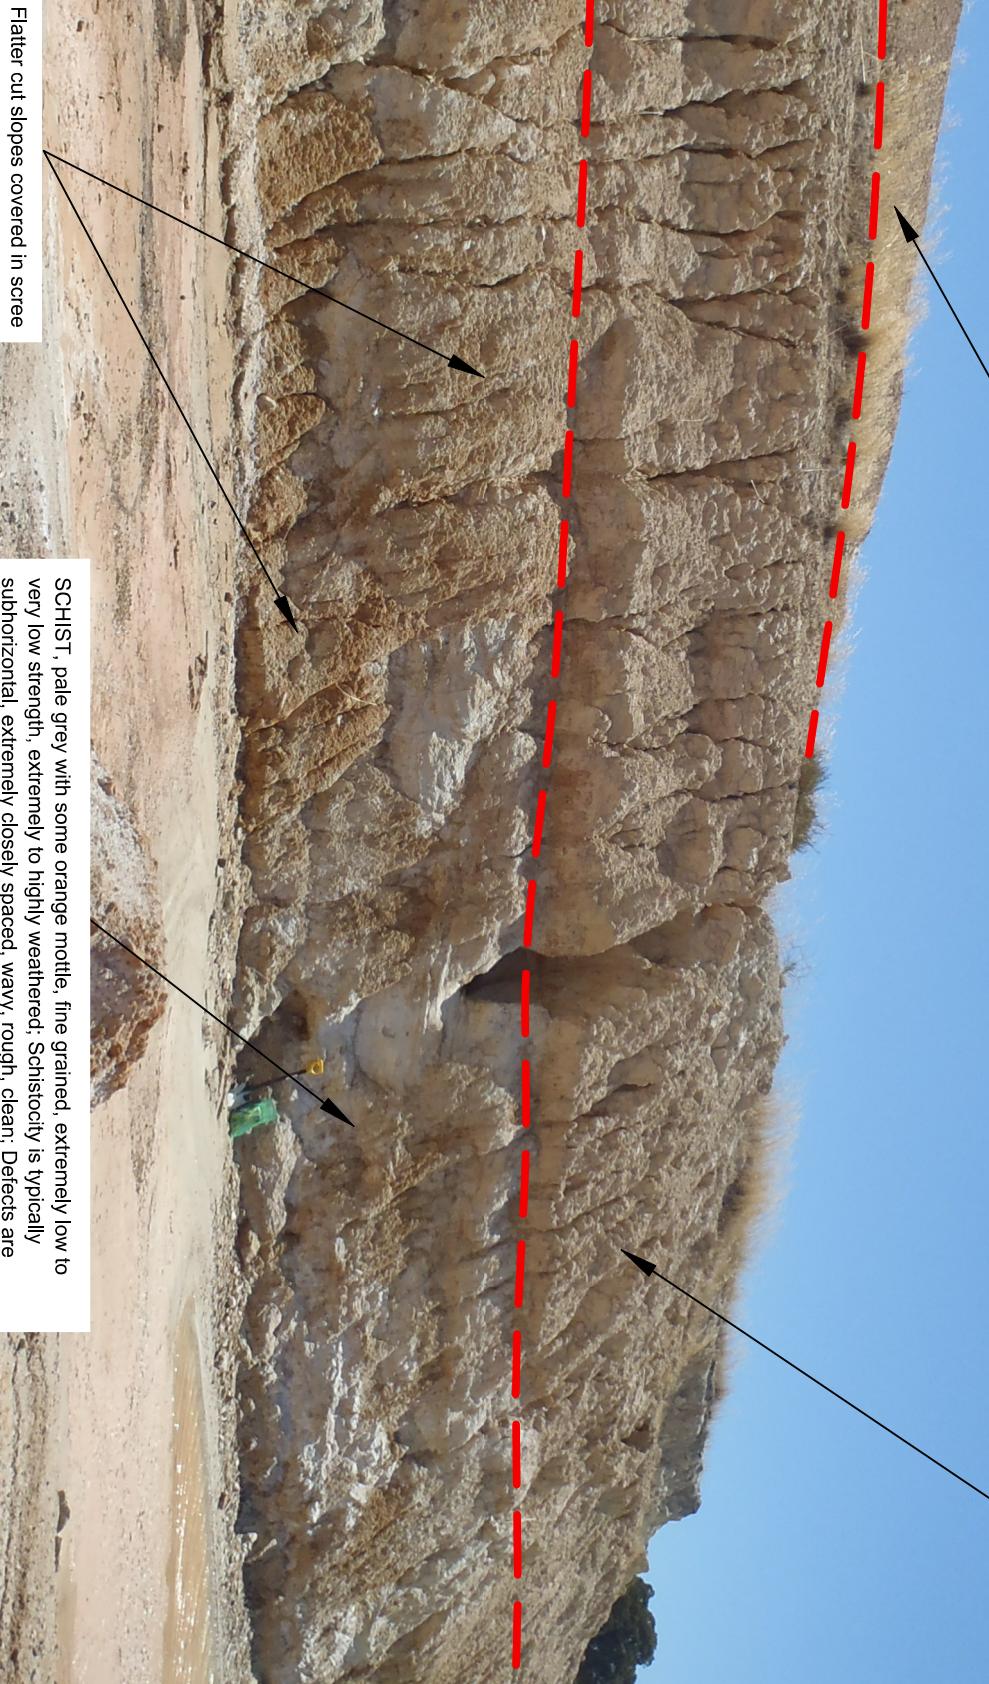
CLIENT:	OPAL VALE PTY LTD	DRAWN:	TM	DATE:	08/02/13
PROJECT:	OPAL VALE LANDFILL PROJECT	CHECKED:	PDM	DATE:	08/02/13
		PROJECT No.	2013-0007	FIGURE No.	02
SCALE:	NTS	REVISION:	A	DATE:	08/02/13

The materials encountered at Exposure 1 are presented in Figure 2 which shows that the underlying lithology contains planes of weakness that comprise the following:

- *Sub-horizontal Schistosity*: typically extremely closely spaced, wavy, rough, clean and closed; and
- *Sub-vertical Defects*: typically joints, sub vertical, closely to widely spaced, planar, very rough, clean, with some iron staining, closed.

FILL / CLAYEY SANDY GRAVEL (GC), red brown, gravel is fine to coarse grained, angular quartzite and rounded laterite.

SANDY CLAYEY SILT (MLCCL), mottled pale grey and orange brown, low to medium plasticity, with gravel of rounded laterite and angular quartzite, variable very weak iron cementation; Very stiff to hard.

SCHIST, pale grey with some orange mottle, fine grained, extremely low to very low strength, extremely to highly weathered; Schistosity is typically subhorizontal, extremely closely spaced, wavy, rough, clean; Defects are typically joints, sub vertical, closely to widely spaced, planar, very rough, clean, closed, some with iron staining, occasional quartz veins.

Flatter cut slopes covered in scree

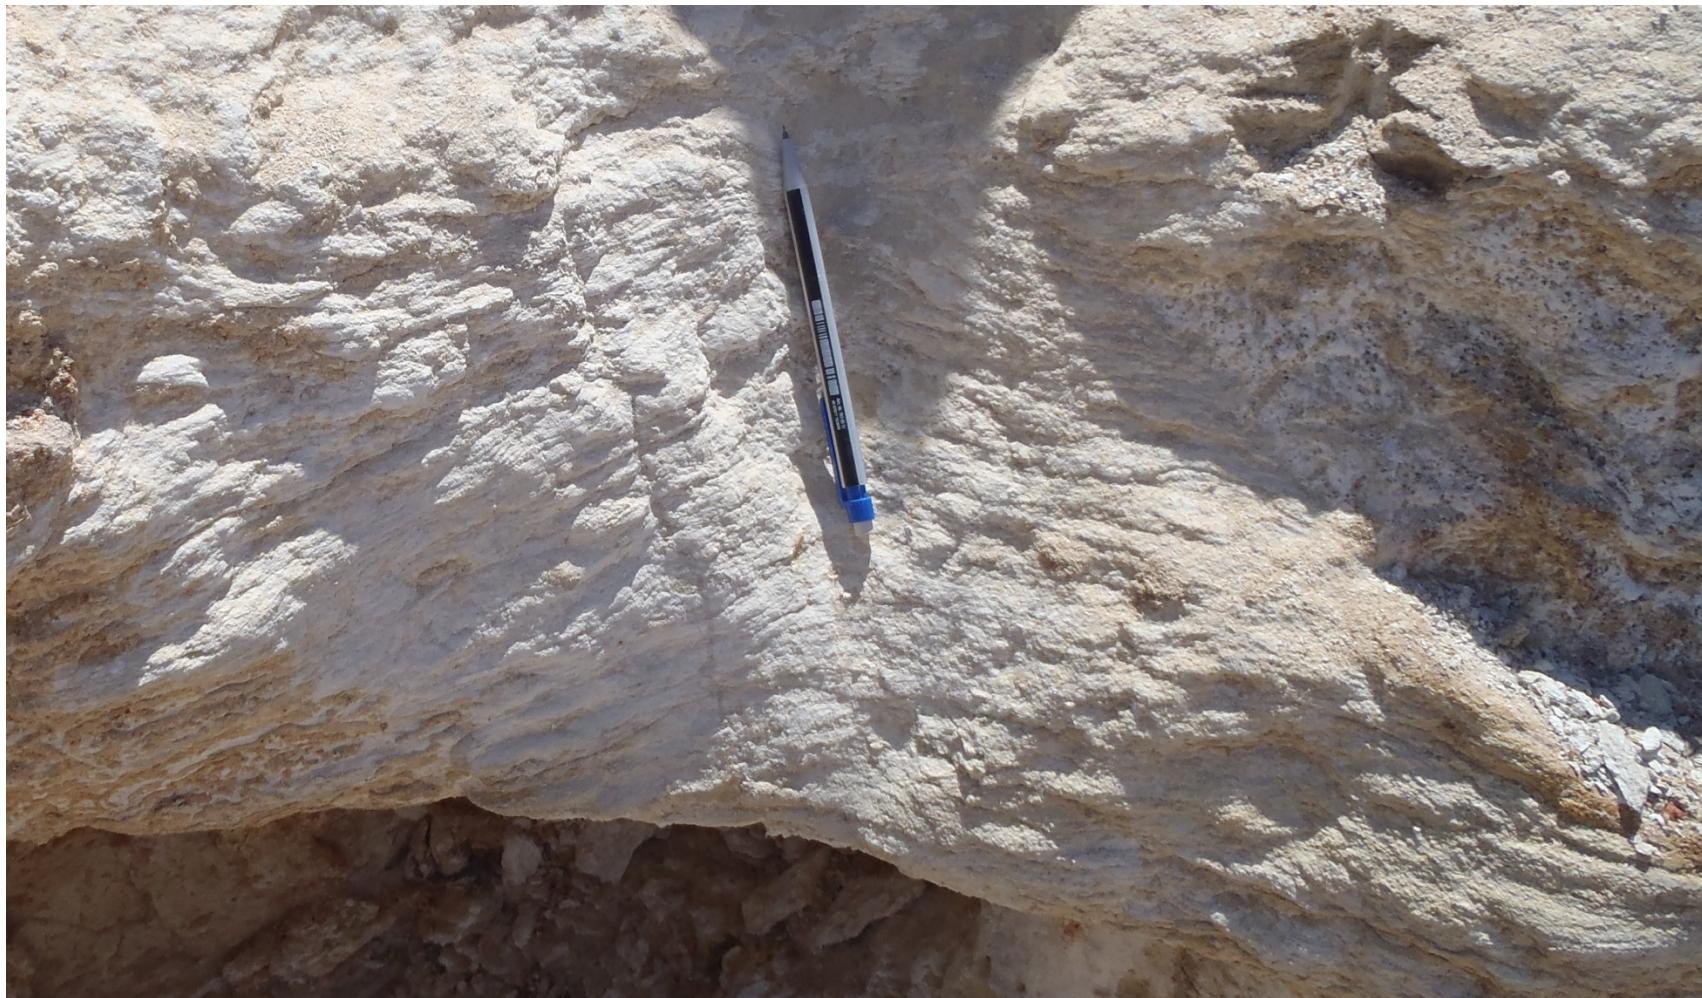
- Although the orientation of the schistosity would kinematically allow for planar failures, it is judged that the roughness and waviness (Plate 3) of the schistosity would generate too much friction for a planar failure to occur. In other words, we would anticipate that the friction angle of the schistosity is larger than the dip angle (typically measured at approximately 15 to 30 degrees). In addition, there is no evidence of planar failure at this location;

- Although the orientation of the schistosity would allow for planar failures, as described above, the roughness and waviness (Plate 3) of the schistosity would generate too much friction for a planar failure to occur;
- Some defects intersect the schistosity at an orientation to the face that will allow for wedge type failures to occur. The likelihood of wedge type failures was confirmed on site by the presence of open sub vertical joints and the presence of some boulders at the base of the slope (Plate 4, Figure 3); and
- The dip direction of the defects in comparison to the face indicates that there is not potential for toppling failure at this location.

**PLATE 3** – Typical Rock Schistosity

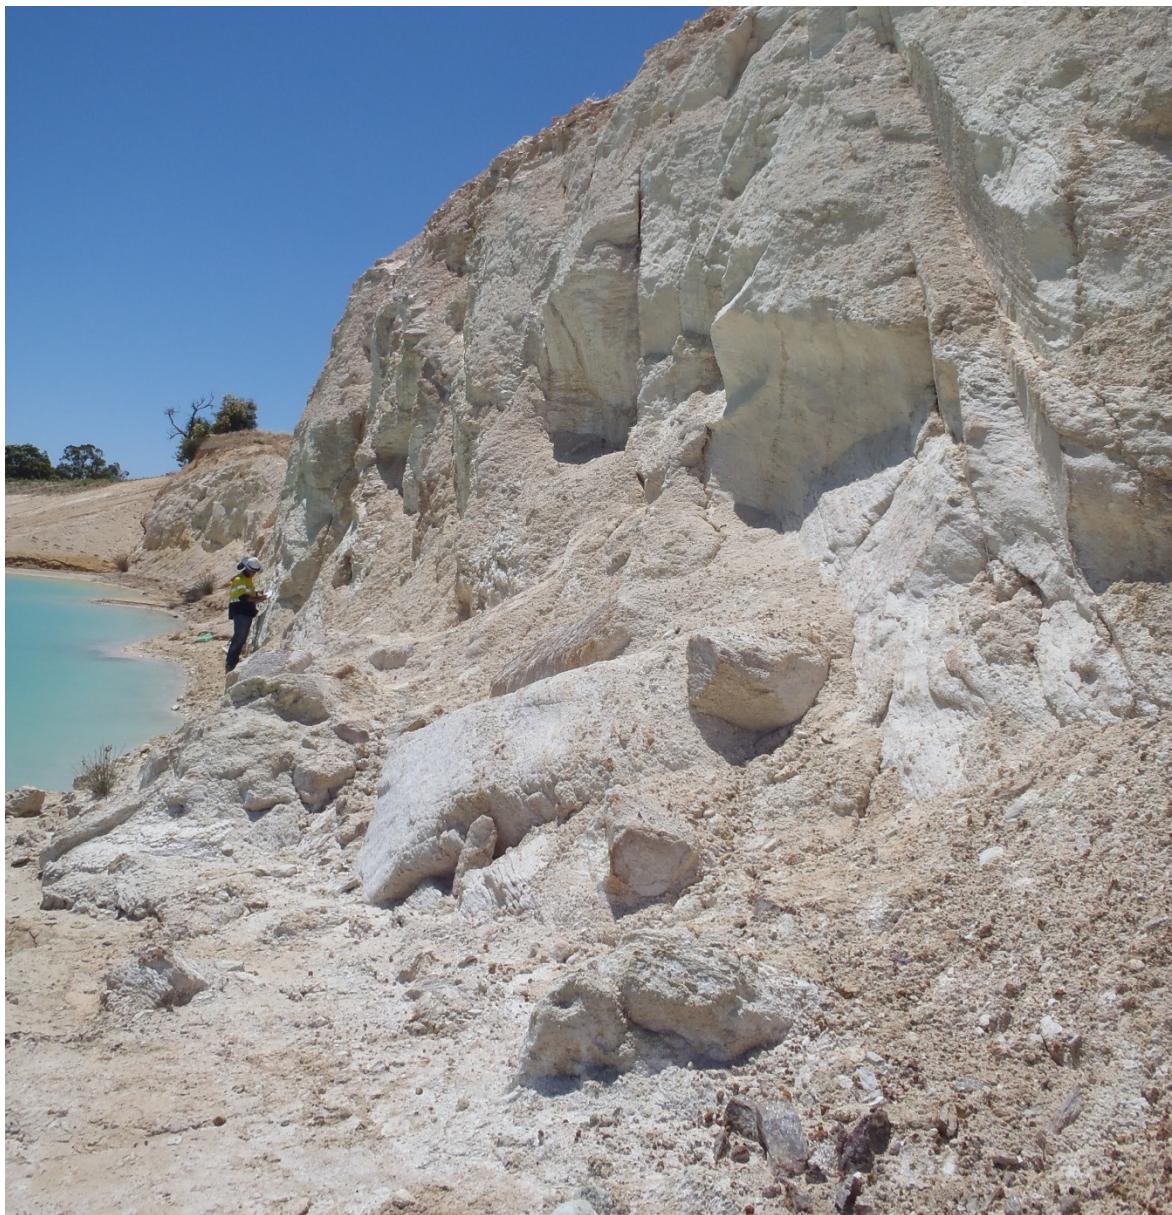
The materials encountered in Exposure 2 are presented in Figure 3 which shows that the lithology has a sub-horizontal schistosity and sub-vertical jointing similar to that of Exposure 1. However, unlike Exposure 1, several of the defects were found to have partings of up to 15mm which is probably due to stress release from the removal of clay during previous land use. These partings became tighter with depth.

**PLATE 4** – Open Jointing and Slope Debris at Base of Slope Observed in Exposure 2
