Bluebird Gold Mine

GNH Pit TSF Conversion

GNH Pit TSF Conversion – Geotechnical Assessment and TSF Design

Report reference number: 754-PERGE340337-R02

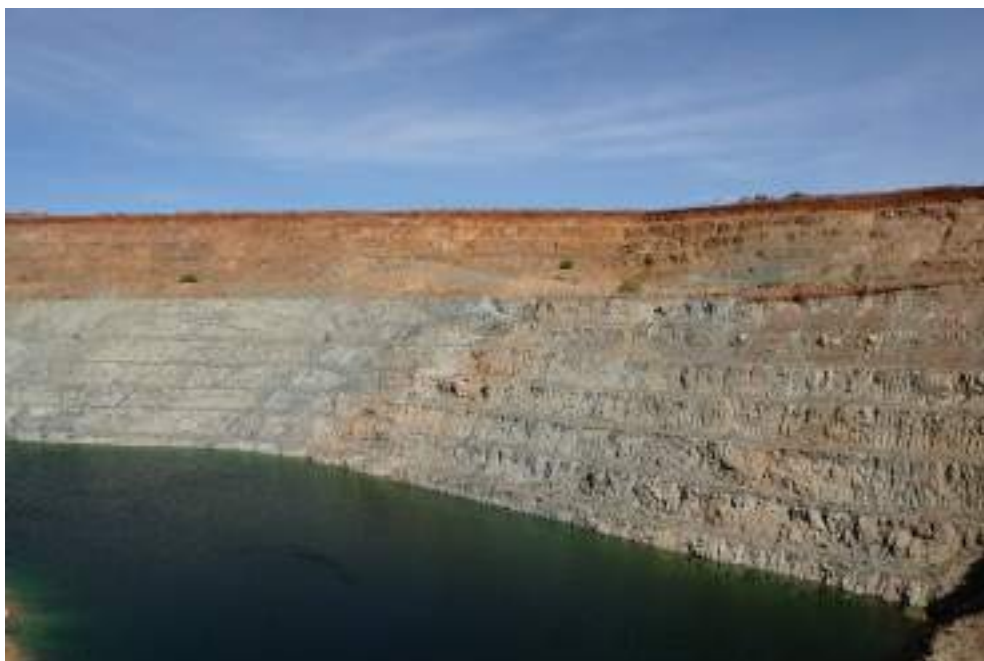
No significant changes to the GNH west wall were noted since the previous monitoring visit in April 2023. There are no large scale failures present in this pit wall. Several erosion gullies are present which have not changed significantly in recent monitoring intervals. The slope is approximately 65m high and benched at approximately five metre intervals. Survey provided by Westgold indicates a slope angle of approximately 40 degrees from the horizontal, which decreases to 30 degrees near the top of the slope. The south end of the pit is essentially a single slope, while the northern end is split into two segments by a wide bench approximately 25m from the top of the slope. The pit is partially filled with water.

Figure 3 - West Wall of GNH Pit from north end

- Tailings should be placed so that the beach is formed against the west wall;
- Spigots should be placed below the top half of the slope, where the slope is closer to the highway and the grade of weathering is highest;
- The degree of erosion around the spigot location should be monitored regularly. If excessive erosion is noted, then placement at that spigot should cease and the spigot should be moved.
- Survey monitoring of the west wall should increase in frequency during the early phases of tailings placement.

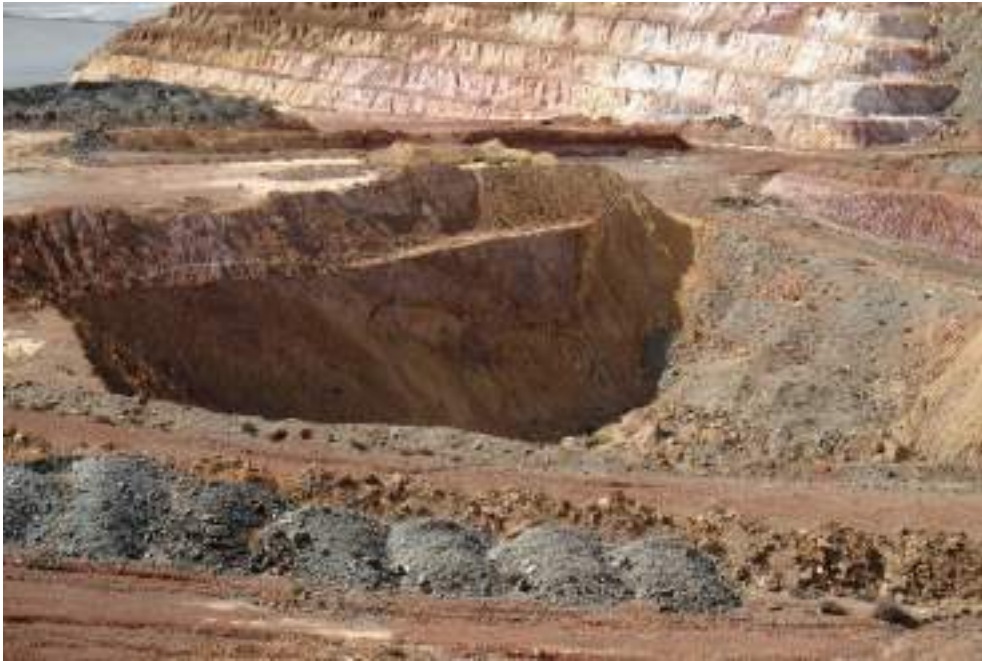
Figure 4 - Saddle between GNH and Bluebird East pits

A significant previous slope failure has previously occurred along the south edge of the Bluebird East pit. The failed area was more weathered than the GNH west face, and in general the Bluebird East pit slopes exhibited a greater degree of weathering than the GNH pit. The north-west slope below the spigot appears to have comparable rock condition to the GNH pit.

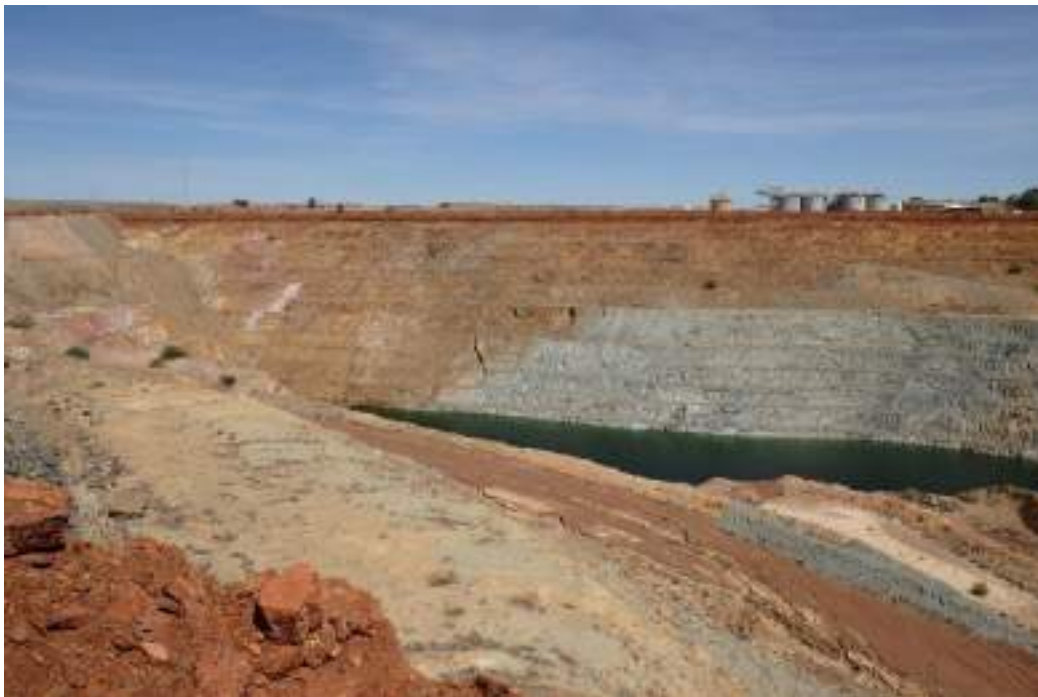
Figure 5 - GNH Pit west wall from east side (left of frame is adjacent to GNH)

The change from one slope to a segmented slope approximately coincides with a change in weathering condition, with much fresher rock being present on the north side of the slope.

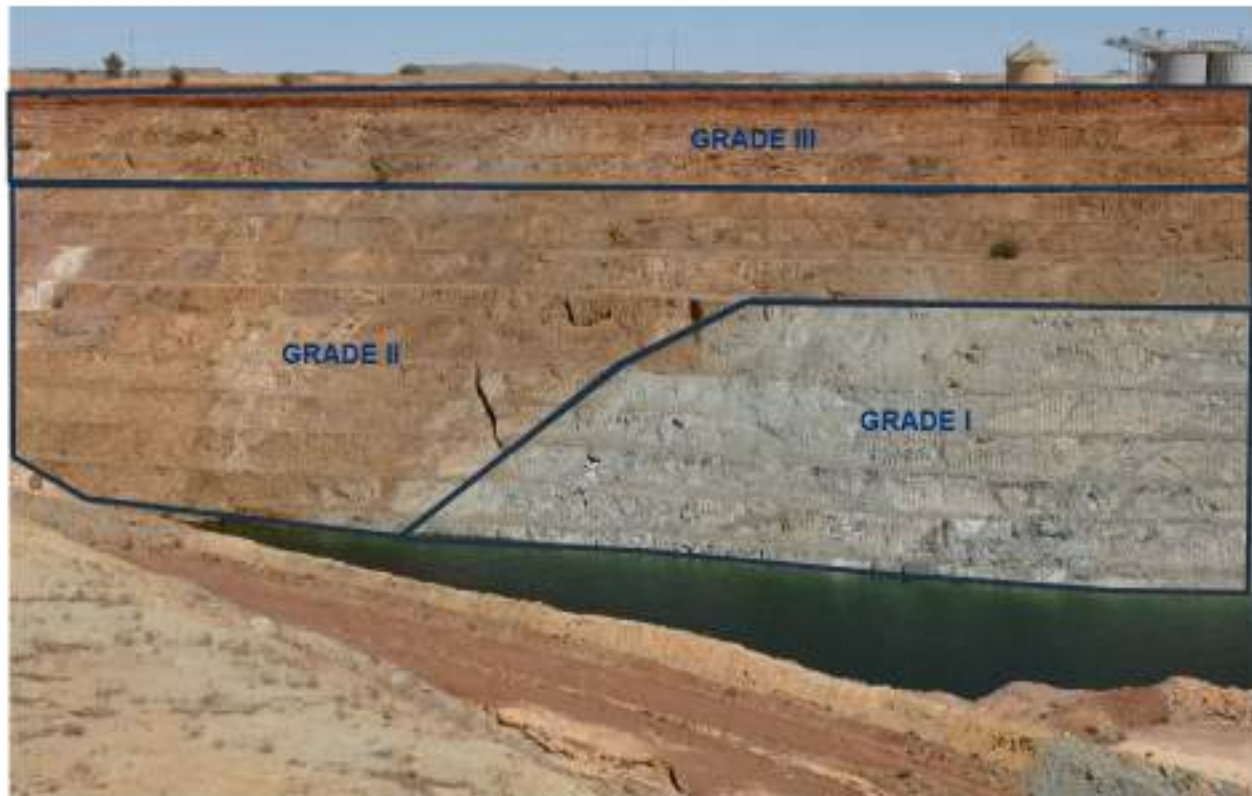
The minimum factors of safety considered are 1.3 for an internal failure of the slope, or 1.5 for a failure that affects the Great Northern Highway surface (including shoulder). The south portion of the slope is considered more critical, as this contains a greater degree of weathering and closer proximity to the highway.

Figure 6 - Assigned weathering grades in the west wall

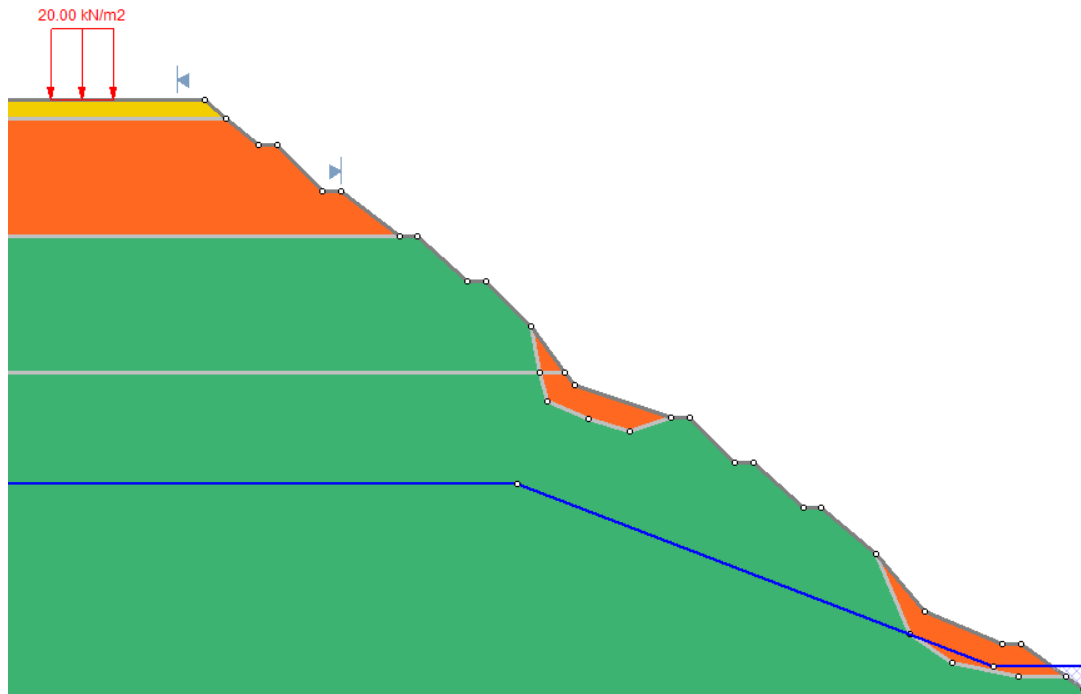
A “what-if” analysis was conducted for erosion and increased weathering at spigot locations. For this analysis two points of the slope were cut-back, with the surrounding rock increasing in weathering grade from Grade II to Grade III. The eroded sections were assigned arbitrarily, but at locations where spigots are likely to be placed. The eroded zones were not placed in the highly weathered near surface zones, as spigot placement in that zone is not recommended while the slope height is large. The what-if section is illustrated below.

Figure 7 - What-If Analysis with eroded zones.

The analysis indicated that stability at the highway surface is not greatly affected by the development of minor erosion and weathering around spigots.

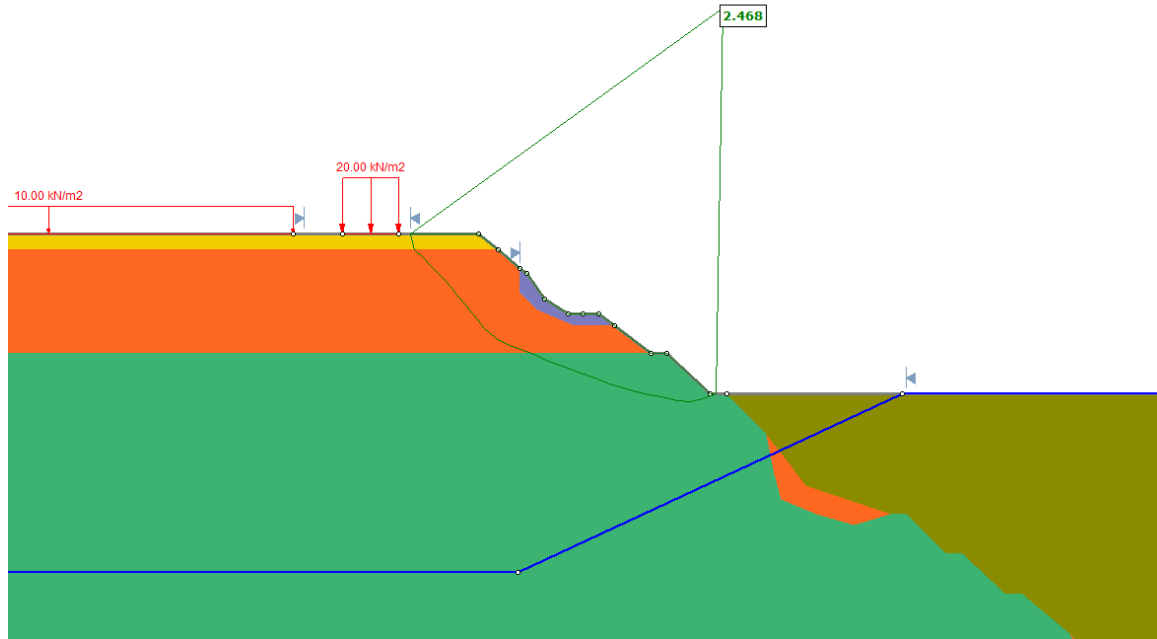
A further analysis was also carried out for a future scenario where the pit is substantially infilled with tailings, and a spigot placed within the Grade III rock has caused additional weathering to gravel. This analysis indicated that slope stability effects would be localised only, and stability of the highway surface remained at an acceptable level. At this height within the slope the spigot erosion is potentially more impactful to the road, and should be more carefully monitored, or the spigots placed elsewhere within the TSF once the tailings deposition reaches this level.

Figure 8 - Stability on an infilled pit with erosion/weathering at a high-placed spigot

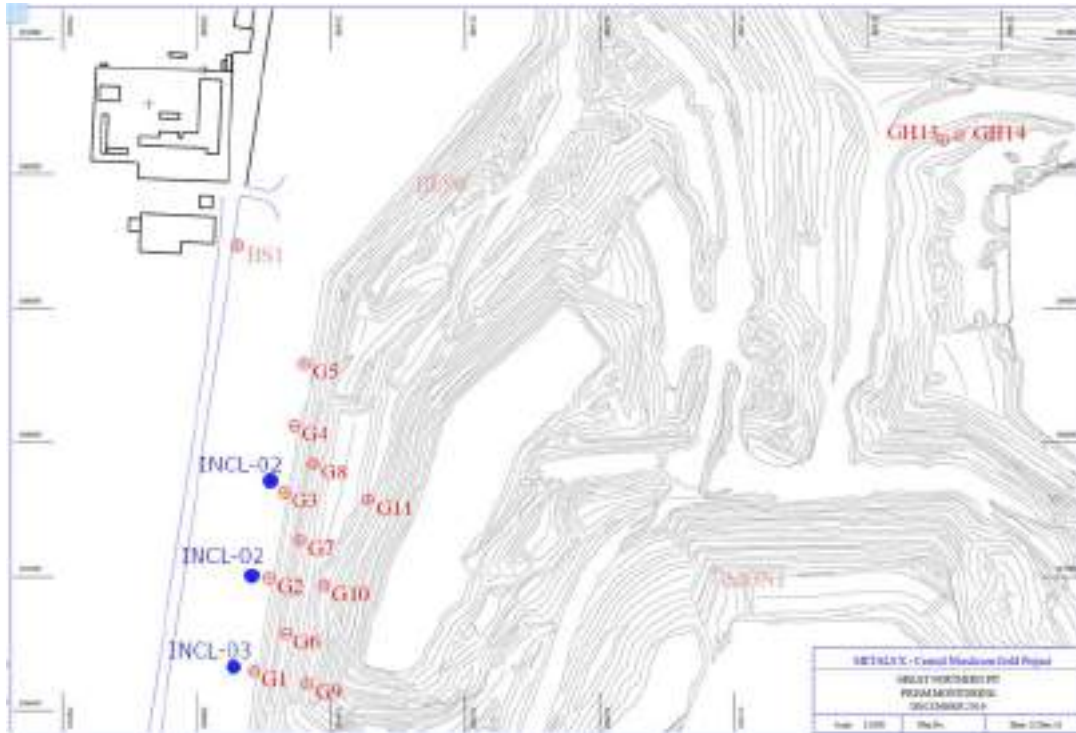
Inclinometers and survey prisms are present along the west wall of GNH pit for the purposes of ongoing monitoring of any pit wall movement adjacent to the highway. The prisms are currently surveyed about once every two weeks, while the inclinometer are read annually. An increased frequency of prism surveying is recommended, to at least weekly or twice weekly. Additional inclinometer readings may be required if visual observations or prism monitoring indicates a potential for movement. The location of prisms and inclinometers is indicated on Figure 10.

Figure 10 - Existing instrumentation locations
