Application for Licence Amendment

Licence Number	L8457/2010/2
Licence Holder	Silver Lake (Integra) Pty Limited
ACN	093 278 436
File Number	2012/006865
Premises	Salt Creek Processing Facility Mount Monger Road EMU FLAT WA 6431 Legal description – Mining tenements M25/71, M25/125, M25/133, M25/307, M25/347 General purpose lease L25/27, L25/31, L25/33, L25/41 Miscellaneous licence G25/02 As defined by the Premises maps attached to the Revised Licence
Date of Report	07 November 2023
Decision	Revised licence granted

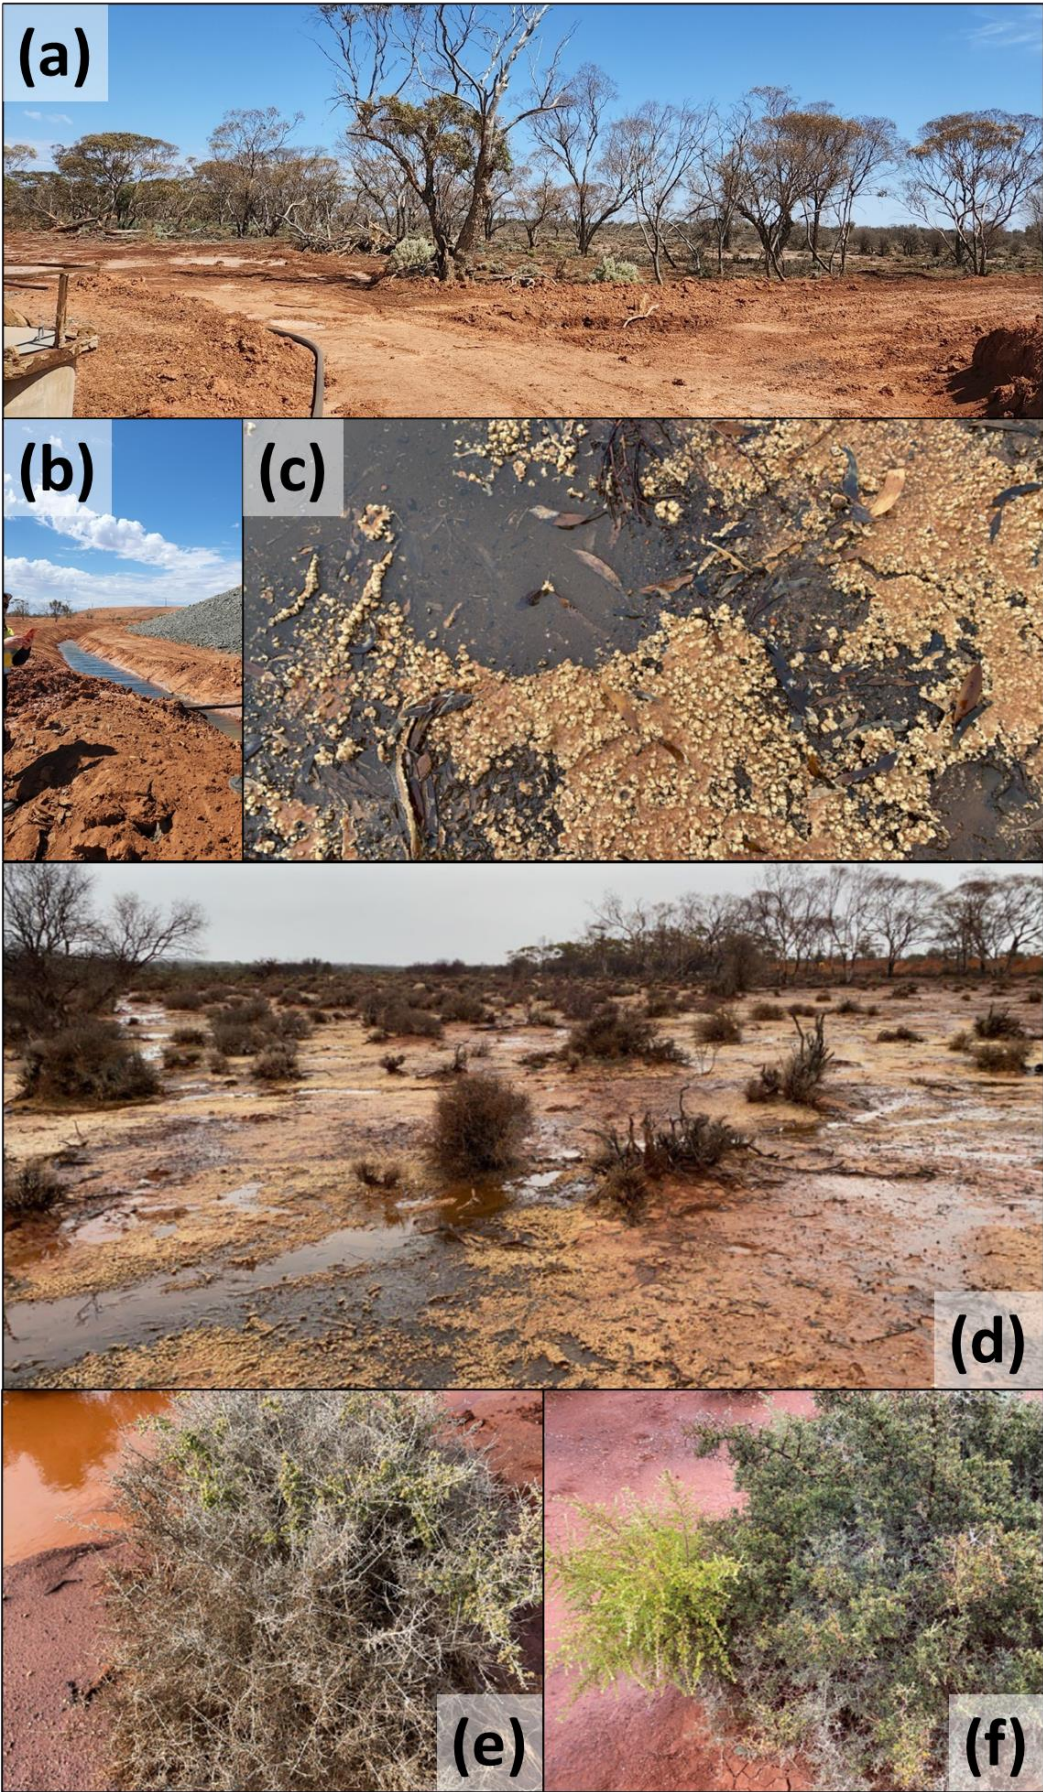
Figure 1: Photographic documentation of environmental impacts

In the same quarter of 2023, an inspection conducted by the Department of Mine, Industry Regulation and Safety (DMIRS) on 21 March 2023 found vegetation stress and potentially death on the northern boundary of TSF2, which was advised to be a result of the rising SWL (Figure 1a). The TSF2 toe drain was also showed to be filled with seepage water, which suggested that recovery pumping may not have been undertaken adequately to reduce water level at the drain (Figure 1b).

On 8 May 2023, the Licence Holder encountered an area of light-discoloured soil directly west of the TSF2. The area was thought to be impacted by groundwater mounding and surface expression of hypersaline groundwater, resulting in a salt crust (Figure 1c) and degradation of vegetation (Figure 1d).

The assessment recommended natural recovery by rainfall to dissipate and flush salt crusts from the impacted soils and sediments as it would cause the least disturbance to the environment (Stantec 2023). While the timeframe for natural recovery will depend on climactic conditions, this was not considered a significant issue as there are no significant or unique ecological values in the area.

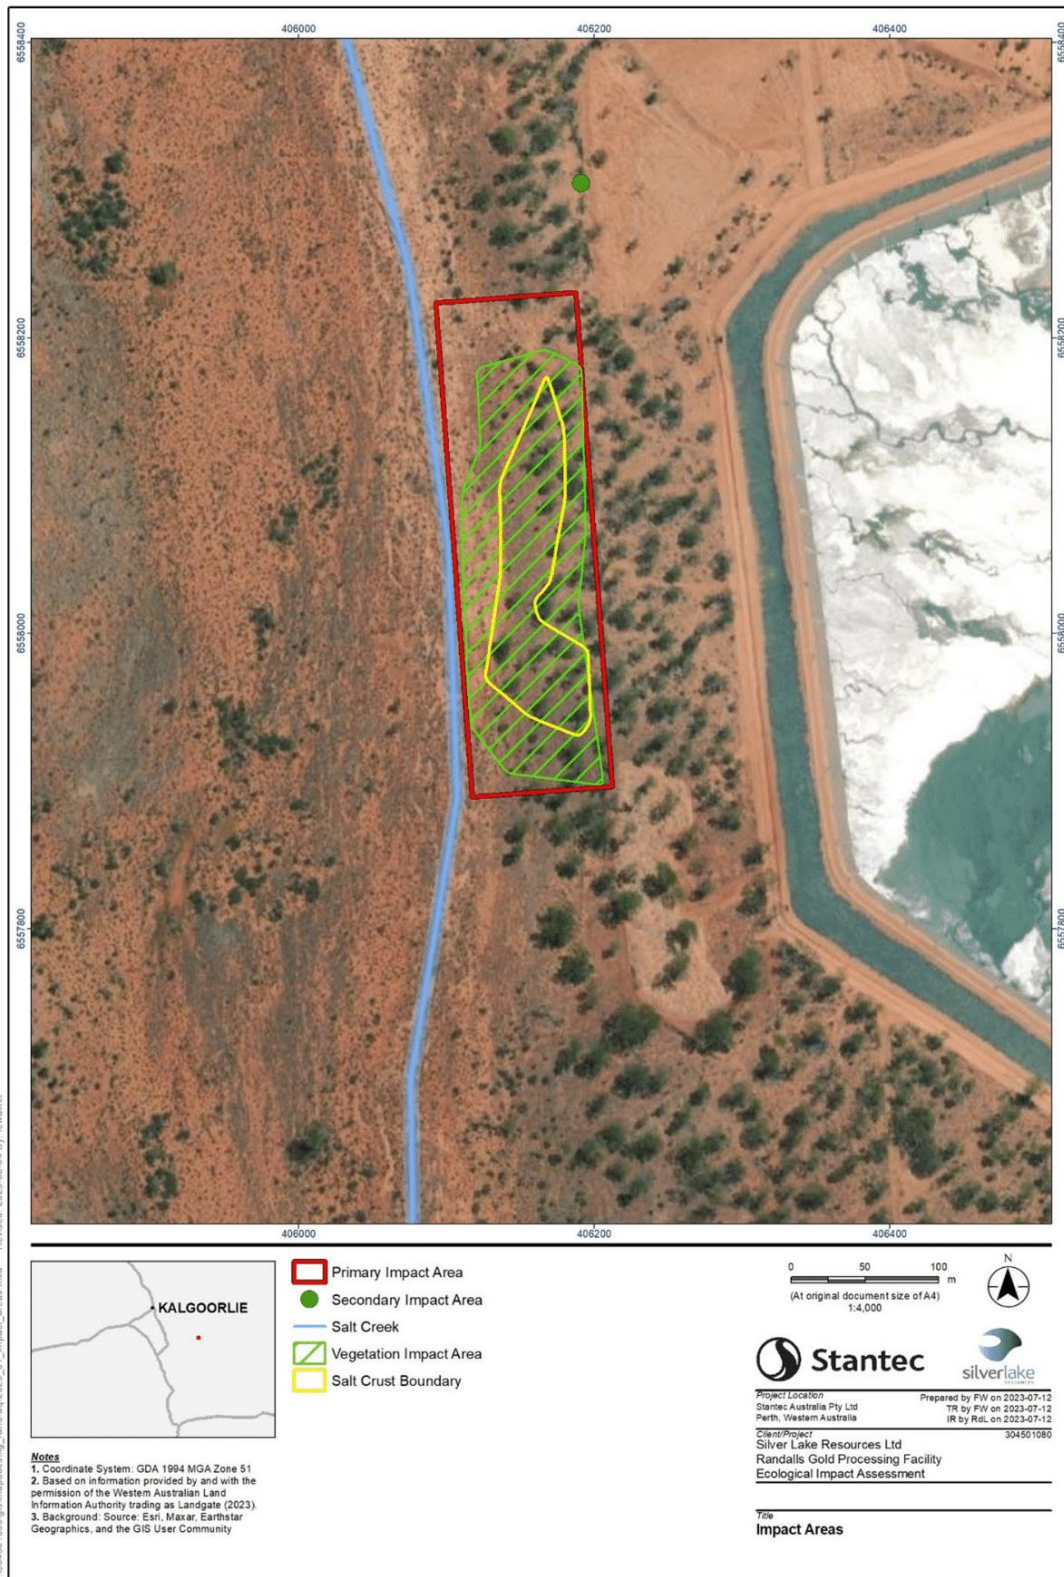
Figure 2: Extent of vegetation impact and salt crusting

Surface expression was evident at two locations: the largest area of primary impact is adjacent to TSF2, including parts of Salt Creek, while a smaller, secondary area is groundwater discharging out of a decommissioned un-grouted bore standpipe adjacent to the topsoil stockpile, approximately 100 m north of the primary impact area (Figure 2). The Licence Holder formally notified the department through an N1 form on 9 May 2023.

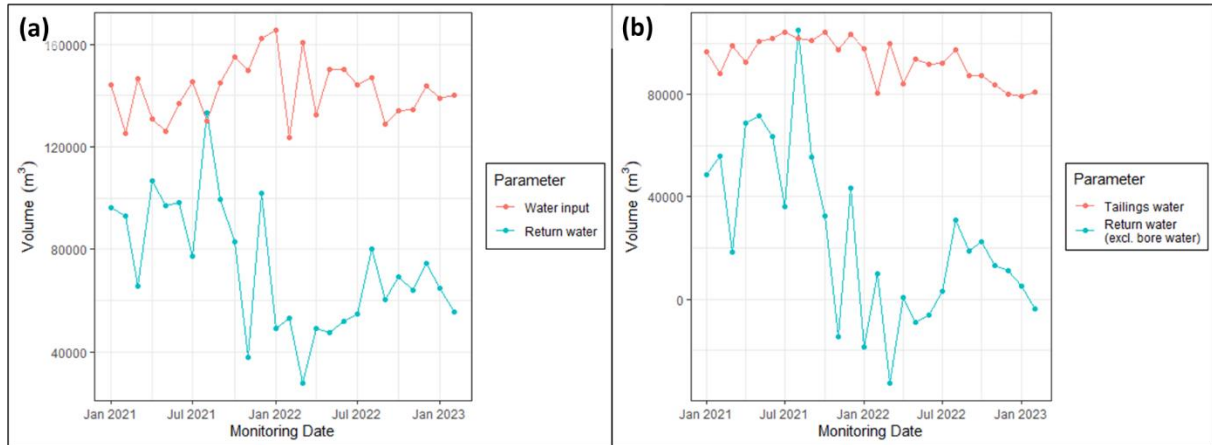
Figure 4: Comparison of water inputted into TSF2 and return water

In the water balance provided, the department noted that a pan evaporation factors of 0.5 and 0.88 was utilised for the supernatant pond and tailings beach, respectively. However, the rate of evaporation from the surface of a hypersaline water body is typically lower than for a similar freshwater body. Measurements taken from TSFs with hypersaline water in the Goldfields region have indicated pan evaporation factors of about 0.4 and 0.2 for supernatant pond and

tailings beach in the region (Newson and Fahey 2003). The same investigation also indicated that tailings beaches that are covered with salt crusts are likely to have a pan factor of less than 0.2. In those respects, the pan evaporation factors utilised in the existing water balance likely overestimates evaporation from TSF2, meaning there is a greater volume of water in the TSF that could potentially infiltrate as seepage.

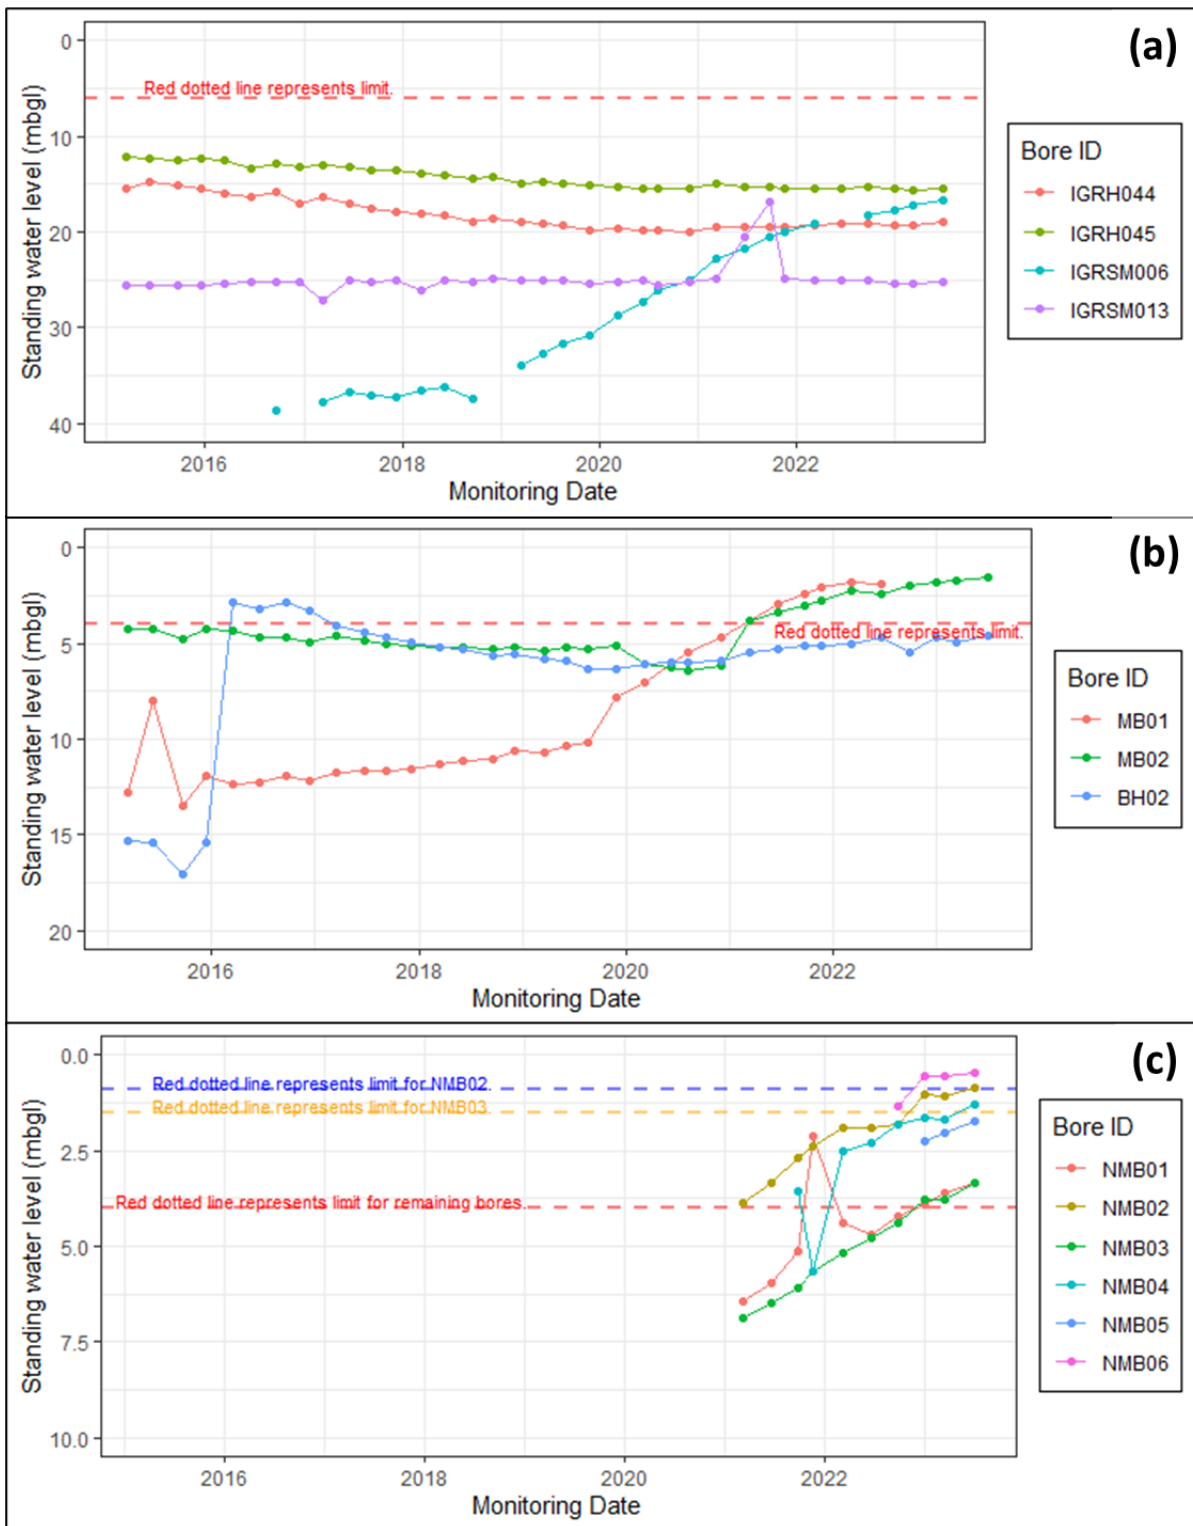
Figure 6: Standing water level trends at groundwater monitoring bores (a) east of TSF2, (b) west of TSF2 (pre-TSF2) and (c) west of TSF2 (recently installed to monitor TSF2)

By December 2022, standing water levels at all monitoring bores³ surrounding the western portion of TSF2 were detected above 4.0 mbgl (Figure 6b and Figure 6c). Groundwater was

closest to the surface along the north-west and south-west of the premises. In March 2023, monitoring bores NMB06 (i.e., north-west) and NMB02 (i.e., west) had standing water levels at 0.47 mbgl and 0.86 mbgl, respectively. Contouring of groundwater elevation data from this monitoring event indicated that the local water table was present between RL 292.0 m and RL 296.0 m⁴, flowing in primarily a south-westerly direction (Figure 7).

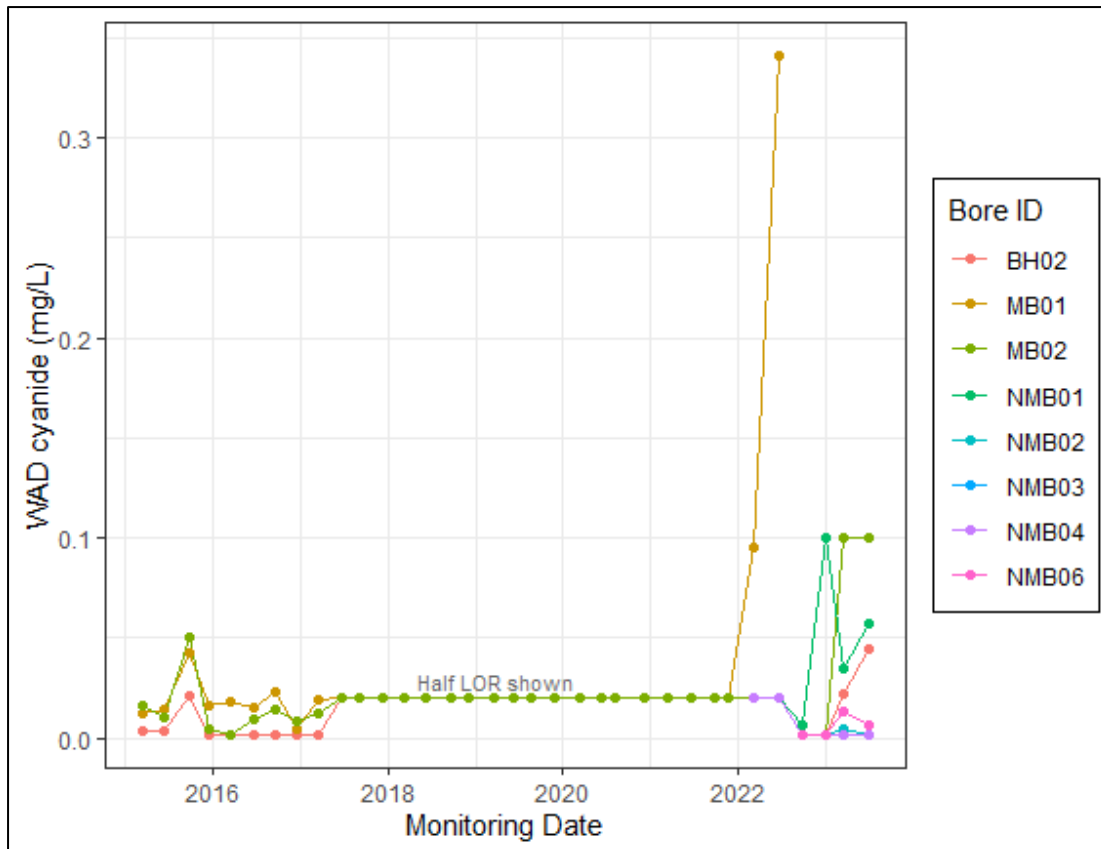
Figure 8: Weak acid dissociable cyanide concentrations

Since 2017, WAD CN has historically been detected below the limit of reporting. However, detectable concentrations of WAD CN have been observed in monitoring bores BH02, MB002, NMB02 and NMB06 during groundwater monitoring events in 2023 (Figure 8). Earlier, in 2022, WAD CN was also detected in monitoring bores NMB01 and MB001.

Despite the lack of temporal trends observed in the existing groundwater monitoring data, the recent detection of WAD CN in groundwater monitoring bores may be indicative of seepage from TSF2. That being said, seepage influences on the aquifer may have occurred long before WAD CN was detected in groundwater samples as cyanide may be bound up in metal-complexes that is not detected in WAD CN analytical procedures. Additionally, WAD CN can be rapidly degraded by subsurface microorganisms in some geological environments, resulting in a short half-life.

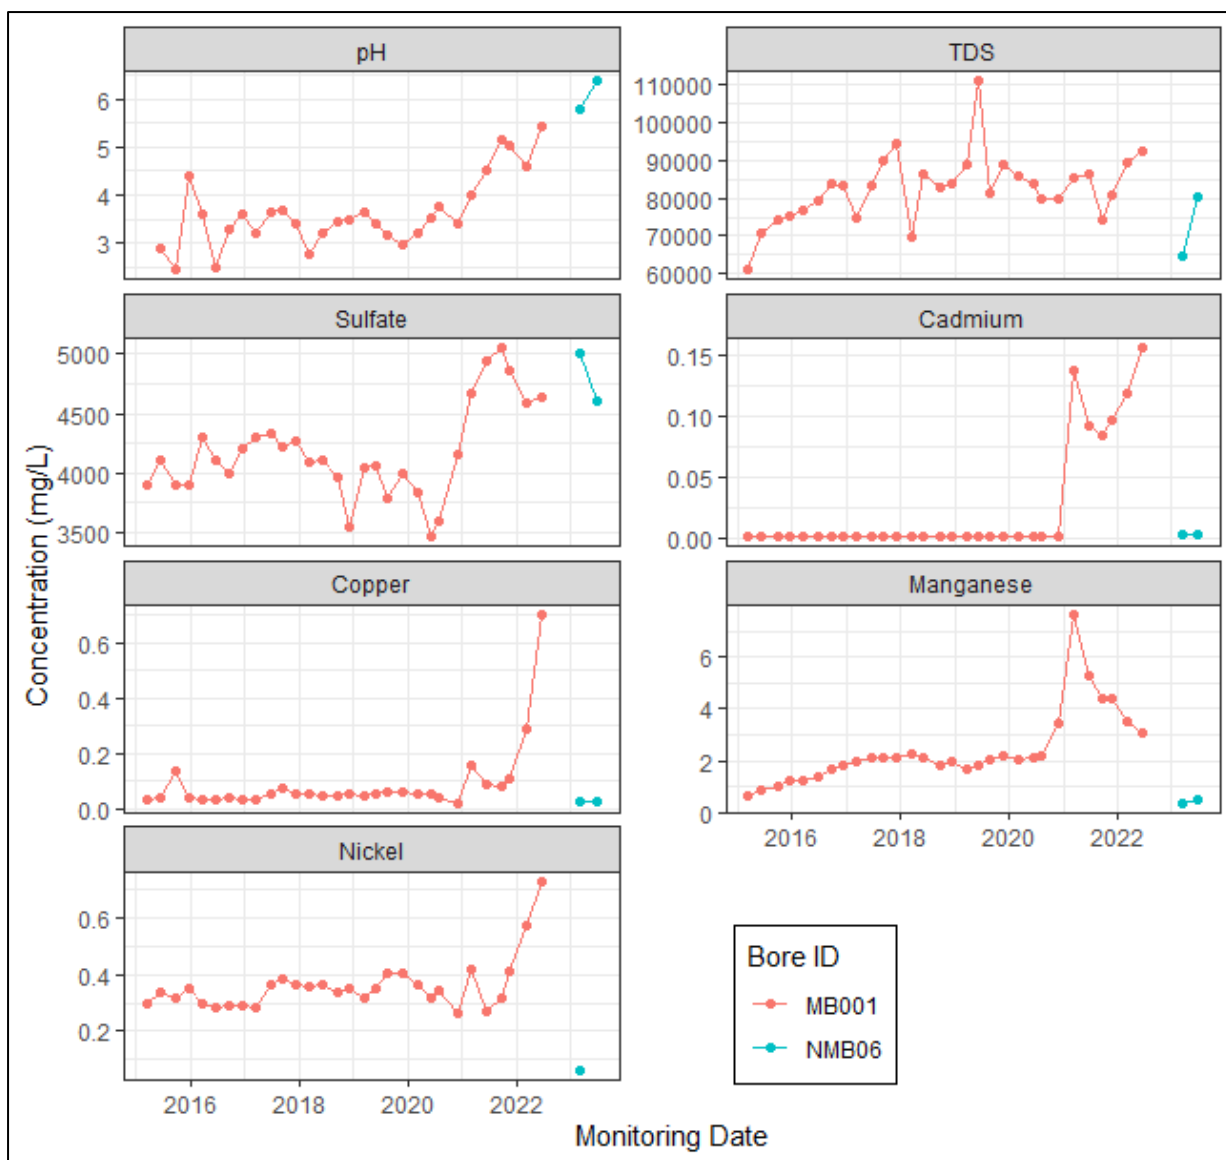
Figure 9: Groundwater chemistry plots at monitoring bore MB001 and replacement bore NMB06

A monitoring bore of potential concern was the now-decommissioned MB001 located north-west of TSF2, which had reported the shallowest groundwater, not only has the standing water level at this bore location increase logarithmically since 2019 (Figure 6) and WAD CN concentrations up to 0.34 mg/L in 2022 (Figure 8), changes in the groundwater chemistry had also been observed (Figure 9). Specifically, field pH appeared to have increased from historically around 3 pH units to 5 pH units in the 2021 monitoring events onward. In addition, dissolved metal concentrations of copper, nickel, manganese and cadmium, as well as sulfate concentrations also became elevated during this period. Heavy metals, such as copper and nickel, are known to form strong complexes with cyanide ions and are readily leached from minerals during gold ore processing (Rees & van Deventer 1999). No significant changes in TDS were observed. No further monitoring is possible at this location as the monitoring bore was decommissioned in 2022 to construct the North Groundwater Recovery Drain.

A shallower replacement monitoring bore NMB06 was installed in September 2022 approximately 35 m away from MB001. Groundwater sampled at this monitoring bore was less acidic, with sulfate concentrations comparable to MB001 (Figure 9). Of note was that elevated metal concentrations previously identified in MB001 were not elevated in monitoring bore NMB06, despite being a shallower bore (and thus, able to detect impacts from seepage from immediately). Continued monitoring is required to better understand the groundwater in this area, given previous observations at MB001.
