Application for Licence Amendment

| Licence Number | L9010/2016/1 |
| Licence Holder | Mount Morgans WA Mining Pty Ltd |
| Premises | Mt Morgans Gold Project Mining tenements M39/236, M39/395, M39/390, M39/272, M39/18, M39/228, M39/264, M39/304, M39/240, M39/248, L39/246, M39/441, M39/250, M39/504, M39/745, M39/403, M39/282, M39/36 and M39/1107 |

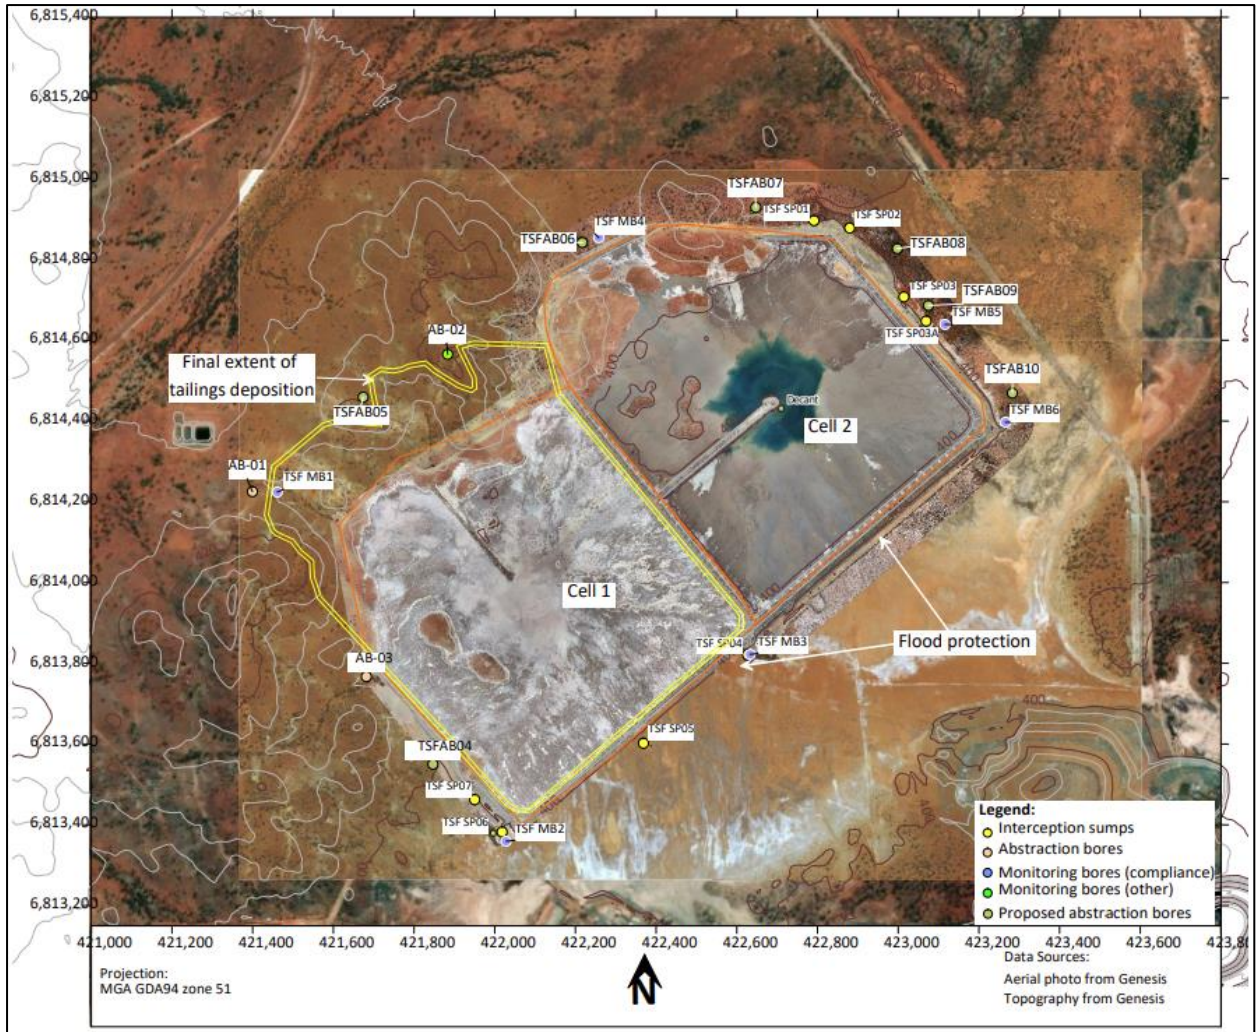
Figure 1: TSF Cell 1 and Cell 2 monitoring and seepage recovery infrastructure (Sourced from GRM 2024)

Within the GMP (2024) it is mentioned that two abstraction bores (TSFAB01 and TSFAB03) were installed to control groundwater mounding at TSF MB1. Figure 1 provides the current monitoring and seepage recovery infrastructure and the proposed seepage recovery infrastructure if groundwater levels continue to rise surrounding the TSF. GMP (2024) has also recommended that additional seepage infrastructure is installed at TSF MB4, TSF MB5 and TSF MB6 to control the rising groundwater expected from the future tailings deposition at Cell 2. The seepage infrastructure suggested involves abstraction bores equipped with a submersible pump with headworks, gensets and pipelines to pump intercepted groundwater to the TSF surface or to the process plant.

Recently, there has been a reduction in groundwater levels surrounding TSF Cell 2 as presented in Figure 5, however it is noted that the Premises has been in care and maintenance since March 2023 (CMW 2023). Currently the only discharge deposited into the TSF Cell 2 is the leachate recovered from sumps: 02, 03, 03A, 04, 05, 06 and 07 (Figure 1).

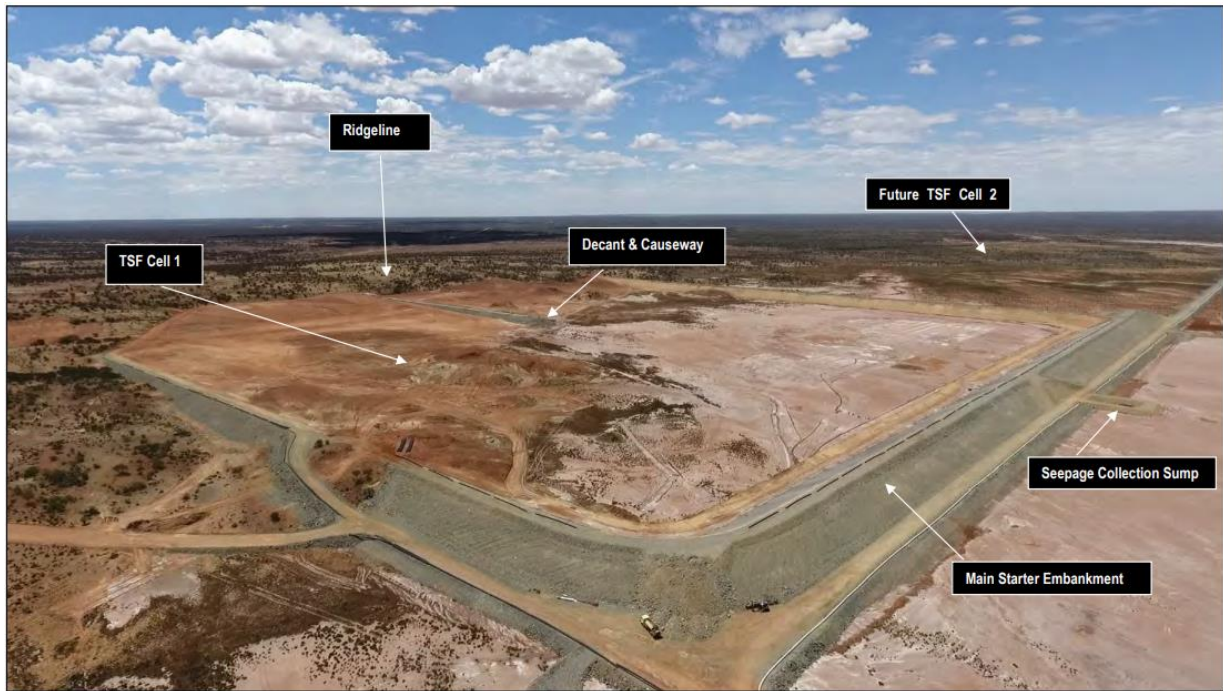
Initial construction of TSF Cell 1 was completed in January 2018 and included an underdrainage system which involved a 1.5 mbgl cut-off lined trench under the upstream toe of Stage 1 Cell 1 embankment to restrict potential seepage under the perimeter embankment. The trench leads to a seepage collection sump consisting of a 1.5 x 1.5 x 1.5 m lined concrete box (Figure 2). TSF Cell 2 was completed in April 2019 and included a cut-off lined trench under the upstream toe of Stage 1 Cell 2 which leads to a seepage collection sump (Dacian 2019).

Figure 2: Seepage collection sump at the construction of TSF Cell 1 Stage 1 (Sourced from Dacian 2018)

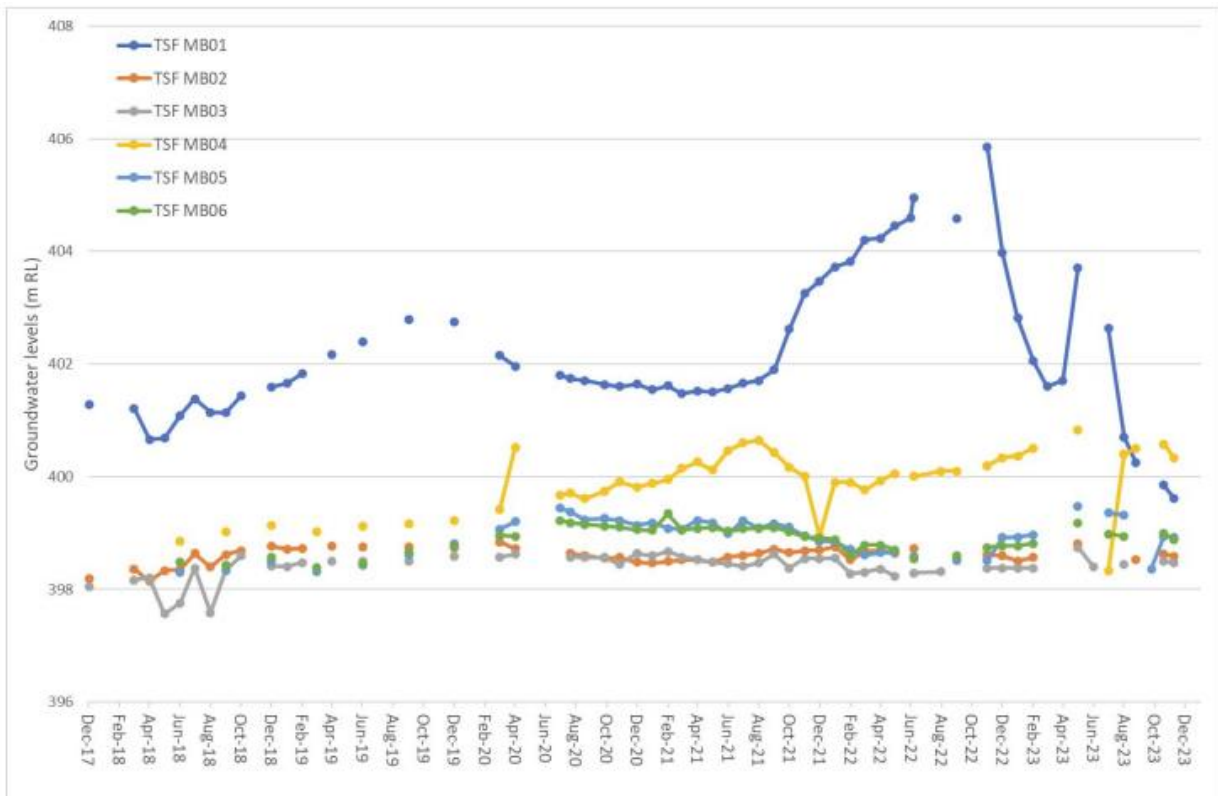
In October 2022 the Licence Holder installed three groundwater abstraction bores (TSFAB01 – TSFAB03) to reduce the groundwater levels at the northwest embankment of the TSF (near TSF MB1). The reduction of groundwater levels in TSF MB1 was deemed necessary as groundwater levels at TSF MB1 are at a higher elevation than those downgradient (Figure 3).

Figure 3: Groundwater levels (mRL) from December 2017 to December 2024 (Sourced GRM 2024)

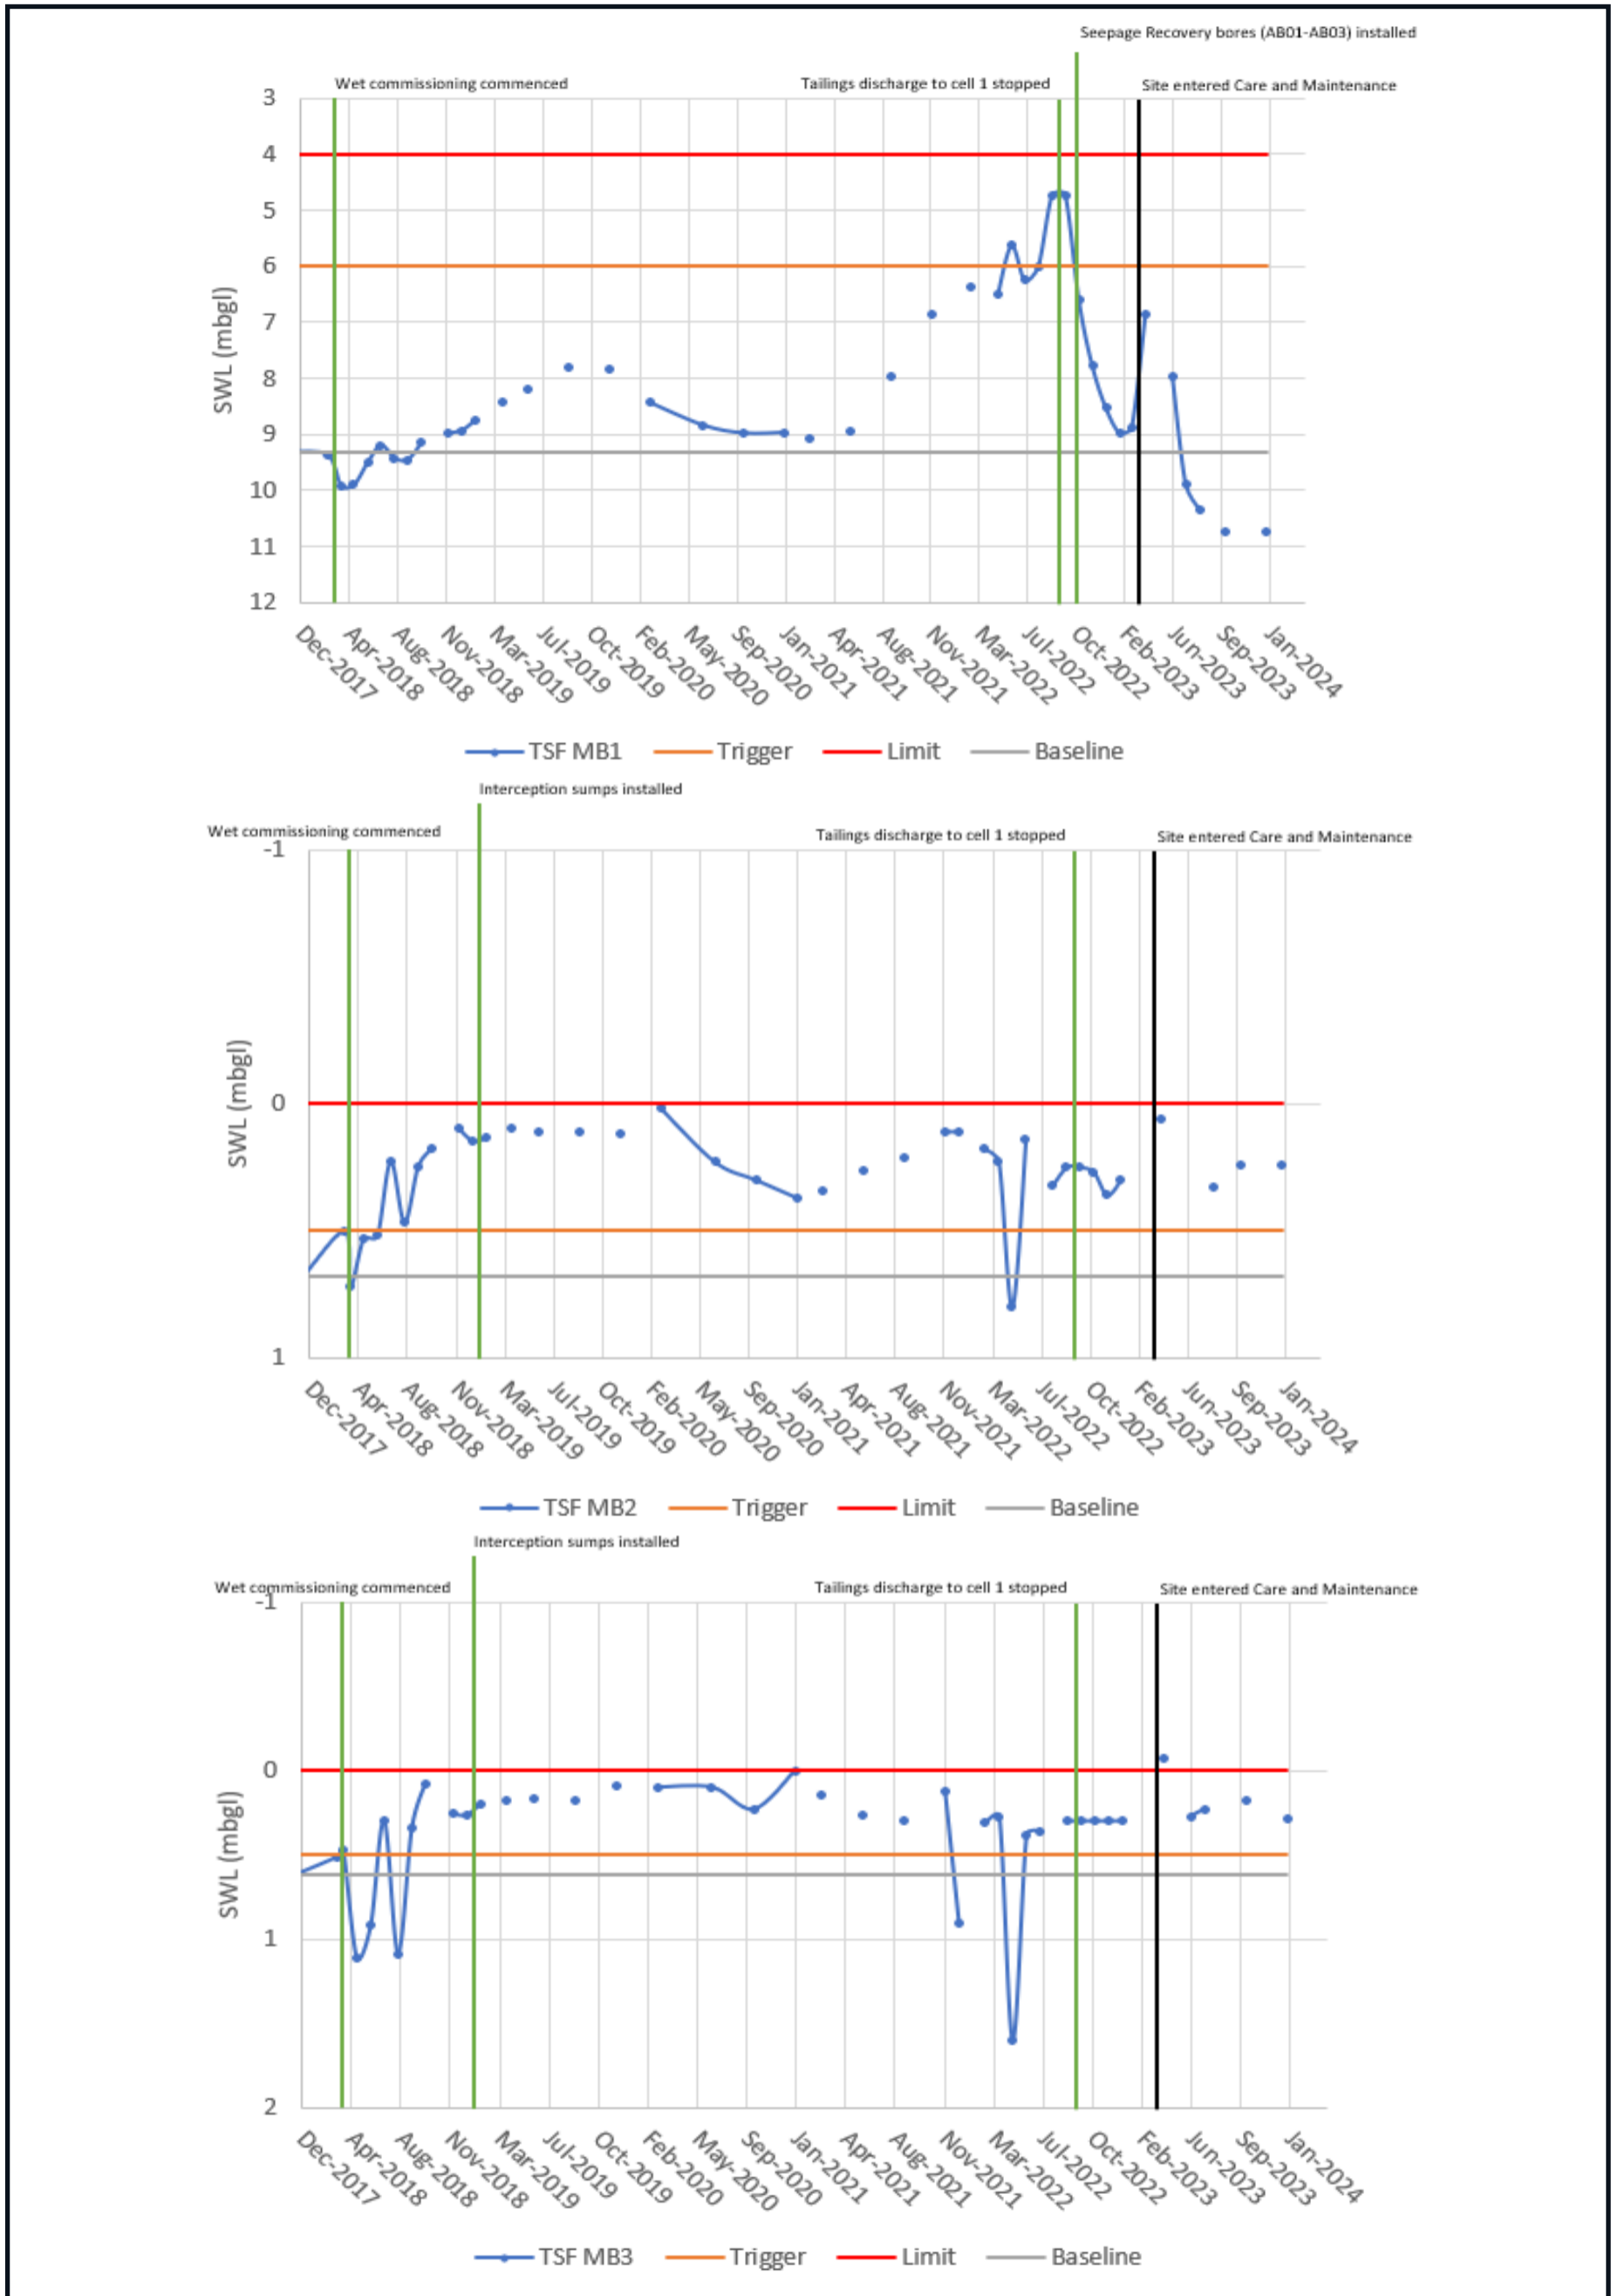
It was observed that TSFAB02 was receiving low abstraction yields during installation and was therefore constructed as a monitoring bore (GRM 2024). Installation of the seepage recovery bores were completed after tailings discharge to Cell 1 was stopped. Both abstraction bores and cessation of tailings discharged appeared to have a significant reduction of groundwater levels from 4.73 mbgl (Figure 4).

Figure 4: Historical groundwater levels with baseline, trigger and action limit levels for TSF Cell 1, trigger and action values sourced from GRM 2021

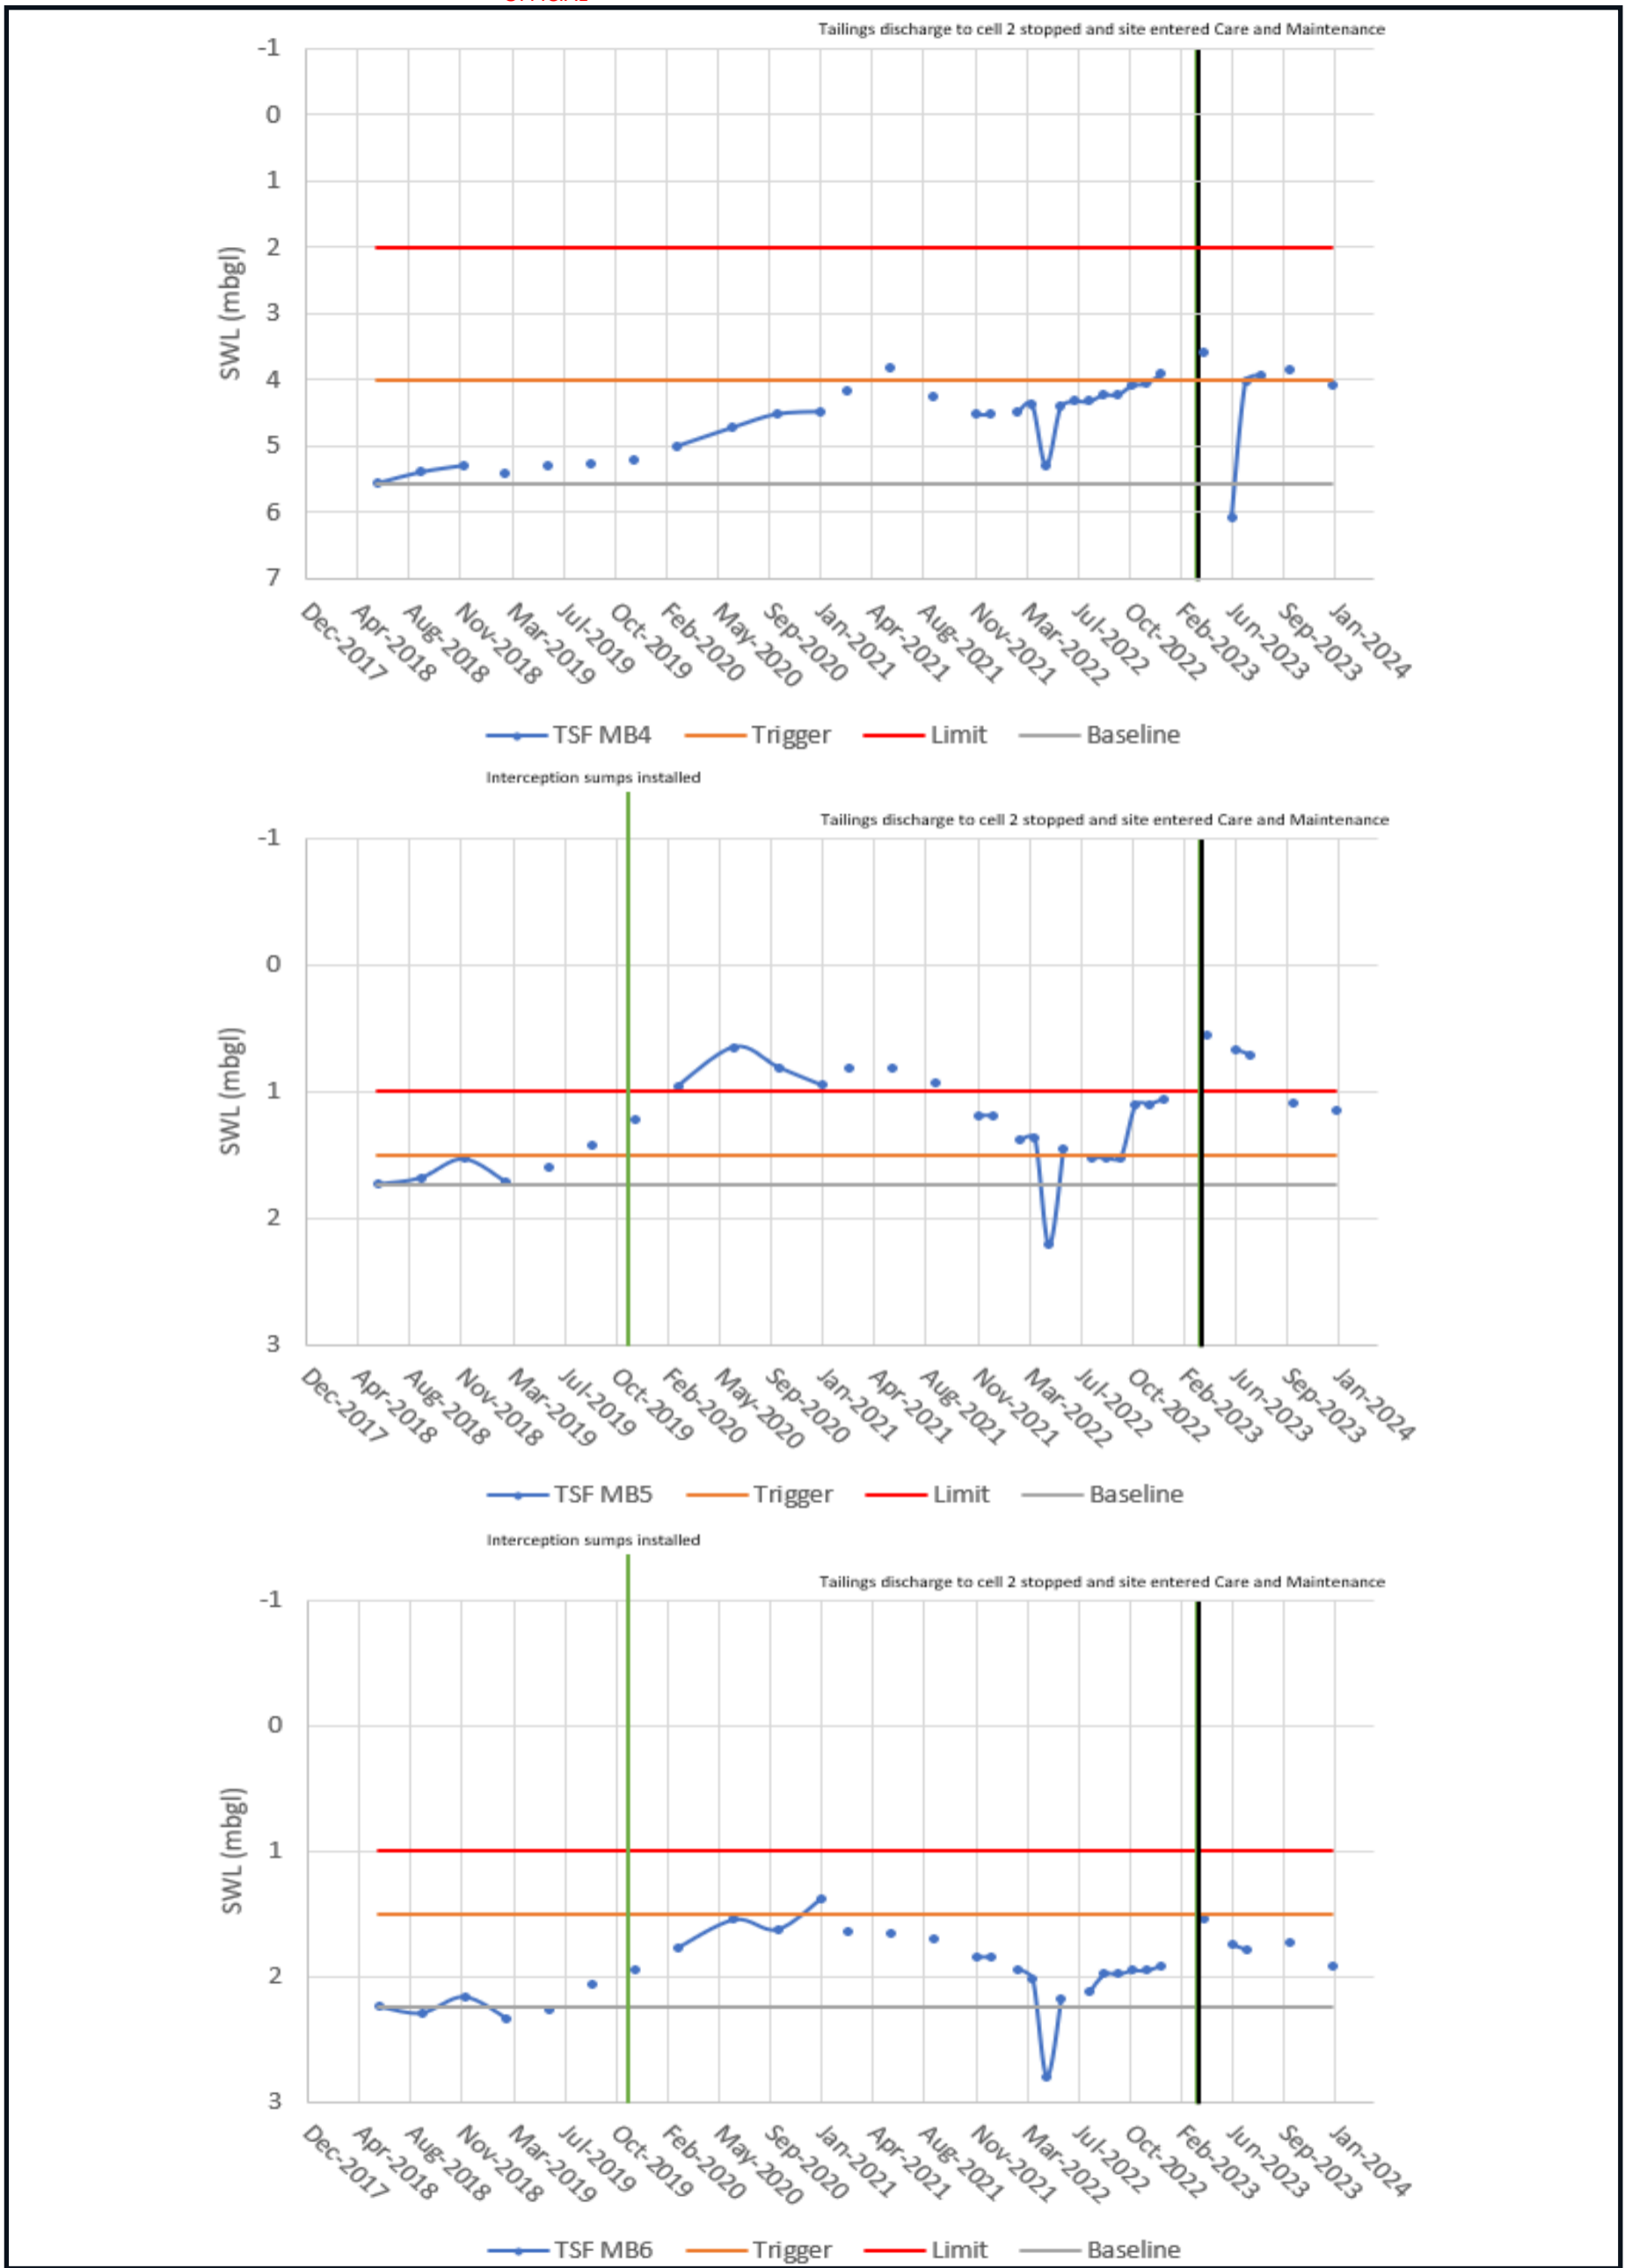
Figure 5: Historical groundwater levels with baseline, trigger and limit levels for TSF Cell 2 trigger and action values sourced from GRM 2021

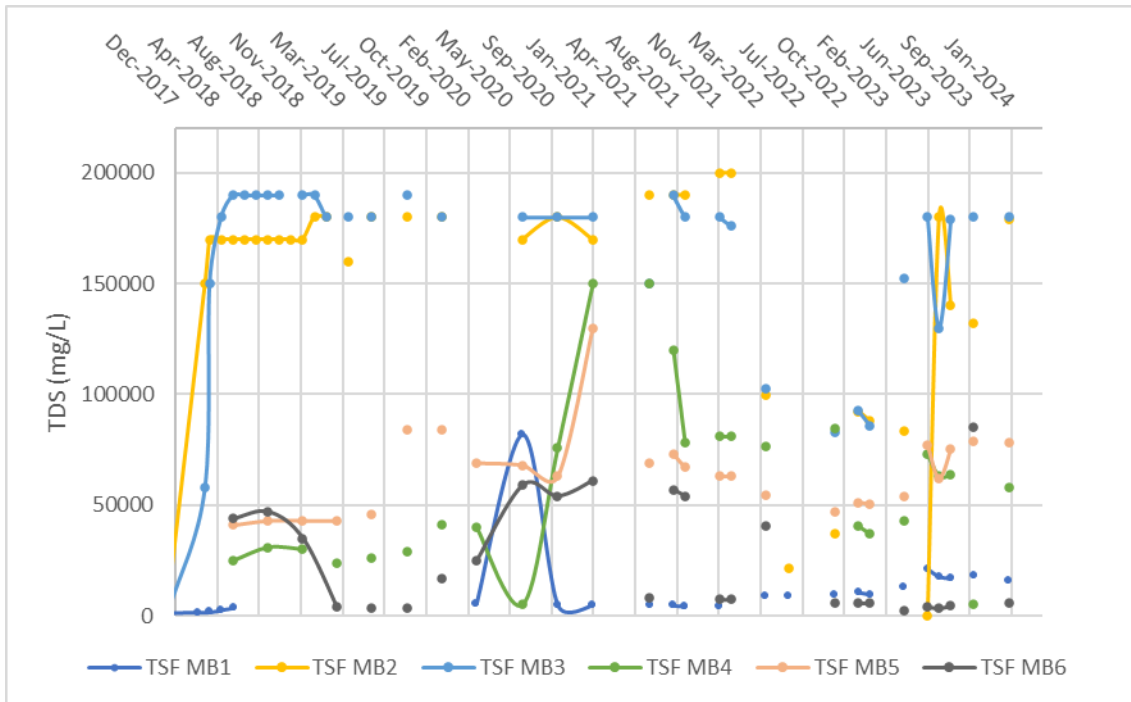
TSF MB6. Since TSF operation began TDS concentrations within all monitoring bores have increased from baseline conditions (Figure 6) however there appears to be on a general downward trend from 2021.

Figure 6: TDS concentration in TSF monitoring bores

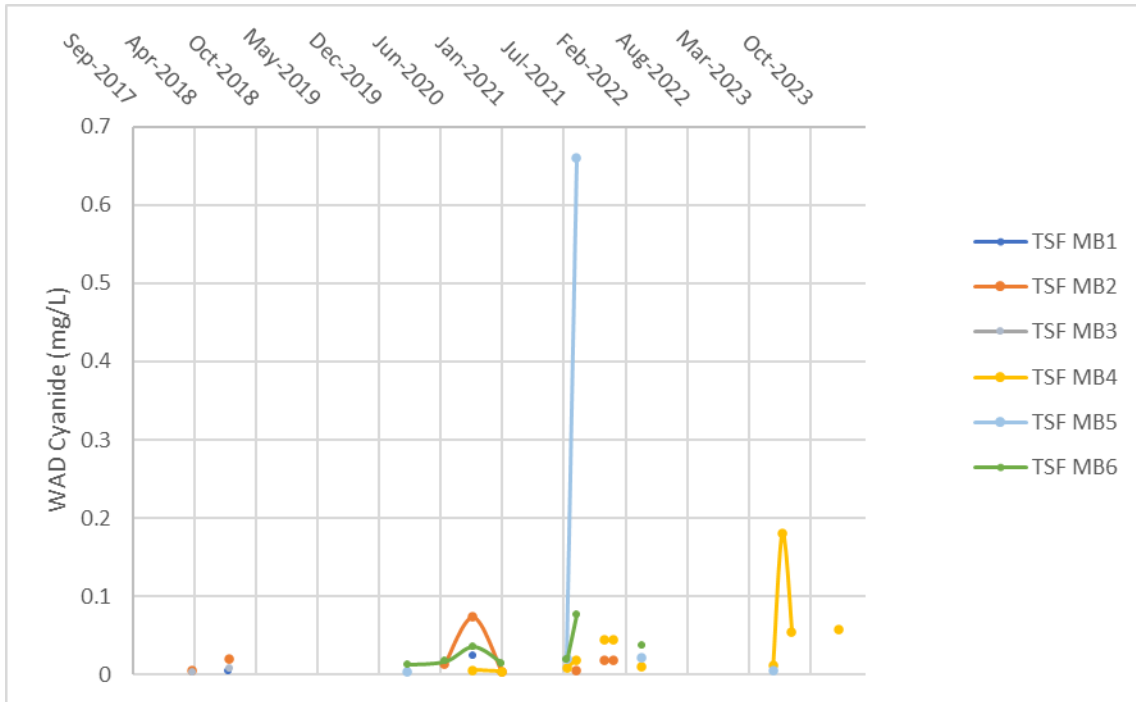
GRM (2021) has suggested that groundwater quality monitoring data indicates that seepage generated from the TSF does not penetrate deeply into the groundwater zones. Evidence of this conclusion was due to the low concentrations of WAD cyanide reported in groundwater samples (Figure 7) when compared with recent TSF decant pond samples (12 to 36 mg/L) and decant return samples (4 to 110 mg/L). GRM (2021) has noted that there are no other chemical signatures (metals and metalloids) of TSF seepage reaching groundwater. GRM (2021) notes that the potential impact of groundwater expressions on surface on the playa lake is very small because of the dilution affects. The Department notes that groundwater samples collected from monitoring bores surrounding the TSF (Figure 7) suggests that limited seepage of contaminants is occurring.

Figure 7: Reported concentrations above LOR of WAD Cyanide in TSF groundwater monitoring bores

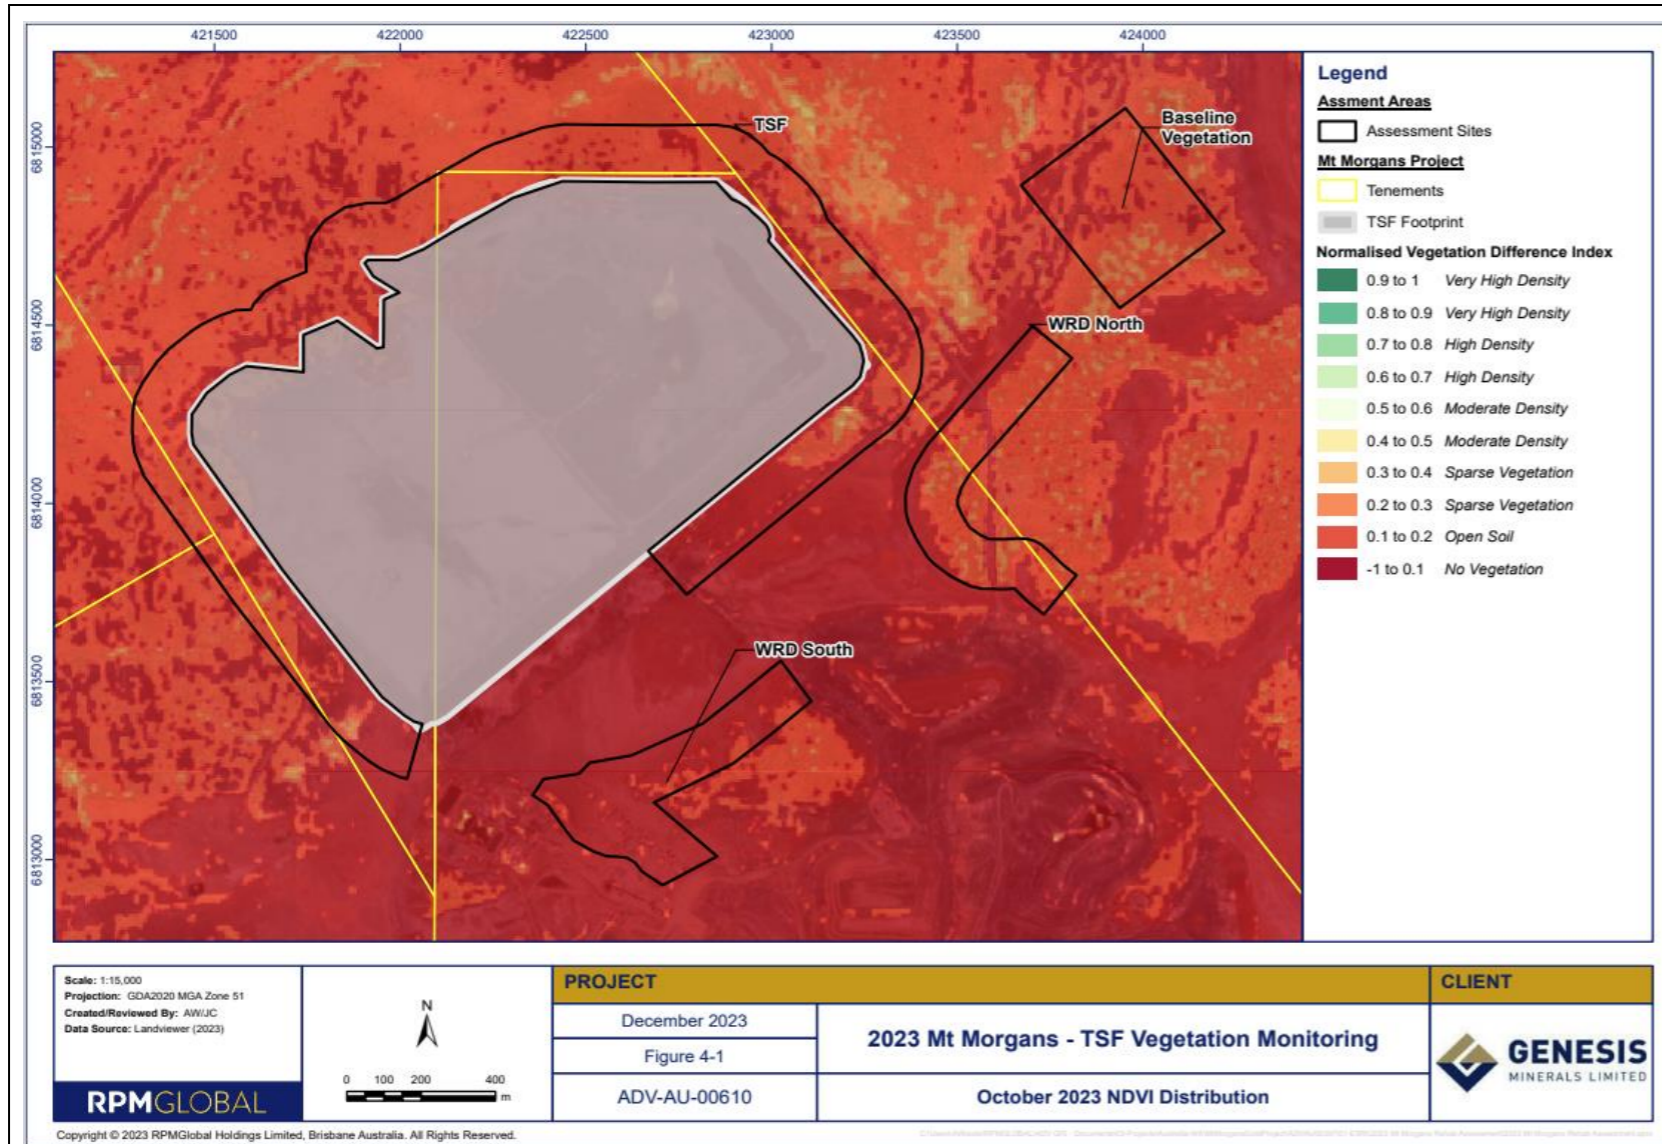
Conclusions presented within the 2023 vegetation monitoring report suggest that there has been an overall decrease in vegetation health and density since the TSF vegetation monitoring program began in 2018. RPM mentions that the vegetation loss extends beyond the TSF zone of influence (Figure 10) and suggests the decrease in vegetation health and density may be attributed to the reducing rainfall trend over the same time-period. RPM states that the southern WRD monitoring location (Figure 8) has notably more vegetation loss than other monitoring locations and suggests that the loss is attributed to dust deposition for the coarse ore stockpile nearby.

Figure 8: Vegetation monitoring areas with October 2023 NDVI distribution (RPM 2024)

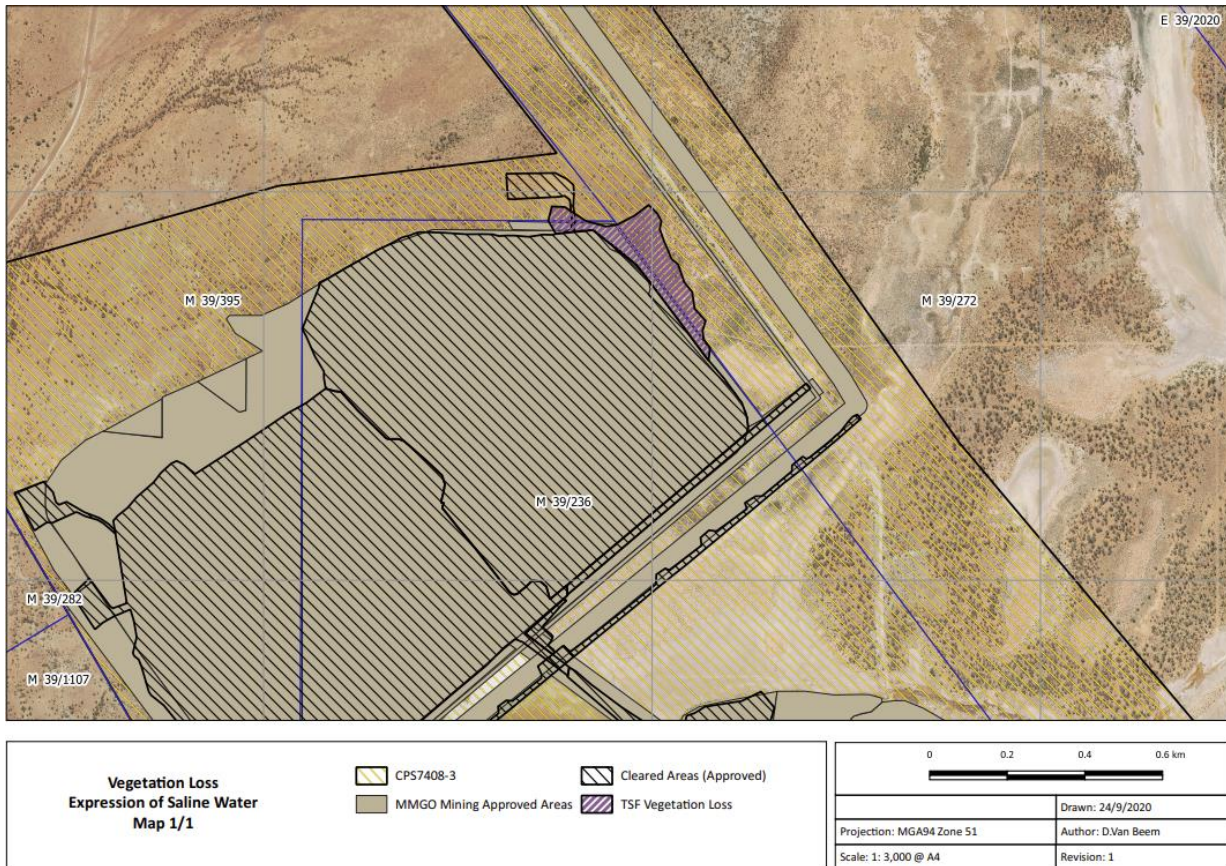
Known incidents of native vegetation loss reported to the Department relating to the operation of the TSF was received from the Licence Holder on the 24 September 2020. The Licence Holder mentioned within the notification that salt deposited from the receding surface water on the eastern side of the TSF has impacted approximately 3.8 hectares of vegetation (Figure 14). Results from the 2020 annual vegetation monitoring event report mentions that there was a slight decrease in overall biomass as observed in the 2020 NDVI but is most likely attributed to a combination of climatic variation and spectral variation (humidity and haze).

Figure 14: Vegetation Loss via expression of Saline Water
