Annual Audit Compliance Report Form

Environmental Protection Act 1986, Part V Division 3

Section A – Licence details					
Licence number:	L4247/1991/13 Licence file number: 2012/0071641				
Licence holder name:	Talison Lithium Austral	ia Pty Ltd			
Trading as:					
ACN:	139 401 308				
Registered business address:	Level 15, 216 St Georges Terrace, PERTH WA 6000. Locked Bag 40, Cloister Square, PERTH WA 6850				
Reporting period:	01/07/202 to 30/06/2024

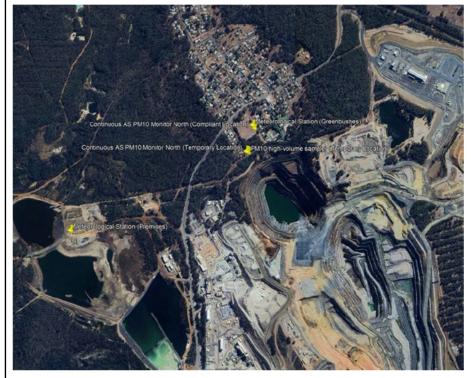
Talison has not installed the Continuous Australian Standard (**AS**) PM10 Monitor North, the Meteorological Station (Greenbushes), or the PM10 high-volume sampler as required by Condition 9, at the specified infrastructure location within the designated timeframe.

No environmental impact has resulted from this non-compliance. All monitoring was completed as required but at alternative locations to that specified in condition 9.

- Meteorological data was collected from the Meteorological Station (Premises) for the entire reporting period
- Continuous PM10 (North) data was collected from a trailer-mounted unit at the temporary location from the due date of November 30, 2023, until 20 December 2023
- On December 20, 2023, the trailer mounted Continuous PM10 (North) was moved to a location compliant with condition 9 and remained there for the remainder of the reporting period
- The PM10 High volume sampler was located at the temporary location for the entire reporting period.

Talison was unable to obtain approval from the Department of Education (DOE) for permanent installation of the Continuous AS PM10 Monitor North, the Meteorological Station (Greenbushes), or the PM10 high-volume sampler at the location specified by DWER in Table 6 and illustrated in Figure 5 of Schedule 1 of the Licence. Approval was given for a trailer-mounted unit to be located at the compliant location on December 20, 2023.

- Meteorological data was collected from the Meteorological Station (Premises) for the entire reporting period
- Continuous PM10 (North) data was collected from a trailer-mounted unit at the temporary location from the due date of November 30, 2023, until 20 December 2023
- On December 20, 2023, the trailer-mounted Continuous PM10 (North) was moved to a location compliant with condition 9 and remained there for the remainder of the reporting period
- The PM10 volume sampler was located at the temporary location for the entire reporting period.

In addition, Talison also conducted ongoing negotiations with DOE to obtain construction approval for the monitoring equipment

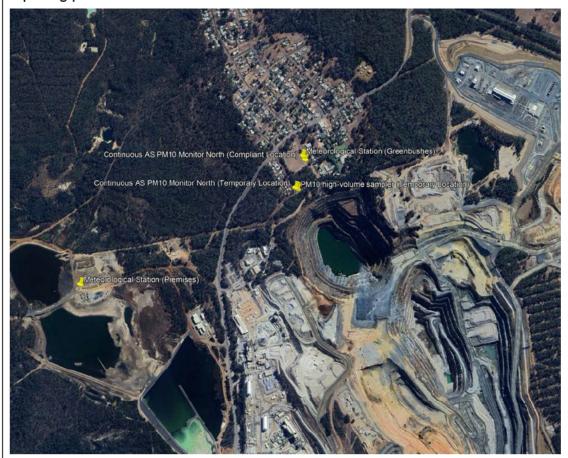
Talison was unable to install the Meteorological Station (Greenbushes) at the specified infrastructure location within the designated timeframe.

No environmental impact has resulted from this non-compliance. All monitoring was completed as required but at alternative locations to that specified in condition 29. As per the Map Below:

Meteorological data was only collected from the Meteorological Station (Premises) for the entire reporting period

Talison was unable to obtain approval from the Department of Education (DOE) for the permanent installation of the Meteorological Station (Greenbushes) at the location specified by DWER in Table 6 and illustrated in Figure 5 of Schedule 1 of the Licence.

Section E – Details of non-compliance with licence condition				
Action taken to mitigate any adverse effects of non-compliance and prevent recurrence of the non-compliance:				
The following actions were taken to mitigate the adverse impacts of the non-compliance				
 Meteorological data was collected from th reporting period 	Meteorological data was collected from the Meteorological Station (Premises) for the entire reporting period			
In addition, Talison also conducted ongoing negotiations with DOE to obtain construction approval for the monitoring equipment				
Was this non-compliance previously reported to DWER?				
⊠ Yes, and				
☐ Reported to DWER verbally	Date: / /			
⊠ Reported to DWER in writing	Date: Date: 30 November 2023, REFL11DM22ENV 2023 (notification that unable to comply with timeline specified by condition 9)
