Annual Audit Compliance Report Form

Licence number:	L4503/1975/14	Licence file number:	DER2013/000901
Licence holder name:	BHP Iron Ore Pty Ltd		
Trading as:	BHP Iron Ore Pty Ltd		
ACN:	008 700 981		
Registered business address:	Level 1, City Square Brookfield Place 125 St Georges Terrace PERTH WA 6000		
Reporting period:	01/07/2023 to 30/06/2024

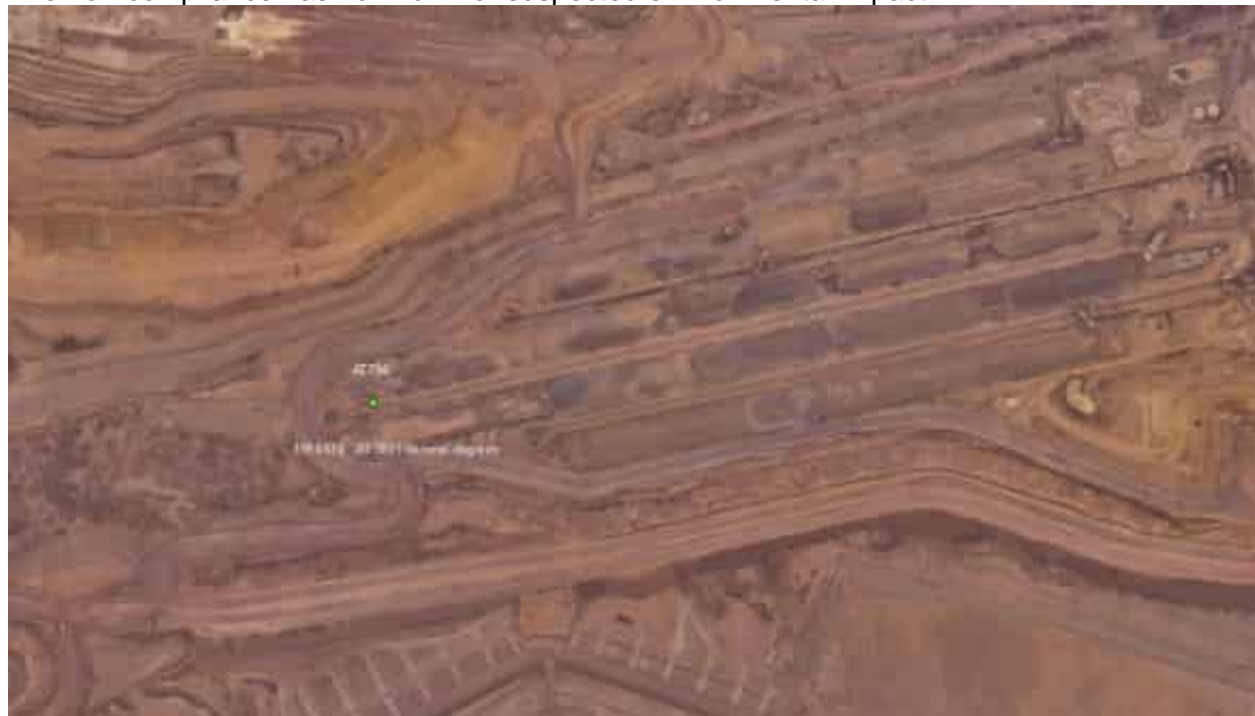
The AT796 weather station not reporting the data required in the Whaleback licence.

The non-compliance has no known or suspected environmental impact.

Equipment failure.

Issue has been communicated to relevant teams. Repair costs have been obtained and assessed. Installation of a new wind sensor with the remaining sensors and communication equipment is in progress.

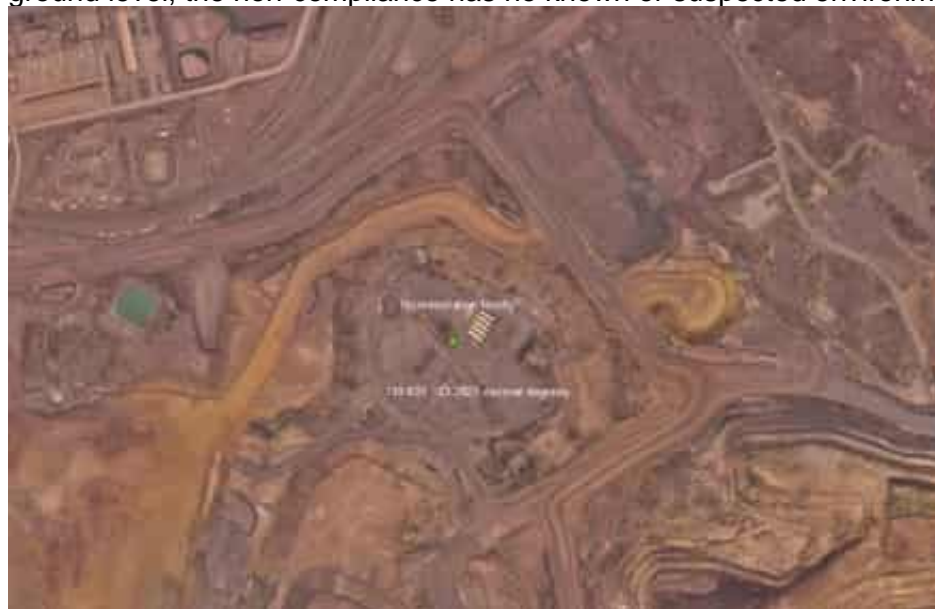
The Mt Whaleback OB29 bioremediation facility cell liner does not meet the permeability requirements of $\leq 10^{-9}$ m/s.

As the Mt Whaleback bioremediation area is located within the OB29 and is above natural ground level, the non-compliance has no known or suspected environmental impact.

Bio-remediation facility does not meet design specifications.

A Landfarm Compliance project is underway which is designing a new facility at a centralised location in Whaleback.

Engagement of engineering service consultant to review and develop design and landfarm practice under Landfarm Compliance project.

The bioremediation facility operational procedure is in the process of being updated.

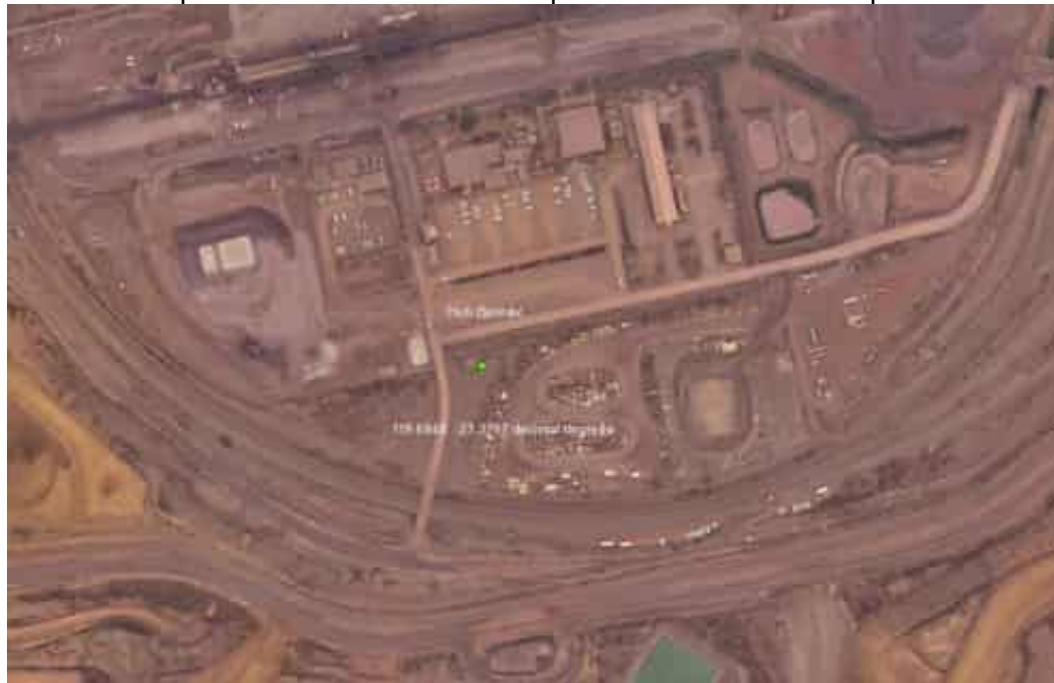
During an inspection it was found the Hub Biomax had faulted causing approximately 200 Litres of effluent to overflow onto the ground.

The non-compliance has no known or suspected environmental impact.

Equipment failure.

Reset pump breaker, pump was faulty. Waste management contractor drained the tanks and replaced the pump on 29/02/24.

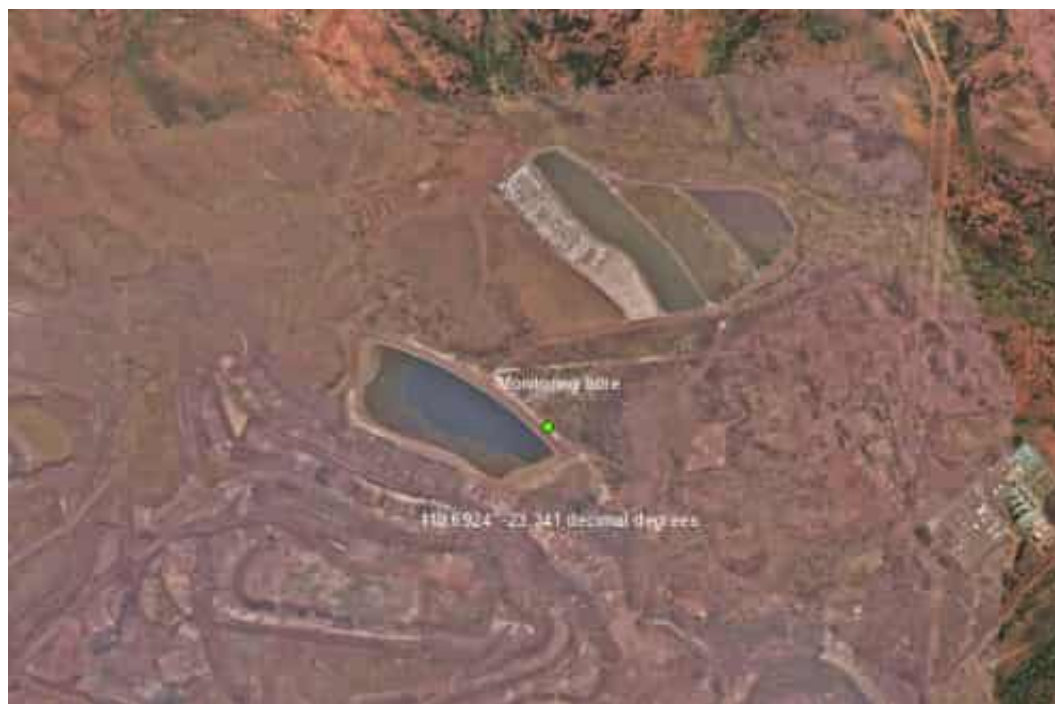
Buried groundwater monitoring bore. Unable to sample due to damaged purging cord and PVC pipe.

The non-compliance has no known or suspected environmental impact.

Equipment damage. Evidence suggests that the bore casing had deteriorated and collapsed.

Reviewing planning options to have the bore reinstated.

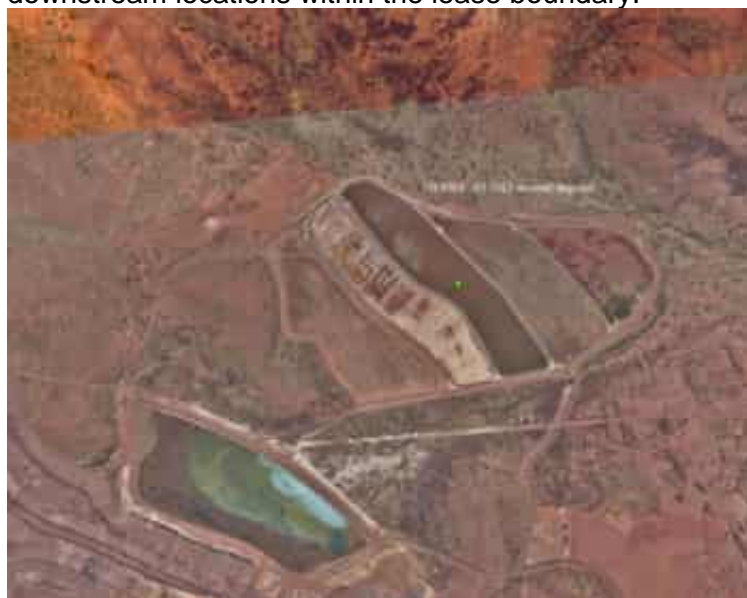
Whaleback ARD dam is non-compliant to L4503/1975/14 Table 15 Number 8, as the integrity of the containment infrastructure has not been maintained.

Minor salt scaring visible within the lease boundary. Potential impact to vegetation in downstream locations within the lease boundary.

Liner integrity compromised due to desiccation of clay, ongoing seepage through foundation of the facility.

Completion of impermeable liner installed in Cell 2 & 3. Future planned lining of Cells 1, 4 & 5.
