Annual Audit Compliance Report Form

Section A – Licence details			
Licence number:	L4513/1969/18	Licence file number:	DER2013/001083
Licence holder name:	BHP Iron Ore Pty Ltd		
Trading as:	BHP Iron Ore Pty Ltd		
ACN:	008 700 981		
Registered business address:	Level 1, City Square Brookfield Place 125 St Georges Terrace Perth WA 6000		
Reporting period:	01/07/2024 to 30/06/2025

Section A – Licence Details			
Licence number:	5611/1993/11	Licence file number:	DER2014/001167
Licence holder name:	BHP Iron Ore Pty Ltd		
Trading as:	BHP Iron Ore Pty Ltd		
ACN:	008 700 981		
Registered business address:	Level 1, City Square Brookfield Place 125 St Georges Terrace PERTH WA 6000		
Reporting period:	01/07/2024 to 30/06/2025

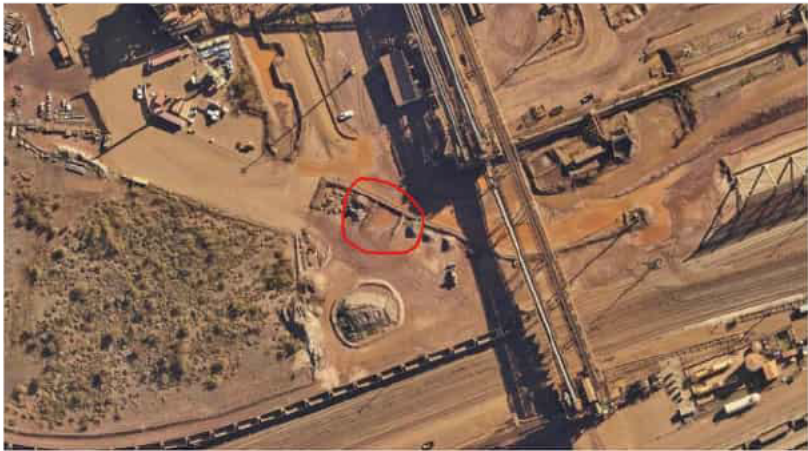
Section E – Details of Non-Compliance with Licence Condition			
Please use a separate page for each condition with which the licence holder was non-compliant at a time during the reporting period.			
Condition no:	1 & Table 14	Date(s) of non-compliance:	September 2024 – June 2025
Details of non-compliance:			
<p>In June 2025 it was identified that a partially bunded unlined evaporation area was being utilised to store potentially contaminated slurry. The slurry was composed of soil material from a nearby excavation area mixed with potable water during hydro-excavation activities. The slurry was stored in the evaporation area to be dried and reused on site within the original excavation area. The potentially contaminated water infiltration discharge is not listed as an authorised emission under Condition 1. The unlined evaporation area is also not an approved part of waste material management infrastructure described in Table 14.</p>

<p>What was the actual (or suspected) environmental impact of the non-compliance?</p> <p>NOTE – please attach maps or diagrams to provide insight into the precise location of where the non-compliance took place.</p>			
<p>The non-compliance has no known or suspected environmental impact. No runoff or discharge to nearby drainage lines was identified. No dried by-product material was used as fill elsewhere on site.</p>

Cause (or suspected cause) of non-compliance:			
Construction and operation of an unauthorised unlined evaporation area to store and manage potentially contaminated slurry by-product under the Port Part V Licence.			
Action taken to mitigate any adverse effects of non-compliance and prevent recurrence of the non-compliance:			
Discharging of potholing material in the area was discontinued.			
Was this non-compliance previously reported to DWER?			
<input type="checkbox"/> Yes, and

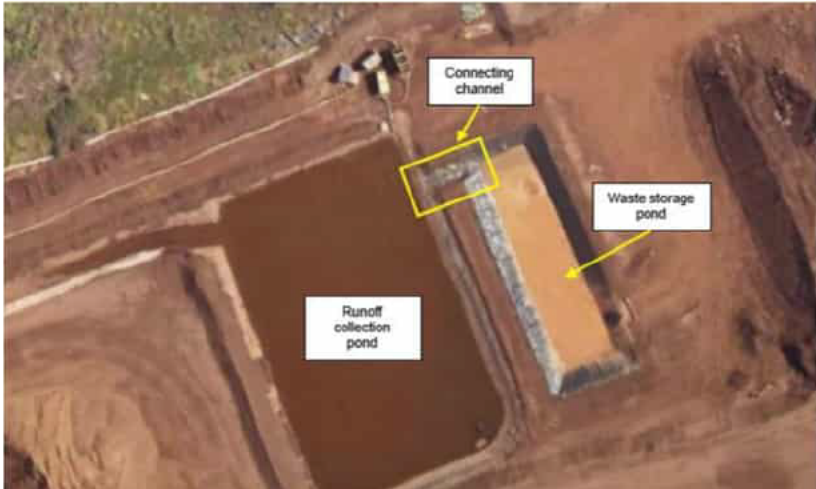
Section E – Details of Non-Compliance with Licence Condition			
Please use a separate page for each condition with which the licence holder was non-compliant at a time during the reporting period.			
Condition no:	12	Date(s) of non-compliance:	12 March 2025 – 9 April 2025
Details of non-compliance:			
<p>A 16.5 m³ lined waste storage pond (Waste Storage Pond) was constructed and operated to store soil and water slurry waste generated from horizontal drilling that intersected the groundwater. The Waste Storage Pond was constructed adjacent to the approved Contaminated Soil Handling Area runoff collection pond (Runoff Pond) and connected to the Runoff Pond via a lined channel, which was ultimately connected to the Water Treatment Plant via a stand-by pump with high- and low-level switches. This was not an approved piece of 'infrastructure' as outlined in Table 10 or 'waste material management infrastructure' as outlined in Table 14.</p>

What was the actual (or suspected) environmental impact of the non-compliance?			
<p>NOTE – please attach maps or diagrams to provide insight into the precise location of where the non-compliance took place.</p>			
<p>The non-compliance has no known or suspected environmental impact. The Waste Storage Pond was constructed in a previously disturbed area and was constructed to the same specifications as the approved Runoff Pond, using a GCL liner and overlain by 1.5 mm HDPE liner. The operation history of the pump associated with the Runoff Pond confirmed no material had been pumped from the Runoff Pond to the Water Treatment Plant. Therefore, no discharge to the environment occurred from the Waste Storage Pond.</p>

Cause (or suspected cause) of non-compliance:			
Construction and operation of an unauthorised lined Waste Storage Pond under the Port Part V Licence.			
Action taken to mitigate any adverse effects of non-compliance and prevent recurrence of the non-compliance:

<p>On 9 April 2025, waste disposal into the Waste Storage Pond was ceased and the pond was isolated by closing off the channel that connected it to the Runoff Pond. Sediment samples were taken of the waste within the Pond; the material was classified in accordance with the <i>Landfill Waste Classification and Waste Definitions 1996</i> guideline and taken for disposal to a licensed facility. The Waste Storage Pond was decommissioned, the area was reinstated to its original condition.</p>			
Was this non-compliance previously reported to DWER?			
<input checked="" type="checkbox"/> Yes, and			
<input checked="" type="checkbox"/> Reported to DWER verbally		Date: 17 April 2025	
<input checked="" type="checkbox"/> Reported to DWER in writing		Date: 17 April 2025
