Appendix 1: North Capel Annual Audit Compliance Report (AACR)

Condition no:	2.2.2	Date(s) of non-compliance:	17/11/2023
---------------	-------	----------------------------	------------

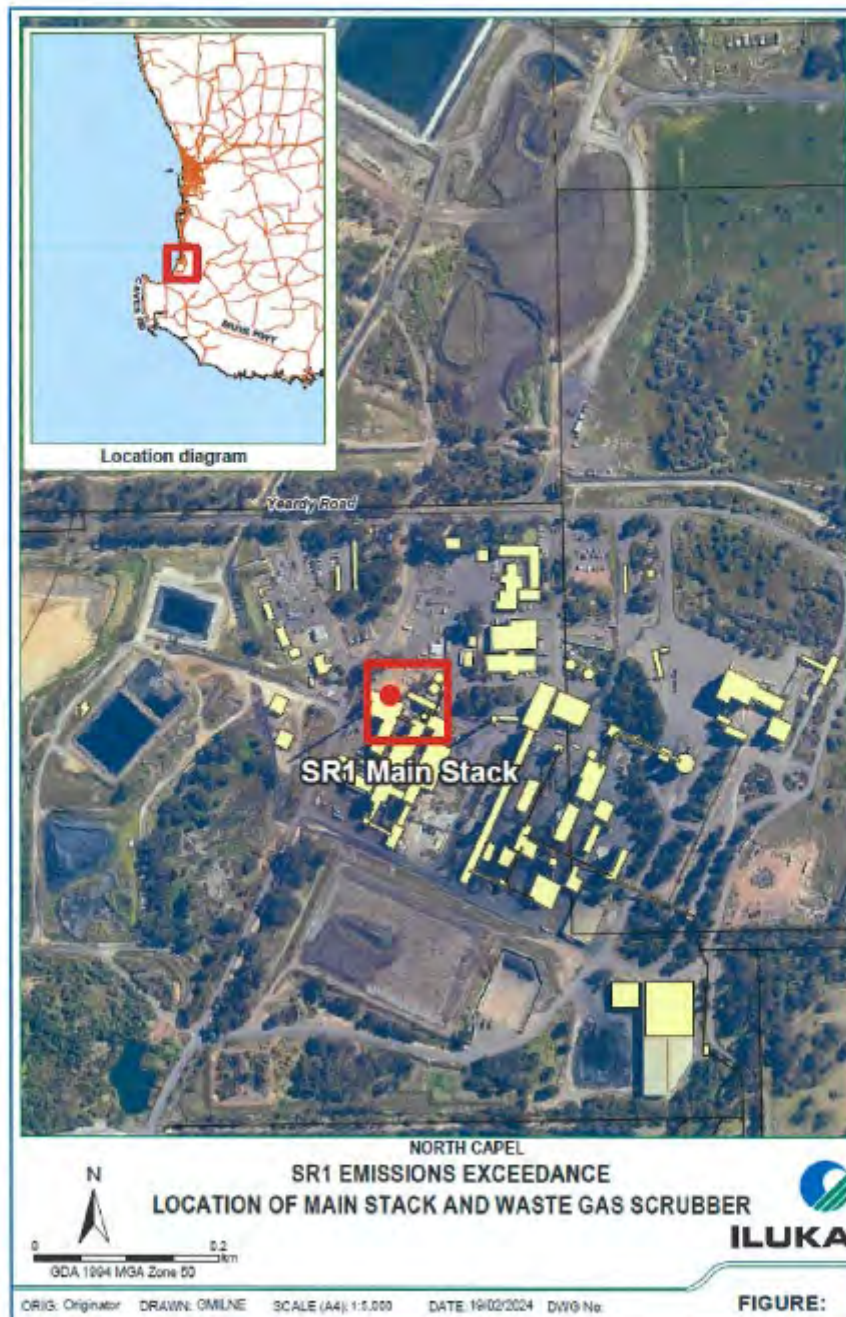
NOTE – please attach maps or diagrams to provide insight into the precise location of where the non-compliance took place.

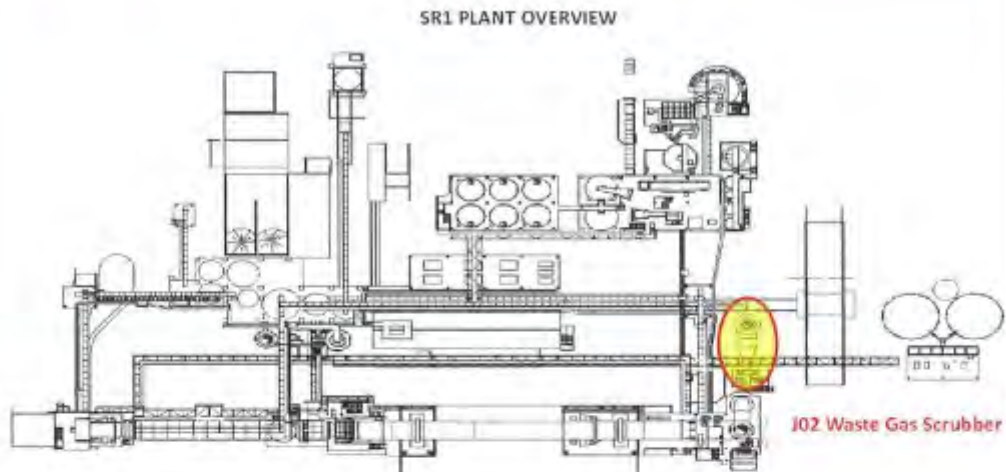
Elevated TPM levels were observed with high Carbon monoxide (CO) levels within the kiln and scrubber process. High CO levels are a result of elevated kiln pressures which reduce oxygen flow, impacting combustion of CO and particulates.

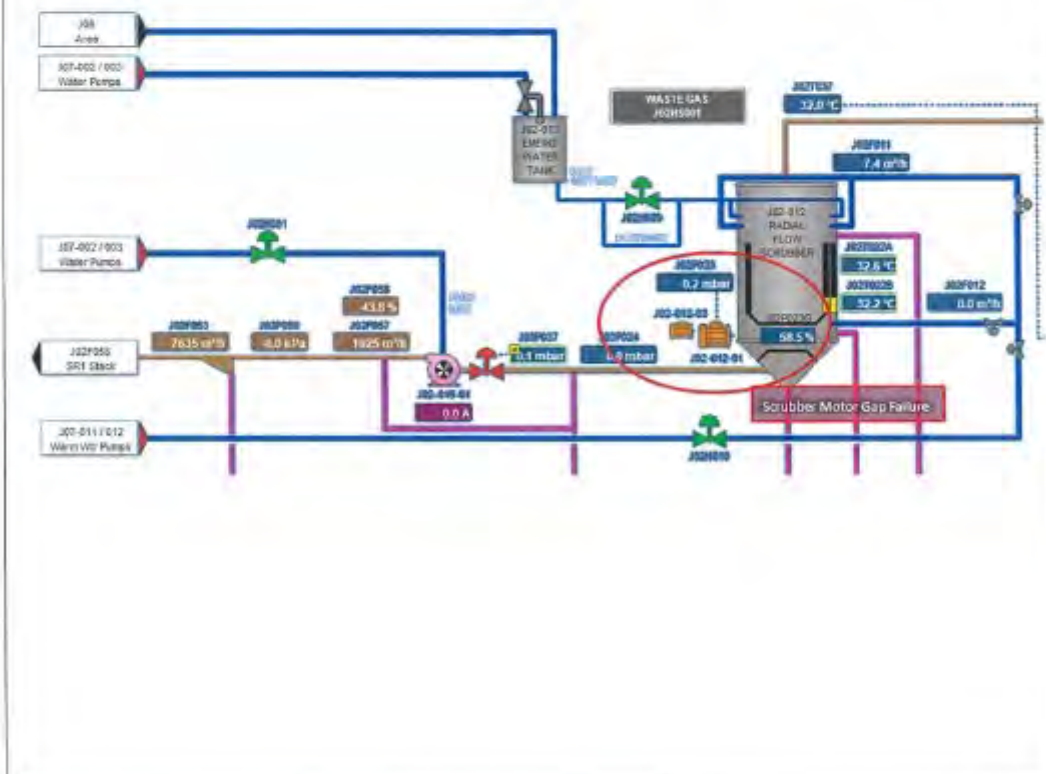
Uniformance Operations Control View – J02_012 Radial flow Scrubber Gap Adjuster

The scrubber gap can normally be altered via the control room to adjust kiln pressures and scrubber throughflow. However adjustments were not responding to control prompts. A technician was sent to verify scrubber gap operation, and it was discovered that the scrubber gap motor had failed.

The scrubber gap motor was repaired on 30th September. Post the repair, kiln pressure control improved significantly and stack emissions returned to target levels.

Process operators have real time access to Plant controls including CO emissions, kiln pressures and feed rates. Any spikes in CO levels are addressed as they occur, to maintain process efficiency. Alarm settings have been tightened, to alert the operators of possible adverse conditions leading to inefficient scrubber operations.
