3 Nickel West Leinster

3.1 L4612/1989/11

This report has been prepared to meet the Condition 1 reporting requirements (covering the period 1 July 2024 to 30 June 2025) for Part V Licence L4612/1989/11.

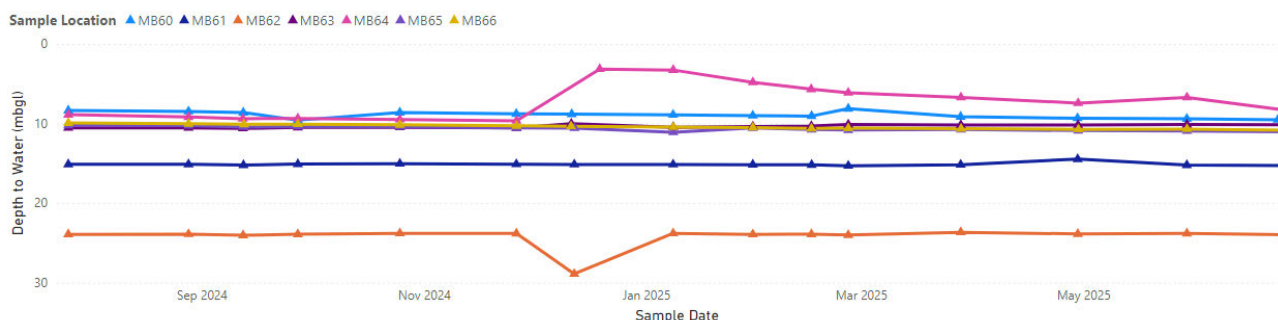
Figure 3-1 NLN TSF2 MB60-MB66 Bores Standing Water Level

The groundwater levels around TSF2 were relatively stable or showed a slight declining trend throughout the reporting period. The exception being MB64, in which water levels rose approximately six meters in the third quarter of the year in response to rainfall events. MB64 is in a low-lying area which floods and holds water for a long period of time after rainfall events. After rainfall in December 2024 and January 2025 water levels rose approximately six meters from November 2024. This bore is located approximately 1.1 kilometres southeast of TSF2 and since February 2025, water levels have been observed to return to normal water level trend. The groundwater level in bores MB60, MB65, MB66 and LNOPB02 are indicating a decreasing trend during FY25, while MB61, MB23, MB63, LWB039, MB07, MB39, MB41, MB42, and MB43 are displaying a stable water level trend over the same period. MB01 was the only bore with a slightly increasing trend during the reporting period, recording a 0.5m rise from the beginning of the year to the end of FY2025. This slight increase in water level is well below historical levels.

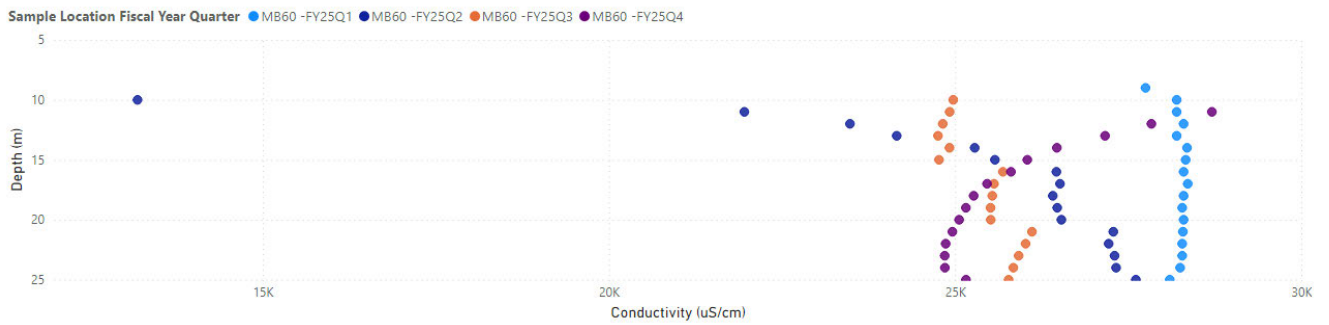
Figure 3-3 NLN MB60 Electrical Conductivity Profile

Vertical groundwater electrical conductivity (EC) profiles are completed from a select number of monitoring bores. Raw data and timeseries plots are presented in Table 3-7 to Table 3-13. Most bores have shown an increase in electrical conductivity throughout the water column during the period 2024 to 2025. This trend, for some bores, also includes slightly higher conductivity readings recorded through the middle portion of the water column.

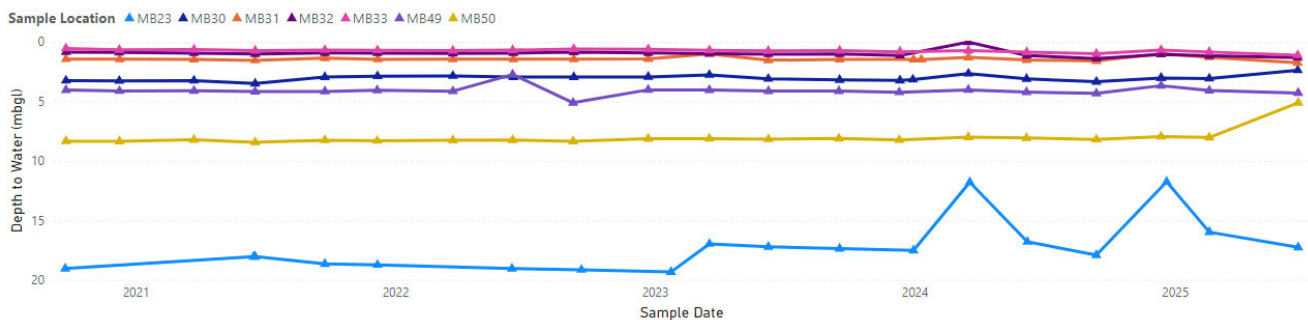
Figure 3-10 NLN TSF3AB and TSF3CD Bores Standing Water Level

The eastern toe monitoring bores for Cells AB and CD (MB30, MB31, MB32, MB33 and MB57) have shallow water levels, which were relatively stable over the year. Further from the toe (MB48, MB50 and MB53), the depth to water increases and long-term trends of gradually rising water at MB48 and MB50 continue. MB50 recorded a 3m rise in June 2025, which will be noted and checked against at the next sampling round in September 2025. MB53 has shown a gradual decrease in mbgl since December 2022. To the east of Cell E, observation for water levels at toe bores MB55 and MB57 show water levels since tailings deposition ceased have begun to lower. MB57 did have a spike in Q2 likely a result of heavy rainfall and has since lowered back within historical range. The more distant bores (MB56, MB58 and MB59) also relatively stable during the reporting period, however long-term trends indicate a gradual rising trend. MB70 showed a slight decrease in water level trend over the reporting period decreasing from 4.71 mbgl to 5.31 mbgl.

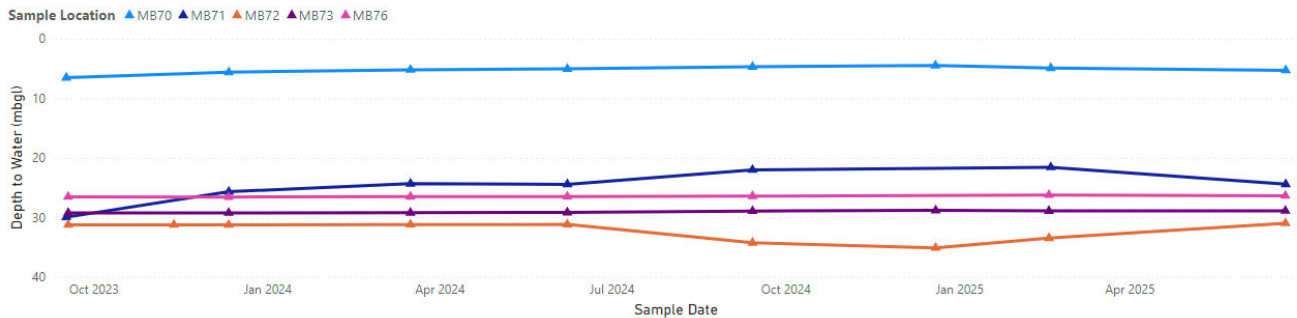
Figure 3-12 NLN TSF3F Bores Standing Water Level

Overall, water levels in the majority of TSF3 monitoring bores were stable throughout the reporting period ranging from 1.01 m to 33.49 m below ground level (mbgl). MB75 remained dry throughout the reporting period, while MB72 was dry during December. Most bores experienced a slight temporary increase in water levels during December 2024, as a result of rainfall, before returning to historical ranges. The greatest depth to water was recorded in MB72, located approximately 150 m north of TSF3.

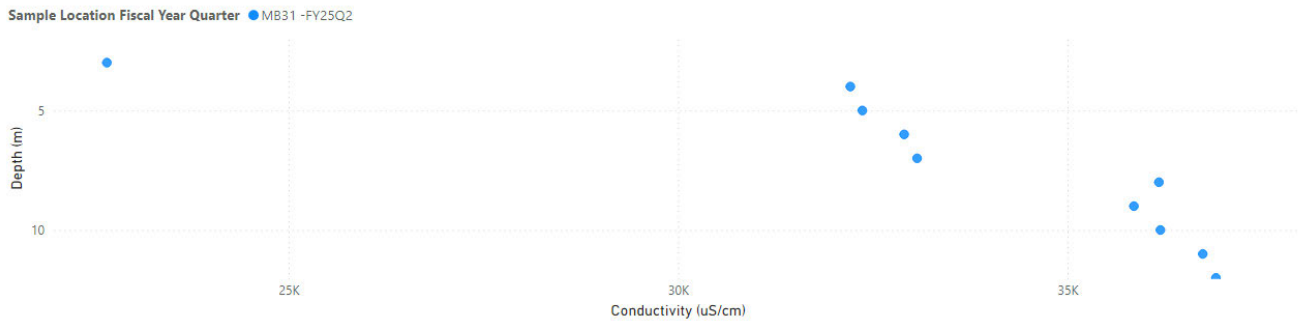
Figure 3-13 NLN MB31 Electrical Conductivity Profile

Vertical electrical conductivity (EC) profiles (from December 2024) indicate an increase in EC with depth in MB31, while MB72 was dry. Future profiles will enable a more robust comparison of EC.
