#### Annual Audit Compliance Report Form

Section A – Licence details			
Licence number:	L5029/1992/11	Licence file number:	2015/002027-6
Licence holder name:	Northern Star (Kanowna) Pty Limited		
Trading as:	KANOWNA BELLE GOLD MINE		
ACN:	010 511 789		
Registered business address:	Kanowna Belle Gold Mine M27/18, 22, 23, 37, 49, 57, 92, 103, 122, 123, 127, 159, 164, 232, 245, 287, 420 and L27/87, 83, 62 KALGOORLIE WA 6430		
Reporting period:	01/01/2021 <b>to</b> 31/12/2021

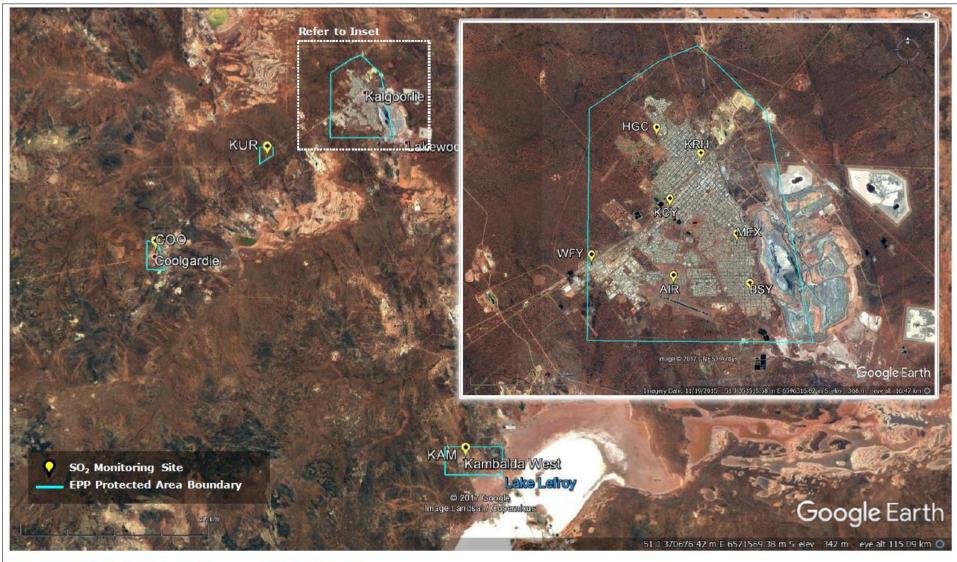
Figure 1: Goldfields EPP Protected Areas and SO₂ Monitoring Sites

- Methods for sampling and a es located at KCY and WFY a	_	•	
What was the actua	al (or suspected) environmen	tal impact of the non-c	ompliance?	
NOTE – please attac compliance took place	h maps or diagrams to provide i e.	nsight into the precise lo	cation of where the non-	
	suspected environmental imegetation are not likely to impa			
See Figure 1.				
Cause (or suspecte	ed cause) of non-compliance:			
Physical constraints of infrastructure and surrounding vegetation since commissioning of the KAMN represent inherent limitations of the selected monitoring sites. Re-positioning the monitoring sites is not considered a viable option given the power and access limitations and characteristics of these locations (i.e., within light industrial areas and regional bushland).				
It should be noted that NSR does not have land or tenure rights at the locations in which the monitoring stations are sited.

Section E – Details of non-compliance with licence condition				
Please use a separate page for each condition with which the licence holder was non-compliant at a time during the reporting period.				
Condition no:	5.3.1	Date(s) of non- compliance:	2021	
Details of non-comp	pliance:			
ambient air quality	<ul> <li>Method for sampling and an applications (section 2.4 – Ta eorological monitoring equipances.</li> </ul>	able 3, 2.6.1, 3.5.1, 3.5	.2.2 and 3.5.2.3).	
What was the actua	al (or suspected) environmen	tal impact of the non-c	ompliance?	
NOTE – please attac compliance took place	h maps or diagrams to provide i e.	nsight into the precise lo	cation of where the non-	
	suspected environmental imy influence the measured win			
See Figure 1.				
Cause (or suspecte	ed cause) of non-compliance:			
A tree approximately 6m tall is located within 8m of the MEX meteorological monitoring tower. However, the Standard also notes that porous structures such as trees are not likely to have as strong effect on wind flow as a building or other obstruction, and as such the proximity of the tree is not considered likely to significantly influence the measured wind speed and direction at the site.

It should be noted that NSR does not have land or tenure rights at the locations in which the monitoring stations are sited.				
		·		
monitoring stations		or tenure rights at the	locations in which the	
Monitoring stations  Action taken to mitinon-compliance:  Consult with DWEF	are sited.	or tenure rights at the non-compliance and prons associated with the	locations in which the event recurrence of the	
Action taken to miti non-compliance: Consult with DWEF develop action plan	are sited.  gate any adverse effects of notice and adverse effects of notice and adverse effects of notice.  R regarding inherent limitation to address non-compliance.  De given to the siting limitation	or tenure rights at the non-compliance and prons associated with the	locations in which the event recurrence of the MEX monitoring site and	
Action taken to mitinon-compliance: Consult with DWEF develop action plan Consideration will be in the event of atype	are sited.  gate any adverse effects of notice and adverse effects of notice and adverse effects of notice.  R regarding inherent limitation to address non-compliance.  De given to the siting limitation	or tenure rights at the non-compliance and prens associated with the ns when assessing the	locations in which the event recurrence of the MEX monitoring site and

Action taken to mitigate any adverse effects of non-compliance and prevent recurrence of the non-compliance:				
Consult with DWER regarding inherent limitations associated with the locations of some of the monitoring sites and develop action plan to address non-compliance.				
Man this non compliance may involve at the DMEDO				
Was this non-compliance previously reported to DWER?  ⊠ Yes, reported in 2020 AACR.				
Reported to DWER verbally Date: / /				
	DWER in writing	Date: 7 /
