Annual Audit Compliance Report Form

Section A – Licence details			
Licence number:	L5206/1987/10	Licence file number:	2012/006906
Licence holder name:	Wiluna Operations Pty Ltd		
Trading as:	Wiluna Mining Corporation		
ACN:	166 954 525		
Registered business address:	Level 3, 1 Altona Street, Wet Perth WA 6005		
Reporting period:	01/01/2020 to 31/12/2020		
Section B – Statement of compliance with licence conditions			
Did you comply with all licence conditions during the reporting period? (please tick the appropriate box)			
<input type="checkbox"/> Yes – please complete: <ul style="list-style-type: none">• section C;• section D (if required); and• sign the declaration in Section F.			
<input checked="" type="checkbox"/> No – please complete: <ul style="list-style-type: none">• section C;• section D (if required);• section E; and• sign the declaration in Section F.			
Section C – Statement of actual production			
Provide the actual production quantity for this reporting period. Supporting documentation is to be attached.

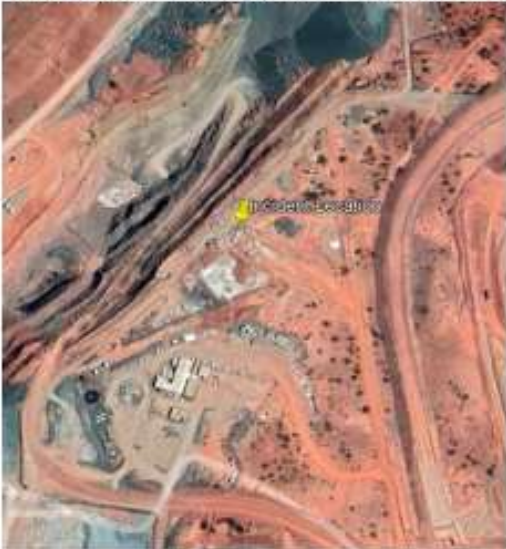
Section E – Details of non-compliance with licence condition			
Please use a separate page for each condition with which the licence holder was non-compliant at a time during the reporting period.			
Condition no:	1.2.2	Date(s) of non-compliance:	9/4/2021
Details of non-compliance:			
Saline Water Discharge - Underground dewatering pipe leak from storage tank pipework.			
What was the actual (or suspected) environmental impact of the non-compliance?			
NOTE – please attach maps or diagrams to provide insight into the precise location of where the non-compliance took place.			
No environmental impact as contained in a historically disturbed operational area.

Cause (or suspected cause) of non-compliance:			
Old pipework and infrastructure.			
Action taken to mitigate any adverse effects of non-compliance and prevent recurrence of the non-compliance:			
Pipework repaired and replaced. Entire system now upgraded and relocated.

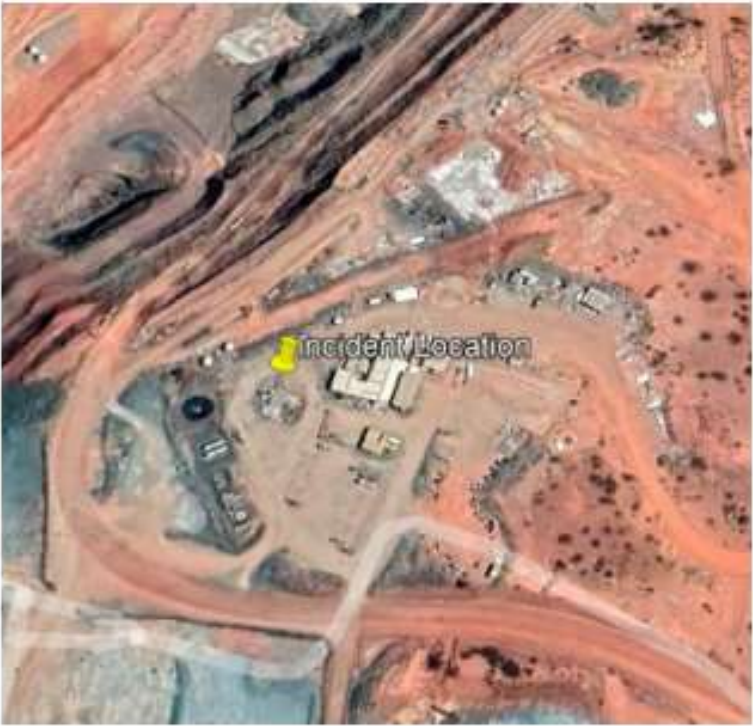
Section E – Details of non-compliance with licence condition			
Please use a separate page for each condition with which the licence holder was non-compliant at a time during the reporting period.			
Condition no:	1.2.2	Date(s) of non-compliance:	24/4/2021
Details of non-compliance:			
Bulletin Workshop Wash Bay Overflowing.			
What was the actual (or suspected) environmental impact of the non-compliance?			
NOTE – please attach maps or diagrams to provide insight into the precise location of where the non-compliance took place.			
No environmental impact as contained in a historically disturbed operational area. No hydrocarbon film was present on the water.

Cause (or suspected cause) of non-compliance:			
Overuse of high flow water hose and lack of wash pad maintenance.			
Action taken to mitigate any adverse effects of non-compliance and prevent recurrence of the non-compliance:			
Total wash pad upgrade to industry standards and assignment of responsibility.

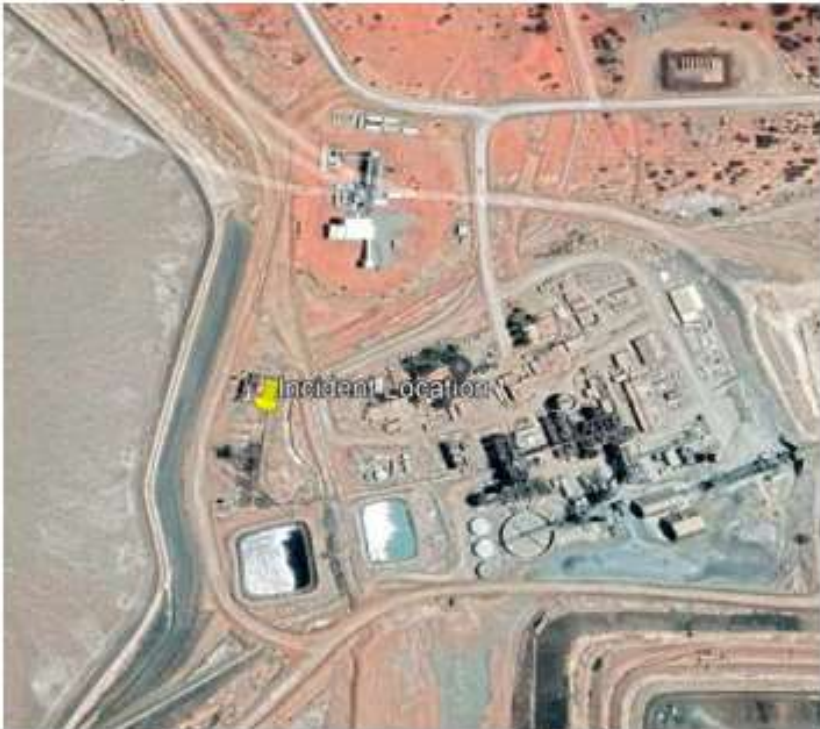
Section E – Details of non-compliance with licence condition			
Please use a separate page for each condition with which the licence holder was non-compliant at a time during the reporting period.			
Condition no:	1.2.2	Date(s) of non-compliance:	1/05/2021
Details of non-compliance:			
Processing Plant Wash Bay Overflowing.			
What was the actual (or suspected) environmental impact of the non-compliance?			
NOTE – please attach maps or diagrams to provide insight into the precise location of where the non-compliance took place.			
No environmental impact as in operational area, contained to the road and old process drain. No hydrocarbon film was present on the water.

Section E – Details of non-compliance with licence condition	
Cause (or suspected cause) of non-compliance:	
Overuse of high flow water hose and lack of wash pad maintenance.	
Action taken to mitigate any adverse effects of non-compliance and prevent recurrence of the non-compliance:	
Wash pad decommissioned and no longer in use.	
Was this non-compliance previously reported to DWER?	
<input type="checkbox"/> Yes, and	
<input type="checkbox"/> Reported to DWER verbally	Date: / /
<input type="checkbox"/> Reported to DWER in writing	Date: / /

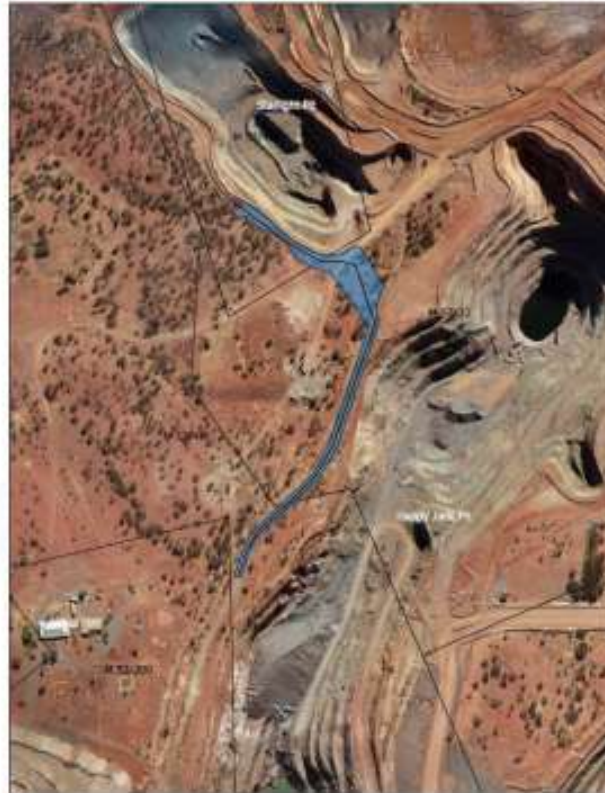
Section E – Details of non-compliance with licence condition			
Please use a separate page for each condition with which the licence holder was non-compliant at a time during the reporting period.			
Condition no:	1.2.2	Date(s) of non-compliance:	7/5/2021
Details of non-compliance:			
Saline Water Discharge - Underground dewatering pipe leak from Happy Jack Pit. This was reported via Section 72 Notification.			
What was the actual (or suspected) environmental impact of the non-compliance?			
NOTE – please attach maps or diagrams to provide insight into the precise location of where the non-compliance took place.			
Saline water was mostly contained within containment infrastructure, however, overflowed a drain and impacted the immediate vegetation.

Pipe was damaged by vehicle impact and spill observed following pumping start-up.

Pumping ceased and the pipework was immediately repaired.
 Area remediated with fresh water and impacted topsoil removed.
 The need for start-up pipeline inspections have been reiterated to staff.
 Improved spill containment in that area to be reconsidered given the breach of the secondary containment.

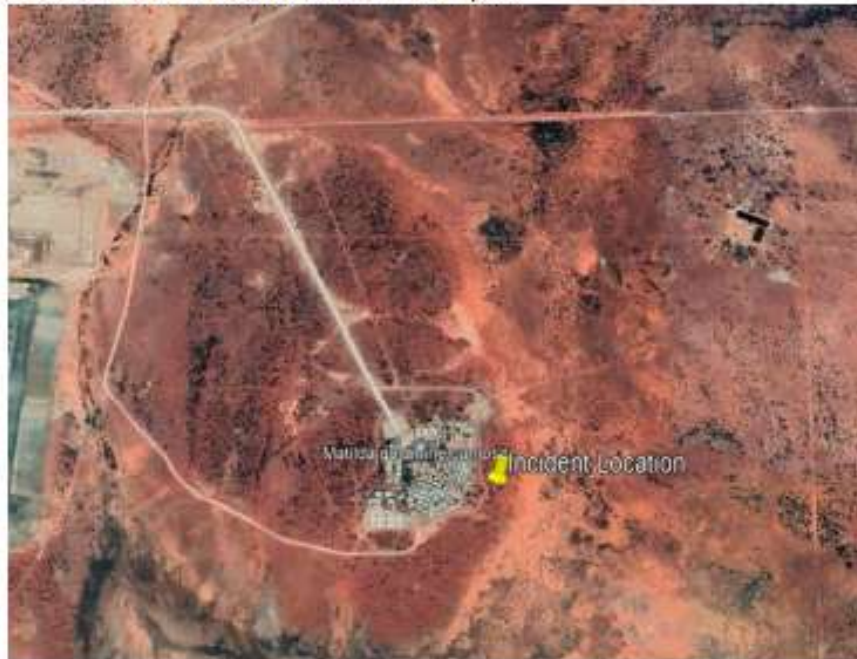
Sewage pipe leak.

Contained to the immediate area. No environmental impact.

Old pipework.

Pipework repaired and replaced.

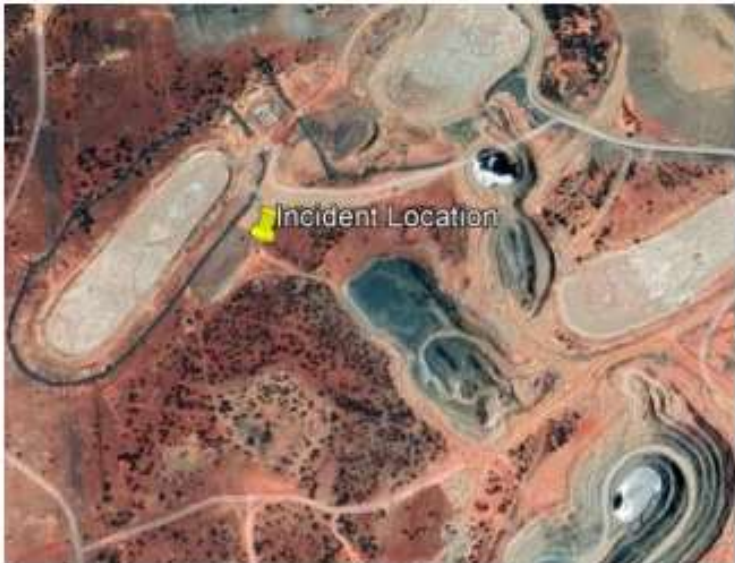
Section E – Details of non-compliance with licence condition			
Please use a separate page for each condition with which the licence holder was non-compliant at a time during the reporting period.			
Condition no:	1.2.2	Date(s) of non-compliance:	28/06/2021
Details of non-compliance:			
Saline Water Discharge - Underground dewatering pipe leak from Happy Jack Pit.			
What was the actual (or suspected) environmental impact of the non-compliance?			
NOTE – please attach maps or diagrams to provide insight into the precise location of where the non-compliance took place.			
No environmental impact as contained to roadway.

Cause (or suspected cause) of non-compliance:			
Vehicle damage.			
Action taken to mitigate any adverse effects of non-compliance and prevent recurrence of the non-compliance:			
Pipework repaired and replaced. Jump over improved to be more trafficable.

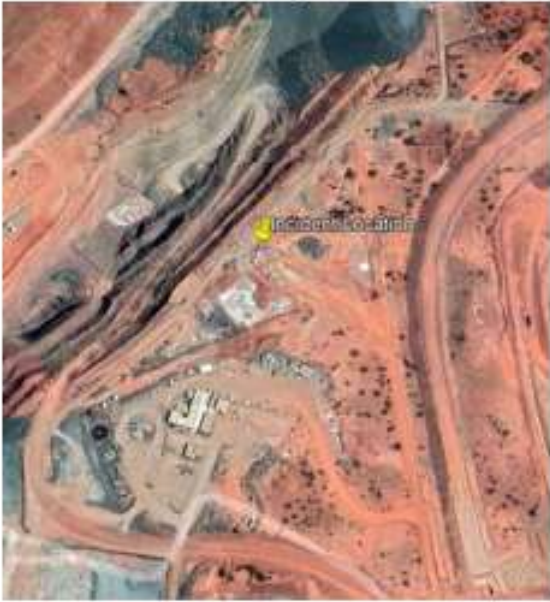
Section E – Details of non-compliance with licence condition			
Please use a separate page for each condition with which the licence holder was non-compliant at a time during the reporting period.			
Condition no:	1.2.2	Date(s) of non-compliance:	1/8/2021
Details of non-compliance:			
Saline Water Discharge - Underground dewatering pipe leak from storage tank pipework.			
What was the actual (or suspected) environmental impact of the non-compliance?			
NOTE – please attach maps or diagrams to provide insight into the precise location of where the non-compliance took place.			
No environmental impact as contained in a historically disturbed operational area.

Cause (or suspected cause) of non-compliance:			
Old pipework and infrastructure.			
Action taken to mitigate any adverse effects of non-compliance and prevent recurrence of the non-compliance:

Section E – Details of non-compliance with licence condition	
Pipework repaired and replaced. Entire system now upgraded and relocated.	
Was this non-compliance previously reported to DWER?	
<input type="checkbox"/> Yes, and	
<input type="checkbox"/> Reported to DWER verbally	Date: / /
<input type="checkbox"/> Reported to DWER in writing	Date: / /

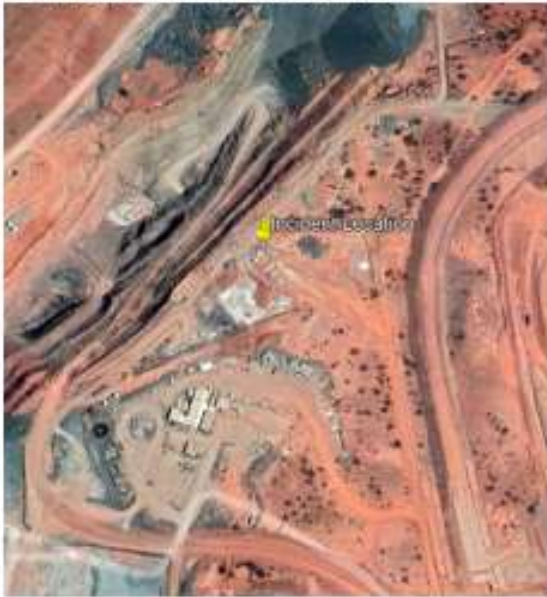
Section E – Details of non-compliance with licence condition			
Please use a separate page for each condition with which the licence holder was non-compliant at a time during the reporting period.			
Condition no:	1.2.2	Date(s) of non-compliance:	29/10/2021
Details of non-compliance:			
Saline Water Discharge - Underground dewatering pipe leak from storage tank pipework.			
What was the actual (or suspected) environmental impact of the non-compliance?			
NOTE – please attach maps or diagrams to provide insight into the precise location of where the non-compliance took place.			
No environmental impact as in operational area and contained.

Cause (or suspected cause) of non-compliance:			
Old pipework and infrastructure.			
Action taken to mitigate any adverse effects of non-compliance and prevent recurrence of the non-compliance:

Section E – Details of non-compliance with licence condition			
Pipework repaired and replaced. Entire system now upgraded and relocated.			
Was this non-compliance previously reported to DWER?			
<input type="checkbox"/> Yes, and			
<input type="checkbox"/> Reported to DWER verbally		Date: / /	
<input type="checkbox"/> Reported to DWER in writing		Date: / /	
Section E – Details of non-compliance with licence condition			
Please use a separate page for each condition with which the licence holder was non-compliant at a time during the reporting period.			
Condition no:	1.2.2	Date(s) of non-compliance:	19/12/2021
Details of non-compliance:			
Saline Water Discharge - Underground dewatering pipe leak from Lone Hand Pit.			
What was the actual (or suspected) environmental impact of the non-compliance? NOTE – please attach maps or diagrams to provide insight into the precise location of where the non-compliance took place.

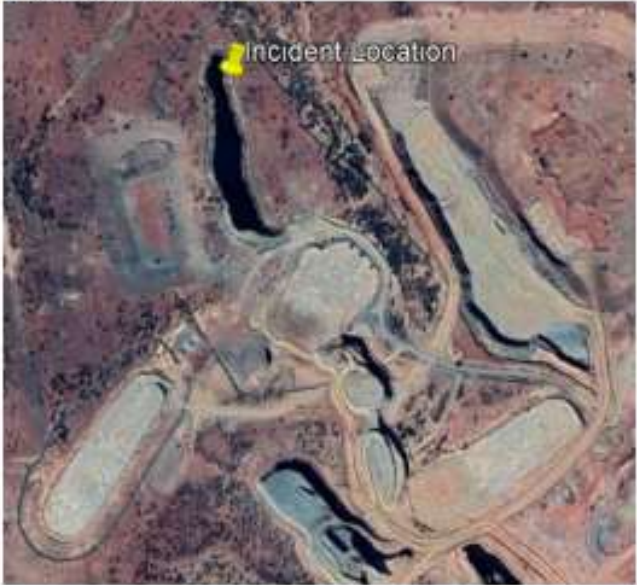
No environmental impact as within pit containment.

Cause (or suspected cause) of non-compliance:			
Vehicle damage.			
Action taken to mitigate any adverse effects of non-compliance and prevent recurrence of the non-compliance:

Section E – Details of non-compliance with licence condition	
Pipework repaired and replaced. Jump over improved to be more trafficable.	
Was this non-compliance previously reported to DWER?	
<input type="checkbox"/> Yes, and	
<input type="checkbox"/> Reported to DWER verbally	Date: / /
<input type="checkbox"/> Reported to DWER in writing	Date: / /
