## Annual Audit Compliance Report Form

| Licence number: | L5415/1988/9 | Licence file number: | DER2013/00900 1 |
| Licence holder name: | BHP Iron Ore Pty Ltd | | |
| Reporting period: | 01/07/2023 to 30/06/2024 | | |

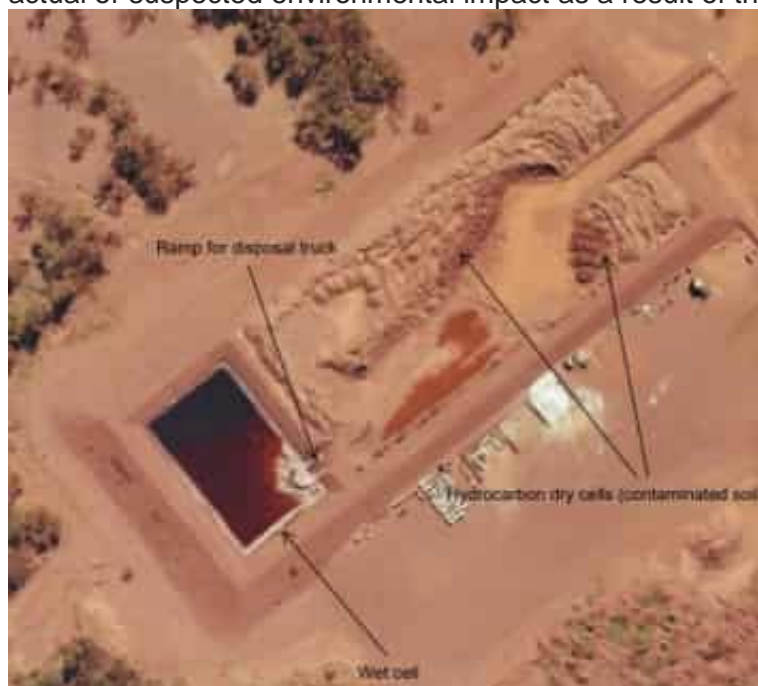
The Jimblebar biofarm is non-compliant against the following Part V license conditions:

- 1.5 mm HDPE liner to achieve a permeability of  $<10^{-9}$  m/s
- The wet cell is lined for a runoff cell and has been used to accept hydrocarbon contaminated waste

There is no known actual or suspected environmental impact as a result of the non-compliance.

BHP has identified that the biofarm facility management requires improvement to ensure hydrocarbon contaminated soil, hydrocarbon contaminated water and nutrient rich wastewater from the Ammonium Nitrate Facility are managed appropriately.

BHP is currently undertaking an investigation into the management of the biofarm facility. During FY2024, no further liquid waste has been disposed of in the bioremediation facility. Hydrocarbon sampling has been completed for the hydrocarbon contaminated soil in the dry cells and turning of the soil to break down hydrocarbons to below NEPM guideline limits is underway.

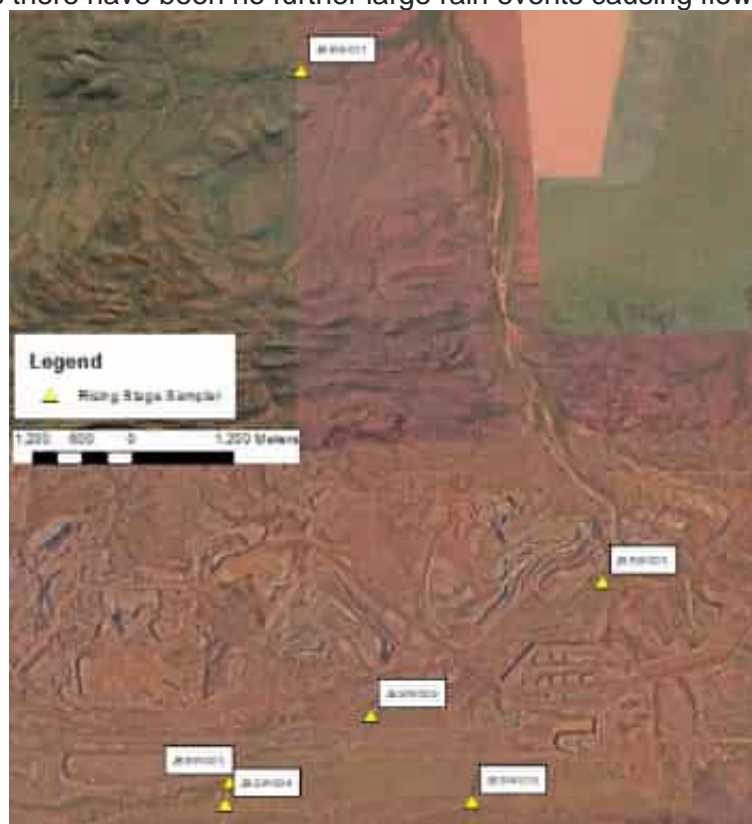
Quarterly monitoring of creek line water quality parameters was not completed as required at six monitoring sites during Q3 of FY2024. Following a high rainfall event all six monitoring sites were damaged and/or destroyed and water samples were unable to be retrieved.

There is no known actual or suspected environmental impact from not monitoring the six monitoring sites as there have been no further large rain events causing flow conditions.

A high rainfall event caused all six newly installed rising stage samplers to be destroyed and/or washed away. Over the course of 48 hours (24 to 25 January 2024), 174.9 mm was received (BoM, Newman Airport).

New rising stage sampler designs are being investigated to be installed in Q1 of FY2025.

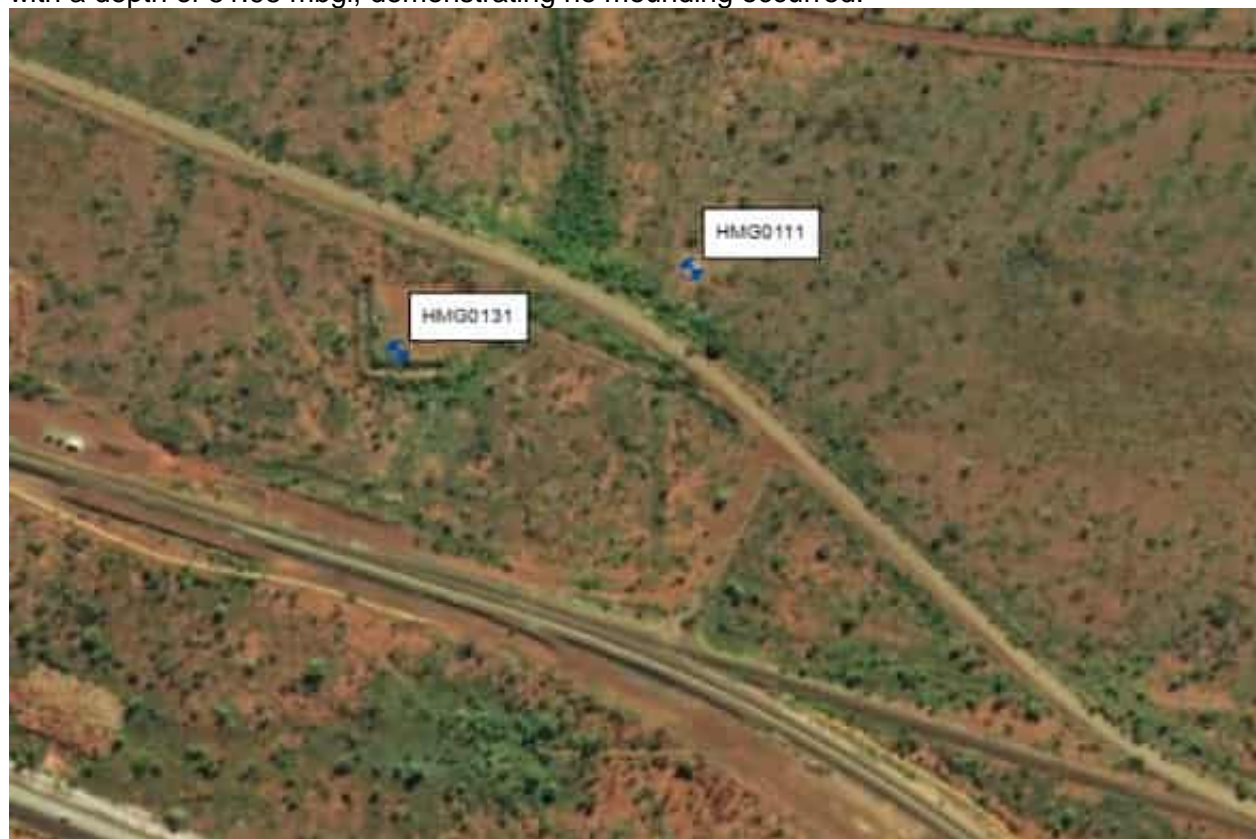
Monitoring bore HMG0111M1 was not sampled for monthly groundwater depth (mbgl) in September 2023 as required by Condition 3.5.1 (Table 3.5.1 in the superseded license prior to the February 2024 License Amendment).

There was no known actual or suspected environmental impact for not recording the groundwater level for HMG0111M1 for September 2023. The bore was dipped on 06/10/2023 with a depth of 51.95 mbgl, demonstrating no mounding occurred.

The monthly dip data couldn't be retrieved for September due to a failure of the bore telemetry equipment. Following the non-compliance, the bore was removed from the license and substituted with HMG0131M.

The telemetry was replaced, data was retrieved for October 2023 and a manual dip was completed.

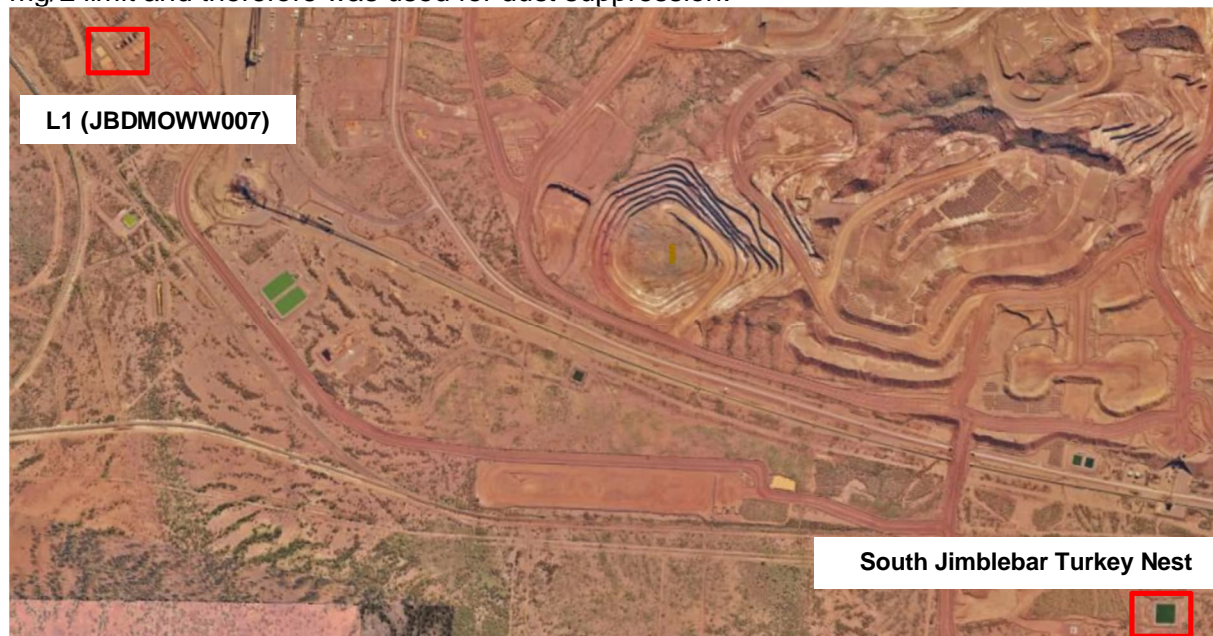
The L1 Jimblebar Oily Wastewater Treatment Plant (JBDMOWW007) monitoring point exceeded the Total Recoverable Hydrocarbons (TRH) licence limit of 15 mg/L for Q1 of FY2024. The treated oily wastewater is used for dust suppression on site and is sampled quarterly as per license requirements.

There was no known actual or suspected environmental impact from the TRH limit exceedance in FY2024. The L1 outflow line discharges to the South Jimblebar turkey's nest and is significantly diluted with raw dewatering water before being used for dust suppression. Monthly TRH samples of the South Jimblebar turkey's nest confirmed that the TRH did not exceed the 15 mg/L limit and therefore was used for dust suppression.

The sample point was no longer an accurate reflection of the water being used for dust suppression as the standpipe for the water trucks is now located at the South Jimblebar turkey's nest.

A License Amendment (issued on 13/02/2024) updated the license point to the South Jimblebar turkey's nest to accurately represent the water being used for dust suppression. There was no exceedance of TRH at SJTN001 in the FY2024 reporting period.

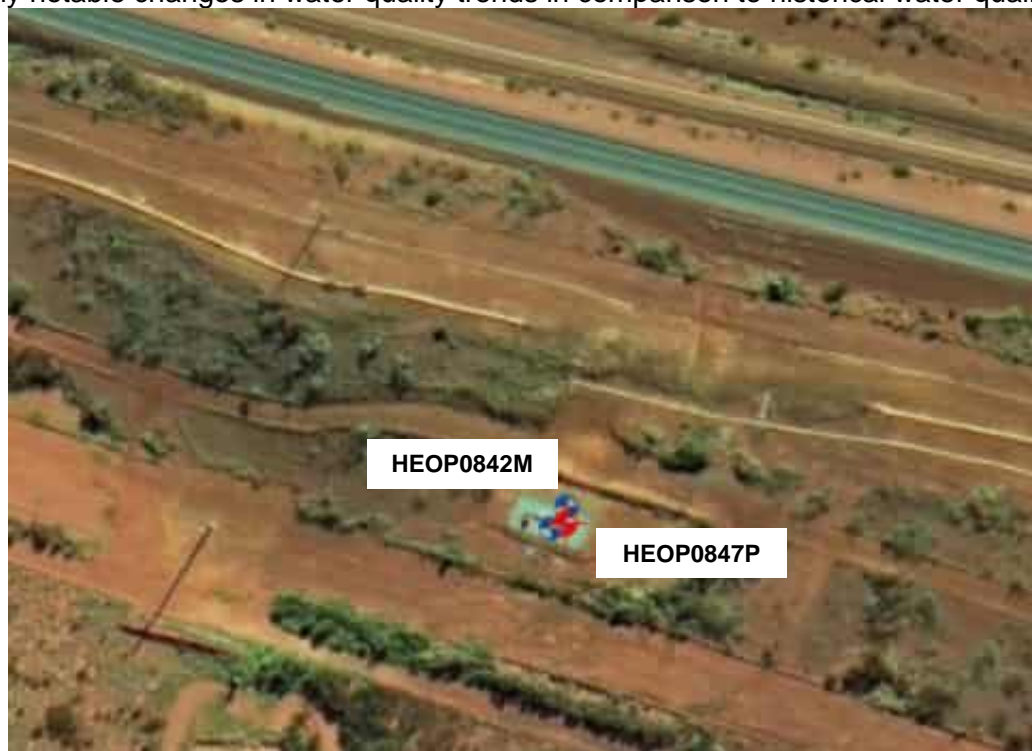
The reinjection bore HEOP0847P was not monitored for Q1 for groundwater quality parameters as required by Condition 3.3.1 (Table 3.3.1).

There was no known actual or suspected environmental impact from not sampling during this quarter. The adjacent ambient monitoring bore (HEOP0842M) was sampled in Q1 and did not show any notable changes in water quality trends in comparison to historical water quality.

Reinjection only occurred during the first six days of Q1. The hydrochemistry sample was unable to be taken as there was no further reinjection occurring for the water sample to be taken.

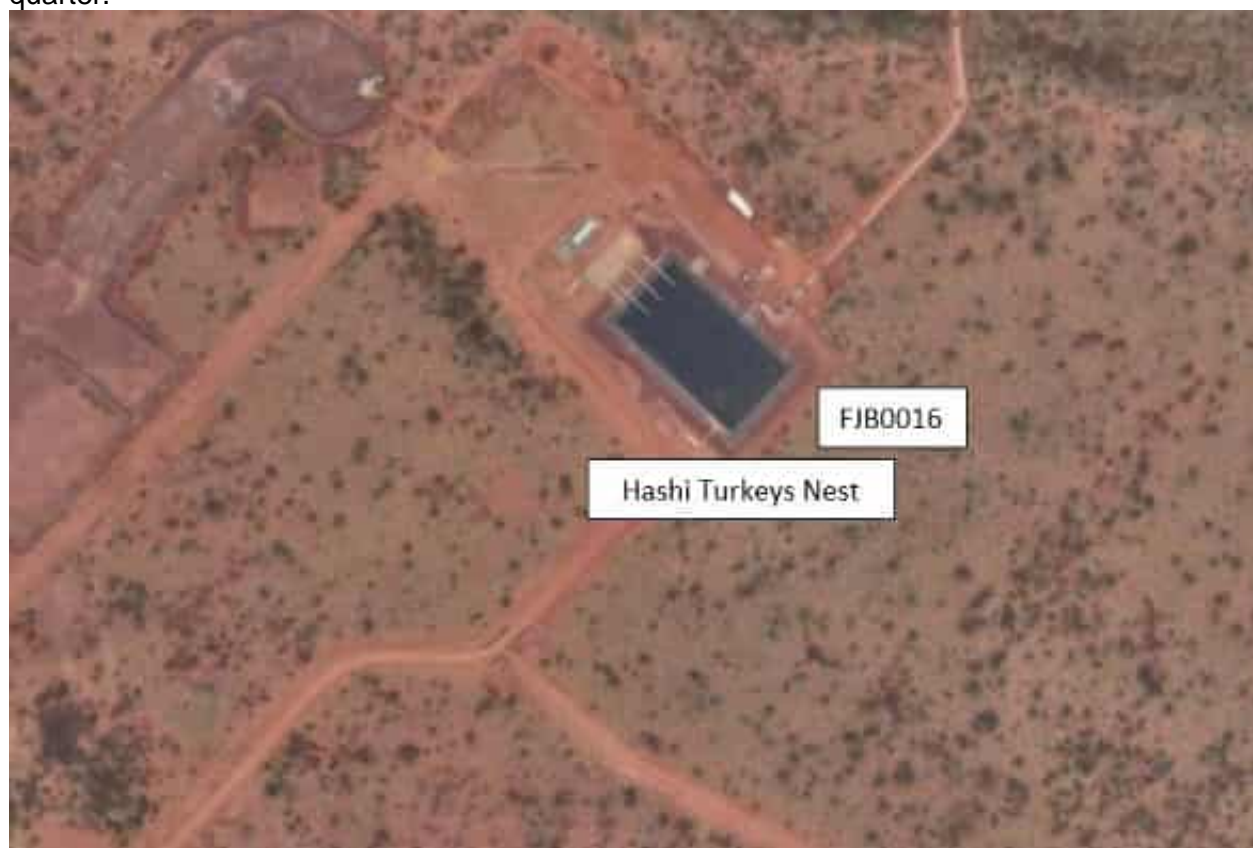
Caramulla surplus water scheme (FJB0016) quarterly monitoring of Total Suspended Solids (TSS) was not monitored for FY2024 reporting period. Quarterly monitoring of TSS is required when discharge and reinjection is occurring. There was discharge and reinjection recorded for the whole FY2024 reporting period.

There was no known actual or suspected environmental impact from not sampling during this quarter.

Administrative error, the parameter was missed off the chain of custody for sampling.

The run sheets were updated and TSS monitoring will be captured for the FY2025 reporting period.
