Annual Audit Compliance Report Form

Licence number:	L5533/1976/11	Licence file number:	2011/005902
Licence holder name:	[REDACTED]		
Trading as:	[REDACTED]		
ACN:	[REDACTED]		
Registered business address:	[REDACTED]		
Reporting period:	01/01/2021 to 31 /12 /2021

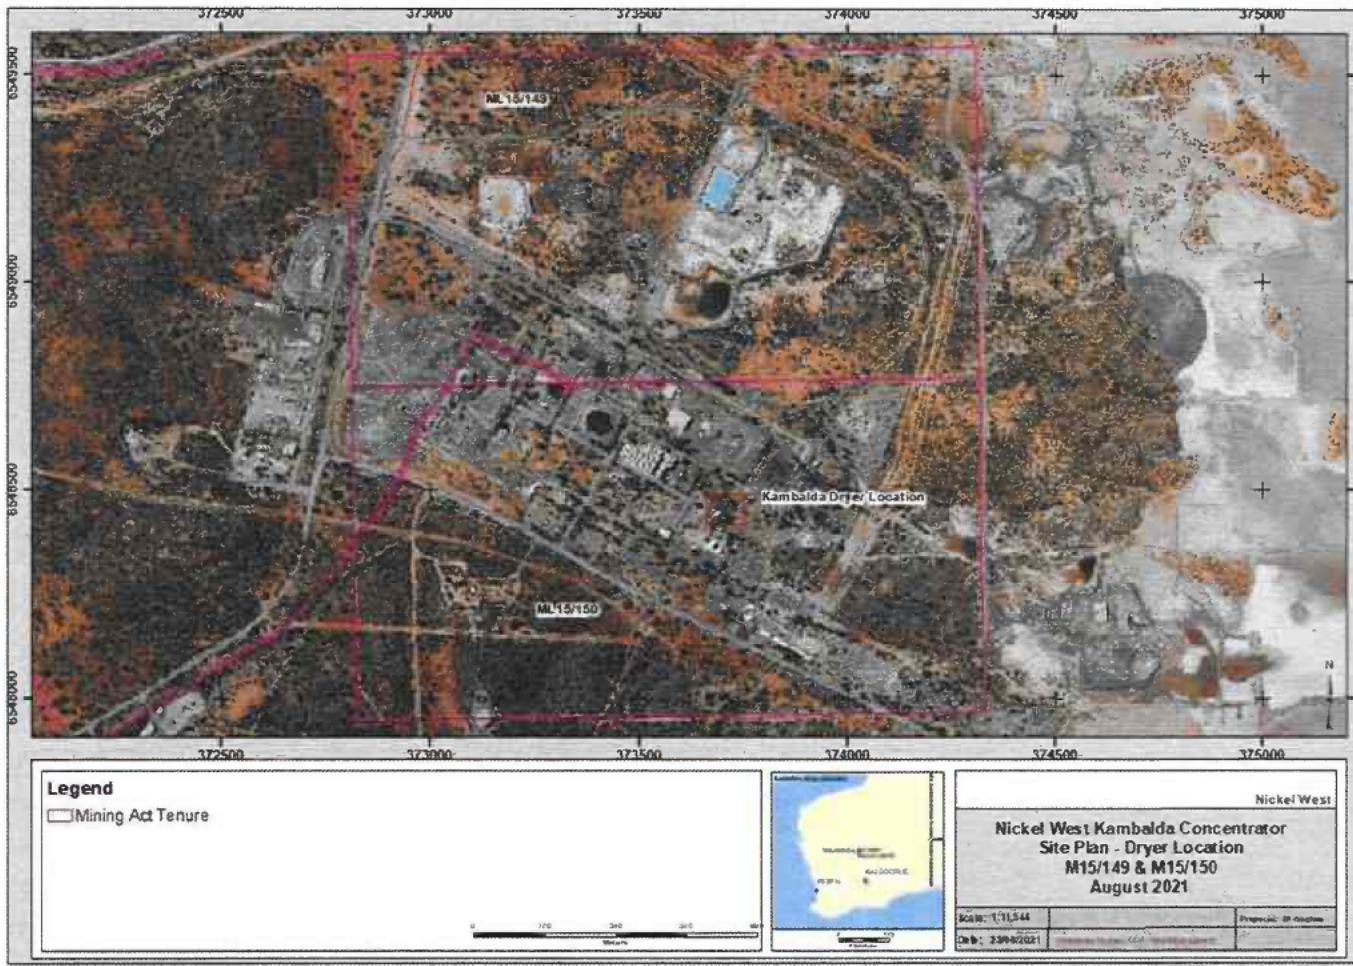
Section E – Details of non-compliance with licence condition			
Please use a separate page for each condition with which the licence holder was non-compliant at a time during the reporting period.			
Condition no:	3	Date(s) of non-compliance:	16 August 2021
Details of non-compliance:			
<p>Three Dryer stack units recorded the following (averaged) particulate concentrations during their monthly (i.e. non statutory) sampling run conducted on 16 August 2021:</p> <ul style="list-style-type: none"> • Dryer 1: 140 mg/m³ • Dryer 2: 360 mg/m³; and • Dryer 3: 130 mg/m³. <p>Licence L5533/1976/11 (L5533) sets the discharge limit for particulates at 250mg/m³. Dryer 2 exceeded this limit.</p>			
<p>What was the actual (or suspected) environmental impact of the non-compliance?</p> <p>NOTE – please attach maps or diagrams to provide insight into the precise location of where the non-compliance took place.</p>

Figure 1: Nickel West Kambalda Concentrator – Dryer Locations

Action taken to mitigate any adverse effects of non-compliance and prevent recurrence of the non-compliance:	
<p>BHP NiW took the following action to mitigate adverse effects and prevent recurrence:</p> <ul style="list-style-type: none"> • Scrubber No. 2 opened up for inspection and cleaning, prior to notification of exceedance, maintenance was triggered by an increase in the exhaust fan amps trend. • Upon notification of exceedance site immediately de-rated Scrubber No. 2 capacity by dropping the dryer operating temperature level and therefore throughput. • Scrubber No. 2 then reconfigured as per validated design. • Reviewed configuration of Scrubber No. 2 to ensure that refurbishment work was executed as per validated design (as represented in Scrubber No. 1 and 3). • Developed a 'handbook' detailing revised and validated design for the concentrator scrubber units. • Finalised a process to review updated scrubber configurations. • Re-tested refurbished Scrubber No. 2 unit on 30 August 2021 which yielded a compliant particulate result of 160 mg/m3.
