Annual Audit Compliance Report Form

Section A – Licence details			
Licence number:	L6131/1990/13	Licence file number:	DER2013/001337-1
Licence holder name:	Pilbara Manganese Pty Ltd		
Trading as:	ConsMin		
ACN:	074 106 577		
Registered business address:	L2/24 Outram street, West Perth WA 6005		
Reporting period:	01/10/2020 to 30/09 /2021

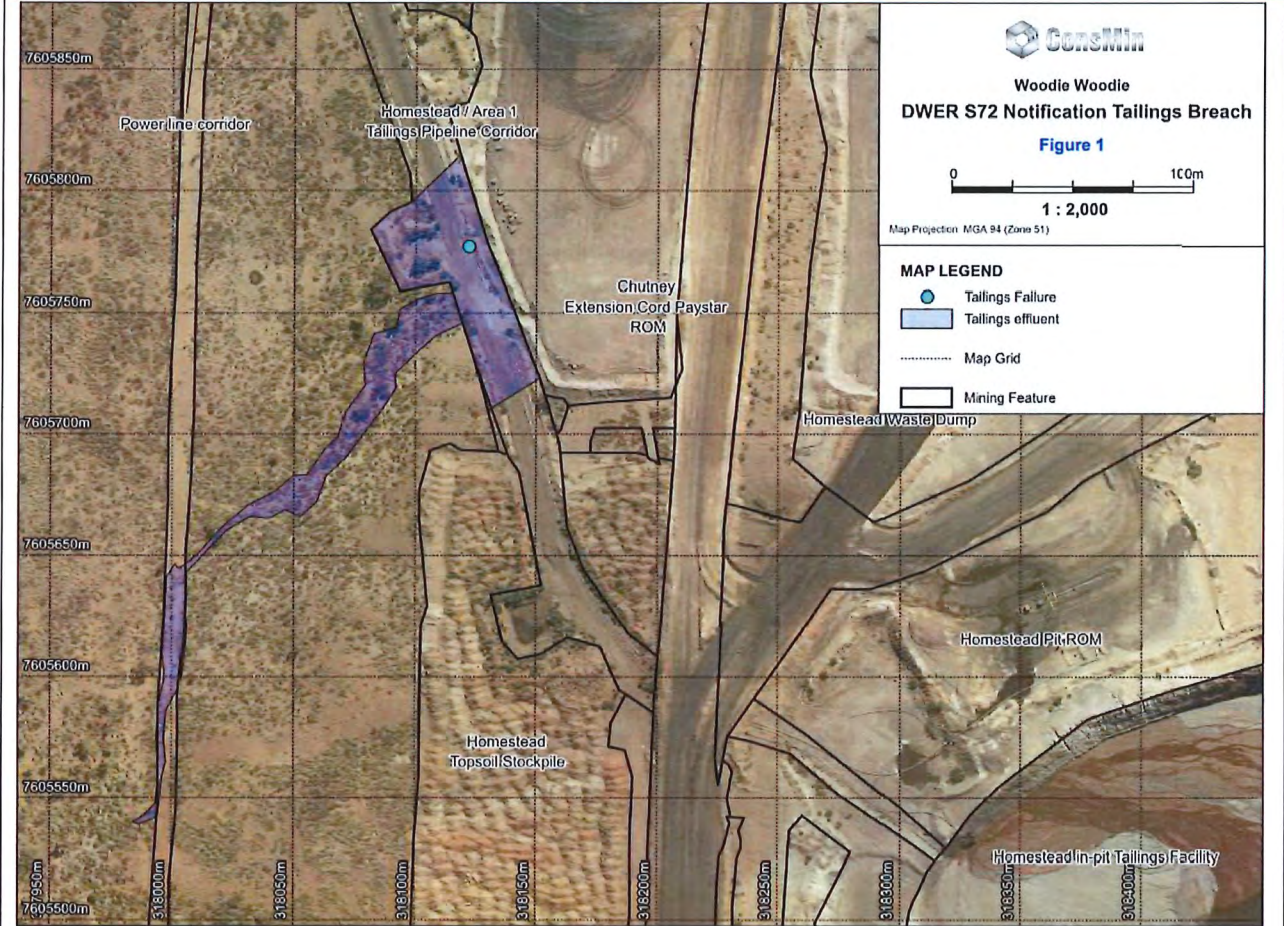
Section E – Details of non-compliance with licence condition			
Please use a separate page for each condition with which the licence holder was non-compliant at a time during the reporting period.			
Condition no:	1.3.1, 1.3.4	Date(s) of non-compliance:	22/05/2021
Details of non-compliance:			
<p>On 22 May at approximately 13:30, as part of routine inspections, a failure within a section of tailings discharge pipeline was identified. Tailings from this pipeline had pooled within the pipeline corridor, filling the adjacent tailings sump and eroding the windrow.</p> <p>As a result, tailings effluent has escaped the pipeline corridor into an area of 0.17 hectares (ha) of adjacent vegetation. The vegetation community impacted is described as <i>Open Low Woodland of Atalaya hemiglauca with Corymbia hamerleyana over Corchorus lasiocarpus subsp. lasiocarpus, *Aerva javanica, Eriachne mucronata and Triodia epactiaon minor watercourses.</i></p> <p>This event was reported to DWER on 24/05/2021 via Section 72 Waste Discharge Notification and recorded within ConsMin internal incident management system, InControl as INX 13434.</p>

<p>What was the actual (or suspected) environmental impact of the non-compliance?</p> <p>NOTE – please attach maps or diagrams to provide insight into the precise location of where the non-compliance took place.</p>			
<p>Environmental impact is considered to be negligible from this event. Given the method of malfunction, coarse grain sediment is primarily limited to the tailing’s corridor finer sediments and water flowing outside into the vegetated area. Tailing’s effluent has not sprayed or misted over adjacent vegetation. Manganese processing is chemically benign. Field samples taken of the tailings spill material immediately after the event did not show any evidence of any chemical contamination.</p>

Figure 1: Location of tailings spill and the impacted area.

Cause (or suspected cause) of non-compliance:
<p>The event was caused by internal erosion of the pipeline by the sediment, causing the pipe to fail. The weakening in this pipeline had not been identified prior to the event.</p> <p>In addition, the spill was not contained within the windrowed pipeline corridor and caused emission to the environment as the barrier has weakened over time and failed under pressure. It is estimated that the spill lasted 1 hour prior to identification.</p>
Action taken to mitigate any adverse effects of non-compliance and prevent recurrence of the non-compliance:
<p>ConsMin investigated the incident and took several actions. The windrow barrier on the tailings corridor which failed was reinstalled to a higher level with more competent material.</p> <p>To improve leak detection a pressure gauge was installed on the tailings pipeline linked to an alarm system activating when pipeline pressure changes. Equipment to scan and assess pipeline thickness has been trialed and visual inspections of the pipeline were increased. Inspection of the line were originally scheduled at 4 times per 24 hour period, were doubled to 8 to increase the early identification of issues.</p> <p>The composition of the discharge was assessed by samples taken from the spill material. On the 26/05/2021 in reply to the Section 72 notification, DWER Pollution Response requested a 3</p>

Section E – Details of non-compliance with licence condition	
<p>month period of photo monitoring of both impacted vegetation and nearby vegetation. This was completed between May 2021 and September 2021, with the photos and health assessment determining the impacted vegetation showed no signs of stress, degradation, or death. As requested by DWER details of the assessment including process, photographs and assessment records have been downloaded and stored pending request for these.</p>	
<p>Was this non-compliance previously reported to DWER?</p>	
<p><input checked="" type="checkbox"/> Yes, and</p>	
<p><input type="checkbox"/> Reported to DWER verbally</p>	<p>Date: / /</p>
<p><input checked="" type="checkbox"/> Reported to DWER in writing</p>	<p>Date: 24/05/2021</p>

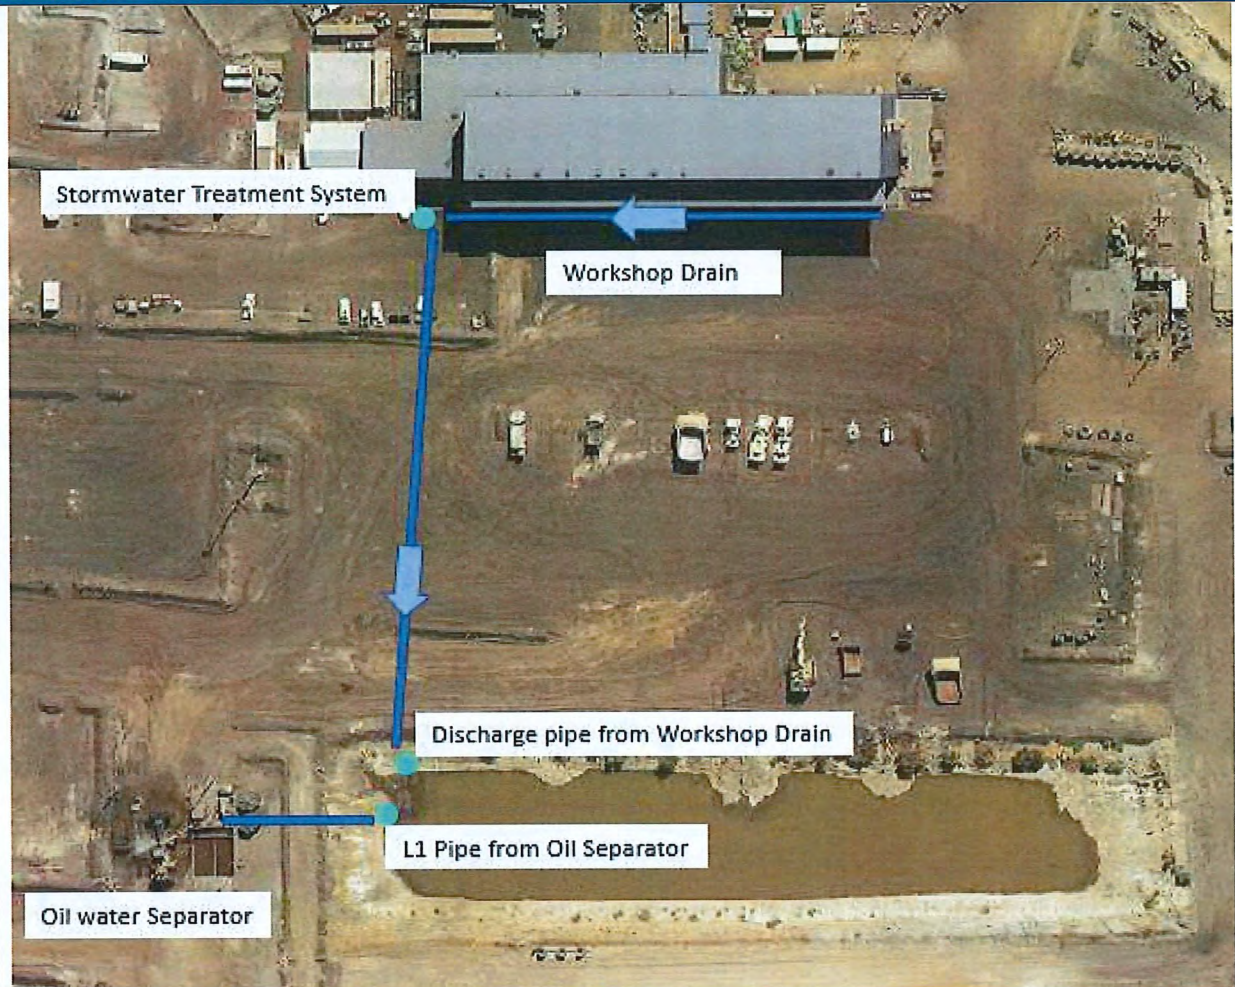
Section E – Details of non-compliance with licence condition			
Please use a separate page for each condition with which the licence holder was non-compliant at a time during the reporting period.			
Condition no:	2.3.1	Date(s) of non-compliance:	13 October 2021
Details of non-compliance:			
<p>During an internal audit of the workshop and washpad facilities it was identified that the workshop drain bypasses the washpad Oily Water Separator. Treated effluent from the Oily Water Separator is monitored at licenced sample point L1. The license incorrectly states that emission point L1 is “treated wastewater from oil water separator originating from Greensnake Workshop and wash down area.”</p> <p>The workshop drain is located at the foot of the workshop concrete floor. This drain collects stormwater from the workshop roof and is used to capture water utilised during routine cleaning of the workshop concrete floor. This water may be contaminated with hydrocarbon material.</p> <p>The workshop drain is directed into a Downstream Defender stormwater treatment system located at the end of the workshop. The Downstream Defender system utilises a vortex separator to separate sediment, oil and grease into a catchment trap. The catchment trap is emptied periodically by Veolia waste services and disposed in Port Hedland at a licenced facility.</p> <p>Water treated by the Oily water Separator at license sample point L1 is sampled. The treated water from the workshop drain is disposed via a dedicated outlet pipe infrequently and is sampled on an ad-hoc basis. Sampling occurred most months, except for October, February and August. Results were below the 15 mg/l DWER limit of total recordable hydrocarbon, except for exceedances in January (80.6 mg/l), March (47 mg/l) and May (86 mg/l).</p>

<p>What was the actual (or suspected) environmental impact of the non-compliance?</p> <p>NOTE – please attach maps or diagrams to provide insight into the precise location of where the non-compliance took place.</p>			
<p>No exceedances to evaporation basin TRH concentrations were detected.</p> <p>The evaporation basin, into which the treated water with from the Workshop drain and Oily Water Separator is released has been constructed from natural clay material. Clay at Woodie has been tested and found to be extremely non permeable (1.0×10^{-9} – 6.1×10^{-11} m/s). As the hydrocarbon contaminated water is localised to the evaporation basin, and groundwater level sits 80 m below the pond, Pilbara Manganese Pty Ltd does not consider this non-compliance to have resulted in environmental impact.</p> <p>In addition, the evaporation basin and greater workshop areas, have been identified as requiring sampling and investigation at Mine Closure, to determine any potential locations which may require management under the <i>Contaminated Sites Act 2003</i>.</p>

Figure 2: Location of pipe discharging from the workshop drain into the lined evaporation pond.

Detailed schematics are not available for the workshop, which was constructed in 2008. Information available incorrectly indicates that the Workshop collection drain enters the Oily Water Separator, before discharging into the evaporation pond.

The discharge pipe from the workshop drain will be sampled on an ad-hoc basis when stormwater flows are able to be captured. In addition, quarterly samples will be taken from the evaporation pond to monitor TRH levels.

On completion of the current assessment under Part 4 of the *Environmental Protection Act 1986*, ConsMin will submit a licence amendment application to correctly reflect the discharge pipe and evaporation basin and point of emission of treated wastewater from the oily water separator.

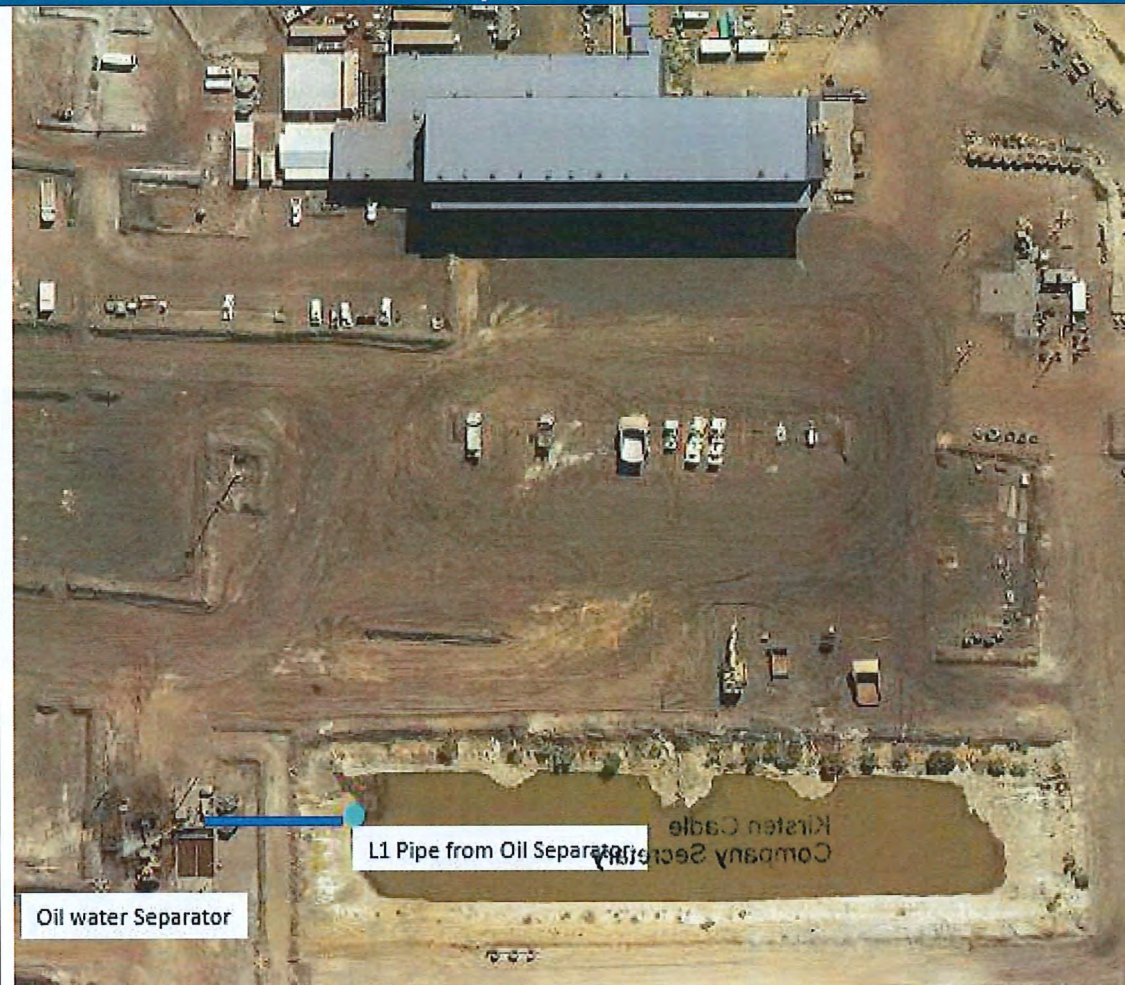
Section E – Details of non-compliance with licence condition			
Please use a separate page for each condition with which the licence holder was non-compliant at a time during the reporting period.			
Condition no:	2.3.2	Date(s) of non-compliance:	3/06/2021
Details of non-compliance:			
<p>As part of quarterly sampling, L1 (Greensnake wash down evaporation basin) was sampled on 26th May 2021. This subsequently resulted in the detection of summed TRH concentration of 86 milligrams per litre (mg/l), this result is above the licenced target limit of 15 mg/l.</p> <p>This event was reported to DWER on 4/06/2021 via Form N1 notification letter and recorded within ConsMin internal incident management system, InControl as INX 13532.</p>			
<p>What was the actual (or suspected) environmental impact of the non-compliance?</p> <p>NOTE – please attach maps or diagrams to provide insight into the precise location of where the non-compliance took place.</p>

<p>Light Vehicles and Heavy Equipment are washed at the wash down bay. All water and sediment are directed into the adjacent sump which then passes through the oily water separator. Hydrocarbon contaminated material is discharged into a 1,000 L Intermediate Bulk Container (IBC) and treated water is discharged into the adjacent evaporation basin.</p> <p>At the time of sampling, the evaporation basin was also sampled, returning a TRH of 2.9 mg/l. The discharge of TRH concentrations above the Licence Limit may have been diluted within the larger evaporation basin. The evaporation basin, into which the water with elevated TRH was released has been constructed from natural clay material. Clay at Woodie has been tested and found to be extremely non permeable (1.0×10^{-9} – 6.1×10^{-11} m/s). As the hydrocarbon contaminated water is localised to the evaporation basin, and groundwater level sits 80m below the pond PMPL do not consider this exceedance to have resulted in environmental impact.</p> <p>In addition, the evaporation basin and greater workshop areas, have been identified as requiring sampling and investigation at Mine Closure, to determine any potential locations which may require management under the <i>Contaminated Sites Act 2003</i>.</p>

Figure 3: Location of L1 discharge point for treated water from the Oil Water Separator.

Initial review of maintenance records has identified that the scheduled three-monthly maintenance works (removal and washing of baffles plus additional cleaning and inspections) was not completed. Further inspection found a blocked overflow pipe outlet within the system which is likely to have contributed to the elevated levels of TRH.

Maintenance work commenced on the 4/6/21 and included:

- The removal, inspection, and cleaning of Oily Water Separator baffles.
- Inspection of float valves.
- Removal, inspection, and cleaning, of skimmers, pumps, hoses, and oil filters.
- Removal of waste sediment from catchment bund.

Maintenance staff were reminded that preventative maintenance on the Oily Water Separator is essential, and if unable to be completed, needs to be escalated to management immediately.

The discharge pipe was improved by replacing the lay flat hose with a polypipe on a camlock system for easy cleaning, and a 6-month preventative maintenance check scheduled to ensure this part of the system is free of blockages.
