## Annual Audit Compliance Report Form

Section A – Licence details			
Licence number:	L6131/1990/13	Licence file number:	DER2013/001337-
Licence holder name:	Pilbara Manganese Pty Ltd		
Trading as:	ConsMin		
ACN:	074 106 577		
Registered business address:	L2/24 Outram Street, West Perth, WA 6005		
Reporting period:	1/10/2022 to 30/09/2023

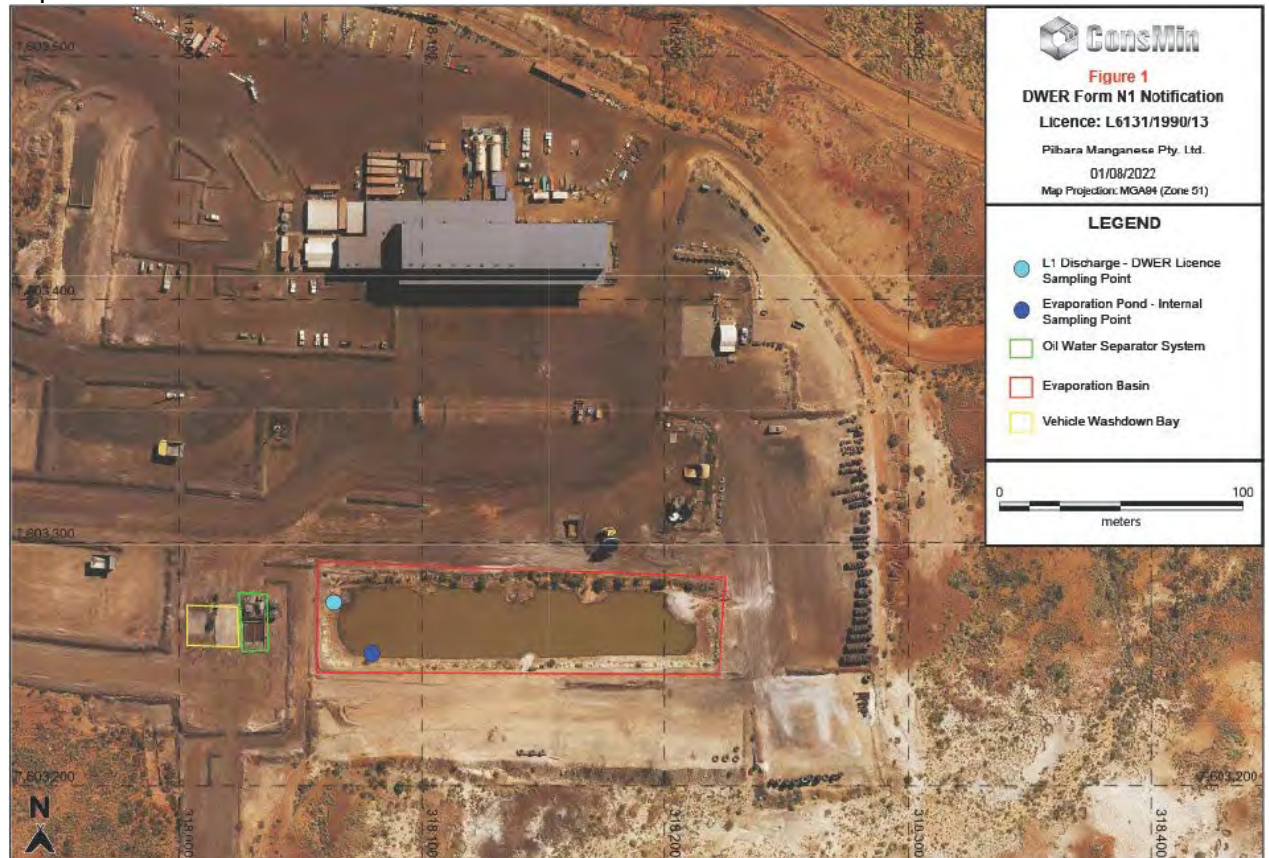
At the time of sampling, the evaporation basin was also sampled, returning a TRH of 14.5 mg/L (below the 15mg/L threshold). The discharge of TRH concentrations above the licence limit at L1 may have been diluted within the larger evaporation basin.

The evaporation basin has been constructed from natural clay material. Clay at Woodie has been tested and found to be extremely non permeable ( $1.0 \times 10^{-9} - 6.1 \times 10^{-11}$  m/s). As the hydrocarbon contaminated water is localised to the evaporation basin, and groundwater level sits 80m below the pond, PMPL do not consider this exceedance to have resulted in environmental impact.

**Figure 2: Location of L1 discharge point for treated water from Oily Water Separator**

1. Large amount of hydrocarbon liquid disposed of directly into the oily water separator inlet sump rather than the designated waste oil Intermediate Bulk Container (IBC).

On 6 November 2022, a site wide notification was sent out to inform employees on the correct disposal method of hydrocarbons. Educational presentations were presented to all work areas to inform and raise awareness on correct methods for hydrocarbon disposal.

Section E.1 – Details of non-compliance with licence condition	
<ul style="list-style-type: none"> <li>- Clean out of solids hopper on 13 and 16 November. Scheduled fortnightly cleaning commenced on 10 December 2022.</li> <li>- ConsMin received advice from Baldwin, OWS manufacture around replacing plate packs within OWS from 12mm to 6mm, increasing the surface area and increasing treatment capability of the tank.</li> <li>- Adjustment of skimmer tubes to manufacturer specs</li> <li>- Quarterly cleanout of outlet pipe and filter on 24 December 2022</li> </ul>	
L1 and Evaporation basin monitoring results:	
Was this non-compliance previously reported to DWER?	
<input checked="" type="checkbox"/> Yes, and	
<input type="checkbox"/> Reported to DWER verbally	Date: / /
<input checked="" type="checkbox"/> Reported to DWER in writing	Date: 15/11/2022

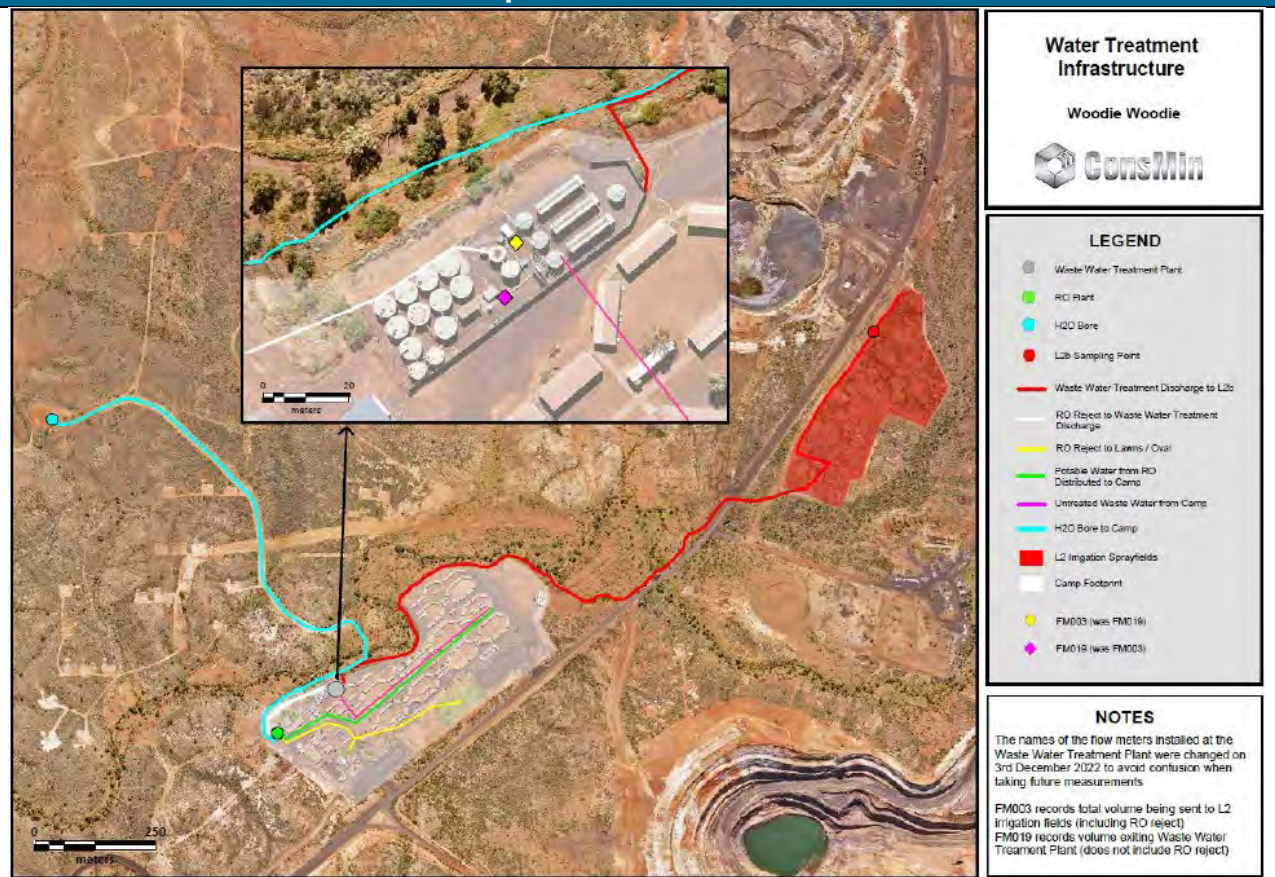
<p>To discern any associated impact on the environment samples were taken from RO plant and L2B on the 2 November 2022. These returned negligible results.</p> <p>To discern any impacts on vegetation health a monitoring program was enacted on the 21 December 2021 (Appendix I). No discernible impacts were observed during the initial monitoring period. During the final round of vegetation health monitoring in June 2023 a slight improvement in vegetation condition was observed in the southwest and west areas monitored, and a deterioration of vegetation health was observed in the north and northeast areas monitored. This was likely a result of regulator application of hardwater to these areas. In response, the L2A spray field area was commissioned to spread the impact of the hardwater discharge.</p>

**Figure 3: Map showing Water Treatment Infrastructure**

1. Intrusion of potable water from the outlet pipes of the Reverse Osmosis (RO) system into subsurface plumbing increasing the discharge through the outlet pipe of the WWTP. The unit was installed on the 20 September 2022.
2. Ruptures within effluent water pipeline allowing intrusion of potable water

Remediation work commenced on the 21 October 2022 and involved identifying and fixing the leaks in the potable water pipeline and the effluent water pipeline to stop potable water from contributing volume to the effluent water treatment system. This involved:

1. Purchasing equipment to identify leaks below the ground surface.
2. Replacing and repairing the damaged pipeline.

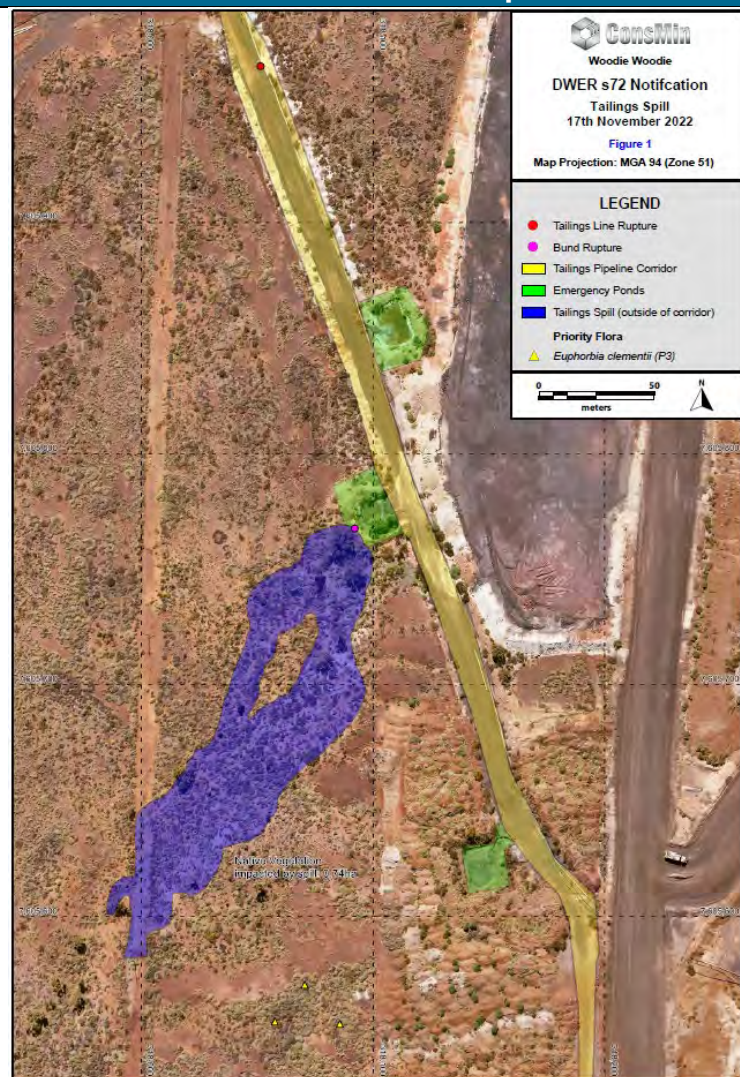
<p>Environmental impact is considered to be negligible. Given the method of malfunction, coarse grains sediment was primarily encapsulated to the tailing's corridor and sumps. Tailing effluent was noted misted or sprayed of adjacent vegetation. Manganese processing is chemically benign, consisting primarily of crushing and screening.</p>			
<b>Table 2: Total disturbance footprint within / outside tailings corridor.</b>			
<b>Disturbance Area</b>			
<b>Area of impact</b>	Southeast of sump		
Aerea within corridor (recovered)	0.33 ha		
Area outside of corridor	0.74 ha		
<b>Total area</b>	1.07 ha		
<p>From the start of the vegetation health monitoring program on the 17 November 2022 till the end of the program on the 17 February 2023 no significant decline in vegetation health was recorded in the area outside the tailings corridor (Appendix I)</p>

**Figure 4: Aerial Imagery on 17<sup>th</sup> November 2022 of tailings spill disturbance footprint, tailings corridor and emergency sumps.**

1. Failure occurred at the base of the pipeline due to continued internal erosion by tailings sediment.
2. Approximately 20 hours of heavy rainfall were received between the 16 and 17 November pushed the emergency sump over its holding capacity.

- Replacing malfunctioned section of pipeline.
- Pumping out tailing's effluent from the emergency sump to the unused, banded, Extension Cord ROM pad.
- Windrowed off sump to prevent further entry of rainfall/tailings into sump.
- Reinstatement of sump wall.
- Upgraded plant control system to include pressure change alarm between flow metres at either end of pipeline.

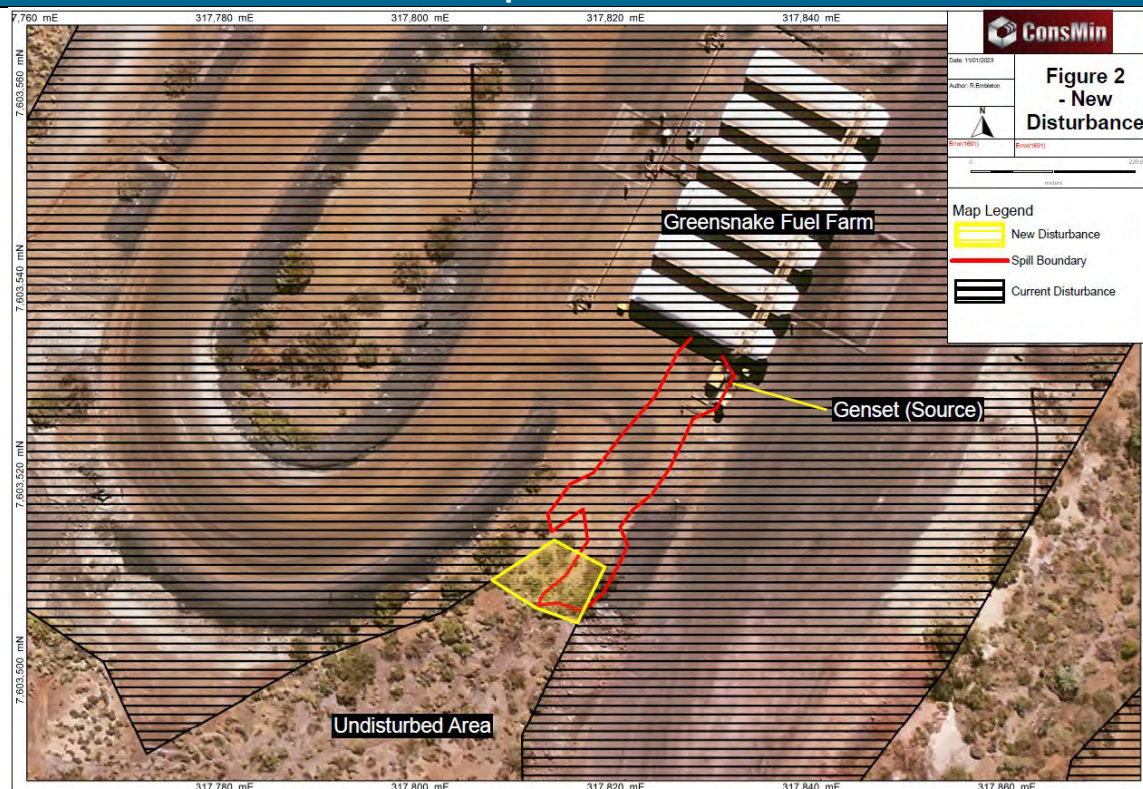
**Figure 5: Diesel spill footprint and associated vegetation clearing required at the Greensnake Fuel Farm**

1. Incorrectly fitted fuel hose on the generators. This had the main fuel supply incorrectly plumbed to the genset tank rather than the fuel pump, leading to fuel gravity feeding out of the tank through the breathers.

- The area was bunded off to stop the further spread of diesel.
- Soaker pads and organic absorbents laid out on the impacted area.
- Contaminated soil was dug out to a depth of 0.3 m by using heavy mobile equipment (HME) and taken to the designated bioremediation area.
- The area was bunded off to stop further risk of diesel run off.

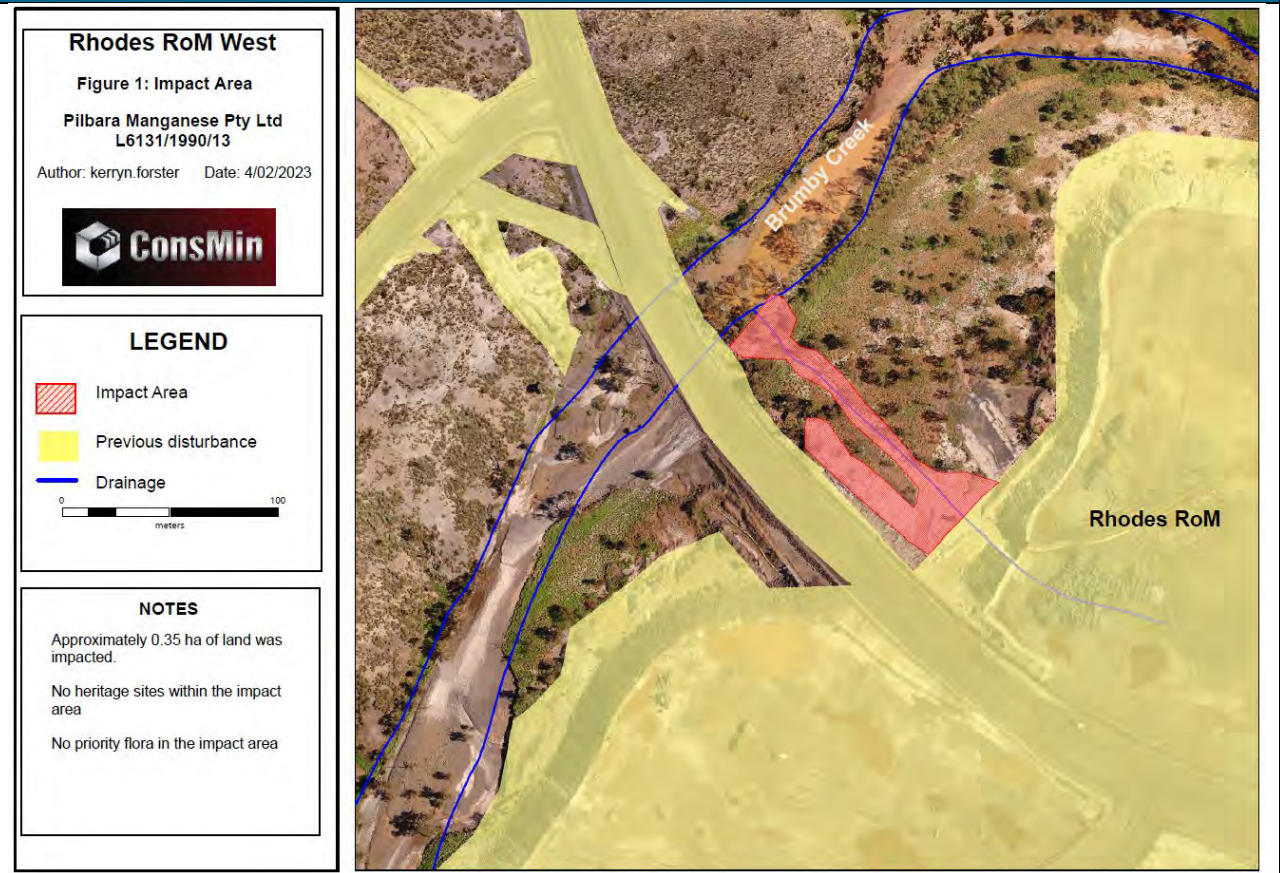
**Figure 6: Impacted area from Rhodes ROM blowout following significant rainfall event.**

1. Blow out occurred due to significant rainfall across the region in the days prior.

- Construction of a windrow to prevent further runoff from pooling within the ROM
- Compaction of batters and further rock armoring of all sides of ROM to reduce erodibility of landforms and availability of sediment for run off.
- Vegetation program was enacted to discern any downstream impacts of blowout (Appendix I).
