Annual Audit Compliance Report Form

Section A – Licence details			
Licence number:	L6942/1997/13	Licence file number:	DER2013/000329
Licence holder name:	BHP Iron Ore Pty Ltd		
Trading as:	BHP Iron Ore Pty Ltd		
ACN:	008 700 981		
Registered business address:	Level 1, City Square Brookfield Place 125 St Georges Terrace PERTH WA 6000		
Reporting period:	01/07/2024 to 30/06/2025

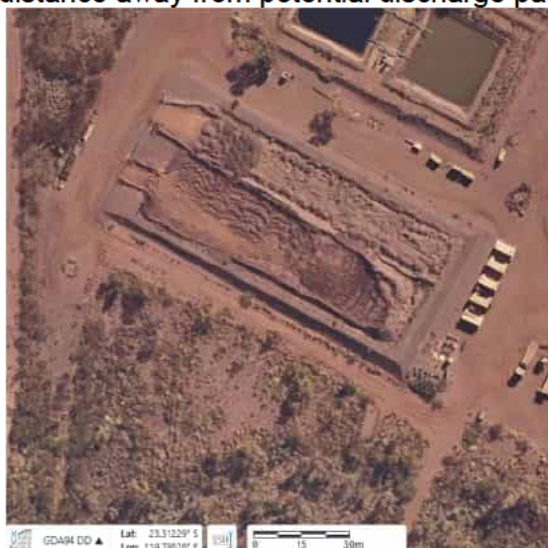
The Eastern Ridge bioremediation facility does not meet the required design specifications stipulated in the Licence. The bioremediation facility cell liner does not meet the permeability requirements of $\leq 10^{-9}$ m/s. Additionally the design of the cell is such that there is potential for contaminated stormwater runoff.

There was no actual (or suspected) environmental impact identified as a result of the non-compliance. The bioremediation facility is characterised by a flat/gentle sloped area, is located a minimum 50 m away from surface water bodies, the groundwater is greater than 3 m below the facility and there is sufficient distance away from potential discharge pathways.

The bioremediation facility was not constructed to the specified requirements stipulated in the Licence, with a facility cell liner permeability of $\leq 10^{-9}$ m/s.

Engineering and design drawings for a new bioremediation facility to be located at Whaleback have been completed in the FY2025 reporting period. The project is pending tollgate into Execution. Additionally, operational guidance documents have been developed for the new facility and are currently pending finalisation.

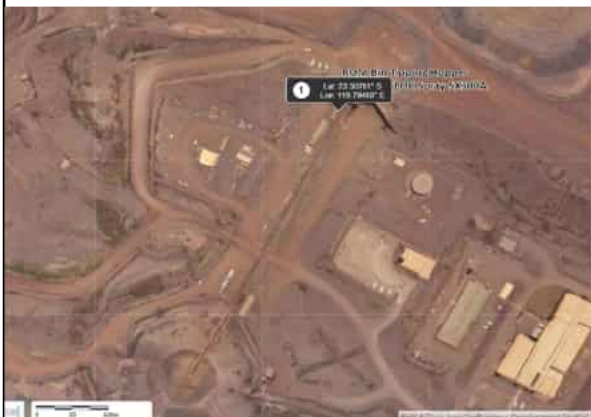
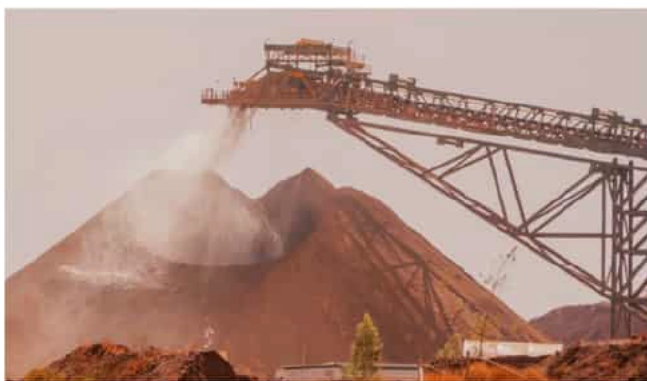
The Licence requires a rate of 90% or more for the Average Monthly Availability of ‘Boom Sprays on Stackers’ and ‘Bulk Ore Conditioning (BOC) sprays’. During the FY2025 reporting period, the Average Monthly Availability did not achieve the rate of 90% or more for boom sprays on stackers in August 2024 (24.99%), September 2024 (57.3%), October 2024 (87.9%) and November 2024 (83.3%). Additionally, the Average Monthly Availability did not achieve the rate of 90% or more for the BOC sprays in September (89.88%).

Above: Boom sprays on a stacker.

The identified cause of the non-compliance was due to the boom sprays on stackers being run in the incorrect operational mode (run in maintenance more rather than in auto mode). Additionally, the BOC spray Average Monthly Availability was below 90% due to the valve at the pump upstream not operating as required as a result of the incorrect setting being selected.

The Licence requirements were communicated to the remote operations team and the control system was reviewed and aligned to ensure performance was in line with our licence operating requirements. A licence amendment was granted on 23 October 2024 which included a change to the Performance criteria from Average Monthly Availability to Average Monthly Performance (Time in Auto) for Stacker Sprays. This amendment clarified the performance criteria, and the process control was amended to meet the licence requirements.

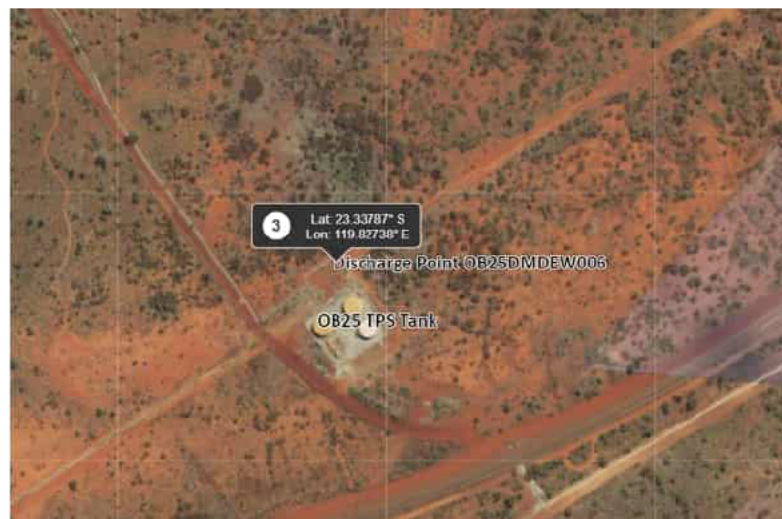
Monitoring point location D06, which is the contingency discharge from the OB25 TPS tank overflow to Homestead Creek, was not sampled for quarter one and quarter two during discharge events as required by the Licence, which stipulates a spot sample to be taken from the OB25 TPS tank quarterly when discharging. It was identified that the monitoring point where samples were being collected from was not in accordance with the location specified in the Licence.

There is no actual or suspected environmental impact from this event. Monitoring point D06 is a dewatering overflow sampling point, discharge only occurs as a contingency event.

The cause of the non-compliance was due to an administrative error. There was an incorrect change in the groundwater monitoring schedule resulting in the required monitoring points being missed for sampling

Relevant teams were consulted and the naming of discharge locations D01 and D07 were reviewed and aligned within the Licence and the internal water database system. The contractor sampling schedule was also updated to reflect the changes to ensure consistency of naming criteria.

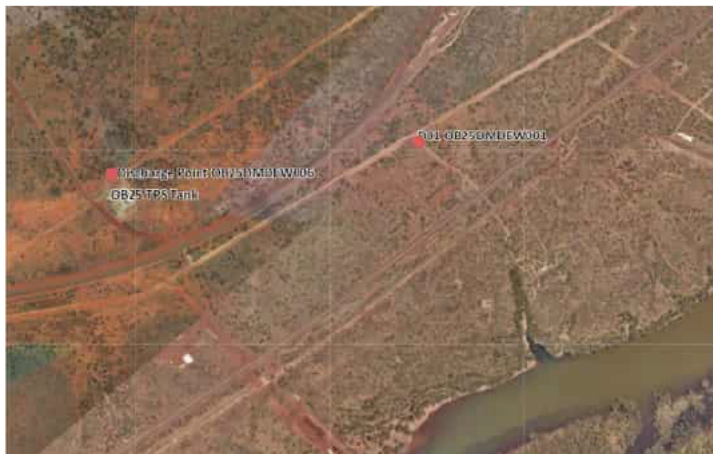
Monitoring point location D01, which is the groundwater abstraction direct discharge to Ophthalmia Dam over existing rip-rap disposal area, was not sampled for water quality parameters in quarter two as required by the Licence, which stipulates a spot sample to be taken quarterly when discharging.

No actual (or suspected) environmental impact from this event. D01 is a dewatering overflow sampling point. Previous and subsequent sampling results are within the internal trigger values.

An administrative error resulted in the sampling contractor not scheduling sampling of site D01 in this period.

To prevent recurrence, a review process for schedule changes will be implemented. This process will ensure that all changes are clearly identified and confirmed with internal relevant stakeholders to ensure the schedule is aligned with the Licence requirements.

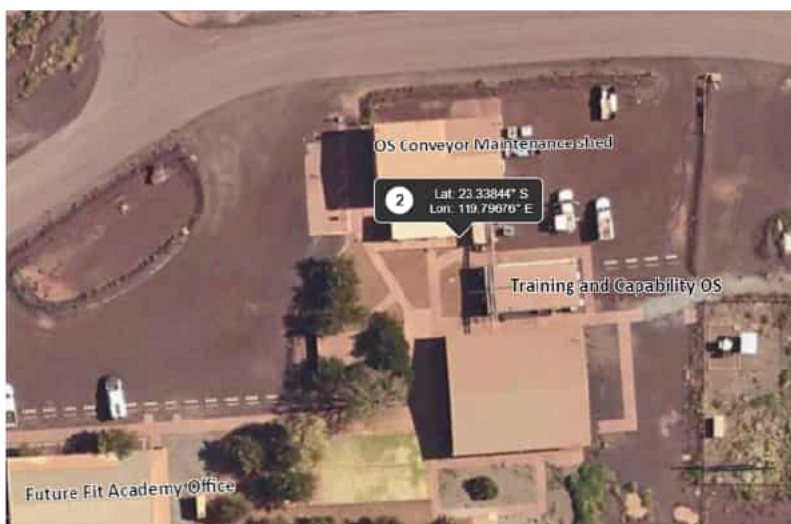
During the FY2025 reporting period, there were two events where effluent was discharged not in accordance with the requirements stipulated in Table 5/Table 8 of the Licence.

There was no actual or suspected environmental impact, the unauthorised discharge was contained to the sealed area and cleaned up once identified.

The cause of the two unauthorised discharge events was due to equipment fault, where the sewage pump failed causing the sewage to discharge into the surrounding environment.

The spills were contained and cleaned up and the faulty equipment (pump and floats) were replaced.

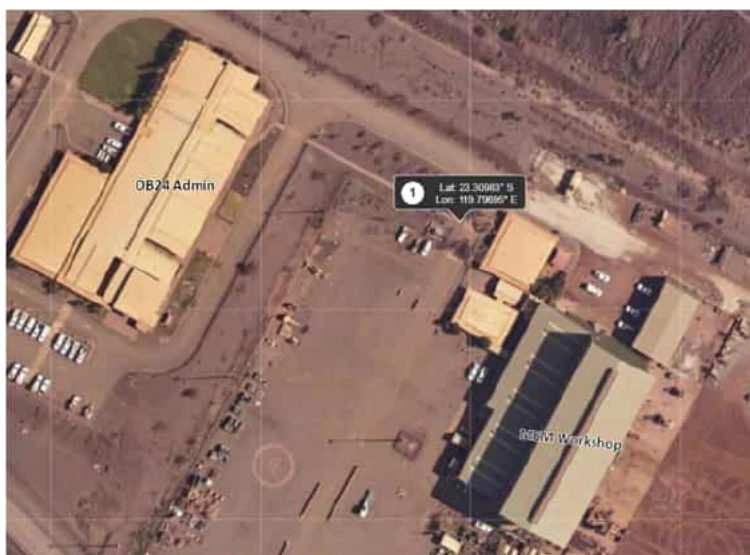
There was an unauthorised discharge of effluent from the Orebody 24 Administration Waste Water Treatment Plant discharge point. The Licence states that sewage is only to be 'discharged in accordance with Table 8 and Table 13 of Schedule 4'.

There was no actual or suspected environmental impact as a result of the tank overflow as discharge was contained to the area and no runoff to nearby receptors was identified.

The cause of the non-compliance was due to faulty equipment. Further investigation identified a faulty float and broken inspection shaft cover, causing the unauthorised discharge to occur.

The spill was contained and cleaned up and the pit was manually pumped out. The concrete inspection shaft and faulty float were replaced.
