## Annual Audit Compliance Report Form

Section A – Licence details			
Licence number:	L7465/1999/9	Licence file number:	2011/011727-1
Licence holder name:	Northern Star Resources Limited		
Trading as:	Northern Star Resources Limited		
ACN:	116649122		
Registered business address:	Level 4, 500 Hay Street, Subiaco WA 6008		
Reporting period:	01 / 01 / 2022 to 31 / 12 / 2022

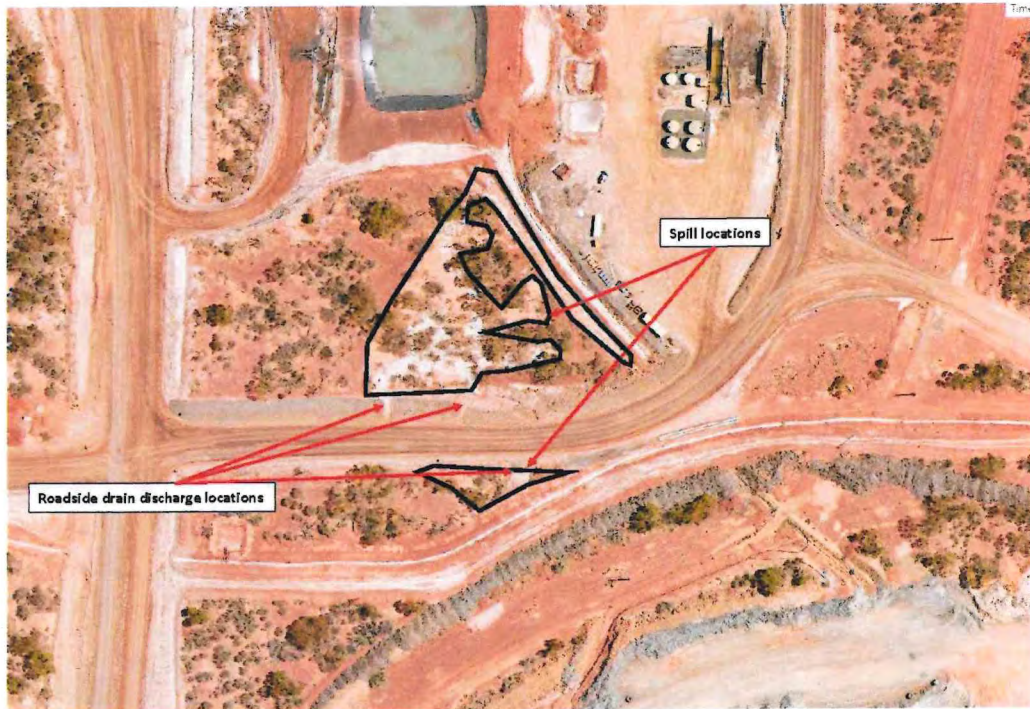
Above image displays the area of discharge relating to the reported spill and identifies the drainage slots that were cut into the bund along the roadway allowing the discharge.

Section E – Details of non-compliance with licence condition	
<b>Cause (or suspected cause) of non-compliance:</b>	
Due to roadway maintenance following a 10mm rain event, new drainage slots were cut into the roadside bunding allowing discharge of hypersaline dust suppression water when mobilised by rainfall events.	
<b>Action taken to mitigate any adverse effects of non-compliance and prevent recurrence of the non-compliance:</b>	
Entire spill was recovered. A bobcat was used to recover the salt effected areas and trees not affected by the salt will be left in-situ. Sumps were dug to capture any potential future water drainage from the roadway.	
<b>Was this non-compliance previously reported to DWER?</b>	
<input checked="" type="checkbox"/> Yes, and	
<input type="checkbox"/> Reported to DWER verbally	Date: / /
<input checked="" type="checkbox"/> Reported to DWER in writing	Date: 22 / 12 / 2022

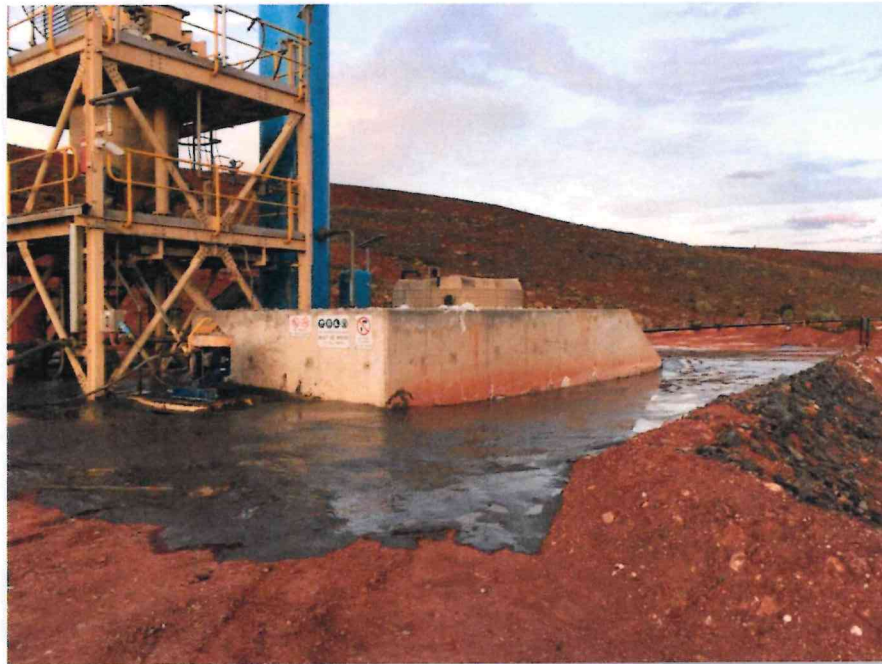
Figure 4- Paste Spill emergency bunker overwhelmed

The spill occurred after the paste pipeline became blocked by scale build up which dislodged within the pipeline and blocked the line at the injection site. A dump valve was opened into the purpose-built catch sump to relieve pressure build up. Due to the volume of material discharged, the sump was overwhelmed, resulting in the sump overflowing to the immediate adjacent area.

Paste left to dry, then cleaned up with bobcat. Waste material disposed of within the Whirling Dervish central landform licenced paste waste location. Spill occurred to disturbed area only, no material impact to the Environment. Incident reported to DWER under Section 72.

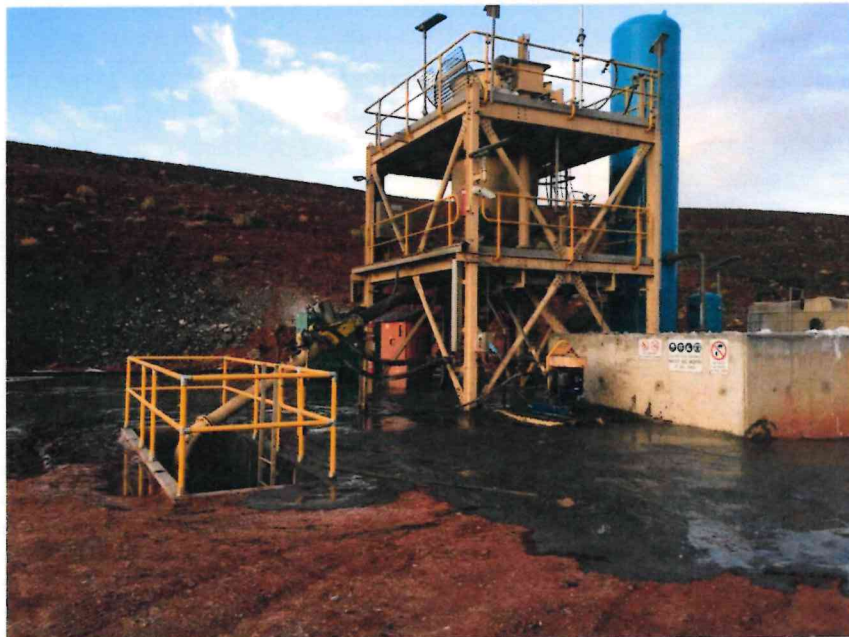
Figure 3- Paste Spill around injection infrastructure

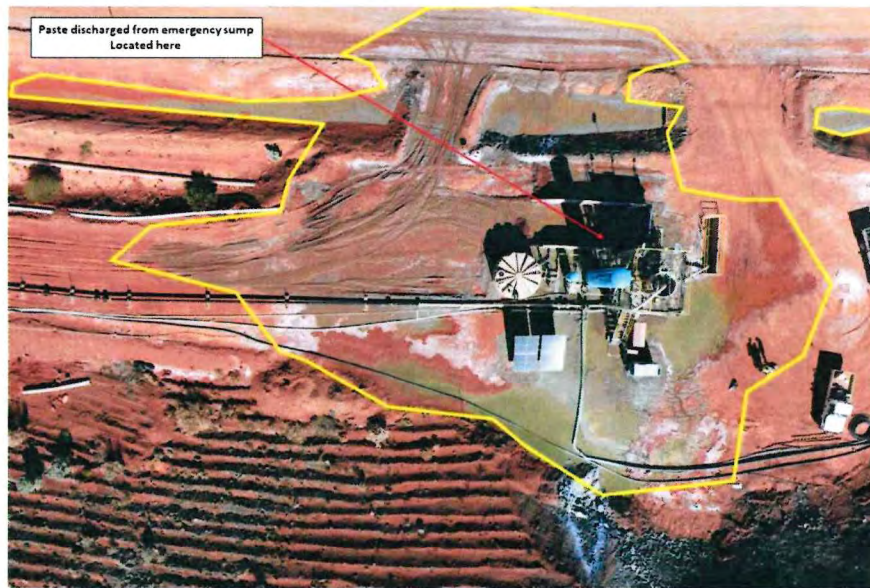
Figure 2- Paste Spill extents

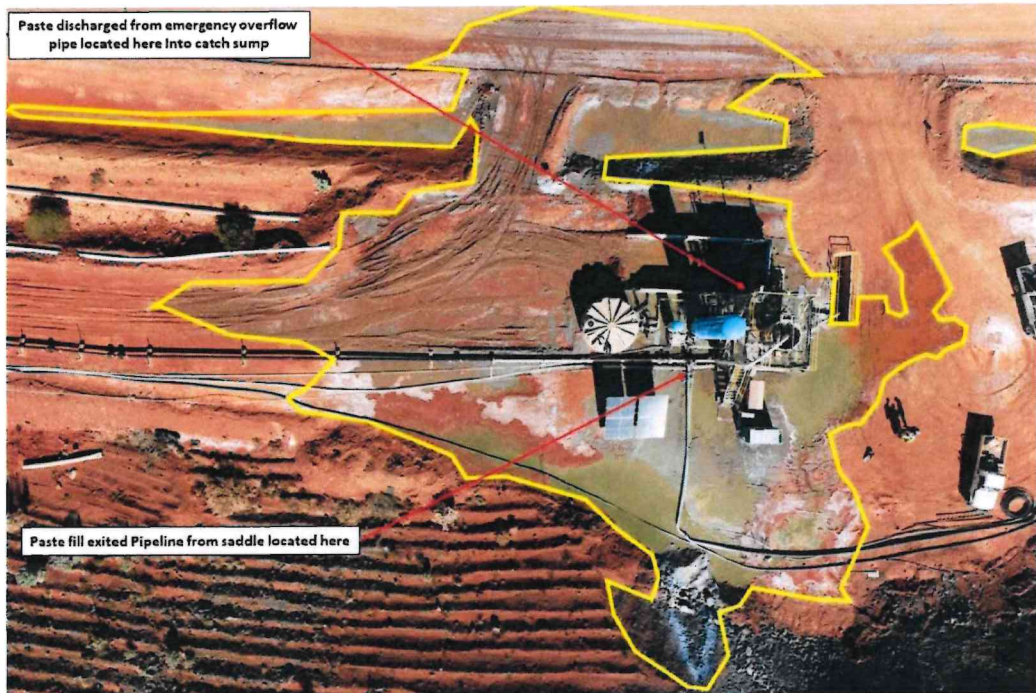
Figure 2- Paste Spill Extents

The spill occurred after the paste pipeline became blocked by scale build up which dislodged and blocked the line. The weakest point in the pipeline (at a pipeline saddle) then released paste to ground, whilst a dump valve was simultaneously opened into the purpose-built catch sump to relieve the pressure. Due to the volume of material discharged, the sump was overwhelmed, resulting in the sump also overflowing to the immediate adjacent area.

Paste left to dry, then cleaned up with bobcat. Waste material disposed of within the Whirling Dervish central landform licenced paste waste location. Spill occurred to disturbed area only, no material impact to the Environment. Incident reported to DWER under Section 72.

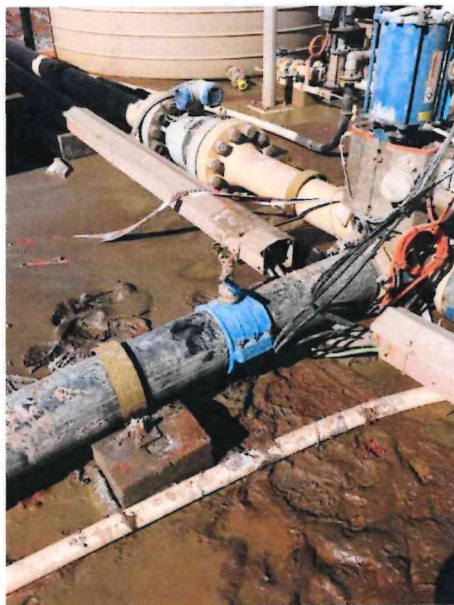
Figure 3- Saddle discharge location (saddle reinstated)

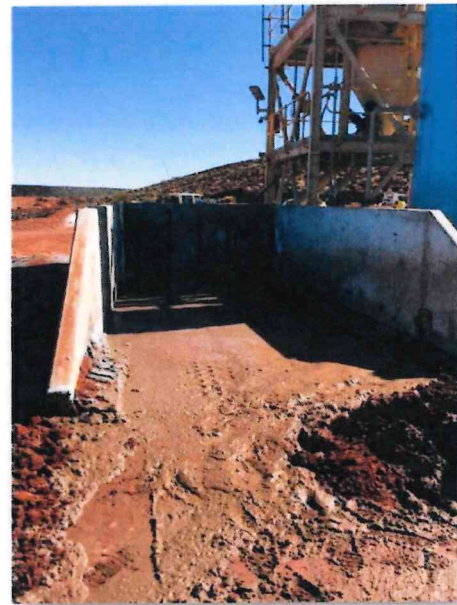
Figure 4- Sump discharge location

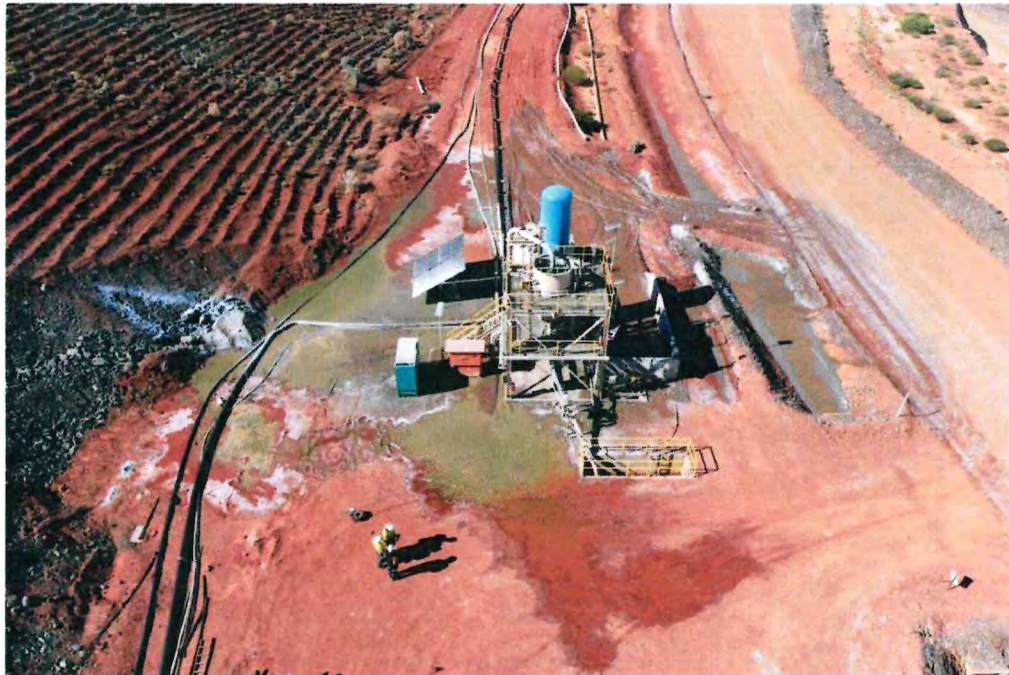
**Figure 3- Paste Spill drone imagery**
