Annual Audit Compliance Report Form

| Licence number: | L7750/2001/10 | Licence file number: | 2011/009482-1 |
| Licence holder: | Evolution Mining (M | Mungari) Pty Ltd | |

| THE RESIDENCE OF THE PARTY OF T | SCHOOL STREET, | | | |
|--|--|---|---|--|
| Condition no: | 3. Tailings Discharge | Date(s) of non- compliance: | 08/10/2021 | |

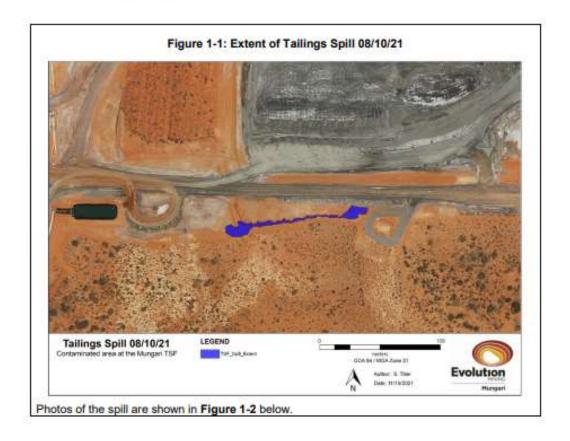
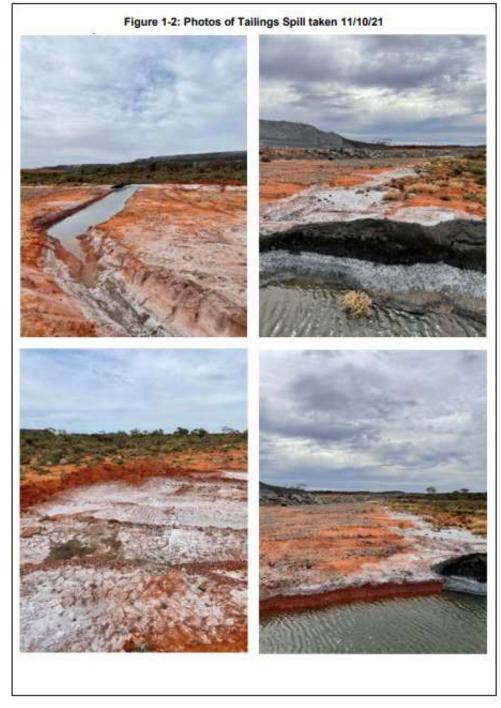
Tailings are transported from the Mungari Processing Plant via pipeline to be discharged into the Mungari TSF. Tailings are directed to different TSF Cells via a T-Piece pipe located in a bunded area. The T-Piece has failed resulting in a spill in the bunded area. Pipework from the bunded area to a catchment dam are in place to drain tailings and prevent overtopping. The Processing Plant was immediately shut down to stop the flow of tailings and the pipeline was flushed with water to remove sediment build up. An operator has noticed the tailings rising in the bunded area and made the decision to break the bund to allow tailings to escape and travel down a culvert. The culvert is in place for surface water run-off therefore tailings began to flow towards nearby vegetation. Operator attempted to stop the flow by bunding with dirt and dry tailings. A very small area of bushland was impacted by the spill.

An area of approximately 463m² along the edge of the vegetation impacting a number of small shrubs, Figure 1-1 shows the extent of the spill.

Operator error.

The spilled material was scraped up and removed from the area as shown in Figure 1-3 below. It was also verbally confirmed with operators in the area to not break bunds. Bunds were re-established.
