Annual Audit Compliance Report Form

Section A – Licence details

Licence number:	L8008/2004/3	Licence file number:	DER2014/000631
Licence holder name:	Ravensthorpe Nickel Operations Pty Ltd		
Trading as:	Ravensthorpe Nickel Operations		
ACN:	092506584		
Registered business address:	Level 1, 24 Outram Street, West Perth, WA 6005		
Reporting period:	01/05/2022 to 30/04/2023

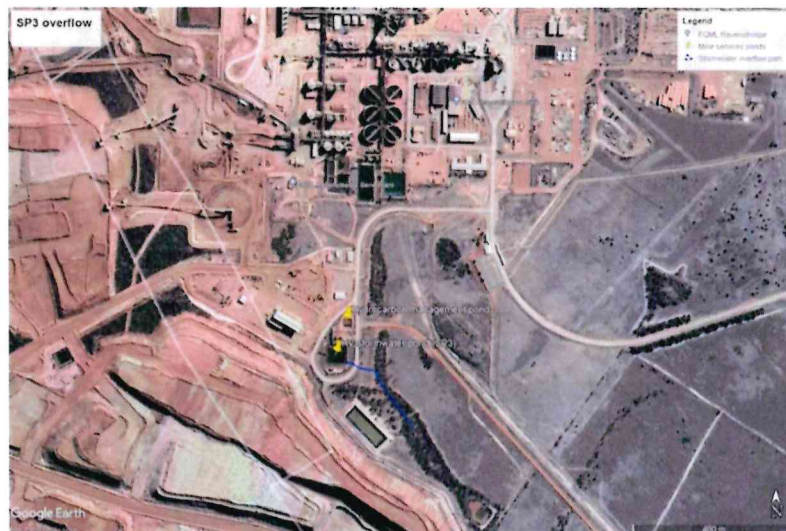
MACA storm-water dam (SP3) overflowed through the spillway resulting in a storm-water discharge containing hydrocarbons into the drain surrounding SP3 and then through the road culvert and downstream into the adjacent creek line. Required freeboard not maintained.

The impacted area is highly disturbed, and the short term impact of the incident is expected to be minor and contained to the immediately affected area. The area has been cleaned up and minimal residual impact is expected.

There were 3 main contributing factors to this incident:

- There was more water remaining in the Halley's mine services area storm-water system due to the mining contractor relocating the bulk of their operations to the Shoemaker-Levy mine. In the past significant quantities of storm-water has been used for dust suppression and other mining operations at the Halley's mine and there is now less of a requirement for this.
- Due to dot point 1 and rainfall, the storm water pond was, at the time of the incident being operated above the allowed freeboard resulting in less capacity available to contain additional storm water.

Section E – Details of non-compliance with licence condition	
<ul style="list-style-type: none"> The waste oil separation system in the nearby oily water pond which usually feeds clean treated water to the storm water pond was not operating optimally. This led to some minor quantities of waste oil making it through into the clean water tank feeding the storm water pond. Some of this waste oil subsequently exited the pond via the spillway. 	
Action taken to mitigate any adverse effects of non-compliance and prevent recurrence of the non-compliance:	
<p>Overflow through the SP3 spillway was stopped using sand bags. Pond level lowered using Cleanaway Industrial vac truck. Cleaned-up the deposited hydrocarbon in the impacted area. More thorough maintenance of waste oil recovery system to ensure only water enters the storm water pond. Clean water tank added to weekly inspection schedule and better management of waste oil recovery system to ensure it is operating correctly.</p>

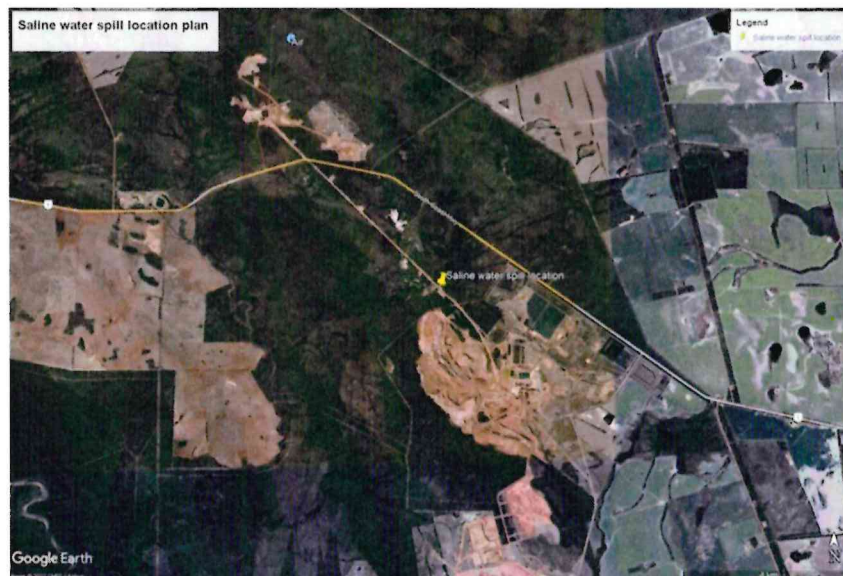
Saline water (seawater) was released to the environment at approximately chainage 6400, along the RNO processing plant to Shoemaker – Levy saline water pipeline.

No impact expected from this incident as water flowing in the affected creek line is already saline.

There were 4 main contributing factors to this incident:

- An inspection undertaken on the morning of the 12th July, revealed that the Shoemaker-Levy saline water pipeline had split at a poly weld near the 6400 chainage mark of the SML conveyor corridor.
- An excavator was working nearby leading up to the incident and was using a pipeline crossing point immediately downstream of the pipeline weld that split.
- It is considered likely that movement in the pipeline caused by the excavator crossing repeatedly led to the weld weakening and eventually splitting.
- The cold temperatures that occurred on the morning of the incident may have contributed by increasing the brittleness of the pipeline.
- Saline water breached the pipeline v-trench and found its way into the cleared conveyor corridor and then to the nearby already saline creek-line

The pipeline was isolated and the weld repaired. The pipeline was then returned to service. A review of pipeline flow and leak controls was completed and changes were made to these other than to better manage heavy machinery working in the vicinity of the pipeline.

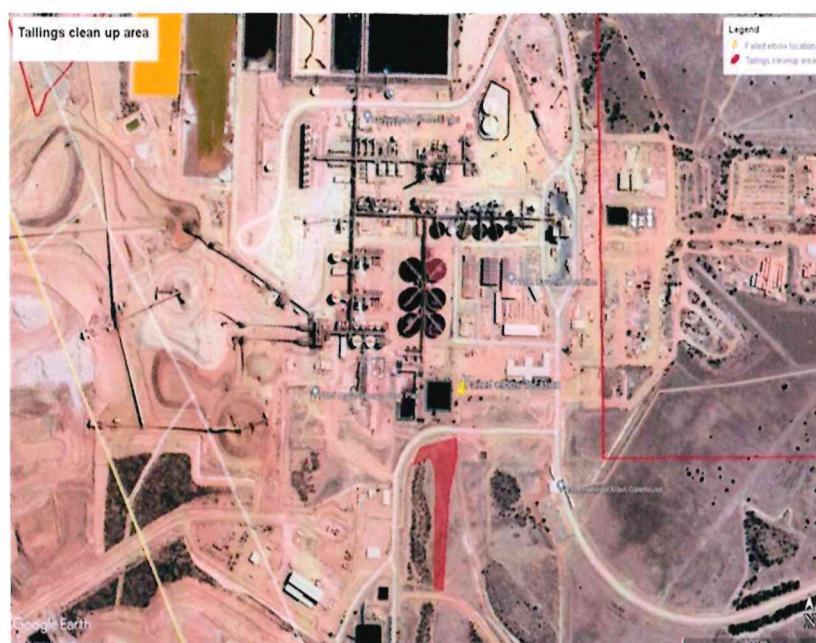
Tailings slurry was released to the environment immediately downstream of the Storm water South (top) pond at the RNO processing plant. Tailings slurry drained downstream into the nearby dry creek bed.

The impacted area is highly disturbed, and the short term impact of the incident is expected to be minor and contained to the immediately affected area. The area has been cleaned up and minimal residual impact is expected.

There were 5 main contributing factors to this incident:

- Tailings leak reported from an elbow in the main RNO tailings line (steel pipeline) on the 13 July 2022 at 4.00 am.
- The elbow was located adjacent to the upper southern storm water pond (SP2) at the RNO plant site.
- The subject elbow section of pipeline had been partially buried in the soil causing corrosion of that section which contributed to the failure.
- A section of the downstream tailings pipeline containment bunding was breached during the incident which contributed to tailings spill.
- Tailings spilled from the bunding breach into the downslope paddock area and dry creek bed

Section E – Details of non-compliance with licence condition	
Action taken to mitigate any adverse effects of non-compliance and prevent recurrence of the non-compliance:	
<ul style="list-style-type: none"> • Tailings discharge was switched across to the welded HDPE backup tailings line to stop tailings flow in the main line. • Corroded pipeline elbow section replaced and elevated above soil level to prevent further corrosion impact. • Bunding breach repaired 	
Was this non-compliance previously reported to DWER?	
<input checked="" type="checkbox"/> Yes, and	
<input type="checkbox"/> Reported to DWER verbally	Date: / /
<input checked="" type="checkbox"/> Reported to DWER in writing	Date: 13/07/2022

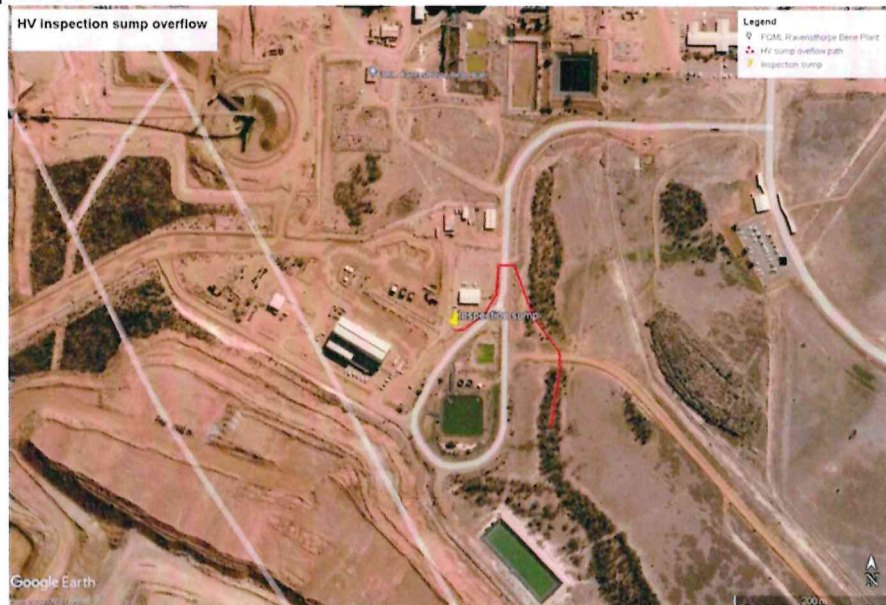
HV workshop inspection sump overflowed due to sediment buildup in system resulting in a minor spill to the external drainage system and then to the nearby ephemeral creek bed.

No impact expected

There were 3 main contributing factors to this incident:

- The overflow of wash water from the HV workshop sump was primarily caused by a buildup of sediment in the HV wash down sedimentation pond which blocked the discharge pipeline.
- Excessive build-up of sediment in the pond resulted from lack of preventative maintenance (i.e. regular removal of sediment).
- Overflowing wash water could not be effectively controlled during the spill event, as minimal control mechanisms were in place.

- HV workshop sedimentation pond to be cleaned out on a more regular basis to ensure sediment does not build up leading to a blockage in the discharge pipeline.
- Culvert gates are being investigated for installation on certain drain culverts downstream of the HV workshop area so that in the event of a spill these can be closed to minimize the risk of downstream impact

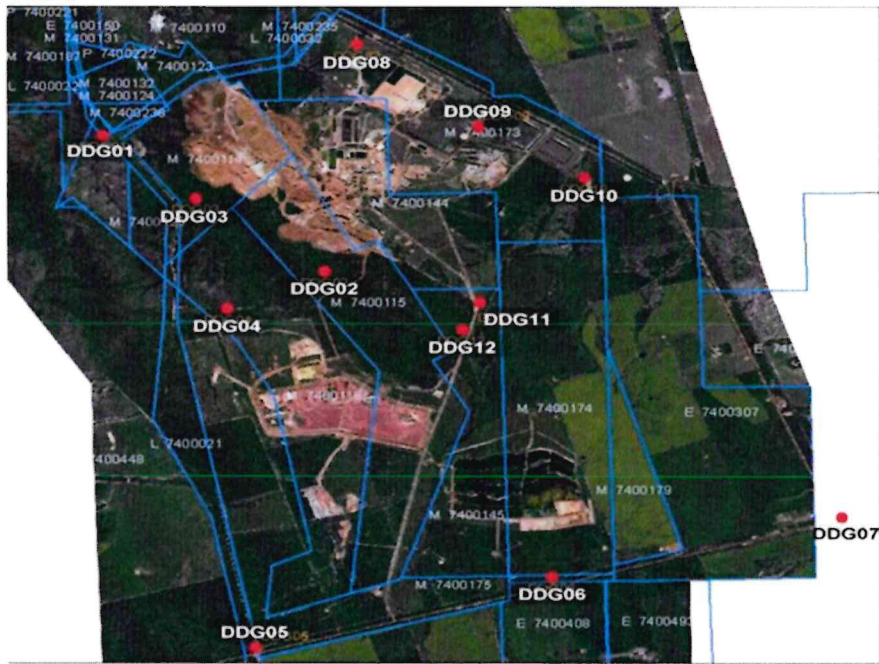
Section E – Details of non-compliance with licence condition			
Please use a separate page for each condition with which the licence holder was non-compliant at a time during the reporting period.			
Condition no:	3.5.1	Date(s) of non-compliance:	10/2022
Details of non-compliance:			
Dust deposition in DDG08 for October, 2022 exceeded licence target of 4g/m3/month.			
What was the actual (or suspected) environmental impact of the non-compliance?			
NOTE – please attach maps or diagrams to provide insight into the precise location of where the non-compliance took place.			
No impact expected

Cause (or suspected cause) of non-compliance:			
Unclear. No specific cause could be determined however evidence suggests it was not mining related			
Action taken to mitigate any adverse effects of non-compliance and prevent recurrence of the non-compliance:			
Investigated possible causes however no corrective action plan could be determined in this case, as RNO continues to implement dust management controls

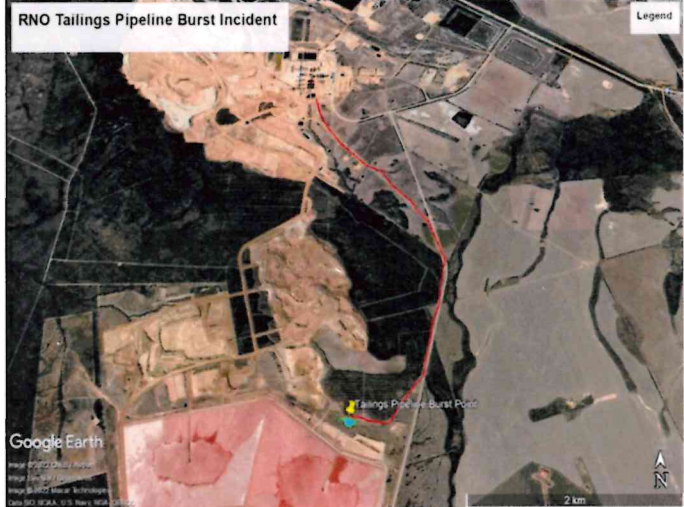
Section E – Details of non-compliance with licence condition			
Please use a separate page for each condition with which the licence holder was non-compliant at a time during the reporting period.			
Condition no:	1.3.2	Date(s) of non-compliance:	03/11/2022
Details of non-compliance:			
Tailings slurry was released to the environment at the North East shoulder of the Tailings Storage Facility. Tailings slurry drained downwards around the burst point			
What was the actual (or suspected) environmental impact of the non-compliance?			
NOTE – please attach maps or diagrams to provide insight into the precise location of where the non-compliance took place.			
No impact expected as the area is highly disturbed

Cause (or suspected cause) of non-compliance:			
The HDPE spool failure seemed to be from the internal lifting of the pipe spool lining due to over-pressure for a HDPE material as opposed to a steel spool.

Action taken to mitigate any adverse effects of non-compliance and prevent recurrence of the non-compliance:			
<ul style="list-style-type: none"> • Cleanup initiated. • Increased monitoring/surveillance on the pipeline. • 12 new steel spool bends ordered and delivered in mid-January 2023 to replace all existing spools on the pipeline. • Replacement work began in early February. • New spares will be preserved undercover to avoid any damage due to weather. 			
Was this non-compliance previously reported to DWER?			
<input checked="" type="checkbox"/> Yes, and			
<input type="checkbox"/> Reported to DWER verbally		Date: / /	
<input checked="" type="checkbox"/> Reported to DWER in writing		Date: 03/11/2022

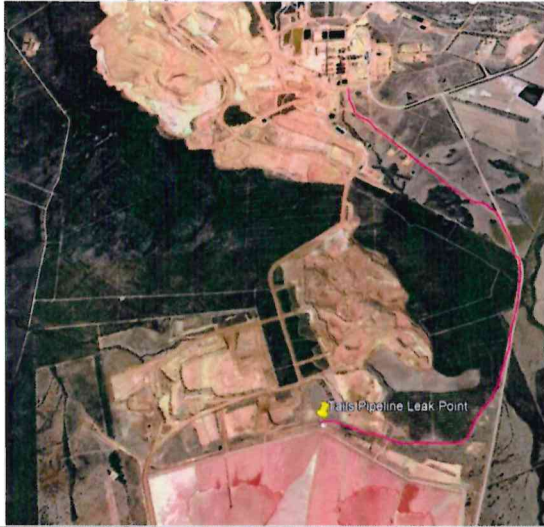
Section E – Details of non-compliance with licence condition			
Please use a separate page for each condition with which the licence holder was non-compliant at a time during the reporting period.			
Condition no:	1.3.2	Date(s) of non-compliance:	28/11/2022
Details of non-compliance:			
Tailings slurry was released to the environment at the North of the Tailings Storage Facility 1 dividing wall. Tailings slurry drained downwards around the leak point as seen in Fig 1. See Pictures attached.			
What was the actual (or suspected) environmental impact of the non-compliance?			
NOTE – please attach maps or diagrams to provide insight into the precise location of where the non-compliance took place.			
No impact expected as the area is highly disturbed.

Cause (or suspected cause) of non-compliance:			
The HDPE spool failure seemed to be from the internal lifting of the pipe spool lining due to over-pressure for a HDPE material as opposed to a steel spool.

Action taken to mitigate any adverse effects of non-compliance and prevent recurrence of the non-compliance:			
<ul style="list-style-type: none"> • Cleanup initiated. • Increased monitoring/surveillance on the pipeline. • 12 new steel spool bends ordered and delivered in mid-January 2023 to replace all existing spools on the pipeline. • Replacement work began in early February. • New spares will be preserved undercover to avoid any damage due to weather. 			
Was this non-compliance previously reported to DWER?			
<input checked="" type="checkbox"/> Yes, and			
<input type="checkbox"/> Reported to DWER verbally		Date: / /	
<input checked="" type="checkbox"/> Reported to DWER in writing		Date: 28/11/2022

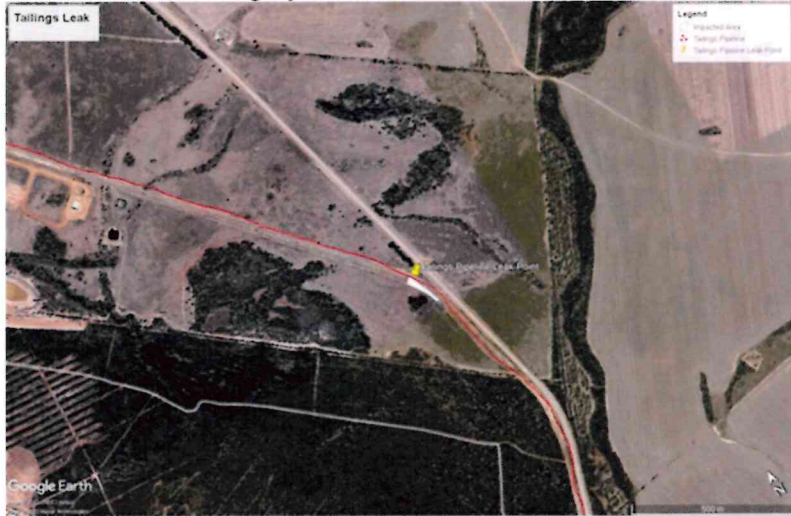
Section E – Details of non-compliance with licence condition			
Please use a separate page for each condition with which the licence holder was non-compliant at a time during the reporting period.			
Condition no:	1.3.2	Date(s) of non-compliance:	04/12/2022
Details of non-compliance:			
Tailings slurry was released to the environment at the North of the Tailings Storage Facility adjacent to the southern access road. Tailings slurry drained downwards around the leak point.			
What was the actual (or suspected) environmental impact of the non-compliance?			
NOTE – please attach maps or diagrams to provide insight into the precise location of where the non-compliance took place.			
No impact expected as the area is highly disturbed.

Cause (or suspected cause) of non-compliance:			
The HDPE spool failure seemed to be from the internal lifting of the pipe spool lining due to over-pressure for a HDPE material as opposed to a steel spool.

Action taken to mitigate any adverse effects of non-compliance and prevent recurrence of the non-compliance:			
<ul style="list-style-type: none"> • Cleanup initiated. • Increased monitoring/surveillance on the pipeline. • 12 new steel spool bends ordered and delivered in mid-January 2023 to replace all existing spools on the pipeline. • Replacement work began in early February. • New spares will be preserved undercover to avoid any damage due to weather 			
Was this non-compliance previously reported to DWER?			
<input checked="" type="checkbox"/> Yes, and			
<input type="checkbox"/> Reported to DWER verbally		Date: / /	
<input checked="" type="checkbox"/> Reported to DWER in writing		Date: 04/12/2022

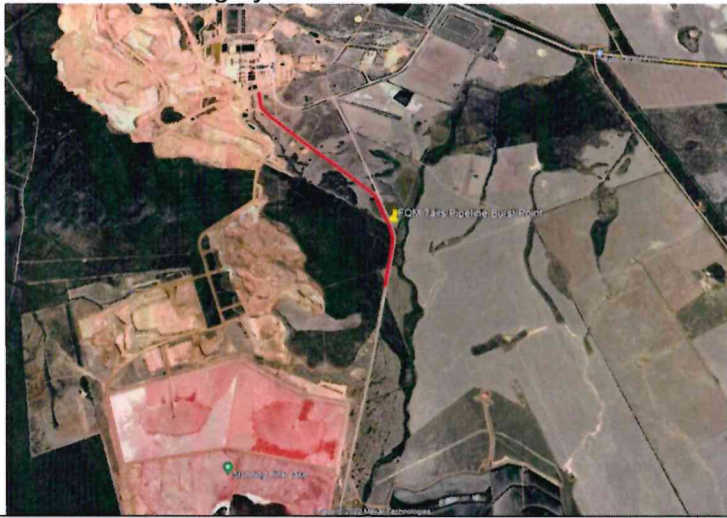
Section E – Details of non-compliance with licence condition			
Please use a separate page for each condition with which the licence holder was non-compliant at a time during the reporting period.			
Condition no:	1.3.2	Date(s) of non-compliance:	13/12/2022
Details of non-compliance:			
Tailings slurry was released to the environment along the South access road. Tailings slurry drained downwards around the burst point.			
What was the actual (or suspected) environmental impact of the non-compliance?			
NOTE – please attach maps or diagrams to provide insight into the precise location of where the non-compliance took place.			
No impact expected as the area is highly disturbed.

Cause (or suspected cause) of non-compliance:			
The HDPE spool failure seemed to be from the internal lifting of the pipe spool lining due to over-pressure for a HDPE material as opposed to a steel spool.			
Action taken to mitigate any adverse effects of non-compliance and prevent recurrence of the non-compliance:

<ul style="list-style-type: none"> • Cleanup initiated. • Increased monitoring/surveillance on the pipeline. • 12 new steel spool bends ordered and delivered in mid-January 2023 to replace all existing spools on the pipeline. • Replacement work began in early February. • New spares will be preserved undercover to avoid any damage due to weather. 			
Was this non-compliance previously reported to DWER?			
<input checked="" type="checkbox"/> Yes, and			
<input type="checkbox"/> Reported to DWER verbally		Date: / /	
<input checked="" type="checkbox"/> Reported to DWER in writing		Date: 13/12/2022

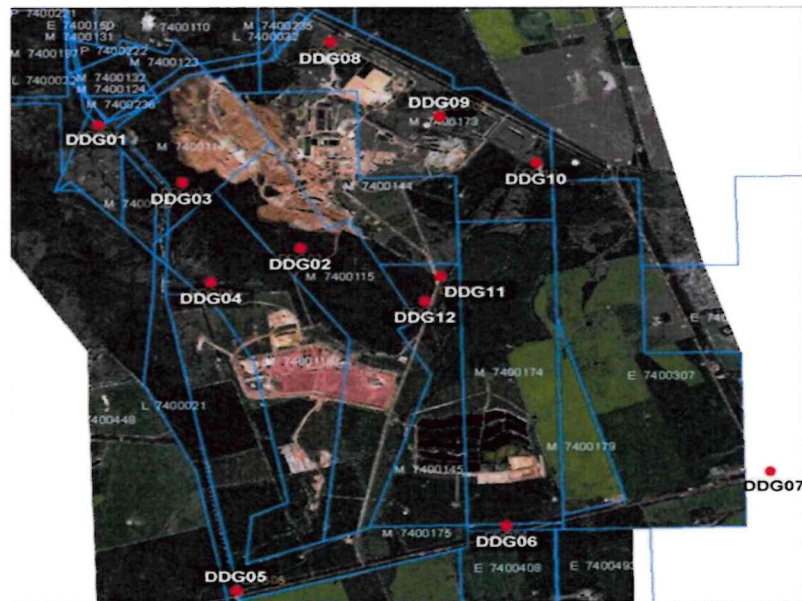
Dust deposition in DDG08 for December, 2022 exceeded licence target of 4g/m3/month.

No impact expected

Given the prevailing wind directions for December and the fact that other DDGs located around the mining and processing areas did not exceed the target, it is unclear what has caused the target exceedance. Of particular note in this regard are DDG02 (0.55 g/m2/month), DDG03 (0.61 g/m2/month) and DDG04 (0.55 g/m2/month) which are located immediately downwind from the Hale-Bopp mining area and Tailings Storage Facility (TSF) when the wind is from the south east.

Investigated possible causes however no corrective action plan could be determined in this case.

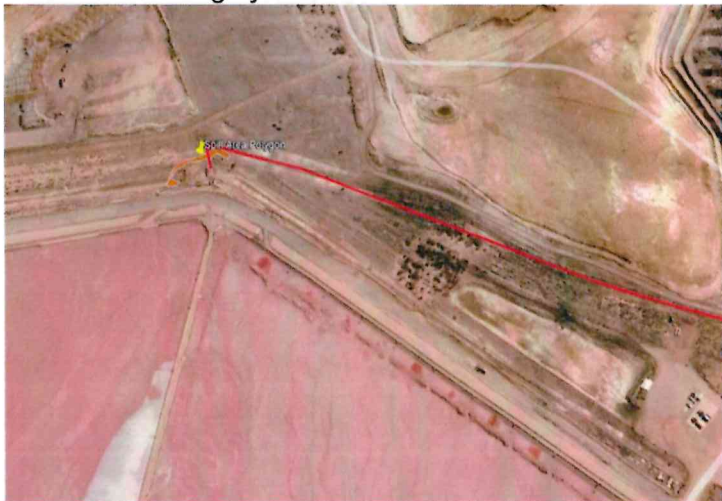
Section E – Details of non-compliance with licence condition			
Please use a separate page for each condition with which the licence holder was non-compliant at a time during the reporting period.			
Condition no:	1.3.2	Date(s) of non-compliance:	11/01/2023
Details of non-compliance:			
Tailings slurry was released to the environment at the North of the Tailings Storage Facility 1 dividing wall. Tailings slurry drained downwards around the leak point.			
What was the actual (or suspected) environmental impact of the non-compliance?			
NOTE – please attach maps or diagrams to provide insight into the precise location of where the non-compliance took place.			
No impact expected as the area is highly disturbed

Cause (or suspected cause) of non-compliance:			
The HDPE spool failure seemed to be from the internal lifting of the pipe spool lining due to over-pressure for a HDPE material as opposed to a steel spool.

Action taken to mitigate any adverse effects of non-compliance and prevent recurrence of the non-compliance:			
<ul style="list-style-type: none"> • Cleanup initiated. • Increased monitoring/surveillance on the pipeline. • 12 new steel spool bends ordered and delivered in mid-January 2023 to replace all existing spools on the pipeline. • Replacement work began in early February. • New spares will be preserved undercover to avoid any damage due to weather. 			
Was this non-compliance previously reported to DWER?			
<input checked="" type="checkbox"/> Yes, and			
<input type="checkbox"/> Reported to DWER verbally		Date: / /	
<input checked="" type="checkbox"/> Reported to DWER in writing		Date: 11/01/2023

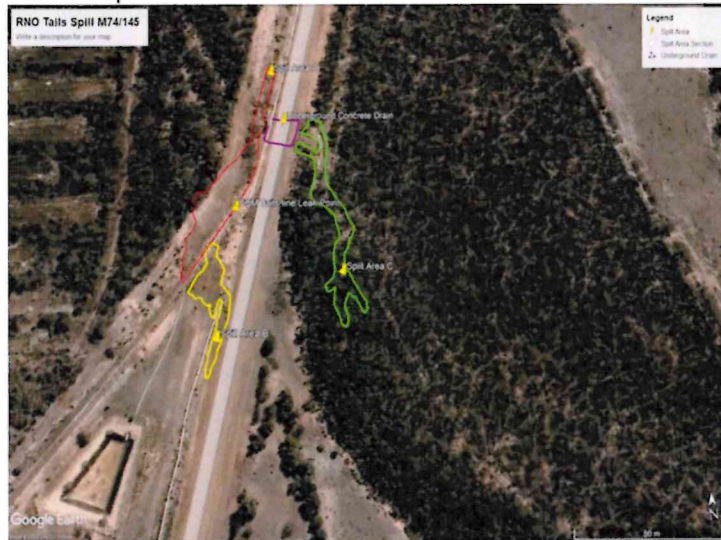
Section E – Details of non-compliance with licence condition			
Please use a separate page for each condition with which the licence holder was non-compliant at a time during the reporting period.			
Condition no:	1.3.2	Date(s) of non-compliance:	07/02/2023
Details of non-compliance:			
Tailings slurry was released to the environment at the North East of the Tailings Storage Facility. Tailings slurry drained over to the opposite vegetation through the concrete drain.			
What was the actual (or suspected) environmental impact of the non-compliance?			
NOTE – please attach maps or diagrams to provide insight into the precise location of where the non-compliance took place.			
The impacted area is highly disturbed, and the short term impact of the incident is expected to be minor and contained to the immediately affected area. The area has been cleaned up and minimal residual impact is expected.

Cause (or suspected cause) of non-compliance:			
The HDPE spool failure seemed to be from the internal lifting of the pipe spool lining due to over-pressure for a HDPE material as opposed to a steel spool.			
Action taken to mitigate any adverse effects of non-compliance and prevent recurrence of the non-compliance:			
<ul style="list-style-type: none"> • Cleanup initiated. • Increased monitoring/surveillance on the pipeline. • 12 new steel spool bends ordered and delivered in mid-January 2023 to replace all existing spools on the pipeline. • Replacement work began in early February. • New spares will be preserved undercover to avoid any damage due to weather. 			
Was this non-compliance previously reported to DWER?			
<input checked="" type="checkbox"/> Yes, and			
<input type="checkbox"/> Reported to DWER verbally		Date: / /	
<input checked="" type="checkbox"/> Reported to DWER in writing		Date: 07/02/2023

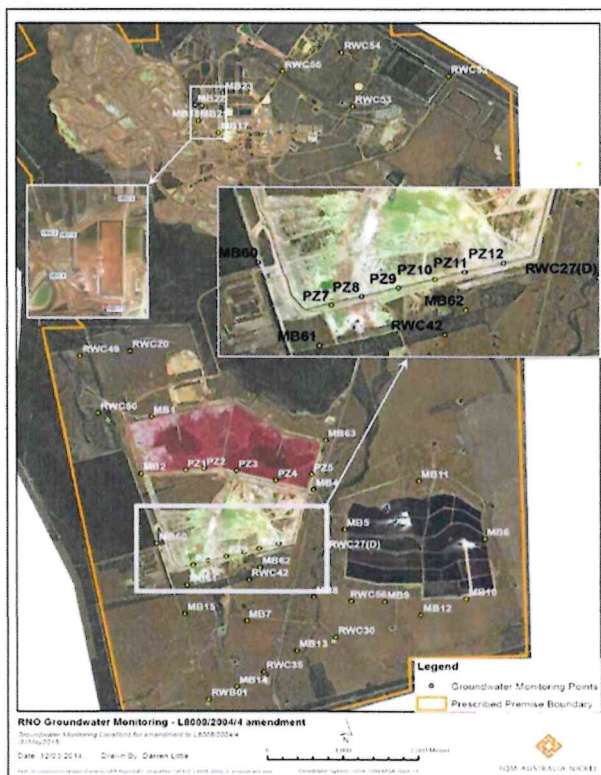
RNO monitoring bore locations

- Monitoring bore MB22 not sampled for water quality in July 2022, October 2022 and January 2022 as per licence requirement.
- Monitoring bore MB2 not sampled for water quality for the 2022-2023 reporting period as per licence requirement.
- Monitoring bores RWC20 and RWC27(D) not sampled in July 2022
- Standing water levels were not recorded from RWC49 and RWC 50 in July 2022.

- MB22 was impacted by conveyor construction works in late 2020.
- MB2 was dry for the reporting period and has consistently been dry for the life of the operation so far.
- RWC20 and RWC27 (D) were temporarily not accessible during the July 2022 sampling run.
- RWC49 and RWC50 were temporarily not accessible during the July 2022 sampling run.

Section E – Details of non-compliance with licence condition	
Action taken to mitigate any adverse effects of non-compliance and prevent recurrence of the non-compliance:	
<ul style="list-style-type: none"> • MB22 was re-drilled right next to its original location in April 2023. Samples were collected in April 2023 sampling program. • MB2 will continue to be monitored and will be sampled should SWL levels become sufficient. • Access to RWC20 and RWC27 (D) has been restored and is not anticipated to be an issue going forward. • Access to RWC49 and RWC50 has been restored and is not anticipated to be an issue going forward. 	
Was this non-compliance previously reported to DWER?	
<input checked="" type="checkbox"/> Yes, and	
<input type="checkbox"/> Reported to DWER verbally	Date: / /
<input checked="" type="checkbox"/> Reported to DWER in writing	Date:

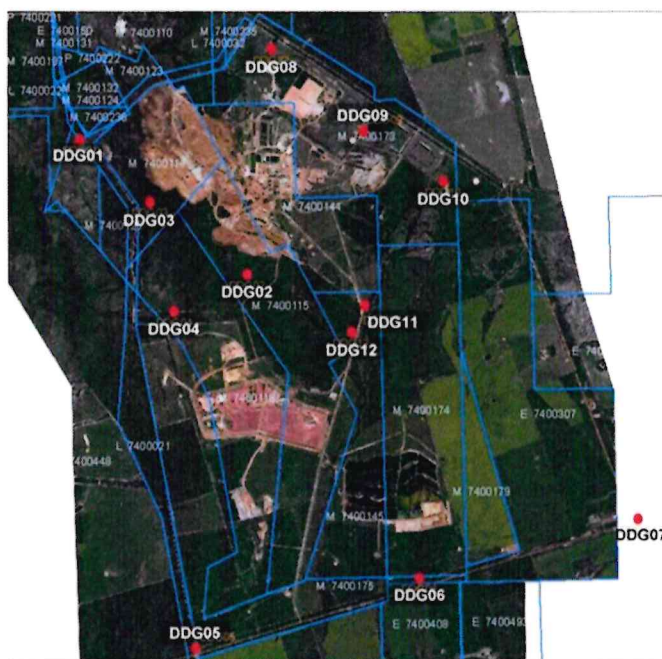
Dust deposition in DDG01 for March, 2023 exceeded licence target of 4g/m3/month.

No impact expected

Given the prevailing wind directions and speed which shows (2- 5 m/s and 5 – 10 m/s) for DDG01 in March, 2023, it could be deduced that there is a possible mining and processing operations attributed impact for DDG01. It is great to note the DDG locations around DDG01 (DDG03, and DDG04) has not been impacted, as such, RNO operations attributed impact on DDG01 will seem minimal. This shows uncertainty as to the major impact source.

Investigated possible causes however no corrective action plan could be determined in this case. Lab result was received on 03/05/2023.

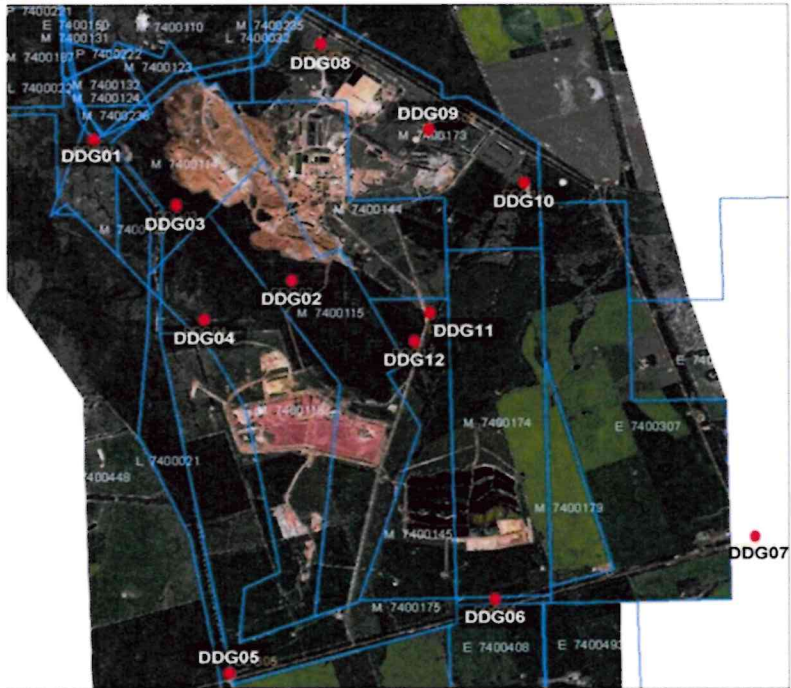
Section E – Details of non-compliance with licence condition			
Please use a separate page for each condition with which the licence holder was non-compliant at a time during the reporting period.			
Condition no:	3.5.1	Date(s) of non-compliance:	March, 2023
Details of non-compliance:			
Dust deposition in DDG11 for March, 2023 exceeded licence target of 4g/m3/month.			
What was the actual (or suspected) environmental impact of the non-compliance?			
NOTE – please attach maps or diagrams to provide insight into the precise location of where the non-compliance took place.			
No impact expected

Cause (or suspected cause) of non-compliance:			
Given the prevailing wind directions and speed which shows (2- 5 m/s and 5 – 10 m/s) for DDG11 in March, 2023, it could be deduced that the impact on DDG11 is from the farmland ripping activity immediately South Easterly of the DDG11 location.			
Action taken to mitigate any adverse effects of non-compliance and prevent recurrence of the non-compliance:

Investigated possible causes however no corrective action plan could be determined in this case. Lab result was received on 03/05/2023.			
Was this non-compliance previously reported to DWER?			
<input checked="" type="checkbox"/> Yes, and			
<input type="checkbox"/> Reported to DWER verbally		Date: / /	
<input checked="" type="checkbox"/> Reported to DWER in writing		Date: 04/05/2023
