Annual Audit Compliance Report Form

Section A – Licence details			
Licence number:	L8008/2004/3	Licence file number:	DER2014/000631
Licence holder name:	FQM Australia Nickel Pty Ltd		
Trading as:			
ACN:	135 761 465		
Registered business address:	Level 2, 18-32 Parliament Place, West Perth, WA 6000		
Reporting period:	01/05/2023 to 30/04/2024

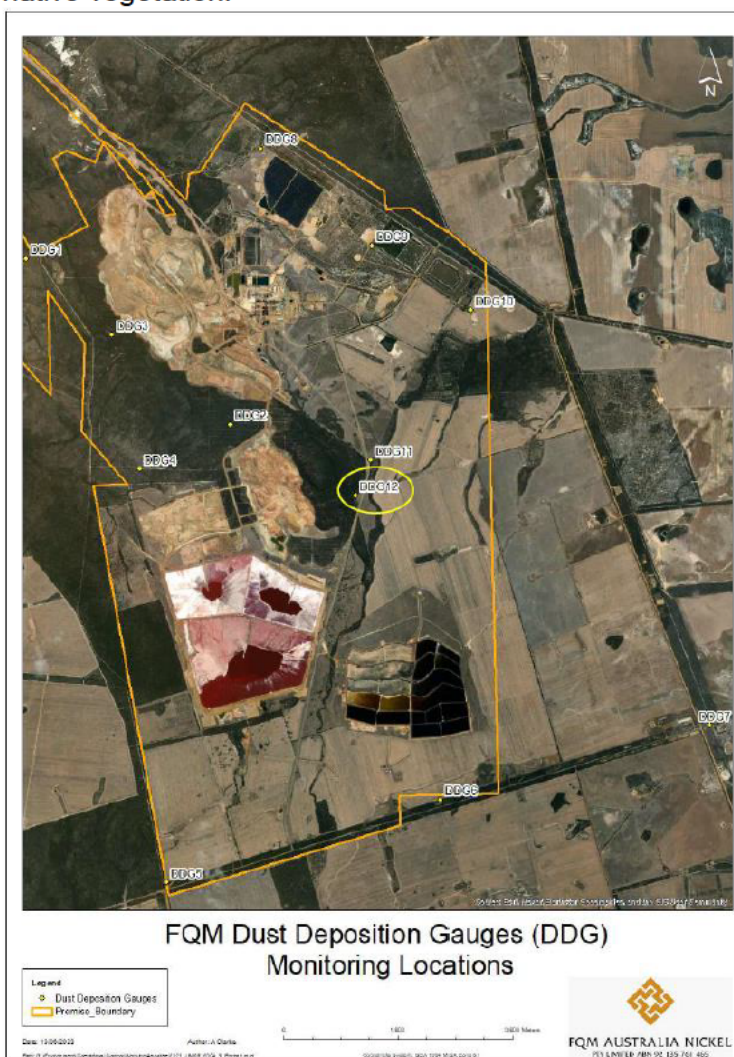
Condition no:	3.5.1	Date(s) of non-compliance:	22/06/2023
---------------	-------	----------------------------	------------

DDG12 exceeded the licence target of 4g/m2/month with 11g/m2/month recorded.

Dust deposition on native vegetation.

Section E – Details of non-compliance with licence condition	
Cause (or suspected cause) of non-compliance:	
Given the prevailing wind speed and directions for May and the fact that other DDGs located around the mining and processing areas did not exceed the target, we believe the exceedance was caused by farming activities on the east and north east of DDG12.	
Action taken to mitigate any adverse effects of non-compliance and prevent recurrence of the non-compliance:	
N/A.	
Was this non-compliance previously reported to DWER?	
<input checked="" type="checkbox"/> Yes, and	
<input type="checkbox"/> Reported to DWER verbally	Date: / /
<input checked="" type="checkbox"/> Reported to DWER in writing	Date: 23/06/2023

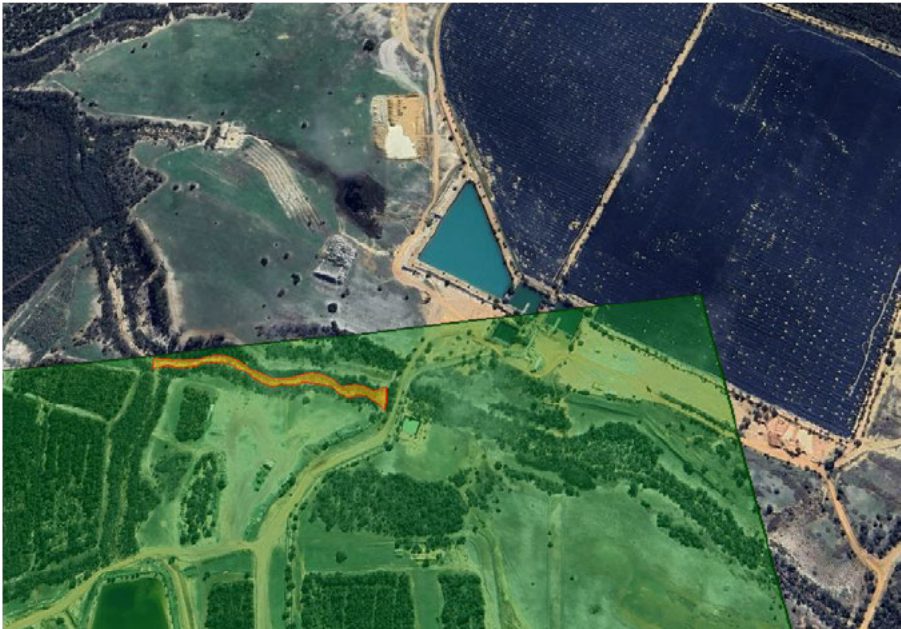
Section E – Details of non-compliance with licence condition			
Please use a separate page for each condition with which the licence holder was non-compliant at a time during the reporting period.			
Condition no:	1.3.2	Date(s) of non-compliance:	28/06/2023
Details of non-compliance:			
Expression of water into an unnamed tributary of Bandalup Creek. The source could not be identified when the seepage was noticed.			
What was the actual (or suspected) environmental impact of the non-compliance?			
NOTE – please attach maps or diagrams to provide insight into the precise location of where the non-compliance took place.			
Potential hypersaline water expression in the creek.

Section E – Details of non-compliance with licence condition	
Cause (or suspected cause) of non-compliance:	
Unknown. The evidence of potential source was inconclusive	
Action taken to mitigate any adverse effects of non-compliance and prevent recurrence of the non-compliance:	
Groundwater and surface water study commenced to determine the flow paths of groundwater and the interaction with surface water.	
Was this non-compliance previously reported to DWER?	
<input checked="" type="checkbox"/> Yes, and	
<input type="checkbox"/> Reported to DWER verbally	Date: / /
<input checked="" type="checkbox"/> Reported to DWER in writing	Date: 28/06/2023

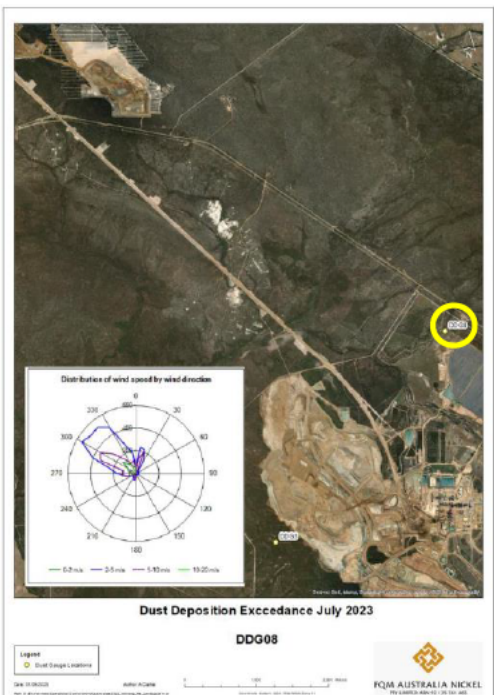
Section E – Details of non-compliance with licence condition			
Please use a separate page for each condition with which the licence holder was non-compliant at a time during the reporting period.			
Condition no:	36	Date(s) of non-compliance:	08/08/2023
Details of non-compliance:			
DDG08 reported an exceedance to the specified 4g/m2/month with 6.5g/m2/month.			
What was the actual (or suspected) environmental impact of the non-compliance?			
NOTE – please attach maps or diagrams to provide insight into the precise location of where the non-compliance took place.			
Dust into native vegetation

Section E – Details of non-compliance with licence condition	
Cause (or suspected cause) of non-compliance:	
Dust liftoff at Shoemaker Levy Opencut.	
Action taken to mitigate any adverse effects of non-compliance and prevent recurrence of the non-compliance:	
Dust mitigation measures are continuously applied at SML.	
Was this non-compliance previously reported to DWER?	
<input checked="" type="checkbox"/> Yes, and	
<input type="checkbox"/> Reported to DWER verbally	Date: / /
<input checked="" type="checkbox"/> Reported to DWER in writing	Date: 01/09/2023

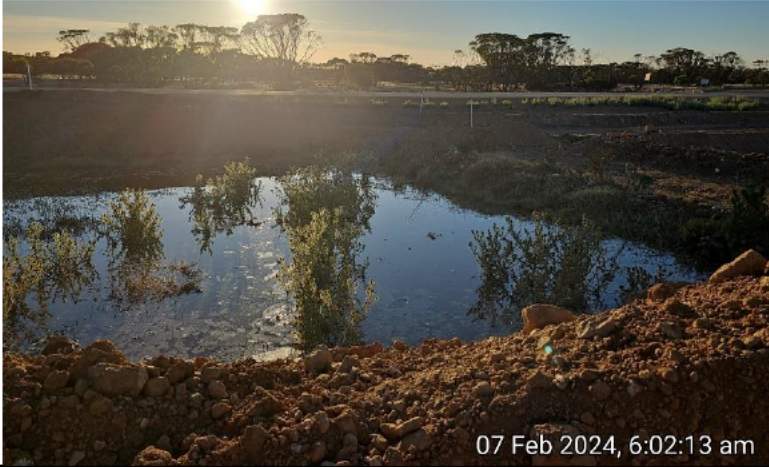
Section E – Details of non-compliance with licence condition			
Please use a separate page for each condition with which the licence holder was non-compliant at a time during the reporting period.			
Condition no:	7	Date(s) of non-compliance:	06/02/2024
Details of non-compliance:			
Decant water breached a windrow and spilled into previously disturbed and degraded vegetation, isolated from further spread by access roads and previously established windrows.			
What was the actual (or suspected) environmental impact of the non-compliance?			
NOTE – please attach maps or diagrams to provide insight into the precise location of where the non-compliance took place.			
Decant water spilled onto soil seeping into the ground.			
<div style="text-align: center;"> <p>West Elevation</p> <p>☉ 111°E (T) • -33.692501, 120.405339 ±14m ▲ 94m</p>

Decant pipeline punctured by excavator tooth while pulling up windrows on the TSF wall, resulting in decant liquid to spill.

Section E – Details of non-compliance with licence condition	
Action taken to mitigate any adverse effects of non-compliance and prevent recurrence of the non-compliance:	
Puncture in pipeline repaired. Area contained by bunding, reducing the risk of transfer to clean environments. Challenge in cleaning the salt deposition as located under HV powerlines.	
Was this non-compliance previously reported to DWER?	
<input checked="" type="checkbox"/> Yes, and	
<input type="checkbox"/> Reported to DWER verbally	Date: / /
<input checked="" type="checkbox"/> Reported to DWER in writing	Date: 07/02/2024

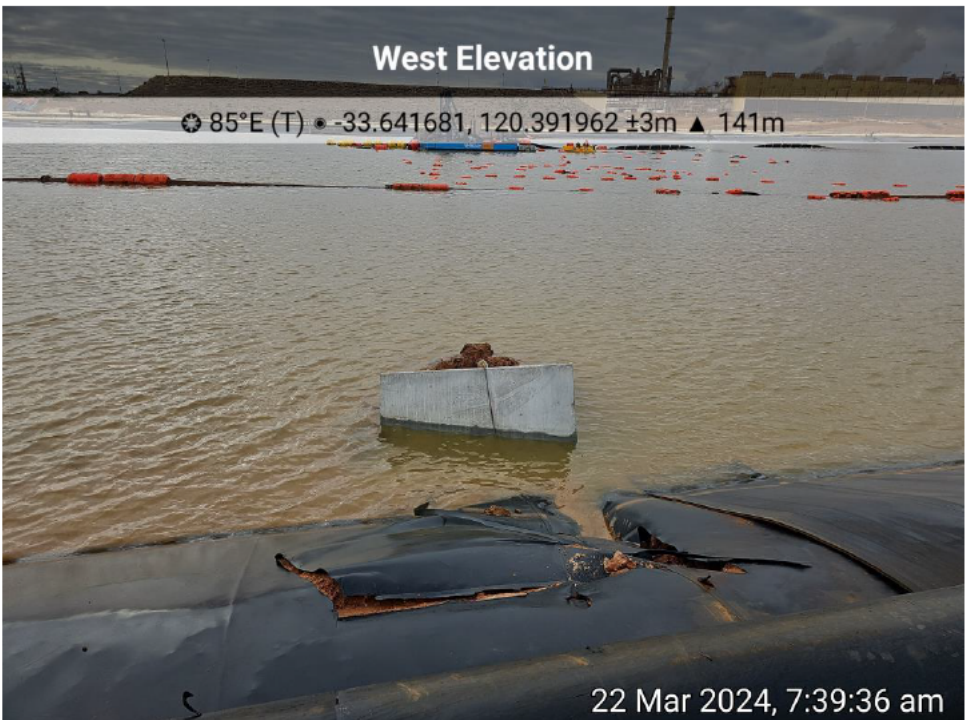
Section E – Details of non-compliance with licence condition			
Please use a separate page for each condition with which the licence holder was non-compliant at a time during the reporting period.			
Condition no:	7	Date(s) of non-compliance:	21/03/2024
Details of non-compliance:			
Water seeping through damaged Lim Buffer Pond liner.			
What was the actual (or suspected) environmental impact of the non-compliance?			
NOTE – please attach maps or diagrams to provide insight into the precise location of where the non-compliance took place.			
Process water seepage below damaged liner to the packed pond. Possible seepage over time could occur.

Section E – Details of non-compliance with licence condition	
Cause (or suspected cause) of non-compliance:	
Anchor block pulled into pond and has damaged the liner during commissioning of mobile remote control Drag Flow dredge in the LIM buffer pond.	
Action taken to mitigate any adverse effects of non-compliance and prevent recurrence of the non-compliance:	
Draining of pond commenced as soon as possible to reduce any possible ingress to visible tears. Liner was patched and welded. Pond was refilled once the repair works were done and validated.	
Was this non-compliance previously reported to DWER?	
<input checked="" type="checkbox"/> Yes, and	
<input type="checkbox"/> Reported to DWER verbally	Date: / /
<input checked="" type="checkbox"/> Reported to DWER in writing	Date: 22/03/2024
