Annual Audit Compliance Report Form

Section A – Licence details			
Licence number:	L8008/2004/3	Licence file number:	DER2014/000631
Licence holder name:	Ravensthorpe Nickel Operations Pty Ltd		
Trading as:	Ravensthorpe Nickel Operations		
ACN:	092506584		
Registered business address:	Level 1, 24 Outram Street, West Perth, WA 6005		
Reporting period:	01/05/2021 to 30/04/2022

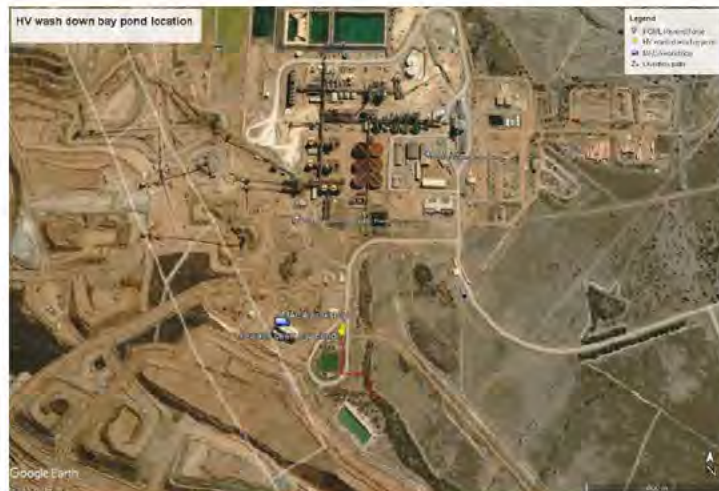
HV wash down bay pond overflowed outside of licenced containment infrastructure due to unexpected heavy rainfall event. Required freeboard not maintained.

No impact expected. Overflow heavily diluted by rainfall runoff. Confirmed through sampling.

Pond skimmer pump not operating automatically allowing water to build up in the pond and overflow. Float switch found to be faulty and replaced.

Cleanaway vac truck mobilized to site to lower pond level immediately. Skimmer pump started manually to lower pond level to required freeboard. Skimmer pump system repaired to restore automatic operation.

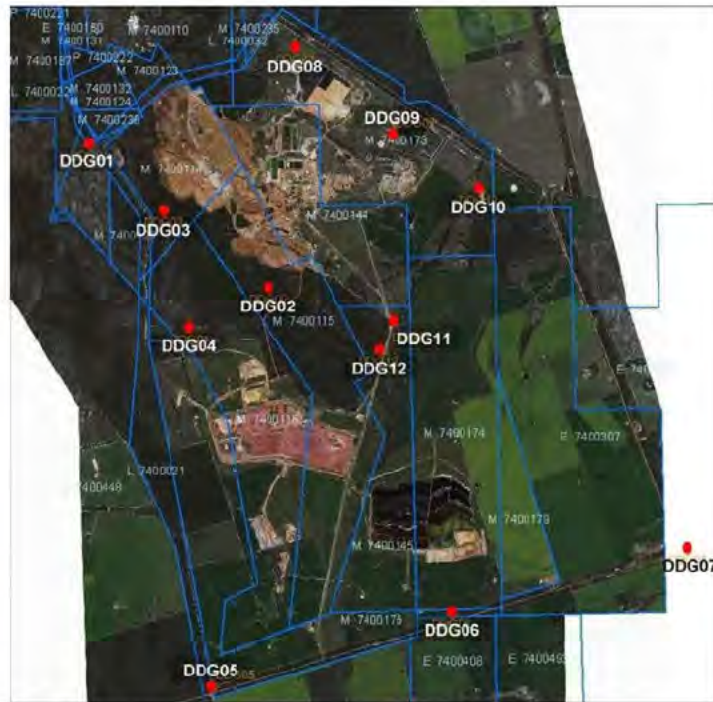
Dust deposition in DDG11 for July exceeded licence target of 4g/m³/month.

No impact expected.

Unclear. No specific cause could be determined however evidence suggests it was not mining related.

Investigated possible causes however no corrective action plan could be determined in this case.

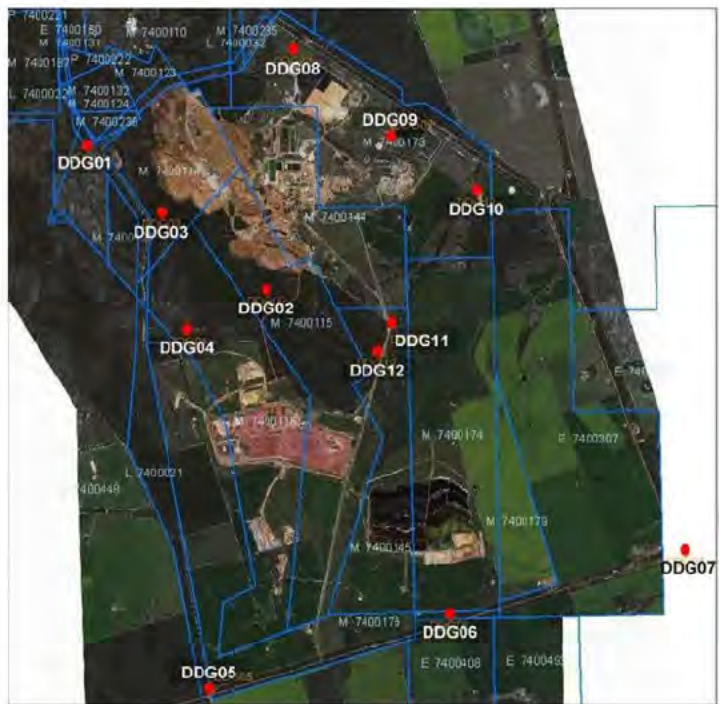
Dust deposition in DDG06 and DDG11 for February exceeded licence target of 4g/m³/month.

No impact expected.

Unclear. No specific cause could be determined however evidence suggests it was not mining related.

Investigated possible causes however no corrective action plan could be determined in this case.

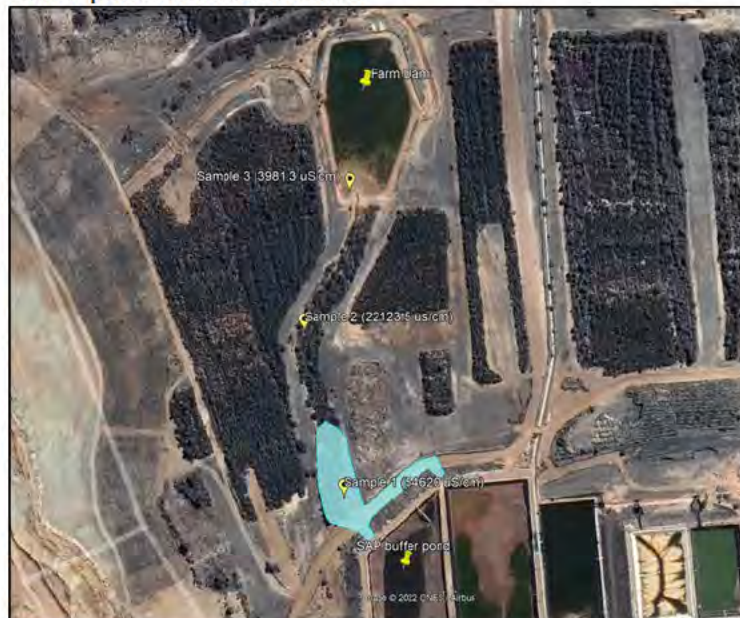
Buffer pond overflow location

Saprolite (SAP) buffer pond overflowed and southern stormwater pond had to be lowered by pumping and controlled water release resulting in water release outside of licenced containment infrastructure due to unexpected very heavy rainfall event in April 2022.

No impact expected. All water heavily diluted by rainfall runoff. Confirmed through sampling. SAP Buffer pond overflow event contained onsite within site sedimentation dam (Farm Dam).

Rainfall storm water runoff exceeded the pumping capacity of the pond pumping systems.

Site water management and pumping system review to minimize risk of site ponds exceeding freeboard requirements. Incidents reported to DMIRS.

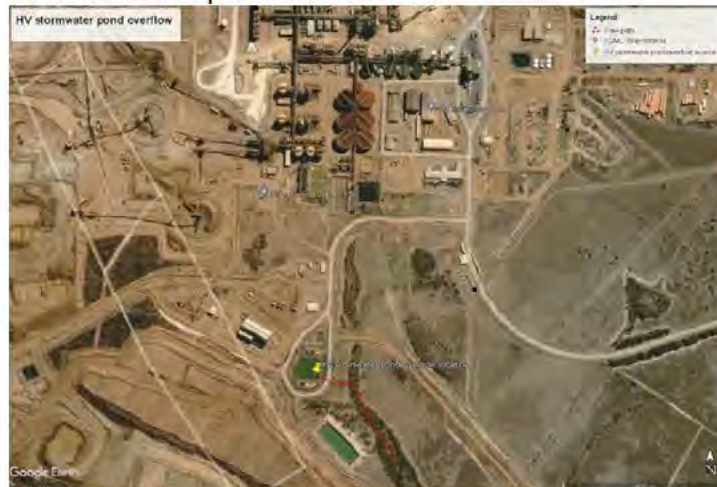
HV stormwater pond overflow location

HV stormwater pond (SP3), saprolite buffer pond and southern stormwater pond freeboard requirements not met due to unexpected very heavy rainfall event in April 2022.

No impact expected. All released water heavily diluted by rainfall runoff. Confirmed through sampling.

Rainfall stormwater runoff exceeded the pumping capacity of the pond pumping systems and subsequently overflowed.

Site water management and pumping system review to minimize risk of site ponds exceeding freeboard requirements. Incidents reported to DMIRS.

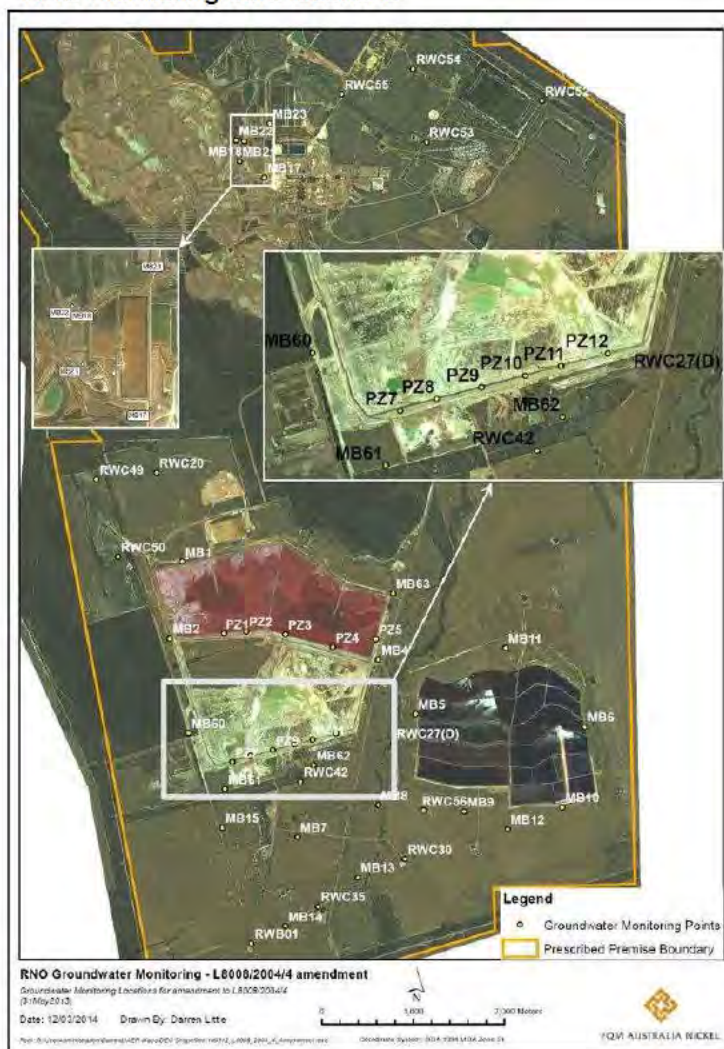
RNO monitoring bore locations

- (1) Monitoring bore MB22 not sampled in October 2021, January 2022 and April 2022 as per licence requirement.
- (2) Monitoring bore MB2 not sampled for water quality for the 2021 - 2022 reporting period as per licence requirement.
- (3) Monitoring bores RWC30 and RWC56 not sampled in July 2021.
- (4) Monitoring bore RWC20 not sampled in April 2022.

No environmental impact resulted from these non-compliances.

Section E – Details of non-compliance with licence condition	
Cause (or suspected cause) of non-compliance:	
(1) MB22 was impacted by conveyor construction works in late 2020 and has not yet been repaired. (2) MB02 was dry for the reporting period and has consistently been dry for the life of the operation so far. (3) RWC30 and RWC56 were temporarily not accessible during the July 2021 sampling run. (4) RWC20 was temporarily not accessible during the April 2022 sampling run.	
Action taken to mitigate any adverse effects of non-compliance and prevent recurrence of the non-compliance:

(1) MB22 will be assessed and repair or replacement undertaken. A monitoring bore drilling rig is scheduled to be onsite in September 2022. (2) MB02 will continue to be monitored and will be sampled should SWL levels become sufficient. (3) Access to RWC30 and RWC56 has been restored and is not anticipated to be an issue going forward. (4) Access to RWC20 has been restored and is not anticipated to be an issue going forward.	
Was this non-compliance previously reported to DWER?	
<input type="checkbox"/> Yes, and	
<input type="checkbox"/> Reported to DWER verbally	Date: / /
<input type="checkbox"/> Reported to DWER in writing	Date: / /
