Annual Audit Compliance Report Form

Environmental Protection Act 1986, Part V

Licence number:	L8008/2004/3	Licence file number:	DER2014/000631
Licence holder:	FQM Australia Nickel Pty Ltd		
Trading as:			
ACN:	135 761 465		
Registered address:	Level 2, 18-32 Parliament Place, West Perth, WA 6000		
Reporting period:	01 / 05 / 2024 to 30 / 04 / 2025

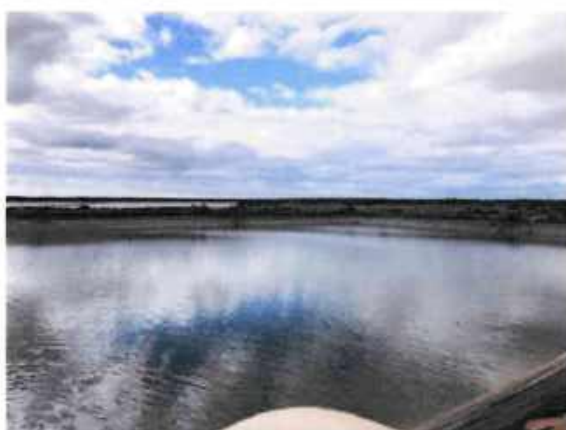
Water accumulating under Raw Water Pond liner.

Figure 1: Reduced water level of the raw water dam

Nil to negligible actual observed impact due to leaked water being pumped out into suitable plant containment. Nil salt scalding or vegetation mortality has been observed in the 12 months that followed the incident. No pooling of water that would suggest ongoing seepage is evident.

During an inspection it was observed that a bubble formed in the pond, indicating the potential for water under the liner. It is suspected that the liner join underneath the discharge spigot may have been damaged by the continued high velocity water impact.

Action taken to mitigate any adverse effects of non-compliance and prevent recurrence of the non-compliance:	
<p>Water level of the pond reduced below suspected tear, water which had leaked under the tear was bled into secure containment and pond level to be maintained below 60% until pond is rectified.</p> <p>When raw sea water demand reduces during care and maintenance, the pond will be pumped down to affect repair of the liner. This is likely to be completed prior to the 2025/2026 summer season.</p>	
Was this non-compliance previously reported to DWER?	
<input checked="" type="checkbox"/> Yes, and	
<input type="checkbox"/> Reported to DWER verbally	Date: / /
<input checked="" type="checkbox"/> Reported to DWER in writing	Date: 07/05/2024

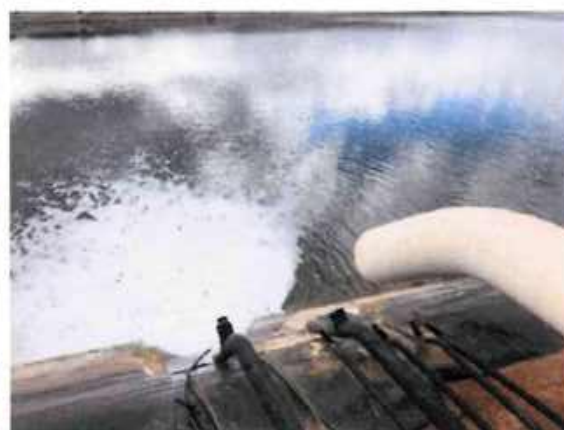
Figure 2: Water pumped into the raw water dam

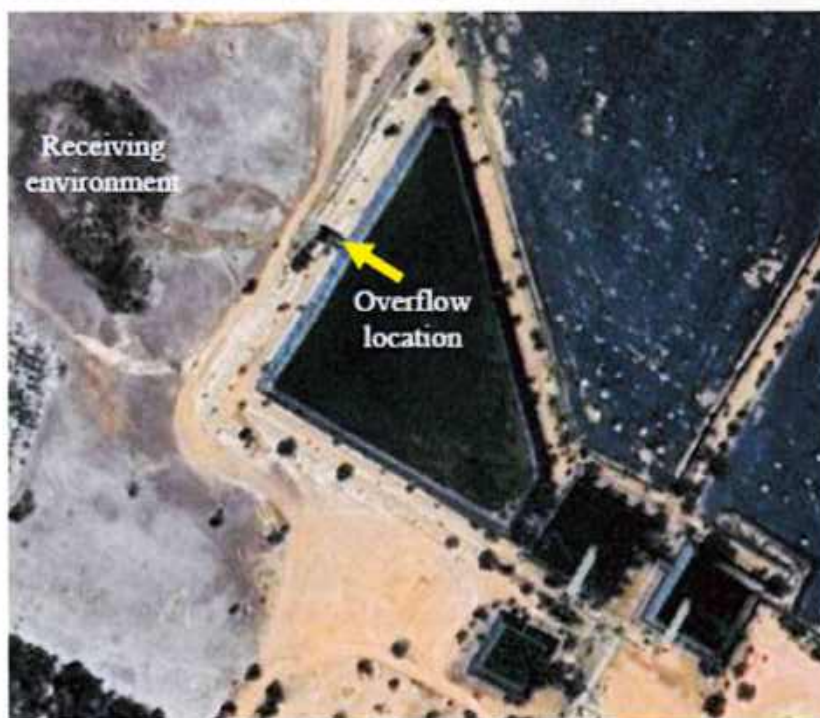
Rain water spilled over spillway into the adjacent environment

Figure 1: Overflow location and receiving environment

There are minimal users of the water which is inadvertently collected during rain events in this pond, which drives the rapid decrease of freeboard.

To address the low use issue, the dam will be pumped more frequently to RNO plant containment and regular inspections will be done to check the freeboard.

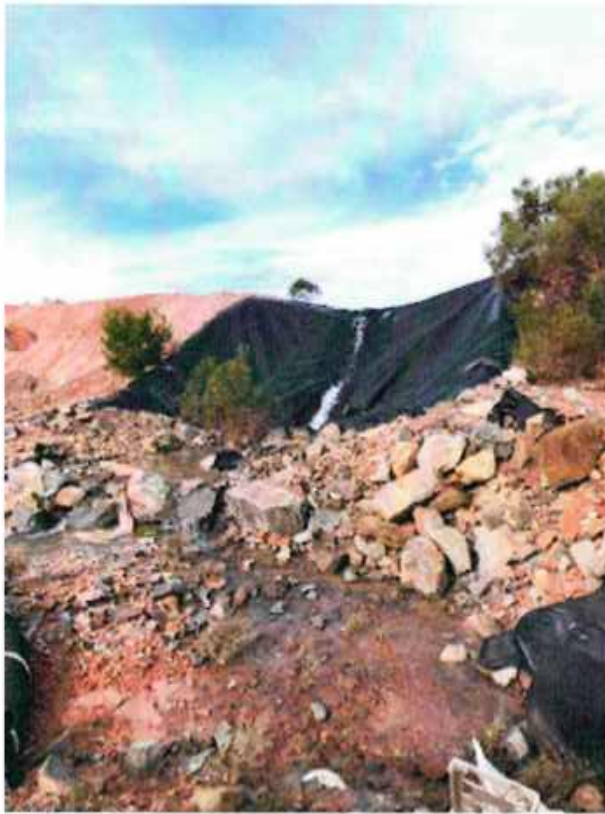
Figure 3: Overflow point

Location is at Table 3 Map reference 32 and Condition 8 of L8008 as at time of incident.

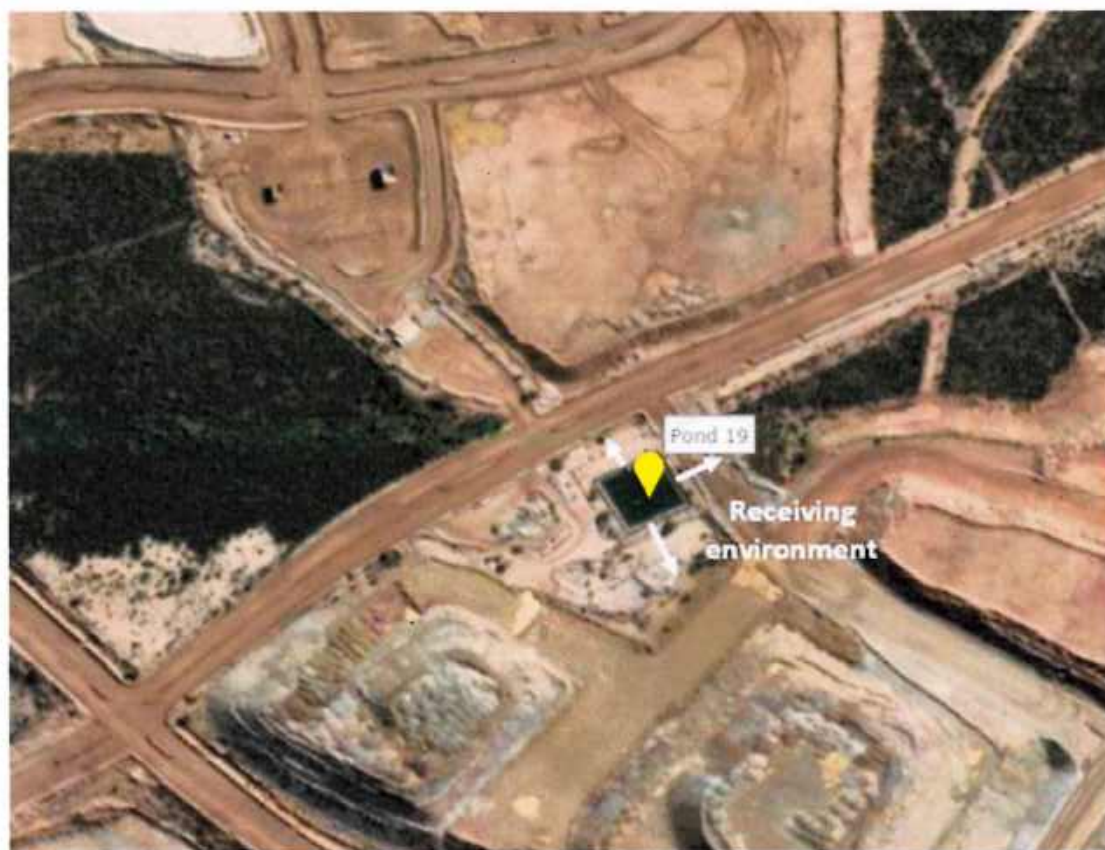
Water has spilled over the Turkeys Nest emankments and into unbunded environments surrounding it.

Nil to negligible impact observed.

Figure 1: Overflow location and receiving environment

Since transitioning RNO into care and maintenance, there has been no end user of the water which was automatically pumped to the turkeys nest and it was not inspected on a daily basis prior to the rain event which preceded the incident.

Action taken to mitigate any adverse effects of non-compliance and prevent recurrence of the non-compliance:	
<p>The automatic transfer of water from the workshop pond to the turkeys nest has been disabled in the RNO data control system to prevent such a transfer without manual intervention. This will cease the filling of the pond without an end user.</p> <p>The water was drained to a suitable sump to allow permissible freeboard to be attained.</p> <p>The turkeys nest will not be used for water transfer purposes going forward.</p>	
Was this non-compliance previously reported to DWER?	
<input checked="" type="checkbox"/> Yes, and	
<input type="checkbox"/> Reported to DWER verbally	Date: / /
<input checked="" type="checkbox"/> Reported to DWER in writing	Date: 20/08/2024

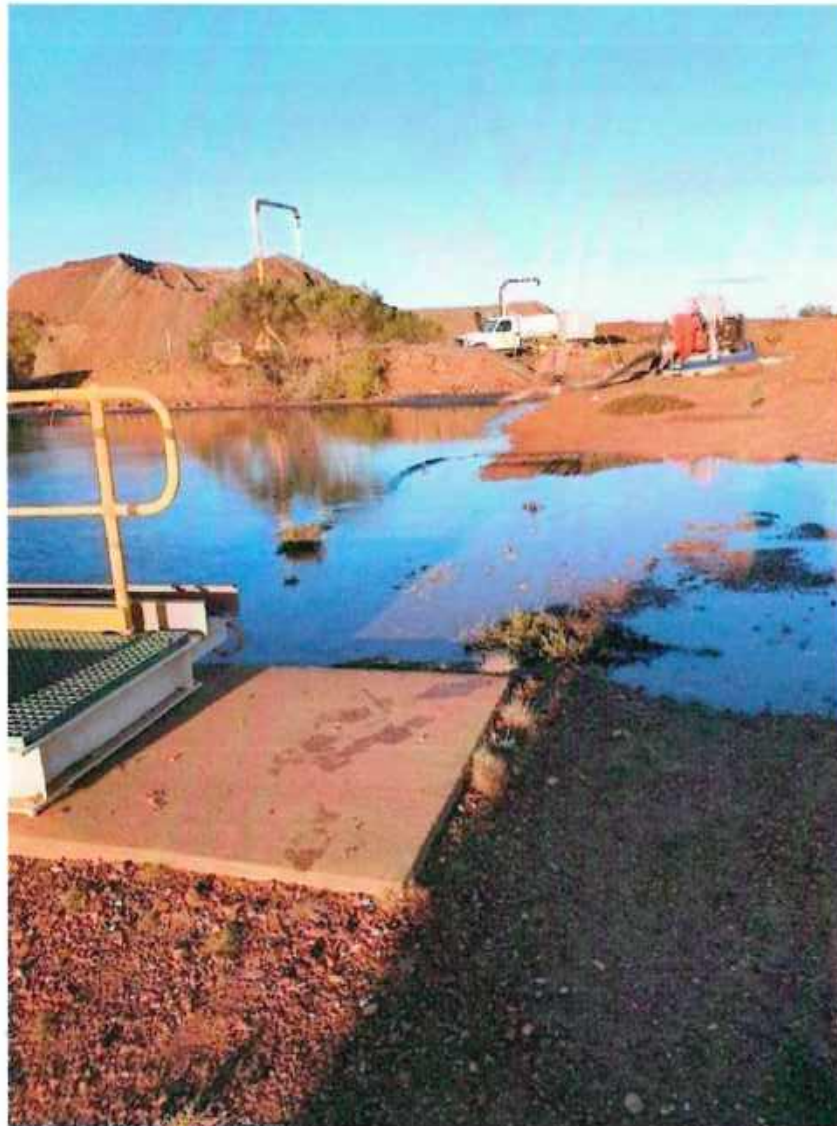
Figure 3: Overflow point facing West

Actual location is Figure 2a, Map Reference 19 on the May 2025 amended version of L8008/2004/3

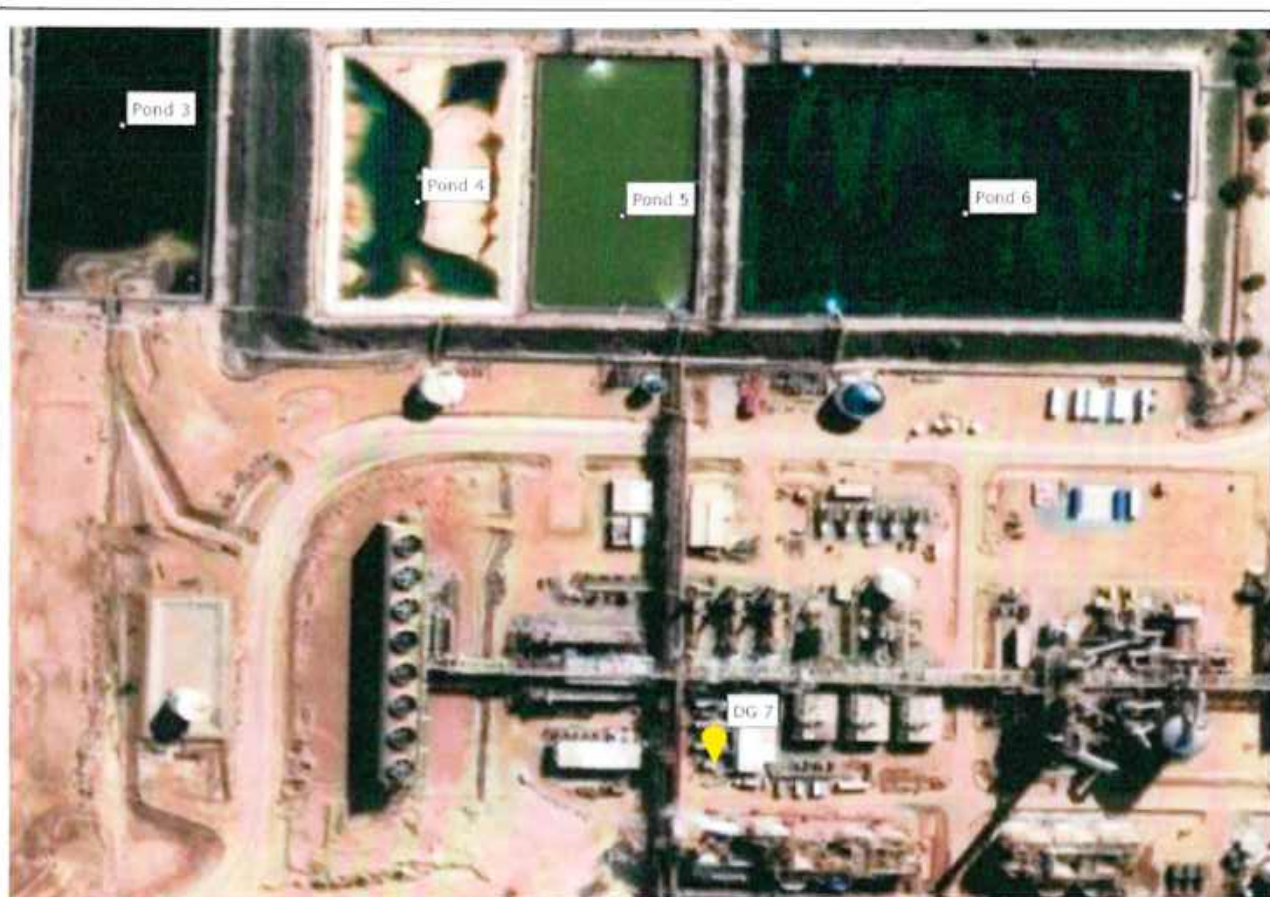
Condition no:		Date(s) of non-compliance:	04/09/2024
Details of non-compliance:			
Diesel has spilled from the fuel tank of DG7 into the surrounding plant area and storm water drainage infrastructure			
What was the actual (or suspected) environmental impact of the non-compliance?			
<p>NOTE – please attach maps or diagrams to provide insight into the precise location of where the non-compliance took place.</p>			
All diesel flow to DG 7 was halted immediately. Limestone scats were used to restrict the downstream flow of diesel through stormwater infrastructure. Cleanup of pooled diesel into IBCs was undertaken, and contaminated roadbase dug out for storage and later decontamination.

Figure 1: Location of DG7 relative to containment infrastructure per License L8008/2004/3

Cause (or suspected cause) of non-compliance:				
<p>DG7 is fitted with an internal, self-bunded fuel tank which may be refilled by an automatic filler system fed by a header circuit which supplies diesel to all DG's. Maintenance was carried out on DG7 during day shift on 03/09/2024 and the unit was not re-started as it is the backup generator in case of blackout.</p> <p>The high level sensor on the DG7 fuel tank failed and this resulted in the fuel supply continuing to run while the unit was not operational. Diesel continued to spill from the breather port on the fuel tank until it was identified at the start of the subsequent shift, the morning of 04/09/25 whereafter the valve was closed immediately.</p>				
Action taken to mitigate any adverse effects of non-compliance and prevent recurrence of the non-compliance:				
<p>The high level sensor was replaced on DG7 and all fuel transfer systems on DGs are checked for faults after routine maintenance related such as this.</p>				
Was this non-compliance previously reported to DWER?				
<input checked="" type="checkbox"/> Yes, and				
<table border="1" style="width: 100%; border-collapse: collapse;"> <tr> <td style="width: 50%;"><input type="checkbox"/> Reported to DWER verbally</td> <td style="width: 50%;">Date: / /</td> </tr> <tr> <td><input checked="" type="checkbox"/> Reported to DWER in writing</td> <td>Date: 04/09/2024</td> </tr> </table>	<input type="checkbox"/> Reported to DWER verbally	Date: / /	<input checked="" type="checkbox"/> Reported to DWER in writing	Date: 04/09/2024
<input type="checkbox"/> Reported to DWER verbally	Date: / /			
<input checked="" type="checkbox"/> Reported to DWER in writing	Date: 04/09/2024

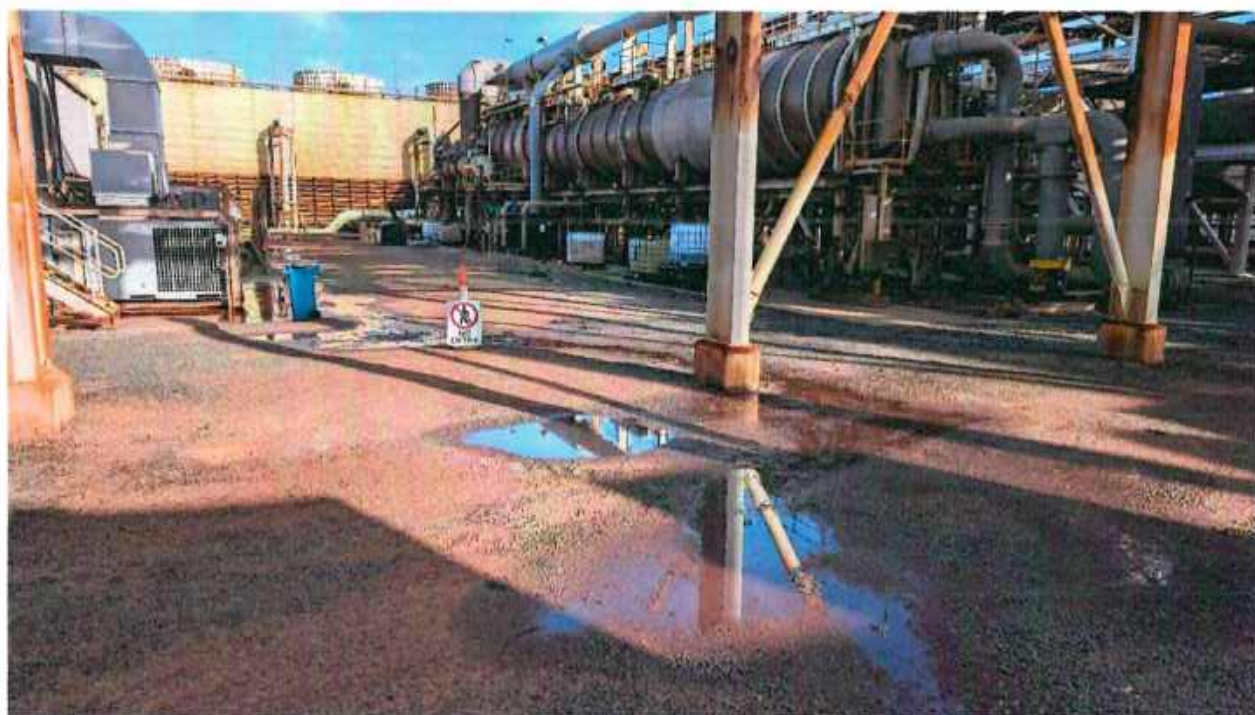
Figure 4: General view of fuel spillage path through water treatment area of the RNO plant toward drainage infrastructure

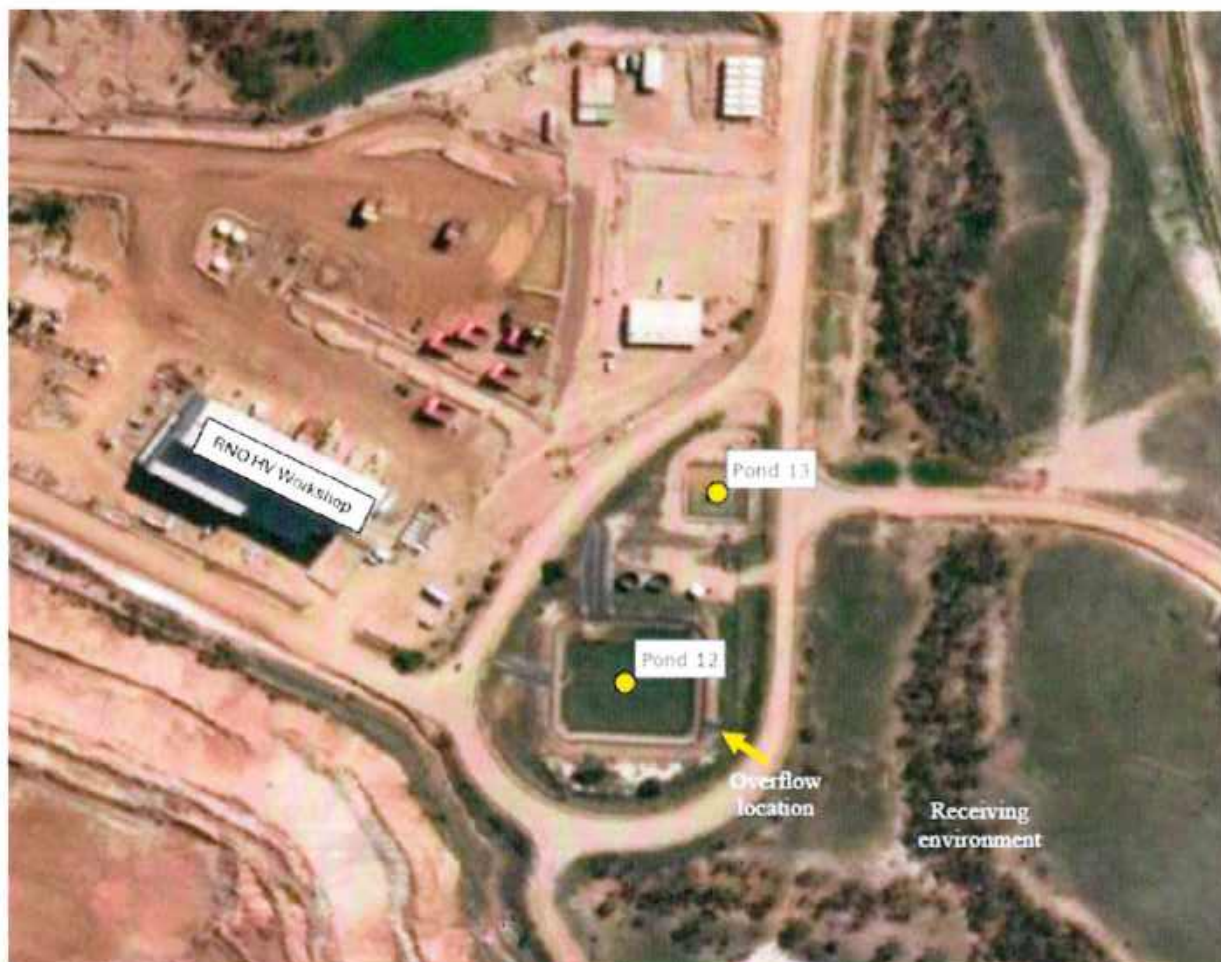
Condition no:	7 & 8	Date(s) of non-compliance:	14/04/2025
Details of non-compliance:			
<p>HV workshop, SML Stormwater and SRSF Ponds overtopping. The incident relates to Conditions 7 & 8, Table 3, Map reference of three ponds - Pond 12, 26 and 32. It was notifiable under Condition 8 of the extant L8008/2004/3 version as at time of the incident (since superseded)</p>			
What was the actual (or suspected) environmental impact of the non-compliance?			
<p>NOTE – please attach maps or diagrams to provide insight into the precise location of where the non-compliance took place.</p>

Nil to negligible actual impact due to the water which was inadvertently discharged to land being fresh and clean in nature. Some minor water logging consistent with broader environmental condition after a considerable rain event.

Figure 1: Overflow location and receiving environment

All three bodies of water catch significant quickflow in the event of a high rainfall event, such as the 70mm in 24 hours which preceded this incident. During care and maintenance, there is little demand for fresh water in the process system whereas in the past, considerable water could be consumed within the plant. This has resulted in capacity of these ponds being rapidly and unforeseeably overwhelmed, as the actual rain received was well in excess of the forecast at the time, which predicted sub 20mm for that period.

SML: This stormwater pond is the end of the line, with no return pumping infrastructure. This leaves no other usage or method of freeboard reduction other than for haul road dust suppression, which is not required during winter care and maintenance. To prevent future occurrence, a return line and pumping set up has been scoped to effectively dewater this dam without water carts.

HV Workshop: Due to the previous Mining Turkeys Nest incident, automatic pumping of this pond based on level sensor was ceased to avoid another Turkeys Nest freeboard incident. The externality of that process change has been this freeboard incident, which was diverted into stormwater drains before entering the creek. To prevent future occurrence, this pond will be checked more frequently and water pumped to suitable containment within the RNO process plant if necessary.

SRSF: To address the low use issue, the dam will be pumped more frequently to RNO plant containment and regular inspections will be done to check the freeboard.
