## Annual Audit Compliance Report Form

Section A – Licence details			
Licence number:	L8148/2006/4	Licence file number:	DER2014/000374-1
Licence holder name:	Koolan Iron Ore Pty Ltd		
Trading as:	Koolan Iron Ore Pty Ltd		
ACN:	099 455 277		
Registered business address:	First Floor, 2 Kings Park Road WEST PERTH WA 6872		
Reporting period:	01 / 01 / 2025 to 31 / 12 / 2025

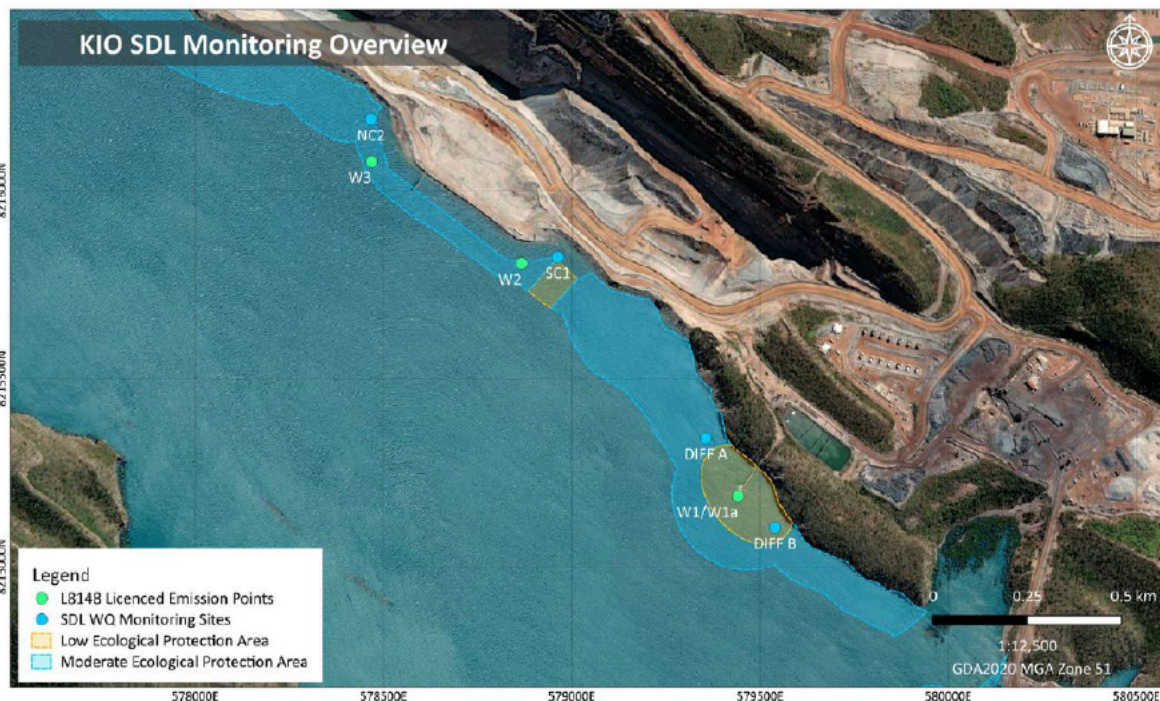
**Figure 1: Location of SDL monitoring Dec 2024-Feb 2025**

The potential effects on marine water quality and benthic producer habitat from occasionally elevated TSS emissions are not considered to be significant, mainly due to the characteristics of the receiving marine environment that is naturally turbid and subject to strong tidal flows each day. Between 4 December 2024 and February 2025, water quality monitoring was undertaken using submersible data logger (SDL's) to monitor for any significant changes to water quality as result of dewatering discharge. The locations of the SDLs and diffusers (W3 and W1/W1a) are shown in Figure 1 (noting that emission point W2 was removed from the Licence during 2025). The results of monitoring conducted by Hydrobiology (2025) indicated that dewatering discharge during this period (in which two exceedances occurred) did not result in a significant decrease in water quality upstream and downstream of outfalls (i.e. W1/W1a and W3). Prior to this event, twice yearly monitoring was undertaken to monitor for changes to water quality from the discharge of dewater. This monitoring, however, is no longer a requirement of the Marine Management Plan based on the previous five years of monitoring which demonstrated that discharge (including exceedances that occurred during these period) did not significantly affect marine water quality.

Historical exceedances have occurred during and following rainfall events. However, the exceedances during the reporting period can be attributed to changing geology (i.e. more Elgee siltstone) and operational factors such as sump placement, vehicle/machinery movements in the pit and pump head positions within the Main pit sump.

Typically, the management actions employed to help reduce TSS levels include:

- ceasing discharge to the ocean allowing the settlement pond to fill (should there be capacity)
- allowing the Main Pit sump to fill (should there be capacity)
- checking placement of sediment booms within the Settlement Pond
- adjusting the position of the pump heads within the sump in Main Pit
