## Annual Audit Compliance Report Form

Section A – Licence details			
Licence number:	L8306/2008/3	Licence file number:	2013/002375-2
Licence holder name:	Newmont Boddington Gold Pty Ltd		
Trading as:	Newmont Boddington Gold Pty Ltd		
ACN:	101 199 731		
Registered business address:	Newmont Australia, Level 5, 500 Hay Street Subiaco, WA, 6008.		
Reporting period:	01 / 01 / 2023 to 31 / 12 / 2023

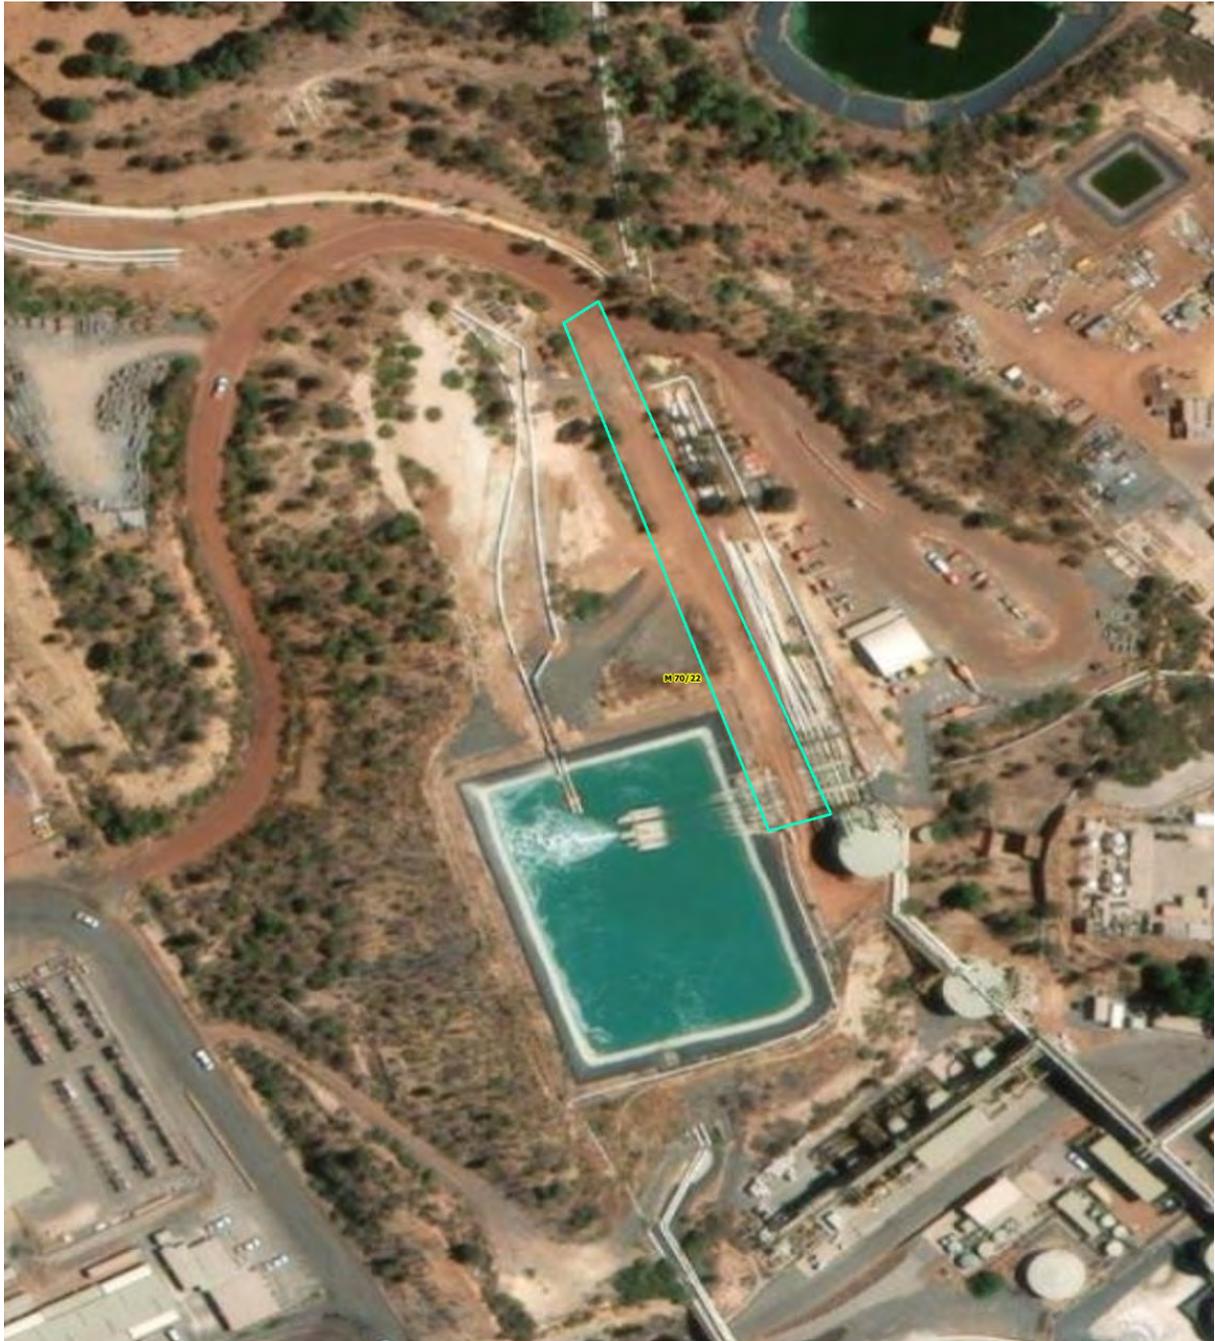
**Figure 1: Location of Process Water Spill**

Section E – Details of non-compliance with licence condition			
Please use a separate page for each condition with which the licence holder was non-compliant at a time during the reporting period.			
Condition no:	4	Date(s) of non-compliance:	5 April 2023
Details of non-compliance:			
Process water spill outside of the NBG Process Water Pond and adjacent earthen road (outside of containment). The process water is returned decant water from the F1 RDA and the water released had a WAD CN reading of 0.84 ppm. Approximately 5000 litres was released.			
What was the actual (or suspected) environmental impact of the non-compliance? <b>NOTE</b> – please attach maps or diagrams to provide insight into the precise location of where the non-compliance took place.			
The process water spill may have resulted in contamination of local soils. No vegetated areas were impacted. Figure 1 and Plate 1 below shows the location of the spill along the Process Water Pond Access Road.

Cause (or suspected cause) of non-compliance:			
The process water leak was caused by a leak in a spool/valve at the process water compound. Following replacement it was found that the flange face of the poly spool at the pipe junction was scalloped, leading to the leak. The spool in question was last replaced in 2016, and misting had been noted several days prior to the spill. The spool had been earmarked for replacement prior to the spill, however fabrication of a new spool was required as the spools had no critical spares available.			
Action taken to mitigate any adverse effects of non-compliance and prevent recurrence of the non-compliance:			
The pipe was isolated to stop discharge, and the area barricaded. Samples of the released water were taken for analysis, and an earthen bund was put in place to contain the spill within the Process Water Pond compound. A temporary replacement spool was fabricated and installed, prior to installation of a new spool and return of process water to the system.

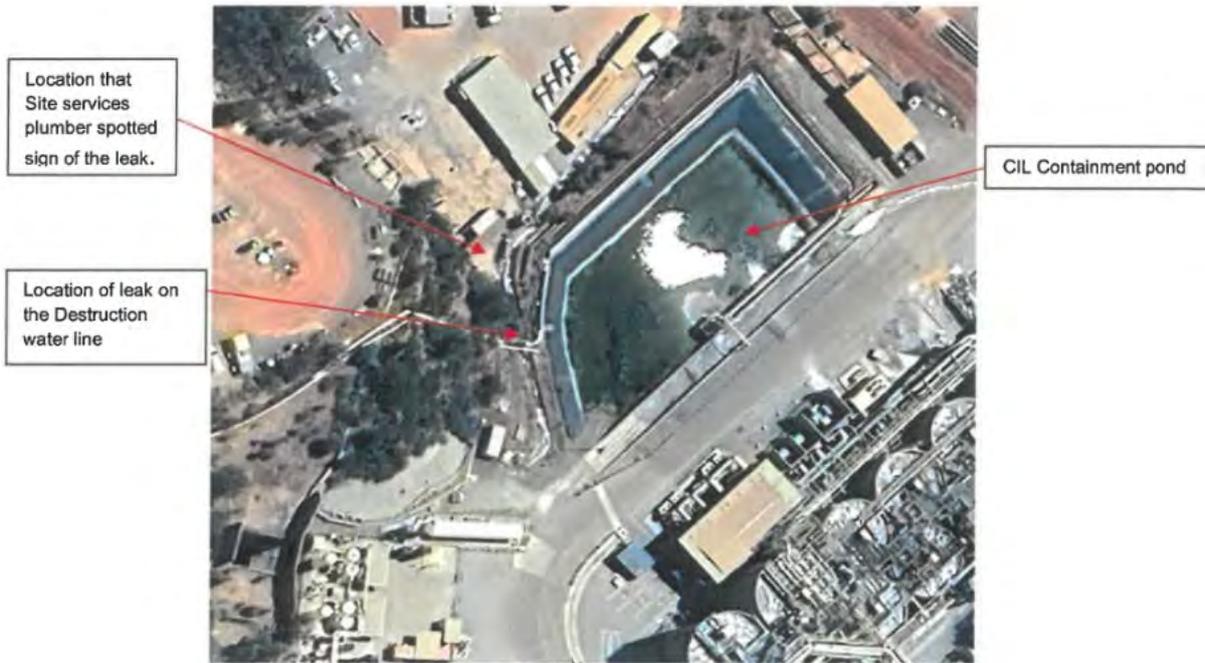
**Figure 2: Location of CIL Destruction Spill**

Section E – Details of non-compliance with licence condition			
Please use a separate page for each condition with which the licence holder was non-compliant at a time during the reporting period.			
Condition no:	4	Date(s) of non-compliance:	15 October 2023
Details of non-compliance:			
A leak in the destruction return line at the back of the carbon-in-leach (CIL) containment sump led to the release of process water to ground, where it then flowed into a concrete drain culvert and into the CIL containment pond. Samples returned a WAD CN reading of 0.71 ppm, and approximately 28,000 L was released, with the majority of this flowing into the CIL containment sump.			
What was the actual (or suspected) environmental impact of the non-compliance?			
<b>NOTE</b> – please attach maps or diagrams to provide insight into the precise location of where the non-compliance took place.			
The process water spill may have resulted in contamination of local soils. No vegetated areas were impacted.

Cause (or suspected cause) of non-compliance:			
The spill was caused by a crack in a double lined pipe (pipe within a pipe). A Five-Why investigation into the cause of the crack was undertaken. It was found that a similar pipe failure had occurred in 2018, and when this was replaced, the new pipeline was not supported correctly, as a 120 degree elbow was resting on wooden gluts at the bottom of a hill. Over time, the wood has rotted away, resulting in the weight of the pipe resting solely on the elbow. This excessive weight, combined with natural expansion and contraction of the poly pipe due to temperature changes has resulted in weakened pipe joints and eventual failure. Additionally, the telemetry alarms were triggered, but were not actioned as per procedure. These alarms are routinely triggered, mostly while conducting tailings line flushes, leading to it being seen as a 'nuisance alarm'.

Action taken to mitigate any adverse effects of non-compliance and prevent recurrence of the non-compliance:			
The area was immediately barricaded and samples of released water were taken. Following confirmation of cyanide solution, the area was dosed with peroxide to reduce the WAD CN levels to below 0.5 ppm. The spill was directed to the CIL containment pond, using rubber lining to direct flows into the concrete culvert adjacent to the spill. Material from the potentially contaminated area were excavated and removed, until all samples returned a WAD CN reading below 0.5 ppm. The damaged section of pipe has been replaced. Further corrective actions implemented include: Assessment of condition of all support structures, and implementation of proper anchoring and support at critical points. Updating the Trigger-Action-Response-Plan or creating a procedure to ensure rupture protection systems are robust, including instructions for responding to alarm scenarios.
