## Annual Audit Compliance Report Form

Section A – Licence Details			
Licence number:	L8308/2008/3	Licence file number:	DER2014/000430-2
Licence holder:	CITIC Pacific Mining Management Pty Ltd		
Trading as:	CITIC Pacific Mining Management Pty Ltd		
ACN:	119 578 371		
Registered address:	45 St Georges Terrace PERTH WA 6000		
Reporting period:	01/07/2024 to 30/06/2025

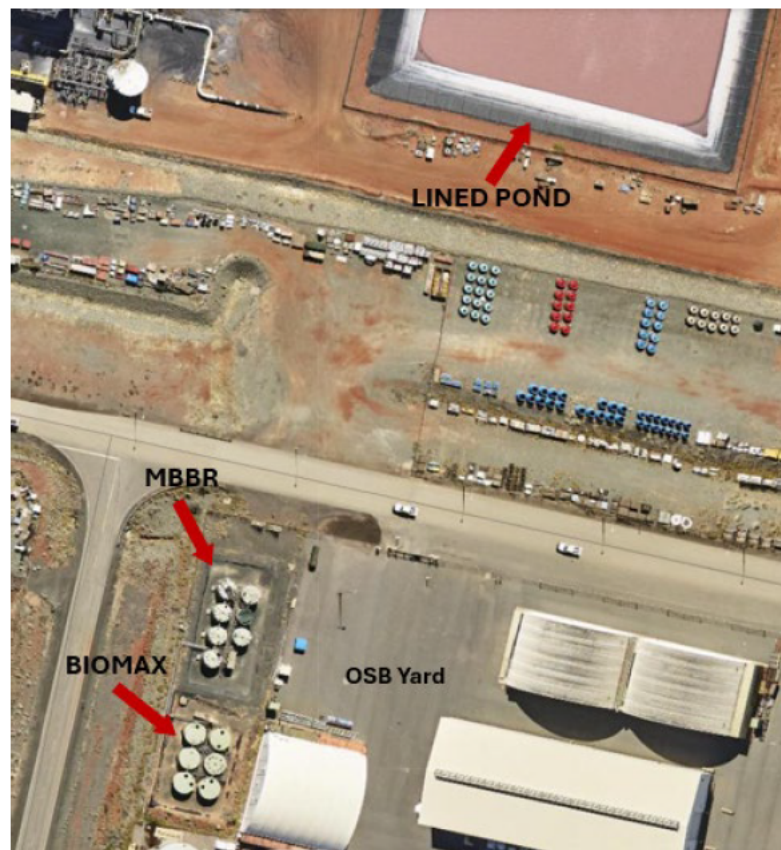
Location of the Biomax/MBBR units.

Processing Biomax wastewater treatment plant (WWTP) flow meter reading exceeded the daily limit of 60 m<sup>3</sup>/day for a period of 2 days. Average for the period was 76.5 m<sup>3</sup>/day, maximum was 81 m<sup>3</sup>/day.

No overflow of tanks occurred, treated wastewater is discharged to a lined pond thus there is no environmental impact.  
 Treated water quality results remained consistent during the period of increased flowrate.  
 The monthly average for Biomax WWTP flow meter was 38.4 m<sup>3</sup>/day, and the yearly average was 30.9 m<sup>3</sup>/day.

Cause (or suspected cause) of non-compliance:	
The investigation identified inflow pipe blockage to the adjacent MBBR WWTP resulting in excess flow into Biomax WWTP. Multiple other contributing factors, including system design and flow distribution deficiencies, inadequate staff training, absence of documented procedures, and a failure to prioritise necessary repair works.	
Action taken to mitigate any adverse effects of non-compliance and prevent recurrence of the non-compliance:	
Implemented engineering solutions for the Concentrator MBBR and Biomax pump blockage issues. Update and finalised WWTP operating procedure and provided training to all operators. Scheduled preventative maintenance, contractor availability and identified priority for repair works.	
Was this non-compliance previously reported to DWER?	
<input type="checkbox"/> Yes, and	
<input type="checkbox"/> Reported to DWER verbally	Date: / /

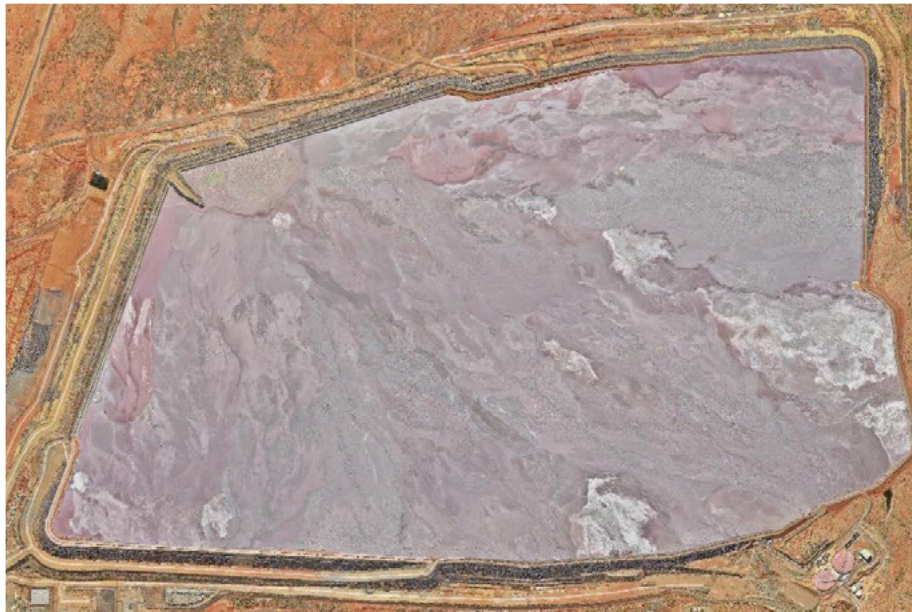
Excessive dust lift off was observed from the TSF following a cyclonic rainfall event.

Investigation found the TSF tailings top crust layer was broken down by intense rain and wind, resulting in airborne dust.

Deposit wet tailings on the affected areas.  
Investigate dust control measures on TSF after rainfall events.  
Update TSF Operating Manual for post rainfall event dust control.

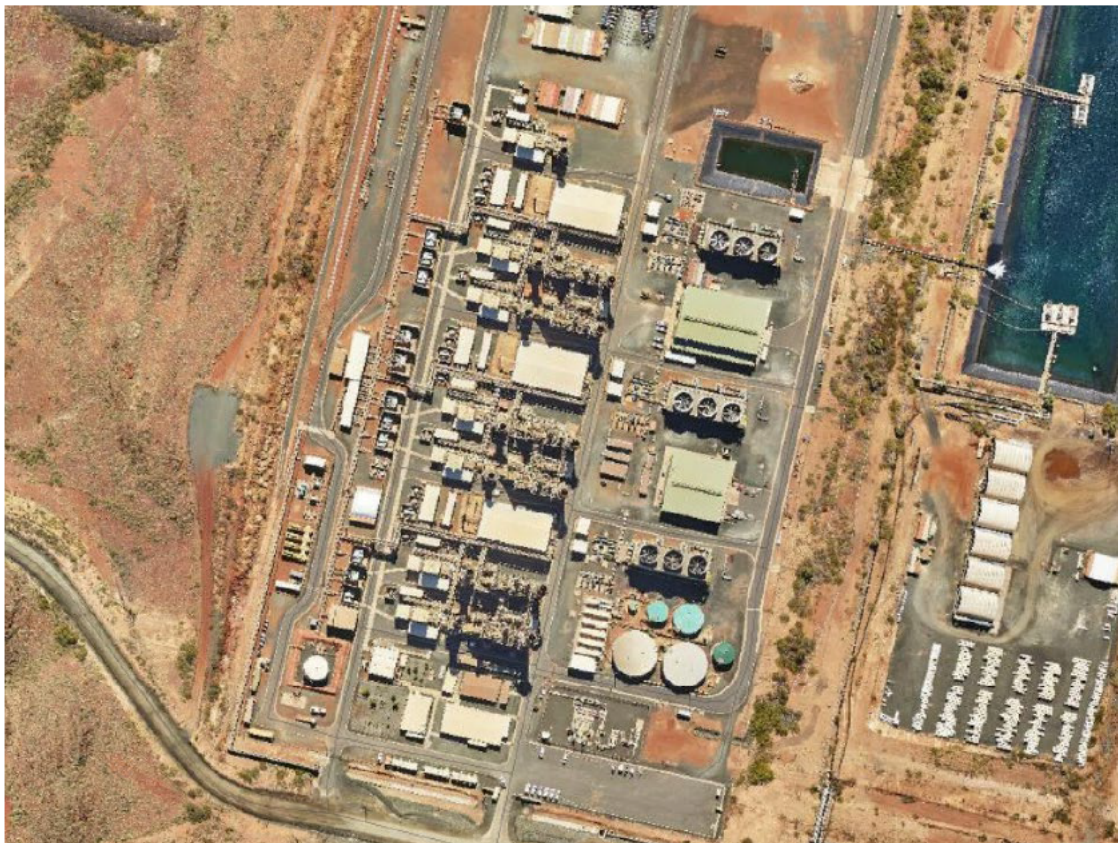
Power Station GT7 CEMS data availability non-compliant with Licence condition. CEMS data availability was 85.96%, WA CEMS code requirement is >90%.

The investigation found a loss of SCC-F (Sample Gas Feed unit) communication on GT7 led to its operation without valid CEMS data, resulting in overall CEMS availability falling below the 90% threshold.

Action taken to mitigate any adverse effects of non-compliance and prevent recurrence of the non-compliance:	
Review preventative maintenance and replacement schedule for all SCC-F (Sample Gas Feed) units across CEMS systems to reduce the risk of recurrence.	
Was this non-compliance previously reported to DWER?	
<input type="checkbox"/> Yes, and	
<input type="checkbox"/> Reported to DWER verbally	Date: / /
<input type="checkbox"/> Reported to DWER in writing	Date: / /

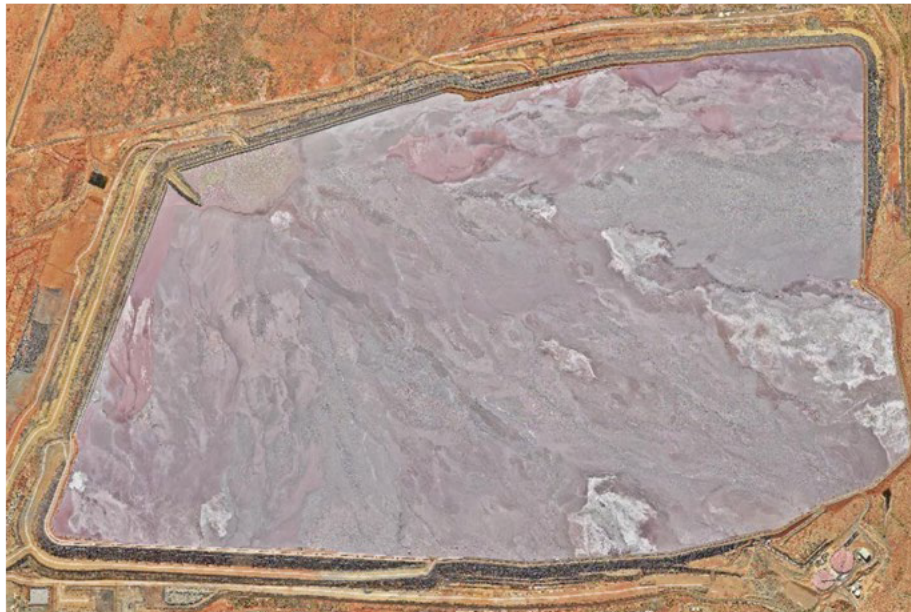
After submission of the TSF RL66m construction report DWER identified that the final eastern embankment height of 70.5mRL exceeded the authorised height of 70mRL.

Investigation identified lack of supervision and management from TSF construction team failed to identify the exceedance in approved design height.

Ensure DWER Licence requirements are included in all future construction scopes of work and adequate auditing of compliance is in place.

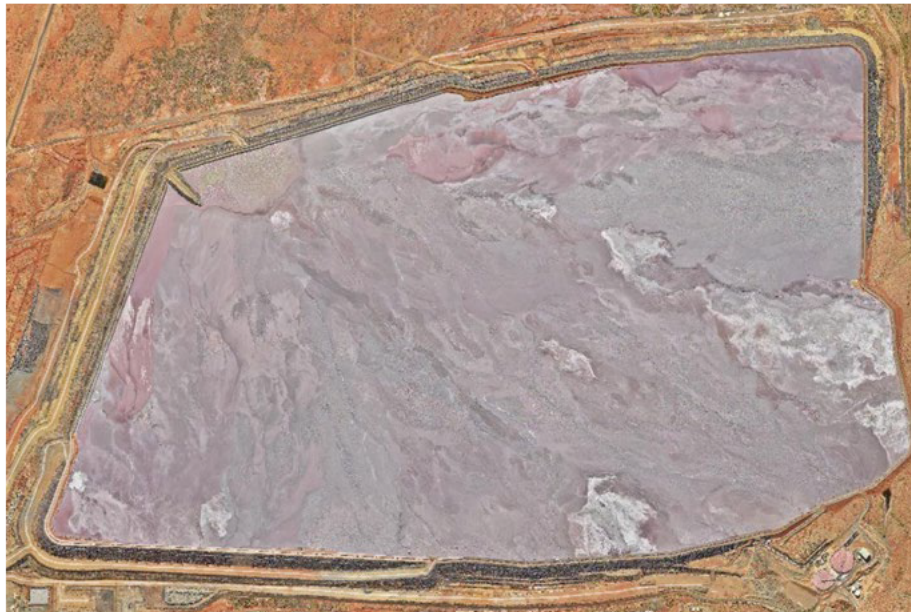
Non-compliance with Licence requirement to submit TSF audit within 7-day timeframe.

Due to contractual disagreements between CPM and the construction contractor, final survey data was not supplied within the 7 days conditioned in L8308/2008/3.

No adverse effects from this non-compliance. Compliance with Licence condition will be reiterated with construction team.
