## Annual Audit Compliance Report Form

*Environmental Protection Act 1986, Part V*

Section A – Licence Details			
Licence number:	L8337/2009/2	Licence file number:	2012/006861
Licence holder:	Genesis Minerals (Leonora) Pty Ltd		
Trading as:	Genesis Minerals Limited		
ACN:	667 073 681		
Registered address:	Lvl 7, 40 The Esplanade, Perth, WA, 6000		
Reporting period:	1/09/2024 to 31/08/2025

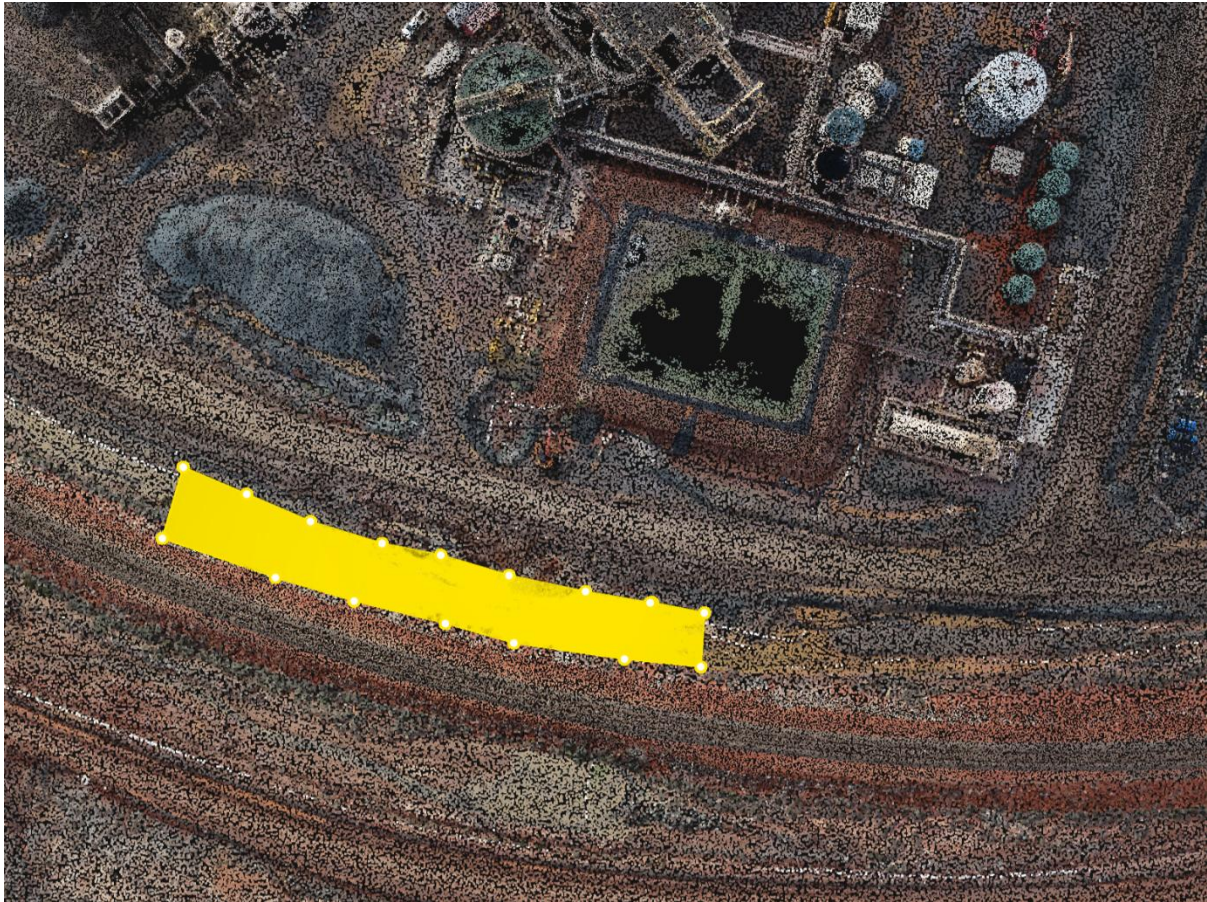
Section E – Details of Non-Compliance with Licence Condition			
Please use a separate page for each condition with which the licence holder was non-compliant at a time during the reporting period.			
Condition no:	1, 2	Date(s) of non-compliance:	24/07/2025
Details of non-compliance:			
Weld failure on buried HDPE pipeline carrying tailings caused 100m <sup>3</sup> tailings to be discharged in the disturbed area between the rail and access road The leak was identified during an inspection, when there was slurry pooling across approximately 1000m <sup>2</sup> within the road and railway corridor.			
What was the actual (or suspected) environmental impact of the non-compliance?			
<b>NOTE</b> – please attach maps or diagrams to provide insight into the precise location of where the non-compliance took place.			
N/A – the slurry was discharged into pre-disturbed catchment areas in site. This is shown in Appendix C.

Cause (or suspected cause) of non-compliance:			
<p>In the period preceding to the event (~36hrs) the thickener to tailings storage facility 3 East was experiencing some variations in line pressures and flows resulting from control automation constraints and manual operation.</p> <p>Thickener automation controls and setpoints were adjusted in the attempt to minimise the likelihood of a reoccurring high tailings line pressures and resultant discharge flow rate drops. Duty Tailings line (Line 1) pressures and flows were presenting concerns for operations and change over to Standby line (Line 2) was undertaken at 17:28 on Wednesday 23rd.</p> <p>Flushing of this line (Line 1) commenced the following day at 08:30am and concluded at 09:00am. The ongoing operation of standby line (Line 2) with a number of control automation constraints competing against each other adversely has resulted in the tailings line being overloaded and possibly causing a weld to fail underground near the railway line with slurry expressed to surface.</p>

Figure 10: Map showing the 1000 m<sup>2</sup> extent of the tailings line 2 slurry discharge on M 37/25.

Action taken to mitigate any adverse effects of non-compliance and prevent recurrence of the non-compliance:			
<p>Decision was made to immediately change tailings discharge from standby (line 2) to duty (line 1) and isolate Line 2.</p> <p>There was a review of the pump operations, which lead to the addition of an interlock to prevent the starting of an additional pump whilst one pump was already operating at high speed. The discharge pressure set point was also reduced, and an audible alarm was added to notify operators of when a pump starts operating in pressure control mode.</p> <p>Approval from Arc infrastructure was sought to access the railway corridor to complete the excavation and recovery of the contaminated material.</p>

The damage to the tailings line was also repaired, and the volume of the spill calculated from a survey flyover.	
Was this non-compliance previously reported to DWER?	
<input checked="" type="checkbox"/> No	
<input type="checkbox"/> Yes, and	
<input type="checkbox"/> Reported to DWER verbally	Date: / /
<input type="checkbox"/> Reported to DWER in writing	Date:
