Annual Audit Compliance Report Form

Environmental Protection Act 1986, Part V

Section A – Licence Details			
Licence number:	L8457/2010/2	Licence file number:	2012/006865
Licence holder:	Silver Lake (Integra) Pty Limited		
Trading as:	Silver Lake (Integra) Pty Limited		
ACN:	093 278 436		
Registered address:	South Shore Plaza Suite 4 Level 3 83-85 South Perth Esplanade SOUTH PERTH WA 6151		
Reporting period:	01/01/2023 to 31/12/2023

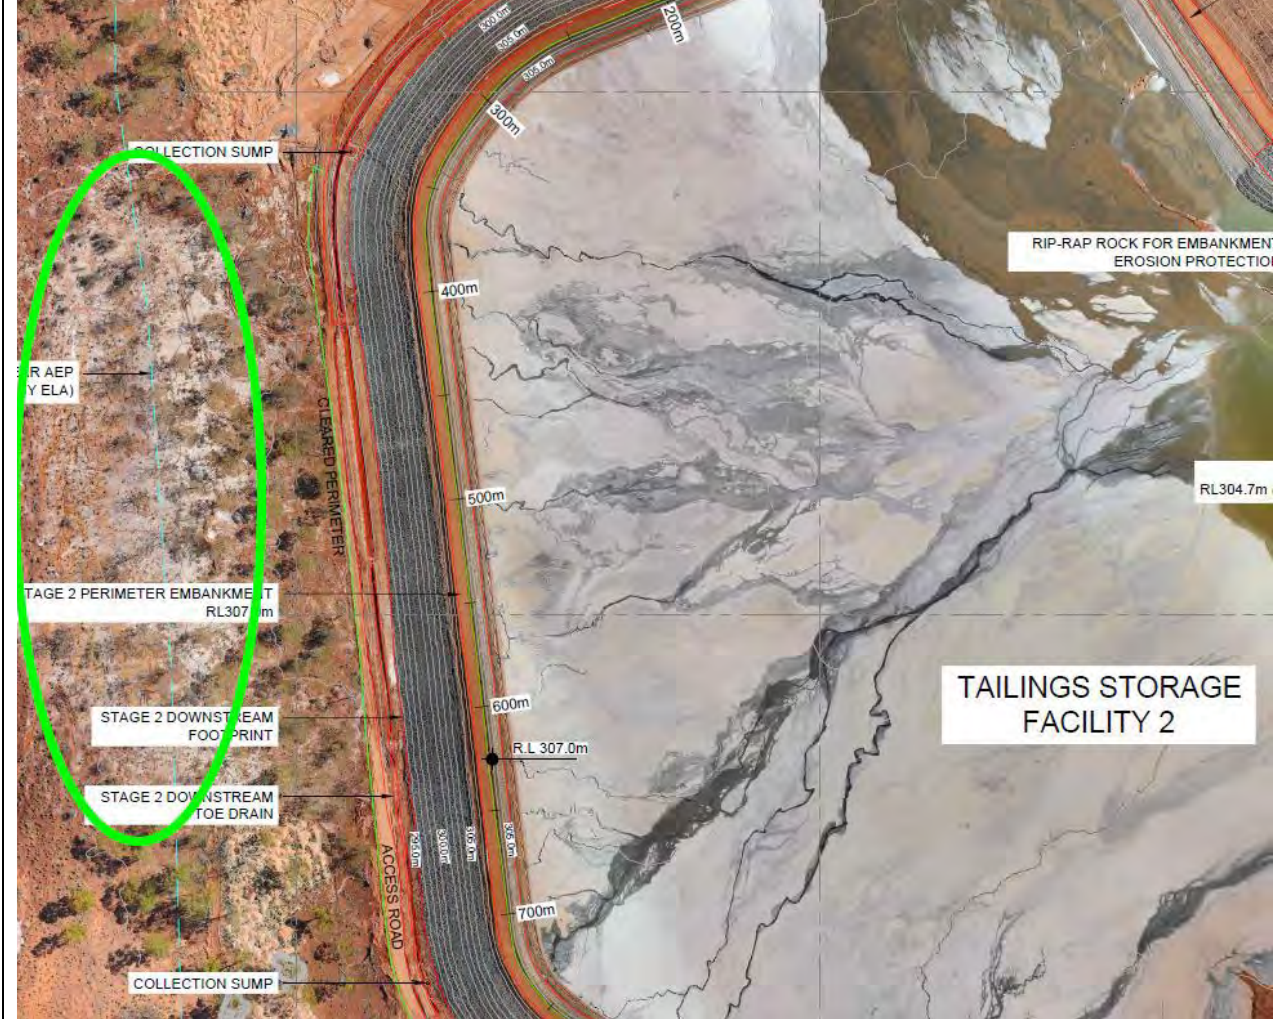
Cause (or suspected cause) of non-compliance:			
On 8 May 2023, a light coloured soil discoloration was identified west of and adjacent to the Randalls Gold Processing Facility (RGPF) Tailings Storage Facility (TSF) 2. The source of the discoloration is not confirmed at this stage however initial reviews indicate hypersaline groundwater mounding from TSF2 activities is a likely contributing factor. No seepage has been identified at the TSF2 embankment walls and groundwater SWLs are naturally shallow in this area. The discoloration was identified from updated aerial imagery included in the 'TSF2 Stage 2 Construction Report' submitted today and a snippet is shown below:

It is unknown when the incident first occurred as this discoloration is not immediately noticeable on the ground/by foot causing a delay in identification and notification.

Silver Lake has constructed two groundwater recovery drains between TSF2 and the impact areas to reduce groundwater levels and prevent surface expression. Additional engineering solutions may be required to prevent further impacts to the environment in the future. As there are no significant or unique vegetation or aquatic biota communities in the vicinity of TSF2, intervention is not required at this stage, and the vegetation and creek should be allowed to recover naturally over time, assisted by large rainfall events. Ongoing monitoring of groundwater, vegetation and the creek should be undertaken to assess recovery and ensure engineering solutions are successful.
