Annual Audit Compliance Report Form

Section A – Licence Details			
Licence number:	L8493/2010/3	Licence file number:	
Licence holder:	Rosslyn Hill Mining Pty Ltd		
Trading as:	Rosslyn Hill Mining Pty Ltd		
ACN:	075523661		
Registered address:	The Park Business Centre 45 Ventnor Avenue West Perth WA 6005		
Reporting period:	01 / 01 / 2025 to 31 / 12 / 2025

Condition no:	Condition 2, Table 1	Date(s) of non-compliance:	17 Mar - 31 Dec 2025
---------------	----------------------	----------------------------	----------------------

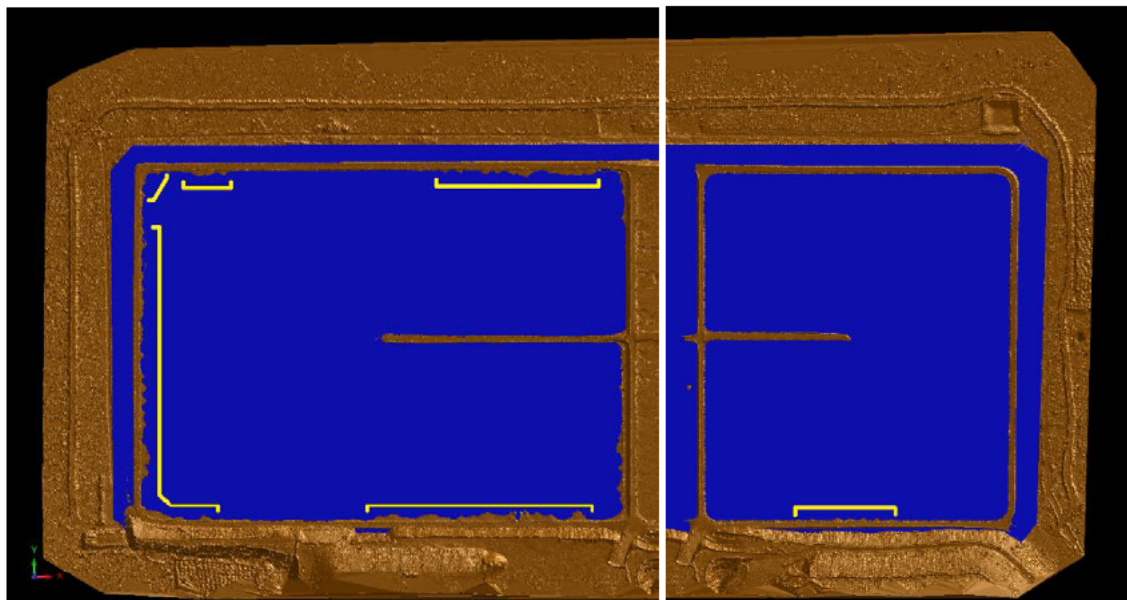
Portions of the Tailings Storage facility (TSF) embankments show tailings exceeding the required minimum 500mm freeboard along the inner wall surface. The local 1 in 100 year/72 hour storm event is estimated at 202 mm of rainfall (2026 BoM IFD data).

The figure below shows sections of the inner embankment for TSF Cells 1 (eastern) and 2 (western) where the surveyed tailings surface exceeds the minimum 500mm freeboard (shown in yellow) as required by Licence L8493/2010/3.

Freeboard exceedances indicated in yellow. Blue indicates the simulated maximum allowable water surface, 500mm below the embankment crest.

Sandy tailings material appears to have blown from the lower beach surface and banked up against the pipework and inner embankment wall. This has reduced the freeboard in the areas outlined in the figure above in yellow. Small-scale erosion of the road gravel has also contributed to the reduction in freeboard.

Action taken to mitigate any adverse effects of non-compliance and prevent recurrence of the non-compliance:	
<p>RHM has conducted the following actions to mitigate the freeboard exceedance:</p> <ul style="list-style-type: none"> Examine the TSF surface using 2021 drone survey data and identify the areas where freeboard is non-compliant. This work was completed in July 2025 and updated in March 2026. The work used the detailed drone survey data to map the TSF cells' surfaces as well as the wall embankments. Volume calculations were performed to determine the maximum amount of rainfall required to overtop the embankments. The work showed that over 6-7 consecutive 1-in-100-year (72hr) rainfall events (each delivering 202mm of rainfall) were required to fill the dam cells. Thus the risk of the dam cells being flooded to the overtop level is very low. For the non-compliant areas, approximately 1,400m of the tailings pipeline infrastructure has been separated at the connection flanges to allow access to the dry tailings cell surface adjoining the non-compliant areas. This work was completed 03 March 2026. RHM plans to complete minor earthworks to move sufficient tailings volume to re-shape the TSF beach surface to a compliant depth 0.5m below the surrounding wall crest. RHM aims to have the remedial earthworks completed in early 2026. An earthworks contractor has been engaged and RHM awaits baseline health monitoring (blood lead level) results before work begins.

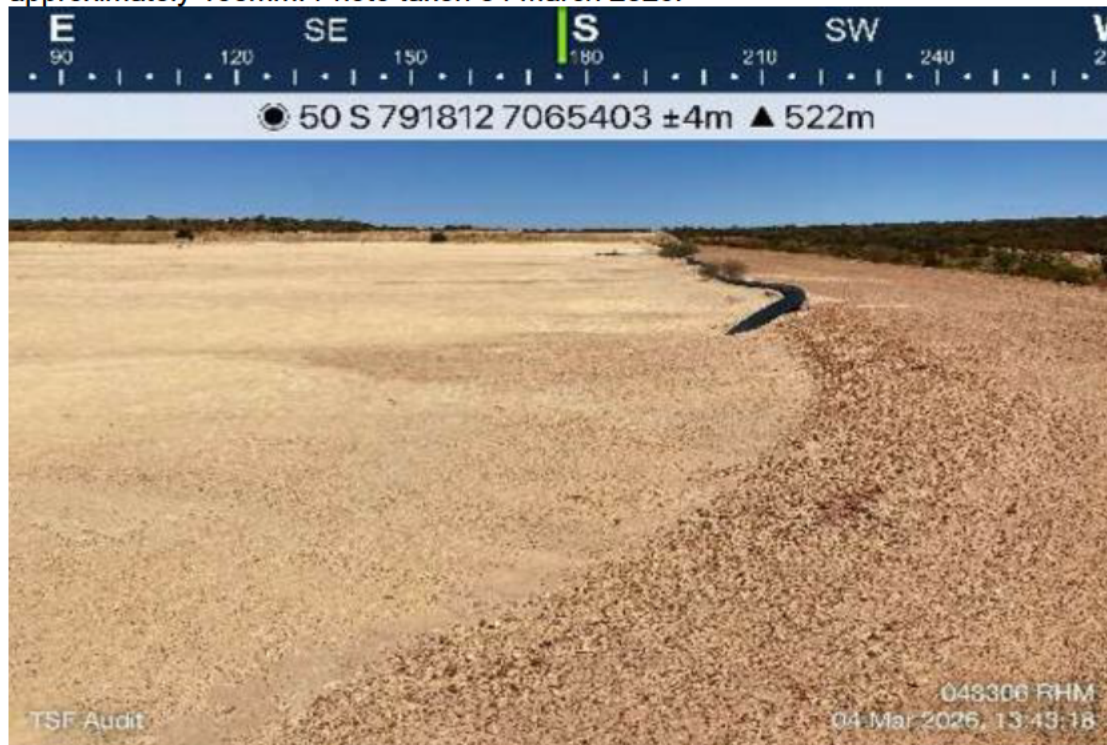
The photo below shows the northwest corner of TSF Cell 2. The freeboard is reduced to approximately 150mm. Photo taken 04 March 2026.
