## Annual Audit Compliance Report Form

Section A – Licence Details			
Licence number:	L8532/2011/2	Licence file number:	DER2014/000885-1
Licence holder:	Genesis Minerals (Leonora) Pty Ltd		
Trading as:	Genesis Minerals Limited		
ACN:	667 073 681		
Registered address:	Lvl 7, 40 The Esplanade, Perth, WA, 6000		
Reporting period:	1/09/2024 to 31/08/2025

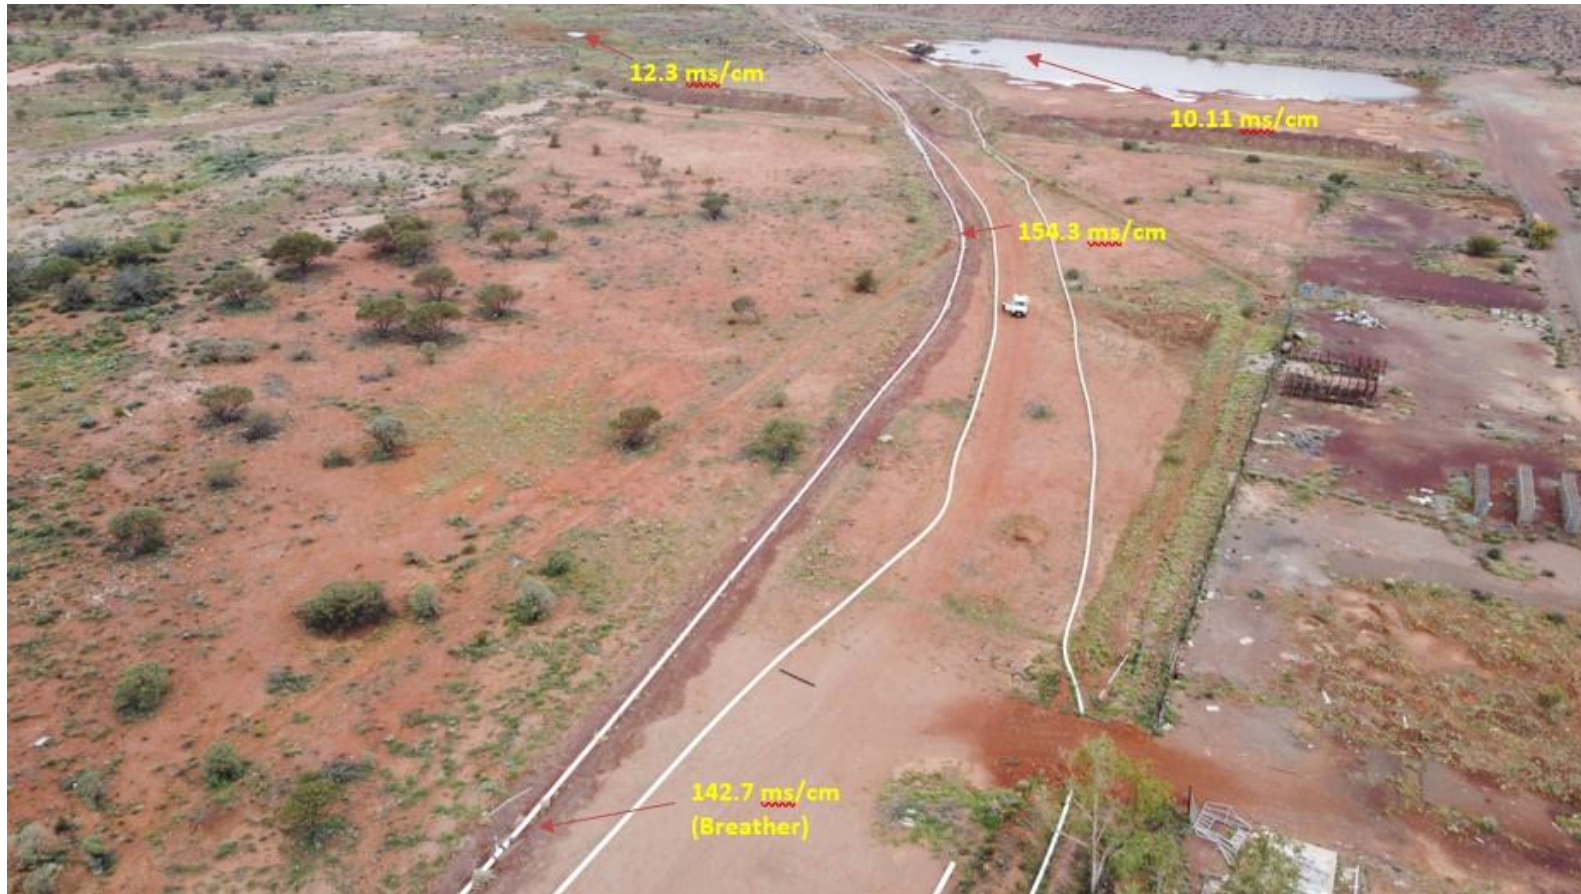
Section E – Details of Non-Compliance with Licence Condition			
Please use a separate page for each condition with which the license holder was non-compliant at a time during the reporting period.			
Condition no:	4	Date(s) of non-compliance:	13/12/24
Details of non-compliance:			
<p>Genesis commenced dewatering of the Harbour Lights Pit to the Trump Pit on 9<sup>th</sup> of December 2024 utilising the existing dewatering line remaining from the previous Northern Star operation. On the 13<sup>th</sup> of December, a technician (Op) made adjustment to flow pump flow rates and subsequently undertook an inspection of the pipeline as part of the works. During this time the Op has identified a leak from a failed breather on the pipeline and subsequently shut water flow to the pipeline to prevent further water loss.</p> <p>The breather failure is suspected to have occurred between 9<sup>th</sup> and 13<sup>th</sup> of October 2024 and is estimated to have lost 1000 kL of saline water during the duration of the event. The saline water did not impact native vegetation as it was retained within the existing spoon drain and adjacent low lying disturbed area at the Harbour Lights care and maintenance site. A total of 29 mm of rainfall was also received for the area during this event that contributed to increased observable volumes on the ground, as well as dilution.</p> <p>An internal investigation identified that telemetry had been active during the failure, however, the volume of loss over time was below the telemetry threshold (noting that thresholds need to account for false alarms associated with +/- 5% metering error rates). With telemetry in place, the non-compliance was with condition 4 of the licence, as the pipeline had not been inspected daily between the dates of 9<sup>th</sup> and 13<sup>th</sup> of October which would have capture the failed breather significantly earlier.</p>

What was the actual (or suspected) environmental impact of the non-compliance?			
<p><b>NOTE</b> – please attach maps or diagrams to provide insight into the precise location of where the non-compliance took place.</p> <p>No environmental impact was expected from the release as the volume was retained within the existing v-drain and nearby disturbed area. Due to the coinciding rainfall, the extent of the spill was identified through field electrical conductivity readings of pooling water within the area. (Figure 1)</p>			
Cause (or suspected cause) of non-compliance:			
The failure was due to a degraded breather coupling, which was not identified or replaced during the recommissioning phase of the pipeline. Subsequently, the non-compliance to condition 4 was associated with not having an appropriate handover phase to implement a system for inspection and inspection record management.			
Action taken to mitigate any adverse effects of non-compliance and prevent recurrence of the non-compliance:

Figure 1: Spill area and extent measurements taken 14 December 2024.

<p>The following actions were undertaken to mitigate the issue:</p> <ul style="list-style-type: none"> <li>- The breathers were inspected and replaced with stainless fittings to prevent corrosion and reduce risk of failure.</li> <li>- Implementation of a daily inspection on the pipeline.</li> <li>- Internal approvals processes (Management of Change, Surface Disturbance Permits) implemented to identify and communicate compliance obligations during project scoping and implementation phases.</li> </ul>			
Was this non-compliance previously reported to DWER?			
<input checked="" type="checkbox"/> No			
<input type="checkbox"/> Yes, and			
<input type="checkbox"/> Reported to DWER verbally		Date: / /	
<input type="checkbox"/> Reported to DWER in writing		Date: / /
