Annual Audit Compliance Report Form

Annual Audit Compliance Report for

- L8578/2011/1

Section A – Licence details			
Licence number:	L8578/2011/1	Licence file number:	2011/003002-1
Licence holder name:	Regis Resources Limited		
Trading as:	Regis Resources Limited		
ACN:	009 174 761		
Registered business address:	Level 2 516 Hay Street SUBIACO WA 6008		
Reporting period:	1/01/2024 to 31/12 /2024

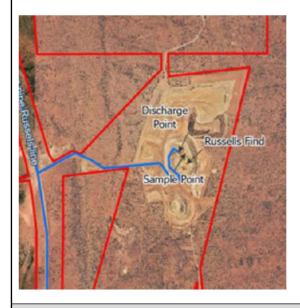
Photo of the incident location:

In November 2024, pH analysis for Russell's Find Pit dewatering was not completed. Due to a wall failure all nonessential personnel could not enter the pit. The mining team assisting with sampling did not record pH. This was not noted at the time, and resampling did not take place.

The non-compliance did not result in any environmental impact. Field sampling conducted in February 2025 and showed no notable variances in pH (8.51). The pit water has remained contained and has not been used for any further purposes.

The missed sampling parameter was not noted, and resampling of Russell's Find Pit did not occur.

The internal environmental report monitoring has been adjusted to ensure missed pit parameters are noted and sampling can be rescheduled.

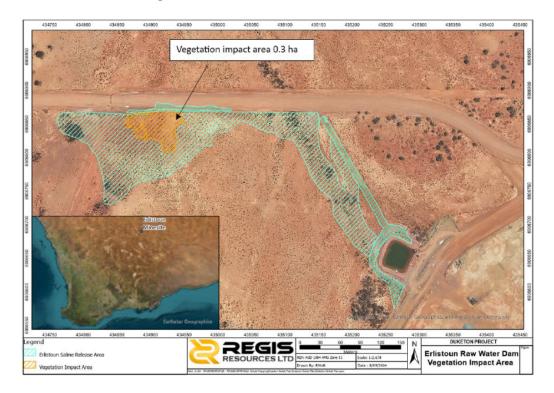
On the 20th of February 2024, a saline water release from the Erlistoun mine site raw water dam was detected. The estimated total of saline water released was 1,670kL, discharging across approximately 3.08 hectares of native vegetation. Water quality analysis detailed the following: pH: 8.04, TDS: 19,591 mg/L.

The impacted area was monitored using both aerial and ground-based photo assessments over a six-month period. The results indicated no significant impact across most of the release area. However, a small section, approximately 0.3 hectares, showed a decline in vegetation health.

The release occurred due to overflow of the dam wall, the release was detected by a passerby and was immediately shut off by the dewatering team.

The water being discharged into the dam was immediately isolated to prevent further inflow. The Erlistoun raw water dam has since been decommissioned (see updated aerial image of the decommissioned raw water dam below).
