## Annual Audit Compliance Report Form

Annual Audit Compliance Report for  
- L8578/2011/1

Section A – Licence details			
Licence number:	L8578/2011/1	Licence file number:	2011/003002-1
Licence holder name:	Regis Resources Limited		
Trading as:	Regis Resources Limited		
ACN:	009 174 761		
Registered business address:	Level 2 516 Hay Street SUBIACO WA 6008		
Reporting period:	1/01/2025 to 31/12 /2025

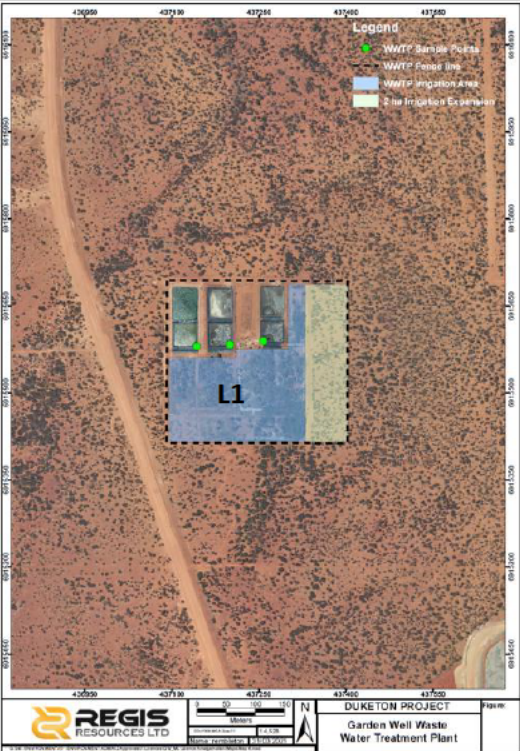
Section E – Details of non-compliance with licence condition			
Please use a separate page for each condition with which the licence holder was non-compliant at a time during the reporting period.			
Condition no:	2.2.2	Date(s) of non-compliance:	2025
Details of non-compliance:			
In the reporting period (2025), Total Phosphorus loading to the Garden Well WWTP irrigation area (L1) was calculated at 146.79 kg/ha/year, exceeding the licence limit of 120 kg/ha/year.			
What was the actual (or suspected) environmental impact of the non-compliance?			
<b>NOTE</b> – please attach maps or diagrams to provide insight into the precise location of where the non-compliance took place.			
The non-compliance did not result in any environmental impact. The exceedance relates to calculated nutrient loading within the approved Garden Well WWTP irrigation area (L1), and no evidence of impacts to land condition, soil health, or the surrounding environment was observed during the reporting period. A map of the Garden Well WWTP irrigation area (L1) is provided below.

Cause (or suspected cause) of non-compliance:			
The exceedance occurred due to increased volumes of treated wastewater being discharged to the irrigation area during the reporting period. An increase in personnel on site resulted in higher wastewater effluent volumes and reduced settlement time in the treatment ponds prior to discharge to the spray field.			
Action taken to mitigate any adverse effects of non-compliance and prevent recurrence of the non-compliance:			
An engineering consultant was engaged to assess expansion of the wastewater treatment plant to accommodate increased personnel on site. The proposed WWTP expansion has been included in the most recent licence amendment application and will be constructed in FY27.			
Was this non-compliance previously reported to DWER?			
<input checked="" type="checkbox"/> No			
<input type="checkbox"/> Reported to DWER verbally		Date:	
<input type="checkbox"/> Reported to DWER in writing		Date:

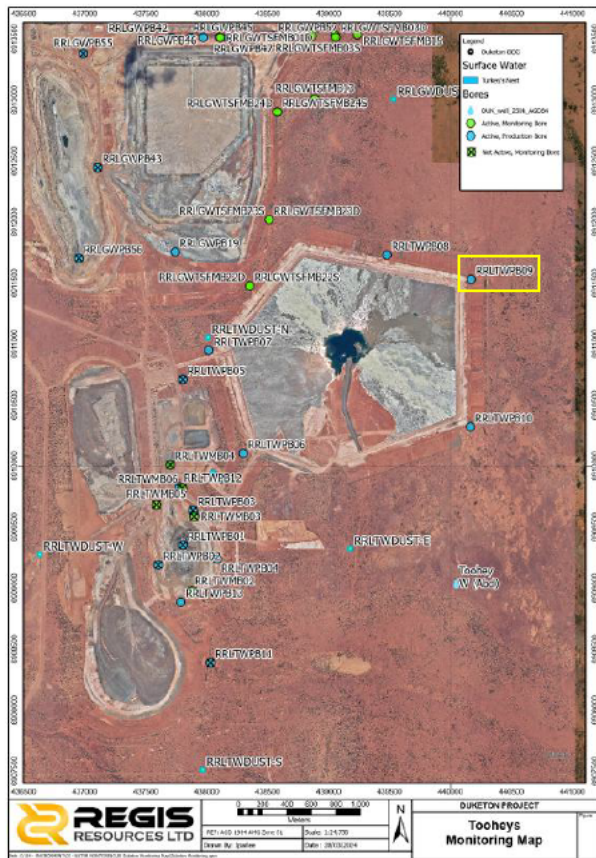
In February 2025, groundwater quality analysis was not completed for monitoring bore RRLTWPB09 as the HydraSleeve installed in the bore could not be accessed during the sampling period. Rescheduling of the sampling did not occur.

The non-compliance did not result in any environmental impact. Groundwater monitoring was completed in accordance with licence requirements for the remainder of the reporting period, with results indicating no significant fluctuations or upward trends in groundwater quality. A map of the monitoring bore RRLTWPB09 location is provided below.

Rescheduled sampling for monitoring bore RRLTWPB09 did not occur.

Internal environmental monitoring reporting processes have been improved to ensure any missed parameters or sampling requirements are identified and can be rescheduled where required.

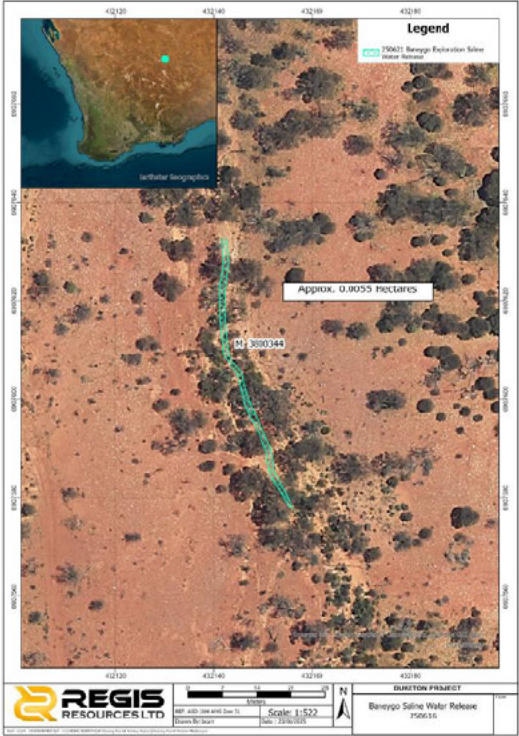
Section E – Details of non-compliance with licence condition			
Please use a separate page for each condition with which the licence holder was non-compliant at a time during the reporting period.			
Condition no:	1.1.5	Date(s) of non-compliance:	16/06/2025
Details of non-compliance:			
At approximately 13:00 on 16 June 2025, a release of saline water was identified from a sump located on exploration drill pad RRLBRTRC248, within tenement M38/344. To ensure that all water generated during drilling activities was contained, multiple sumps were used with water pumped between to ensure containment. The pump was promptly shut down upon detection to prevent any further discharge to the environment. It is estimated that approximately 900 L of saline water was released, impacting an area of approximately 55 m <sup>2</sup> of native vegetation.			
What was the actual (or suspected) environmental impact of the non-compliance?

<b>NOTE</b> – please attach maps or diagrams to provide insight into the precise location of where the non-compliance took place.			
The incident covered approximately 0.0055 hectares of native vegetation area. No priority flora or fauna was impacted. There was no observed impact on the health of vegetation within the saline release area. The saline water was tested in field with findings of pH – 7.83 and TDS – 40,300 TDS/L. A map of the release area is provided below.

Cause (or suspected cause) of non-compliance:			
The investigation found that the release occurred due to water being transferred between sumps without sufficient monitoring. As a result, the receiving sump overflowed, and saline water migrated to an adjacent low-lying vegetated area.			
Action taken to mitigate any adverse effects of non-compliance and prevent recurrence of the non-compliance:			
The dewatering pump was immediately shut down to prevent further release of water. The affected area was flushed with fresh water to remove salt crust and minimise potential impacts to the surrounding area. Vegetation monitoring was undertaken for a period of six months following the incident and reported to DWER. A Standard Work Instruction for sump pumping was developed to include regular checks of sumps to prevent overflow.

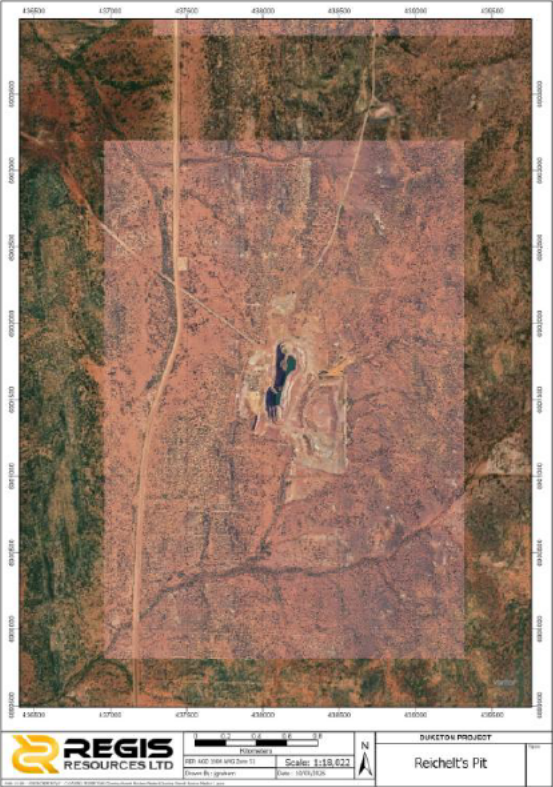
Section E – Details of non-compliance with licence condition			
Please use a separate page for each condition with which the licence holder was non-compliant at a time during the reporting period.			
<input checked="" type="checkbox"/> Reported to DWER in writing		Date: 20/06/2025	
Condition no:	2.3.2	Date(s) of non-compliance:	July, August & October 2025
Details of non-compliance:			
In the reporting period (2025), Total Dissolved Solids (TDS) sample results for discharge into Reichelt's Find Pit exceeded the licence limit of 4,000 mg/L in July (7,700 mg/L), August (7,100 mg/L) and October (7,700 mg/L).			
What was the actual (or suspected) environmental impact of the non-compliance?			
<b>NOTE</b> – please attach maps or diagrams to provide insight into the precise location of where the non-compliance took place.			
The non-compliance did not result in any environmental impact. Historical baseline data, including Reichelt's H1 Report, indicates that groundwater TDS concentrations in the pit have previously been observed at approximately 10,000 mg/L. The discharge TDS concentrations did not exceed these historical baseline levels. Additionally, there are no pastoral wells within a 4 km radius of the area to support stock watering.

A map of the Reichelt's Find Pit location is provided below.

Cause (or suspected cause) of non-compliance:			
The elevated TDS concentrations were caused by dewatering.			
Action taken to mitigate any adverse effects of non-compliance and prevent recurrence of the non-compliance:			
Discharge water quality monitoring will continue in accordance with licence requirements to track TDS concentrations. A review of historical data will be used to inform a future licence amendment to revise the TDS limit so that it reflects the baseline water quality. Pastoral well locations will continue to be monitored to track TDS concentrations.			
Was this non-compliance previously reported to DWER?

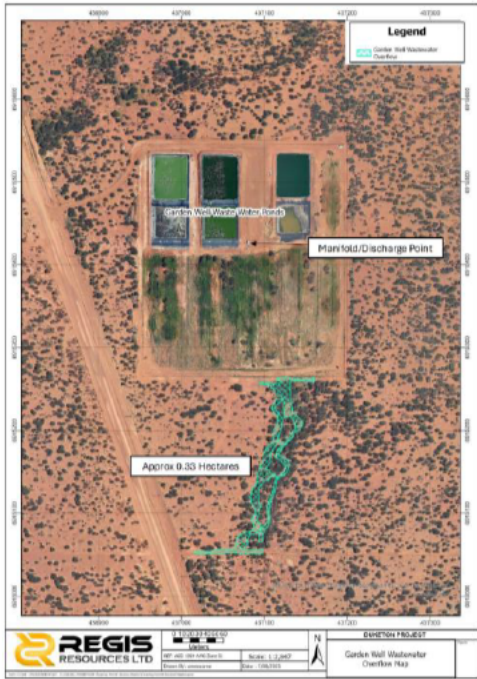
The incident covered approximately 0.33 hectares of native vegetation area. No priority flora or fauna was impacted. There was no observed impact on the health of vegetation within the wastewater release area. The wastewater was lab tested with findings of pH – 8.6, TSS – 250 mg/L, Total Nitrogen – 30 mg/L and Total Phosphorus – 14 mg/L. A map of the release area is provided below.

Cause (or suspected cause) of non-compliance:			
The investigation found that the release was caused by a failure of the plasson connecting the irrigation pipework to the distribution manifold, resulting in wastewater leaking from the manifold for an estimated three-hour period. Wastewater migrated south from the manifold to the southern boundary of the wastewater irrigation field, breaching the perimeter bunding.			
Action taken to mitigate any adverse effects of non-compliance and prevent recurrence of the non-compliance:

The generator was immediately shut down to prevent further discharge. Bunding around the pooled water was reinforced to contain it within the irrigation boundary and the plasson fitting was repaired. The affected area was flushed with fresh water to dilute nutrient concentrations. Vegetation monitoring was undertaken for a period of six months following the incident and reported to DWER.			
Was this non-compliance previously reported to DWER?

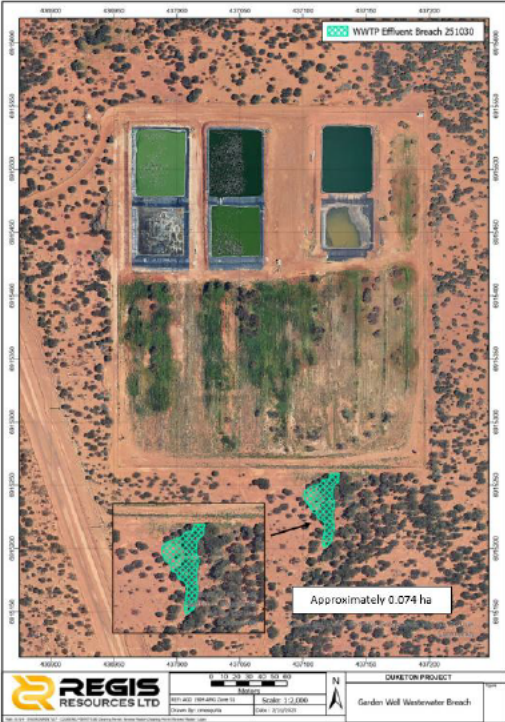
<b>NOTE</b> – please attach maps or diagrams to provide insight into the precise location of where the non-compliance took place.			
The incident covered approximately 0.074 hectares of native vegetation area. No priority flora or fauna was impacted. There was no observed impact on the health of vegetation within the wastewater release area. The wastewater was lab tested with findings of pH – 8.0, TSS – 895.0 mg/L, Total Nitrogen – 55.5 mg/L and Total Phosphorus – 17.0 mg/L. A map of the release area is provided below.

Cause (or suspected cause) of non-compliance:			
The investigation found that the release occurred from wastewater ponding within the irrigation field, attributed to pre-existing soil saturation and reduced evaporation rates, which resulted in an overflow to the south beyond the irrigation boundary.			
Action taken to mitigate any adverse effects of non-compliance and prevent recurrence of the non-compliance:			
The pooled water was pumped back into the pond, and an earthen bund was constructed along the boundary to prevent further overflow. The affected area was flushed with fresh water to dilute nutrient concentrations. Vegetation monitoring commenced for a period of six months following the incident and reported to DWER.			
Was this non-compliance previously reported to DWER?

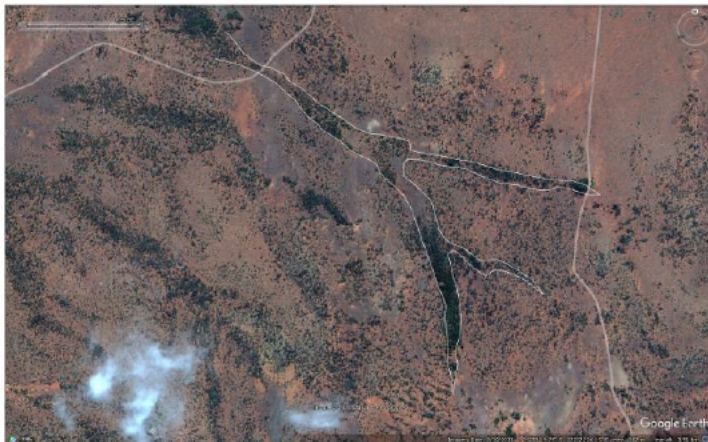
GDW TSF 3 East Wall Seepage

In the reporting period (2025), a new seepage location was identified on the eastern embankment toe of Garden Well TSF3.

There is no anticipated environmental impact as the seepage remains localised and contained within the TSF disturbance footprint, with no evidence of uncontrolled discharge, as reported by CMW Geosciences Pty Ltd in the 2025 TSF Audit. In addition, all chemical analyses for surrounding monitoring bores at GWTSF3 remain below licence limits. A map of the seepage location is provided below.

Northern drainage line pre-construction

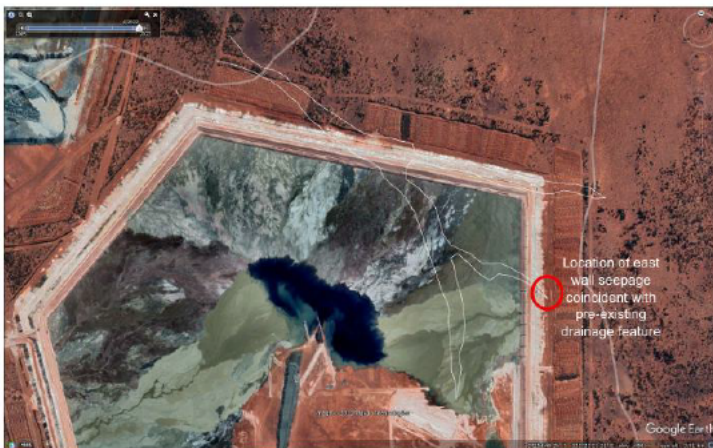
Northern drainage line post-construction showing area of east wall seepage

Section E – Details of non-compliance with licence condition	
Please use a separate page for each condition with which the licence holder was non-compliant at a time during the reporting period.	
Cause (or suspected cause) of non-compliance:	
The east wall seepage appears to be the result of water travelling upstream along a pre-existing drainage channel (see map above) under the influence of increased head as the dam height increases.	
Action taken to mitigate any adverse effects of non-compliance and prevent recurrence of the non-compliance:	
The seepage will be pumped to back seepage management infrastructure located along the northern wall and returned to the TSF.	
Was this non-compliance previously reported to DWER?	
<input checked="" type="checkbox"/> No	
<input type="checkbox"/> Reported to DWER verbally	Date: / /
<input type="checkbox"/> Reported to DWER in writing	Date / /
