Annual Audit Compliance Report Form

Environmental Protection Act 1986, Part V

Section A – Licence Details			
Licence number:	L8675/2012/1	Licence file number:	2012/005167
Licence holder:	Millennium Minerals Limited		
Trading as:	Millennium Minerals Limited (MML)		
ABN:	85 003 257 556		
Registered address:	Unit 7, 140 Abernathy Road, Belmont WA 6984		
Reporting period:	01/10/2017 to 30/09/2018

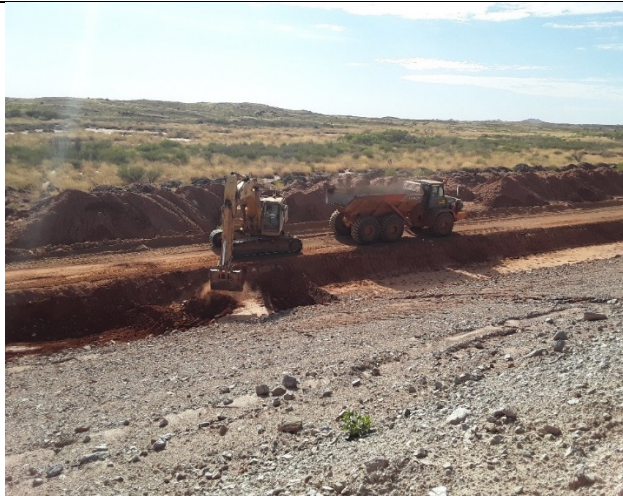
Section E – Details of Non-Compliance with Licence Condition			
Please use a separate page for each condition with which the licence holder was non-compliant at a time during the reporting period.			
Condition no:	Condition 1.3.5 a and b	Date(s) of non-compliance:	12 April 2018
Details of non-compliance:			
<p>TSF2 toe drains were observed to have an open-ended design allowing surface water and potential contamination and discharge of material to the environment. These drains were also full of transported topsoil material, reducing capacity and effectiveness of toe drains.</p>			
<p>What was the actual (or suspected) environmental impact of the non-compliance?</p> <p>NOTE – please attach maps or diagrams to provide insight into the precise location of where the non-compliance took place.</p>			
<p>Both toe drains at the TSF2 facility were full of sediment that had run off surrounding topsoil storage areas (fine topsoil material) into the drains eliminating capacity for surface water capture and thus provided avenue for potential contaminants to enter the environment. Potential for cyanide contaminants (if the facility was seeping into the toe drain) to be flushed out of the drain and into the receiving environment during rainfall events. The toe drains had not illustrated any previous evidence of seepage, though this was also difficult to ascertain due to them being full of topsoil material from nearby stockpiles. There were noted visual impacts to the environment.</p>

Cause (or suspected cause) of non-compliance:			
<p>The proximity (4-5m) of the stored topsoil to the toe drains provided a nearby pathway for topsoil transportation into the drains. The wet season following the initial deposition of the topsoil material (no plant growth to stabilize material) amounted to 650 mm of rain (twice the annual average) which also contributed to the movement of material into the drain. The topsoil recovered from the TSF construction footprint was stored near the TSF due to limited availability of approved clearing areas from DMIRS. Heavy rains and erosion further exacerbated sediment transportation into the toe drain trenches.</p>			
Action taken to mitigate any adverse effects of non-compliance and prevent recurrence of the non-compliance:			
<p>The topsoil sediment in the toe drains was removed and capacity reinstated. All material from the toe drains were deposited back into TSF2 under direction from DWER’s inspecting officers. These works were completed and checked by DWER officers on their second visit to site in May 2018, please see photos below.</p> <p>A location surface water management plan for the site has since been prepared for the facility with recommendations guiding management works. This guidance has enabled further works on constructed bunding with competent rock material adjacent to both the topsoil side and toe drain edge (see photos below) along the eastern boundary of the facility, with similar works proposed on the western boundary during the next construction lift (western end less topsoil ingress and road has been sheeted to provide more effective drainage away from this drain). All four ends of the toe drains have had bunds fully reinstated, with implementation of various sediment basins constructed around the facility to prevent further water flow into toe drains. Surface water management works will continue to be completed during facility construction.</p>

Plate 1 – Removal of Sediment from Toe Drains

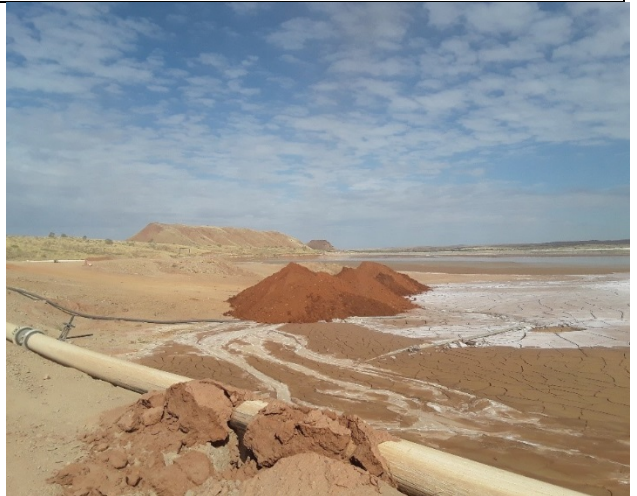
Plate 2 – Deposited material from toe drain in TSF Cell

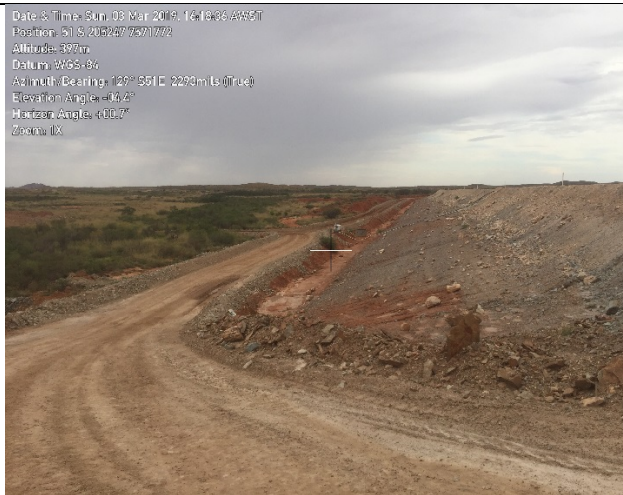
Plate 3 – Bund construction along and at end of toe drains – Eastern Wall

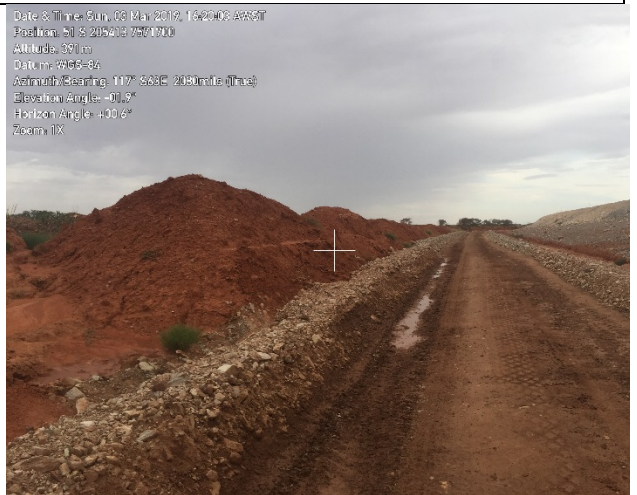
Plate 4 – Constructed bund and drain. Barrier to exclude further topsoil entering toe drain.

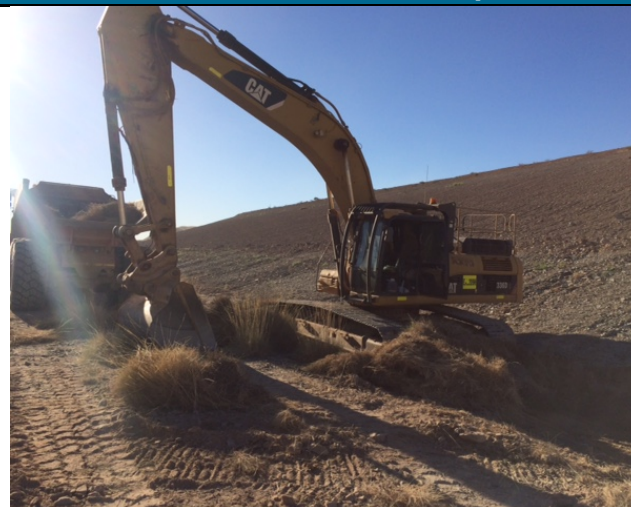
Section E – Details of Non-Compliance with Licence Condition			
Please use a separate page for each condition with which the licence holder was non-compliant at a time during the reporting period.			
Condition no:	Condition 1.3.5 a and b	Date(s) of non-compliance:	12 April 2018
Details of non-compliance:			
<p>Schedule 1 – materials that must not be discharged into the environment. TSF1 toe drains found to have reduced capacity and functionality due to long term sediment build up. This has resulted in water overtopping the drain facility and causing erosion providing avenue for a drain breached, with sediment from the drain then available to enter the natural environment.</p>			
<p>What was the actual (or suspected) environmental impact of the non-compliance? NOTE – please attach maps or diagrams to provide insight into the precise location of where the non-compliance took place.</p>			
<p>Soil samples were taken by inspecting officers and MML environmental staff from the surrounding receiving environment, with returned results not providing any evidence of any elevated contaminants. Background samples were also taken from the surrounding environment (outside the influence of the sediment discharge in the surface water system) providing comparative assessment and further evidence to that contaminants were not present in the environment at this time. There was no visual impact to the receiving environment.</p> <p>Suspended solids from the drain were released to the surrounding environment, with silt and clay materials creating staining and fines to enter the environment. Due to the function of the toe drains and the movement of water from these drains, it could be expected that this has caused environmental impact from these above pollutants entering the natural environment.</p>

Cause (or suspected cause) of non-compliance:			
<p>Due to the lack of regular visual inspections of the toe drains and the overall facility, it was not highlighted the toe drain had filled with sediment and water movement had caused erosion across a low point section of the drain infrastructure. Previous years rainfall was twice the annual average, with several significant events recorded. This combined with a lack inspections and ongoing maintenance contributed to the breach of the drain and the ultimate release of potential contaminants to the receiving environment.</p>			
Action taken to mitigate any adverse effects of non-compliance and prevent recurrence of the non-compliance:			
<p>The entire length of the toe drain infrastructure was cleaned out and any breaches to the drain were reinstated with competent rock material. Surface water management was reviewed, and a number of works were completed to divert water away from the facility including the installation of sediment traps and construction of bund formations to reduce water ingress into the drains. Photos of these works have been provided to the department to provide closeout of the non-compliance (11/09/2018 – Jaala Baldock), further photos of works are also provided below.</p>

Plate 1 – Sediment basin constructed in front of toe drain (location of erosion breach).

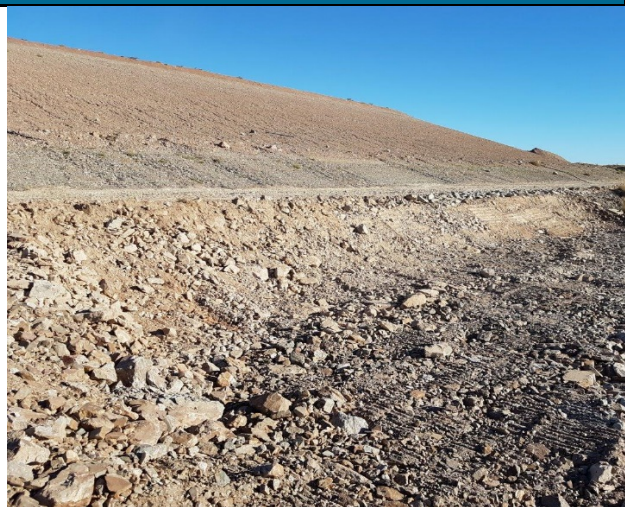
Plate 2 – Built up drain infrastructure (location of breach) front view of Plate 5 below.

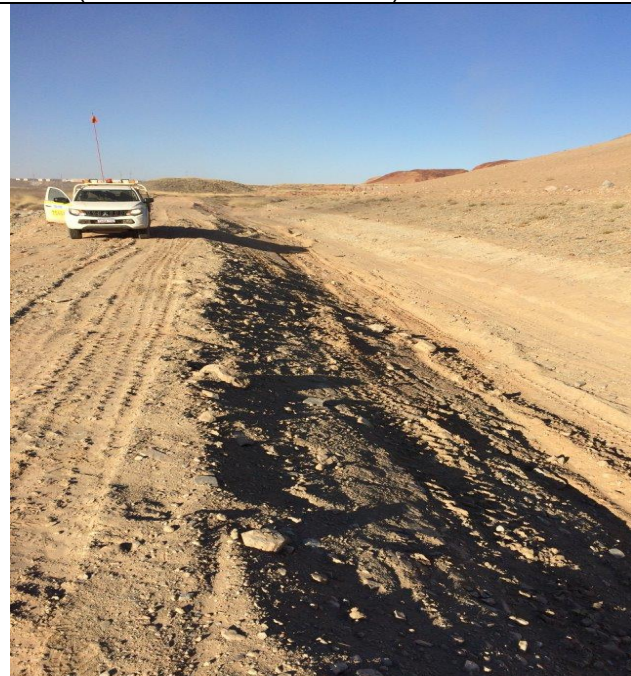
Plate 3 – Bund construction along and at end of toe drains – Eastern Wall

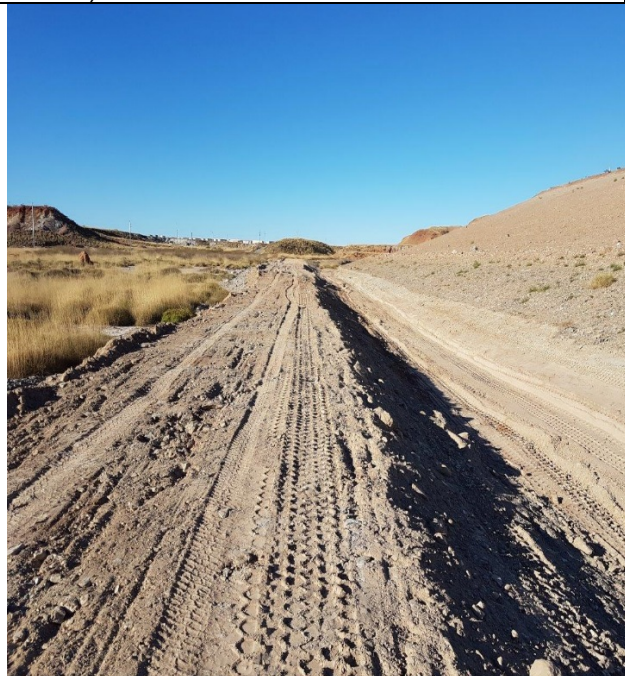
Plate 4 – Constructed bund and drain. Barrier to exclude further topsoil entering toe drain.

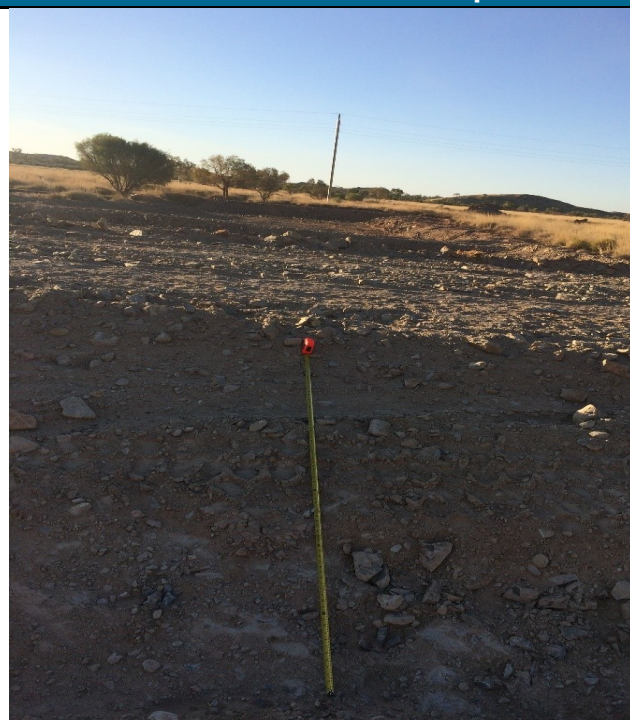
Plate 5 – Depth of construction of toe drain wall at location of erosion breach (sediment basin directly in front to provide water flow from surrounding environment).

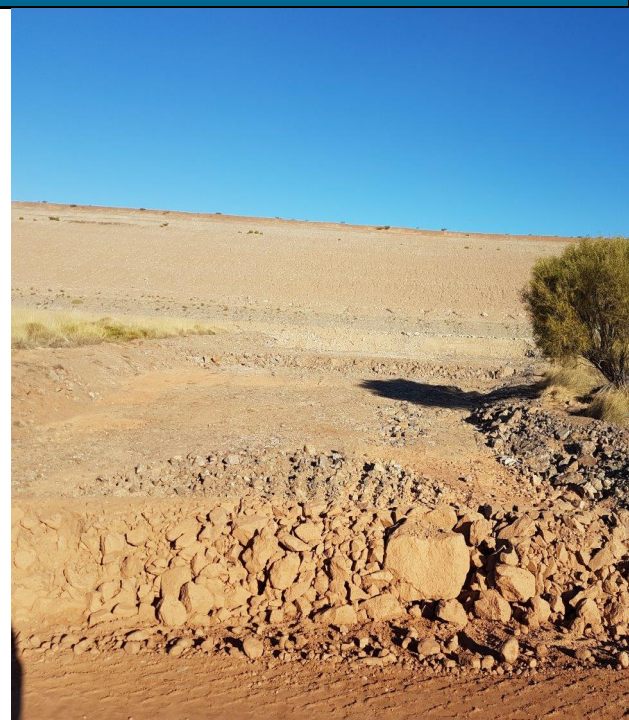
Plate 6 – Sediment basin constructed in front of toe drain (location of erosion breach) to remove excessive water flow away from toe drain infrastructure.

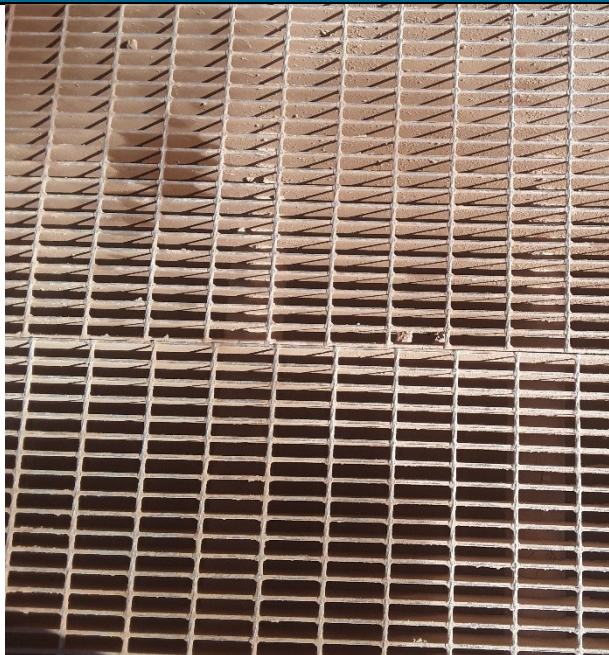
Section E – Details of Non-Compliance with Licence Condition			
Please use a separate page for each condition with which the licence holder was non-compliant at a time during the reporting period.			
Condition no:	Environmental Protection (Unauthorized Discharges) Regulations 2004	Date(s) of non-compliance:	19 April 2018
Details of non-compliance:			
Hydrocarbons from the bulk refueling facility discharged into the environment.			
What was the actual (or suspected) environmental impact of the non-compliance? NOTE – please attach maps or diagrams to provide insight into the precise location of where the non-compliance took place.			
Hydrocarbon discoloration was observed on the soil around the vicinity of the mesh bund, with inadequate protection from further contamination (Main Fuel Farm near the power generation plant).			
Cause (or suspected cause) of non-compliance:			
Hydrocarbons have spilled into the surrounding environment, contaminating soil material.

Plate 1 – Cleaned out grate under fuel supply hose.

Action taken to mitigate any adverse effects of non-compliance and prevent recurrence of the non-compliance:			
All sumps were cleaned out of soil and liquid, with capacity returned. Regular inspections and maintenance of the facility was enacted. Spill kits were refilled with absorbents (see photos below), with site notices provided to staff on the importance of maintaining a clean and contamination free fuel refilling environment. A concrete impermeable pad was constructed at all three fill points across the fuel farm in February/March (see photos below)

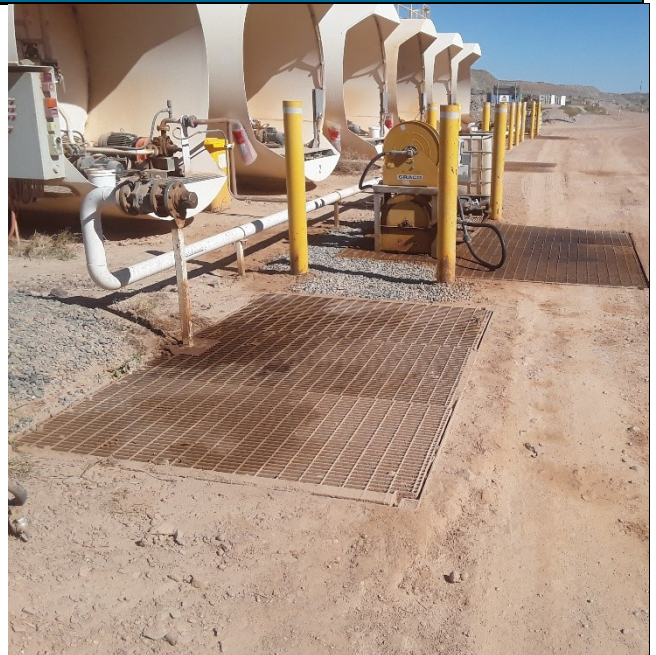
Plate 2 – Fuel farm after contaminated soil removed, signs of staining and potential contamination remain.

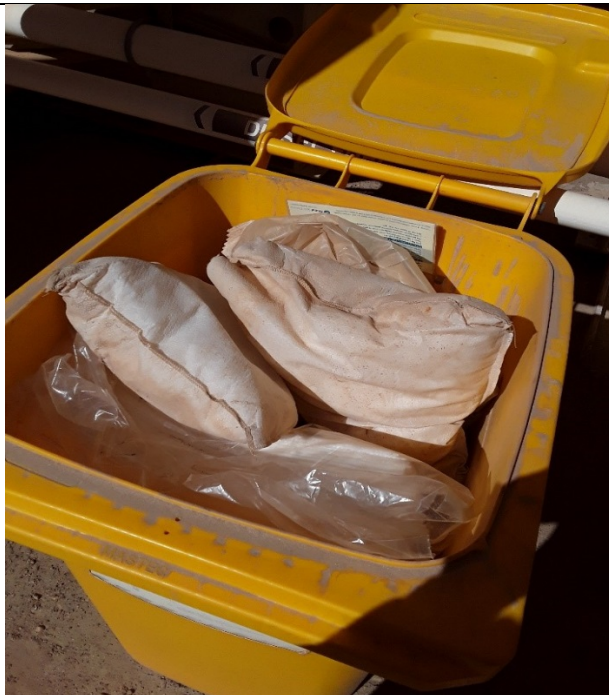
Plate 3 – Spill kits refilled and replaced.

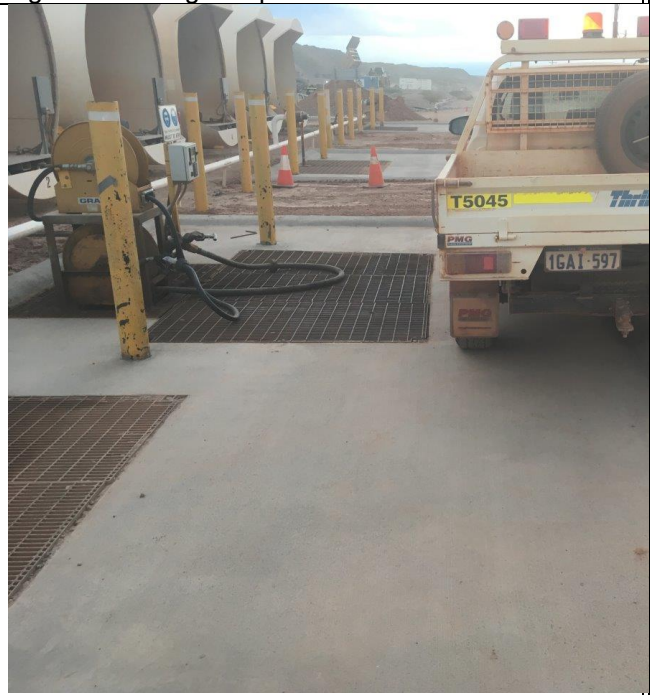
Plate 4 – Impermeable concrete bunding installed at all three fill-up points at fuel farm.
