Annual Audit Compliance Report Form

Environmental Protection Act 1986, Part V Division 3

Section A – Licence details			
Licence number:	8676/2012/1	Licence file number:	201002666-3
Licence holder name:	AngloGold Ashanti Australia Limited		
Trading as:	N/A		
ACN:	008 737 424		
Registered business address:	Level 10 140 St Georges Terrace PERTH WA 6000		
Reporting period:	01/01/2019 to 31/12/2019

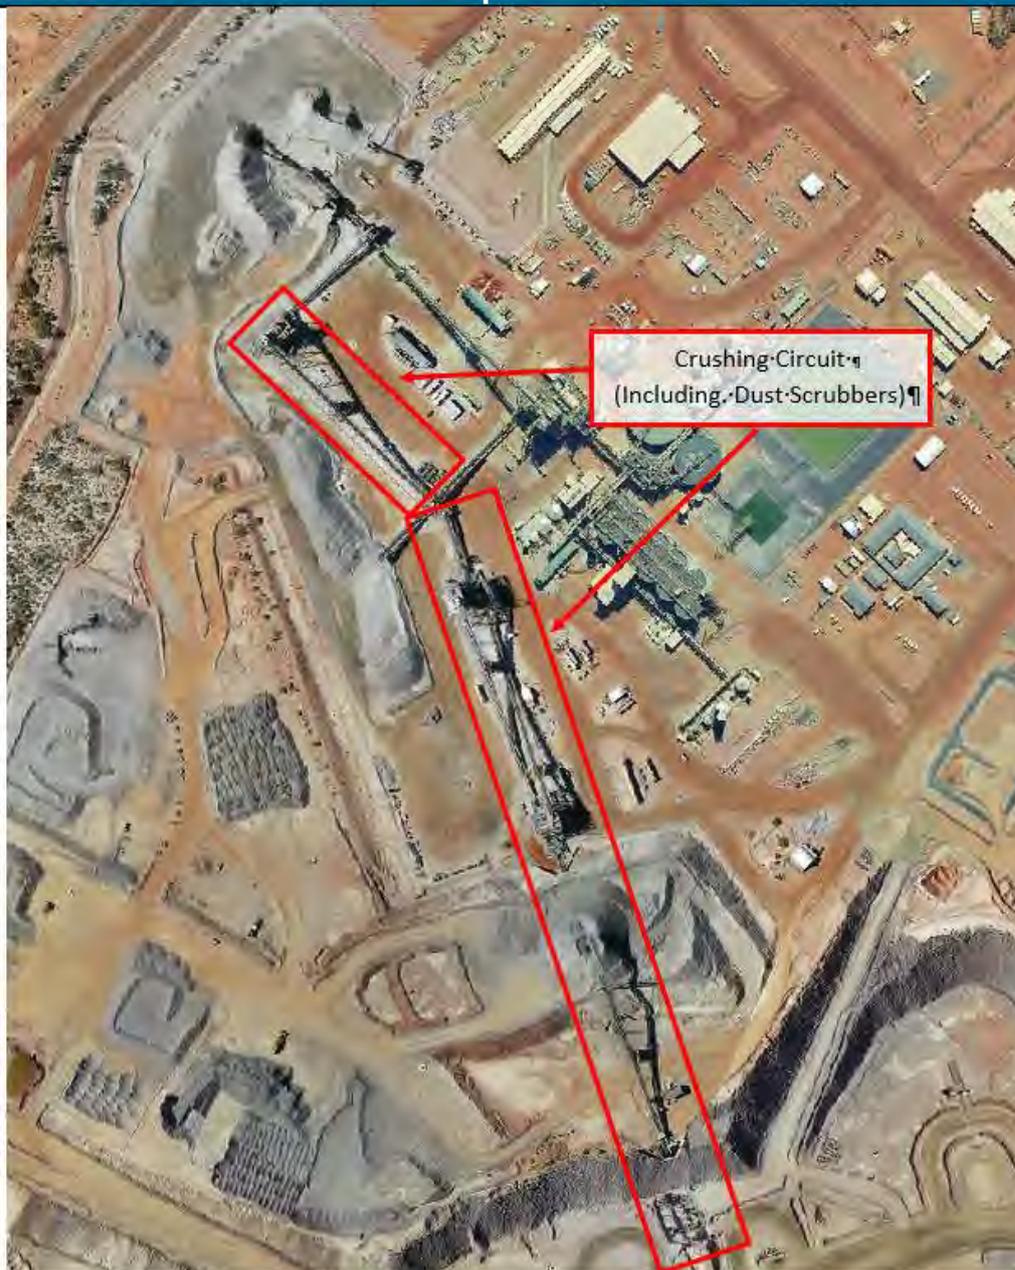
What was the actual (or suspected) environmental impact of the non-compliance?			
NOTE – please attach maps or diagrams to provide insight into the precise location of where the non-compliance took place.			
DUST SCRUBBERS			
<ul style="list-style-type: none"> • Due to the physical location of this infrastructure within the broader disturbed footprint, there has been no observable impact to any environmental receptors, including vegetation (Figure 1).

Figure 1 – Location of Dust Scrubbers within TGM Processing Plant

- The spare parts held on site were not correct and there was a delay in sourcing the correct components.

- Review and update of Planned Maintenance tasks for Dust Scrubbers to improve reliability and asset integrity.
- Review of onsite holdings of critical spares for Dust Scrubber components.

These reviews occurred during Q1 and Q2 of 2019, Q3 and Q4 saw a significant increase in Dust Scrubber Reliability.

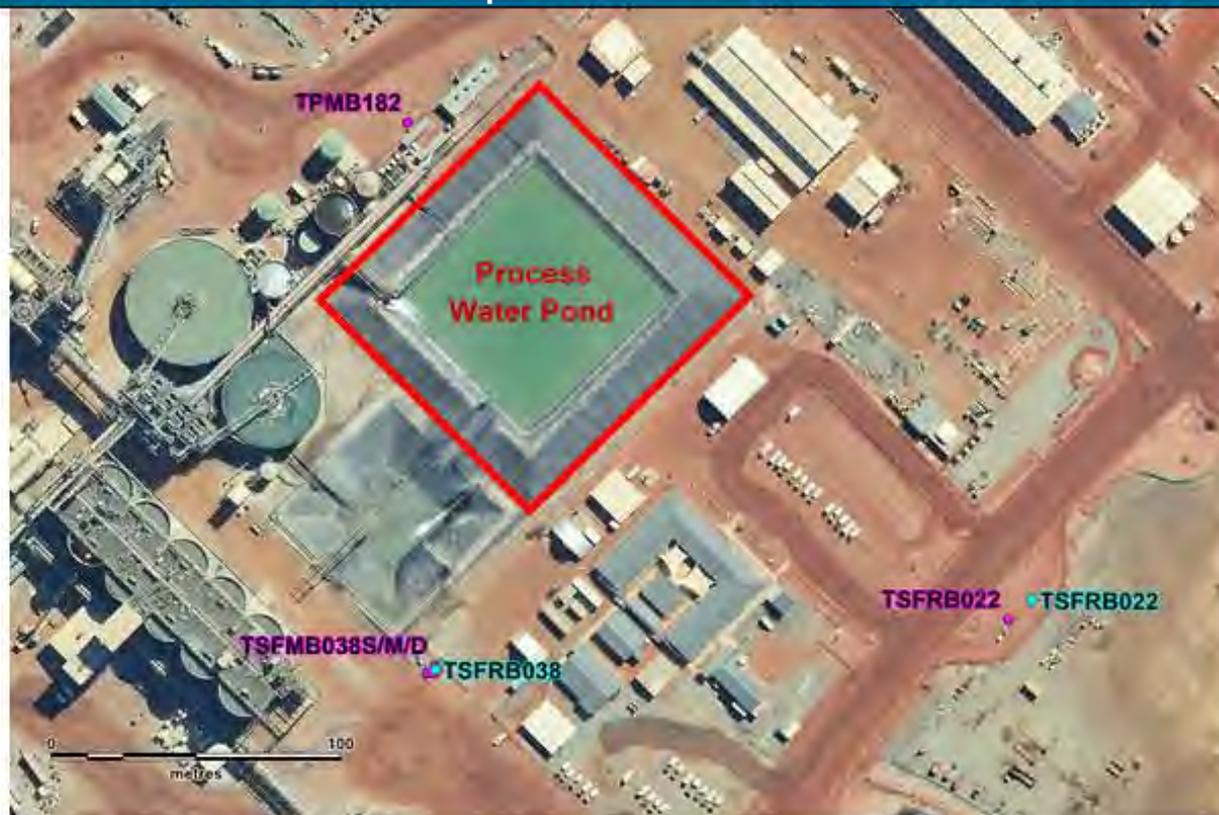
- Localised detection of very low levels of WAD Cyanide in the groundwater environment are not anticipated to have any detrimental impact on the existing saline to hypersaline groundwater regime. There is no known beneficial use of the groundwater in the vicinity of the TGM operation. The Maximum total cyanide concentration reported was 0.16 mg/L which is an order of magnitude below the ICMI generic compliance limit of 1.0 mg/L. As all abstracted water is returned to the plant for re-use in the processing system, there is limited environmental impact associated with these low-level concentrations of cyanide in groundwater.

Figure 2 – Process Water Pond and Monitoring and Recovery Bore Locations

- Suspected failure in the integrity of both the primary and secondary HDPE pond liners in specific areas of the Process Water Pond.

- Initiated project to take the Process Water Pond offline and inspect the pond liners and complete repairs as required.
- At the time of reporting, the Process Water Pond is currently being dredged and the TGM Projects team are installing the required pipework to enable the pond to be taken offline for repairs.

- Recovery bores installed to the south (TSFRB038) and east of the Process Water Pond (TSFRB022) serve a dual purpose in dewatering the aquifer immediately surrounding the PWP, as well as regional mounding associated with the TSF.

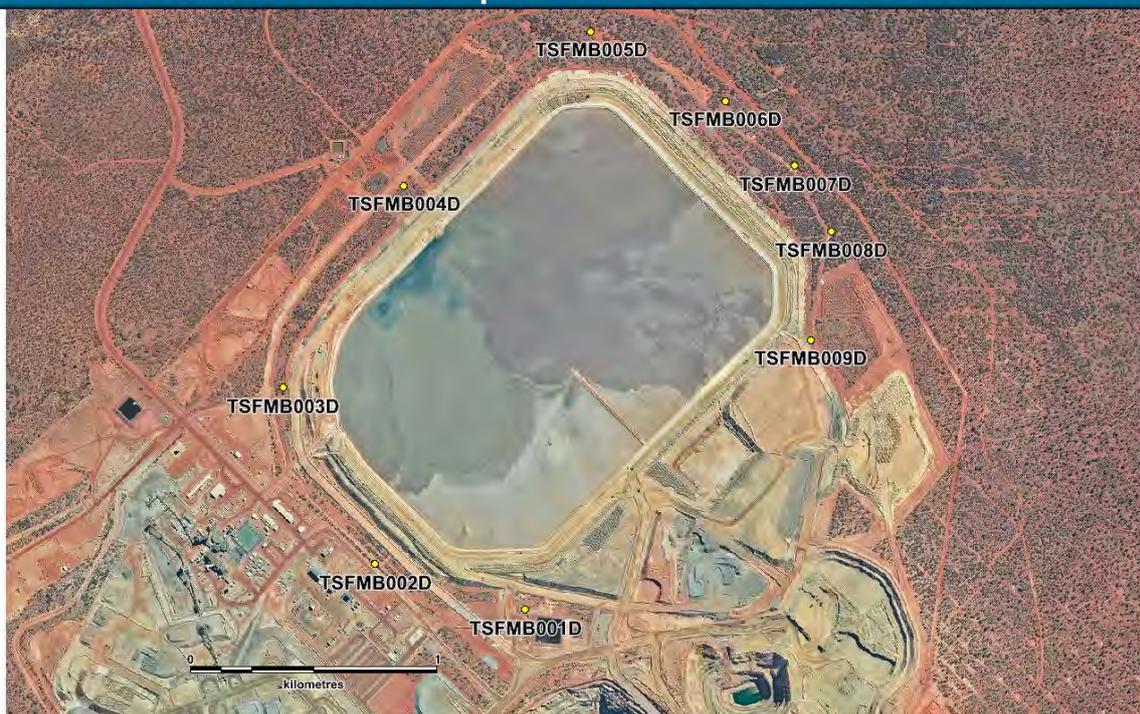
- Localised changes in groundwater quality are not considered to have had any detrimental impact to environmental values. The existing groundwater environment is typically saline to hypersaline and has no known beneficial users.
- Groundwater levels surrounding the TSF were observed to rise in localised areas during the reporting period. Increases in groundwater level were not observed to have any impacts on environmental receptors, including vegetation.
 - Monitoring of vegetation condition in proximity to operational areas has not identified any impacts to vegetation health associated with changes in groundwater quality or groundwater levels.

Figure 3 – TSF Monitoring Bore Locations

- The cause/s of the localised change in groundwater levels and quality from the TSF have been attributed to the increased hydraulic head within the TSF during the reporting period and suspected failure of the compacted clay liner.

- Ongoing groundwater monitoring of water levels and water quality around the TSF.
- Ongoing implementation of the Seepage Mitigation Project to install recovery bores in target areas around the perimeter of the TSF. During the reporting period the following changes were made to the TSF recovery bore network:
 - Five additional recovery bores installed on the southern side of TSF;
 - Five additional recovery bores installed on the western side of the TSF;
 - Two additional recovery bores installed on the northern side of the TSF; and
 - Two inefficient recovery bores were also decommissioned.

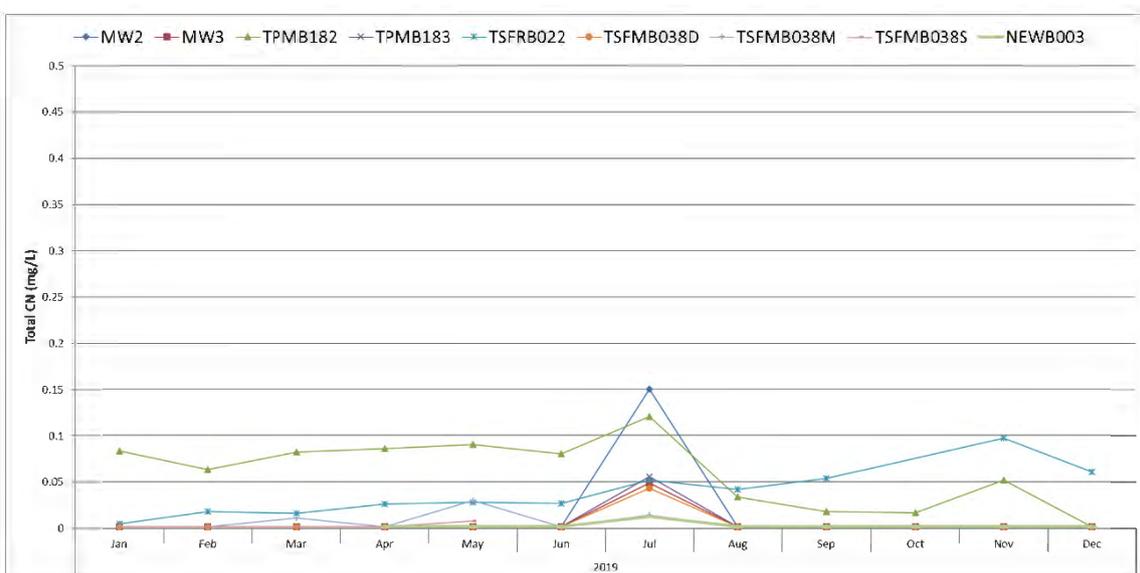
- Three nested monitoring bores (TSFMB038 S, M, D) were installed adjacent to recovery bore TSFRB038 at the south east corner of the Event Pond. The deeper aquifer has been drawn down by approximately 7 m over the reporting period (TSFMB038 M and D), while the shallow aquifer has been completely dewatered from August 2019 onwards, with TSFMB038S becoming dry. This coincides with a sharp decrease in the total cyanide concentrations reported in TPMB182 which is screened across the shallow and saprolite aquifers.

Figure 4 – Total Cyanide in Processing Plant and Recovery Bores

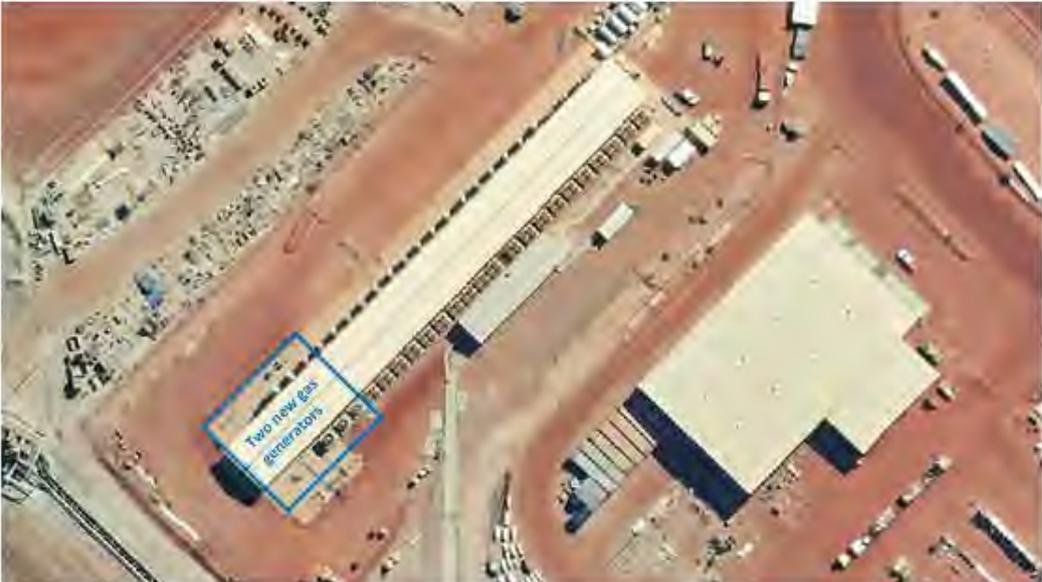
What was the actual (or suspected) environmental impact of the non-compliance?			
<p>NOTE – please attach maps or diagrams to provide insight into the precise location of where the non-compliance took place.</p> <p>No environmental impact will have occurred due to this non-compliance as the two new generators are the same make and model as those previously installed at the TGM power station. The new generators are expected to demonstrate an equivalent range of emissions discharge and further emissions testing is not proposed.</p> <p>In addition to point source emissions from the new generator exhaust stacks (approximate locations are shown in Figure 5), fugitive noise emissions will occur. However, there are no external receptors near the power station.</p>

<p>Figure 5 – Location of New Gas Generators</p>

Cause (or suspected cause) of non-compliance:	
Requirements of the Prescribed Premises Licence Amendment were not communicated to the Vendor and not incorporated into the Scope of Work and limitations around commissioning.	
Action taken to mitigate any adverse effects of non-compliance and prevent recurrence of the non-compliance:	
<p>Actions undertaken include:</p> <ul style="list-style-type: none"> An internal investigation is in progress, including discussions as to the mechanism for incorporating the regulatory requirements associated with the installation of the final generator permitted under the current Licence. <p>Actions to be undertaken include:</p> <ul style="list-style-type: none"> Communication of regulatory reporting requirements to be built into future tender packages for the third generator install scope. 	
Was this non-compliance previously reported to DWER?	
<input checked="" type="checkbox"/> Yes, and
