## Annual Audit Compliance Report Form

Section A – Licence details			
Licence number:	L8676/2012/1	Licence file number:	2012/002666-3
Licence holder name:	AngloGold Ashanti Australia Limited		
Trading as:	N/A		
ACN:	008 737 424		
Registered business address:	Level 10 140 St Georges Terrace PERTH WA 6000		
Reporting period:	01/01/2023 to 31/12/2023

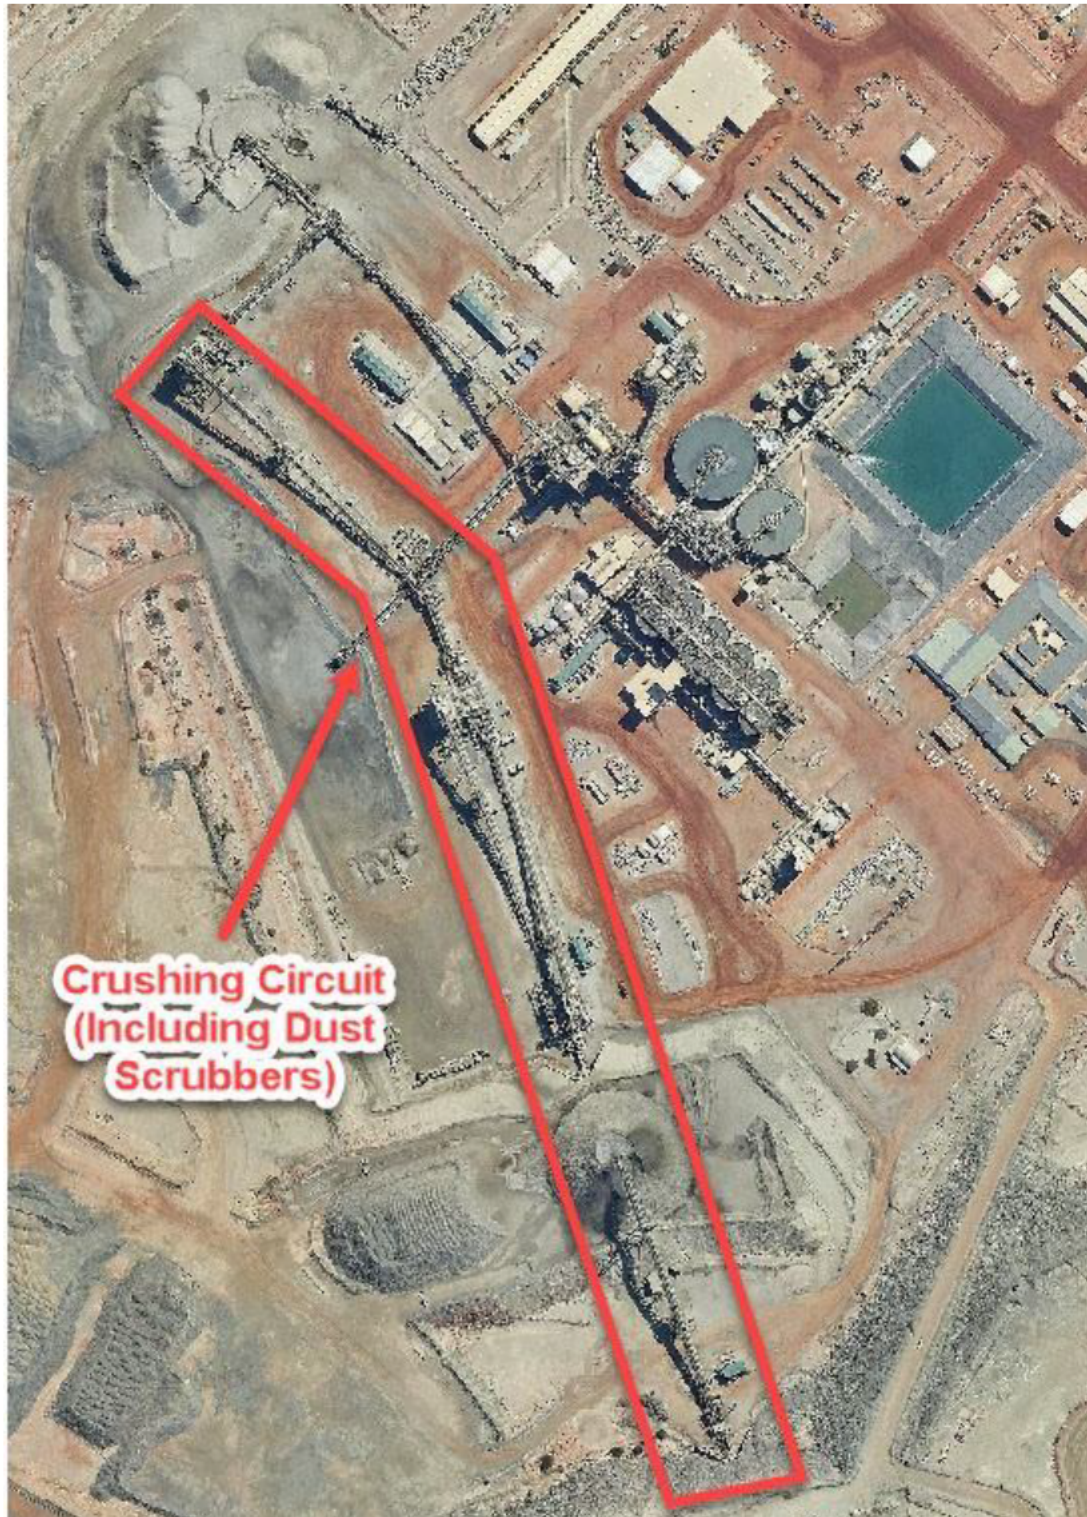
- **Dust Scrubbers within the processing plant;**
  - Dust Scrubbers within the crushing circuit of the processing plant experienced a delayed return to service following frequent blockages and shortage of parts during Q3 and Q4 of the reporting period.
- **Tailings Storage Facility.**
  - The operation of the TSF has been observed to have a localised impact to groundwater quality and groundwater levels historically and during the reporting period.

- Due to the physical location of this infrastructure within the broader disturbed footprint, there has been no observable impact on any environmental receptors, including vegetation (Figure 1).

Figure 1: Location of Dust Scrubbers within the TGM Processing Plant

- The unexpected downtime for the dust scrubbers was due to frequent blockages and shortage of parts.

Section E – Details of non-compliance with licence condition	
Action taken to mitigate any adverse effects of non-compliance and prevent recurrence of the non-compliance:	
<p><b>DUST SCRUBBERS</b></p> <p>Actions completed during 2023 include:</p> <ul style="list-style-type: none"> <li>• Maintenance plan improvements                             <ul style="list-style-type: none"> <li>○ 3 weekly online services</li> <li>○ 4 weekly online services</li> <li>○ 6 monthly services and inspections</li> <li>○ 12 monthly services and inspections</li> </ul> </li> <li>• Parts held as per Original Equipment Manufacturer critical spares lists</li> </ul> <p>Preventative actions for 2024:</p> <ul style="list-style-type: none"> <li>• Secondary screen scrubber design change</li> <li>• Maintenance strategy review by reliability engineer based on failures sustained</li> <li>• Stores stock parts review</li> </ul> <p><b>TAILINGS STORAGE FACILITY</b></p> <p>Actions undertaken during 2023 include:</p> <ul style="list-style-type: none"> <li>• Ongoing groundwater monitoring of water levels and water quality around the TSF.</li> <li>• Continuous monitoring of pore pressure and water levels within the TSF using Vibrating Wire Piezometers (VWPs)</li> <li>• Ongoing optimisation of the borefield by regular casing inspection and general testing for iron bacteria.</li> <li>• Ongoing implementation of the Seepage Mitigation Project:</li> <li>• Three new bores (TSFRB086, TSFRB091 and TSFRB092) became operational and were added to the network of groundwater recovery bores around the perimeter of the TSF.</li> <li>• A seismic reflection survey was undertaken during mid-2023 to better define the structural geology of the area and to identify new targets for water exploration. Drilling later in the year resulted in the construction of 5 additional production bores (TSFRB093; TSFRB094; TSFRB095; TSFRB096; TSFRB098) and 1 monitoring bore. Bores are planned to be equipped in the first quarter of 2024.</li> <li>• Earthworks were carried out within the TSF to install 6 monitoring bores at level 372mRL. Drilling and installation of the monitoring bores is planned for March 2024.</li> </ul>

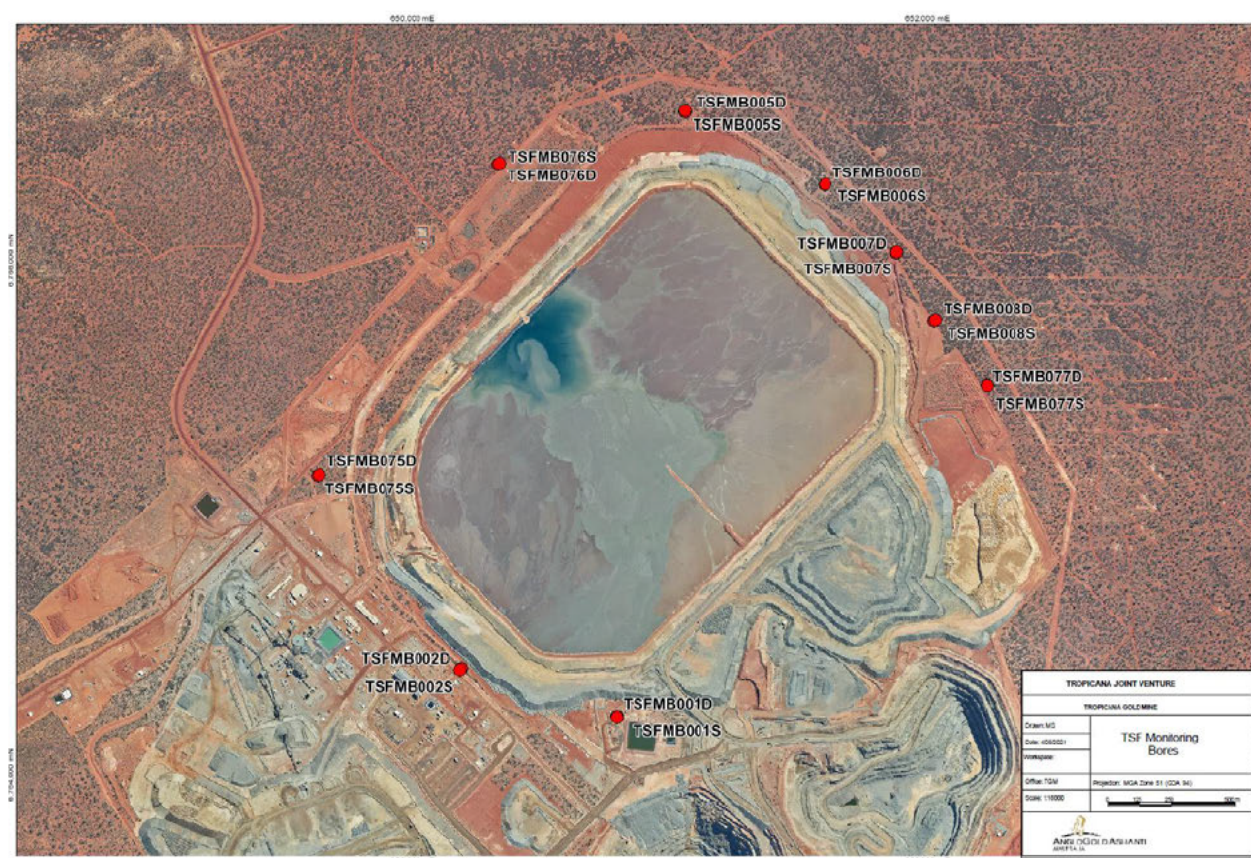
- Localised changes in groundwater quality are not considered to have had any detrimental impact to environmental values. The existing groundwater environment is typically saline to hypersaline and has no known beneficial users. Monitoring bore locations are shown in Figure 2.
- Groundwater levels surrounding the TSF were observed to be mainly stable. However, some have continued to slowly rise during the reporting period. The current groundwater levels were not observed to have any impacts on environmental receptors, including vegetation.
  - Monitoring of vegetation condition in proximity to operational areas has not identified any impacts to vegetation health associated with changes in groundwater quality or groundwater levels.

Figure 2: TSF Monitoring Bore Locations

- The cause/s of the localised change in groundwater levels and quality from the TSF have been attributed to the hydraulic head within the TSF and suspected increased permeability of the compacted clay liner compared to design.

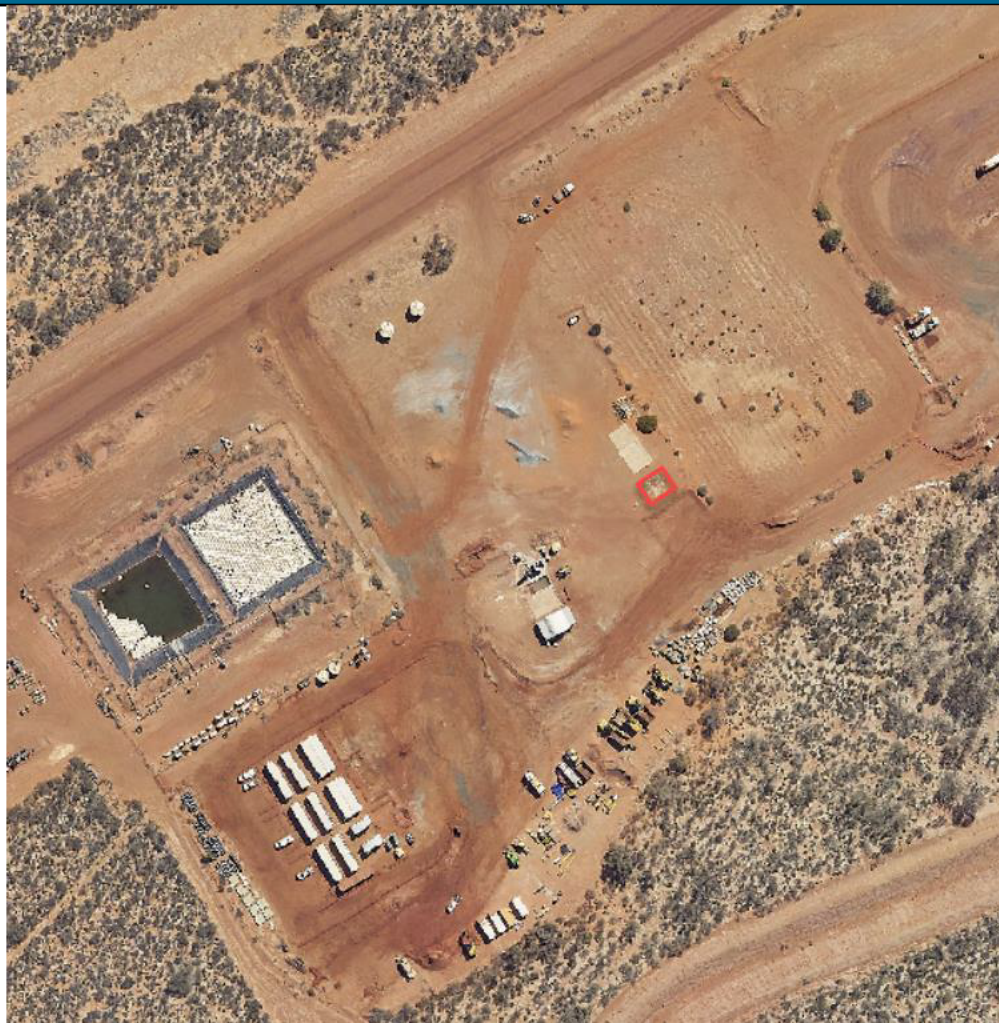
Section E – Details of non-compliance with licence condition			
Please use a separate page for each condition with which the licence holder was non-compliant at a time during the reporting period.			
Condition no:	<b>16.</b> The Licence Holder must ensure that any water draining from the concrete batch plant is contained within a lined slurry pit, settling pond, or silt trap.	Date(s) of non-compliance:	Various times throughout the reporting period.
Details of non-compliance:			
The temporary batch plant slurry pit was not lined.			
What was the actual (or suspected) environmental impact of the non-compliance?			
<b>NOTE</b> – please attach maps or diagrams to provide insight into the precise location of where the non-compliance took place.			
No environmental impact has been observed. The area this was located is compacted and there was minimal volume that went to this pit (Figure 3).

*Figure 3: Location of temporary batch plant - laydown area*

Not constructing an adequately lined slurry pit, settling pond, or silt trap on initial installation of temporary batch plant.

The temporary batch plant is no longer in use. Resources have been allocated to construct a compliant settling pond for when this facility resumes operation.
