## Annual Audit Compliance Report Form

Section A – Licence details			
Licence number:	L8676/2012/1	Licence file number:	2012/002666-3
Licence holder name:	AngloGold Ashanti Australia Limited		
Trading as:	N/A		
ACN:	008 737 424		
Registered business address:	Level 10 140 St Georges Terrace PERTH WA 6000		
Reporting period:	01/01/2024 to 31/12/2024

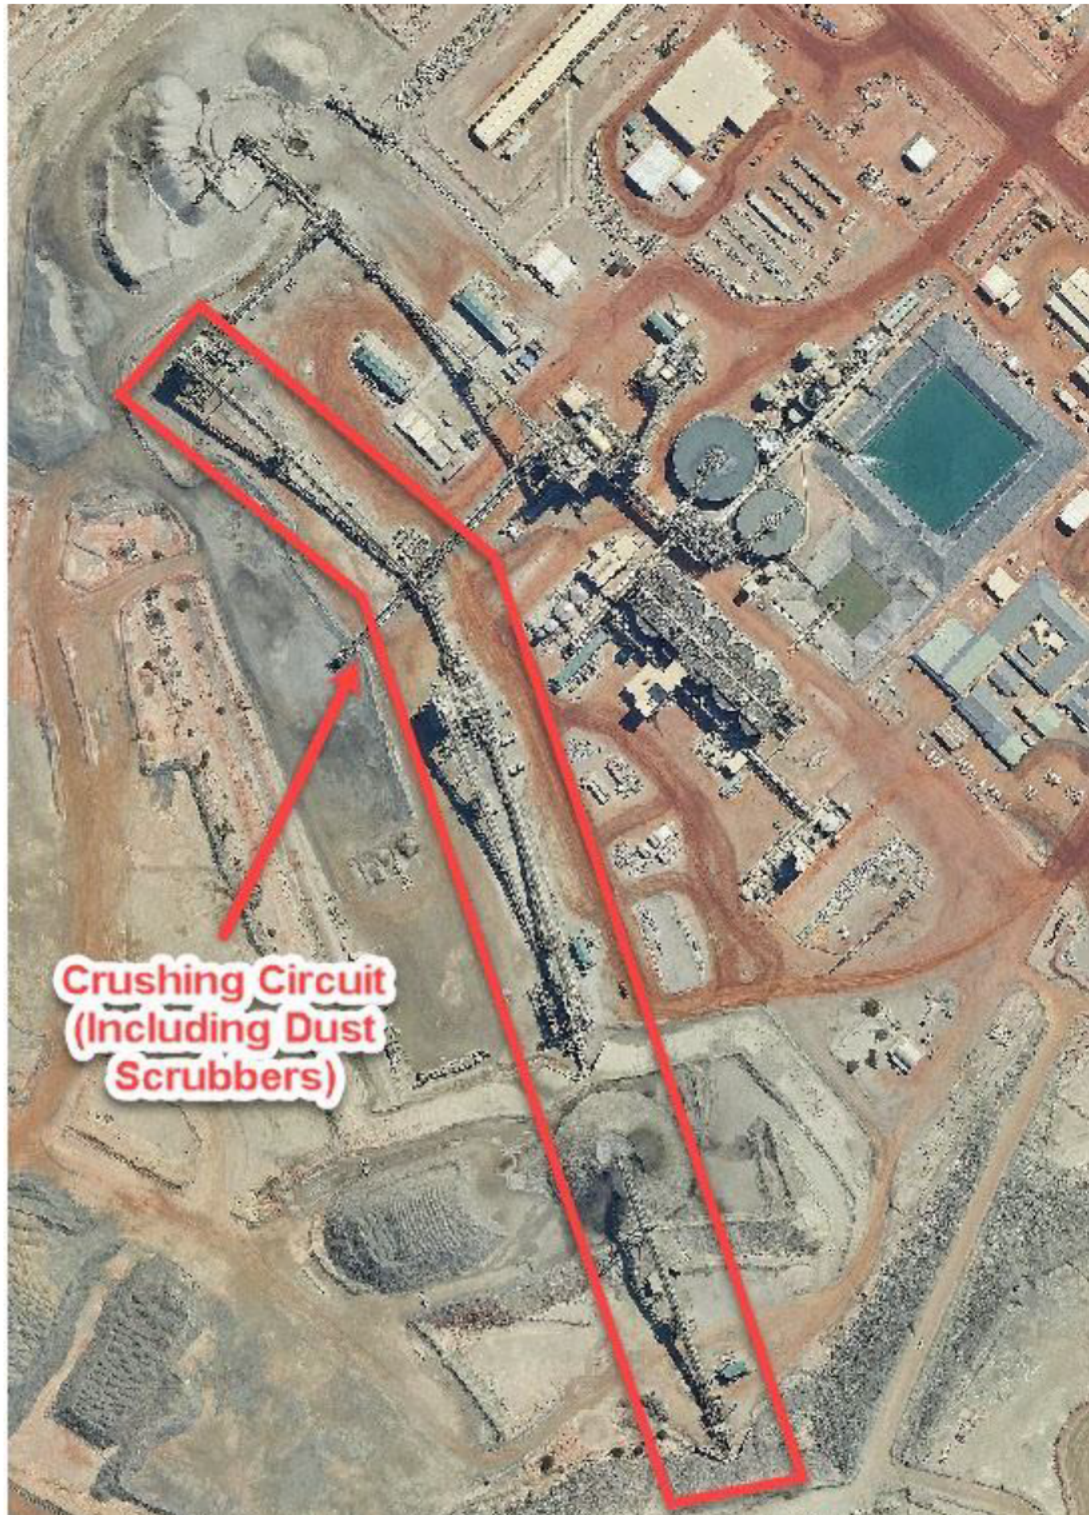
Figure 1: Location of Dust Scrubbers within the TGM Processing Plant

DUST SCRUBBERS

- Due to the location of this infrastructure within the broader disturbed footprint, there has been no observable impact on any environmental receptors, including vegetation (Figure 1).

- The cause of downtime outside of normal maintenance scheduling has been attributed to delayed return to service following blockages and a shortage of parts through the supply chain during the reporting period.

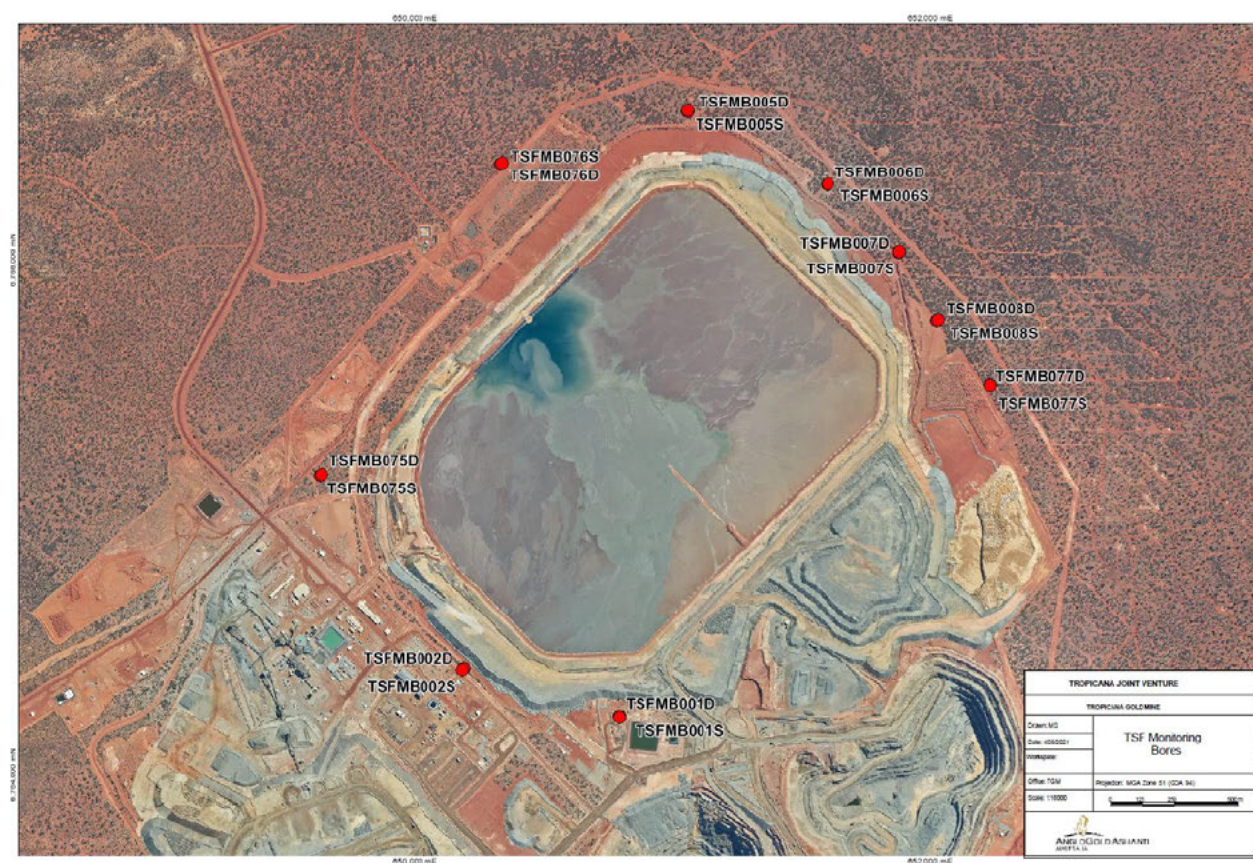
Figure 2: TSF Monitoring Bore Locations

- Localised changes in groundwater quality are not considered to have had any detrimental impact to environmental values. The existing groundwater environment is typically saline to hypersaline and has no known beneficial users. Monitoring bore locations are shown in Figure 2.

- Groundwater levels surrounding the TSF were observed to have risen in many of the TSF monitoring bores as a result of a significant volume of rainfall falling in March 2024 (325 mm of rainfall in 4 days). However, the current levels are stabilising back to pre-rainfall event levels. The current groundwater levels were not observed to have any impacts on environmental receptors, including vegetation.

- Monitoring of vegetation condition, in proximity to operational areas, undertaken by Ecological has not identified any impacts to vegetation health associated to changes in groundwater quality or groundwater levels.

Section E – Details of non-compliance with license condition
<p><b>TAILINGS STORAGE FACILITY</b></p> <ul style="list-style-type: none"> <li>The cause/s of the localised change in groundwater levels and quality from the TSF have been attributed to the hydraulic head within the TSF and suspected increased permeability of the compacted clay liner compared to design, this is under review by the AGAA tailings experts.</li> </ul>
<p>Action taken to mitigate any adverse effects of non-compliance and prevent recurrence of the non-compliance:</p>
<p><b>DUST SCRUBBERS</b></p> <p>Issues with reliability of the dust scrubbers is ongoing and has been reported in the AACR in the 2022 and 2023 reporting periods. The Tropicana Gold Mine (TGM) continues to work towards a solution and to rectify the issue.</p> <p>Actions completed during 2024 include:</p> <ul style="list-style-type: none"> <li>Maintenance plan improvements <ul style="list-style-type: none"> <li>3 weekly online services</li> <li>4 weekly online services</li> <li>6 monthly services and inspections</li> <li>12 monthly services and inspections</li> </ul> </li> <li>Parts held as per Original Equipment Manufacturer critical spares lists</li> </ul> <p>Preventative actions for 2025:</p> <ul style="list-style-type: none"> <li>Secondary screen scrubber design change</li> <li>Maintenance strategy review by reliability engineer based on failures sustained</li> <li>Stores stock parts review</li> </ul> <p><b>TAILINGS STORAGE FACILITY</b></p> <p>Actions undertaken during 2024 include:</p> <ul style="list-style-type: none"> <li>Ongoing groundwater monitoring of water levels and water quality around the TSF.</li> <li>Continuous monitoring of pore pressure and water levels within the TSF using Vibrating Wire Piezometers (VWPs)</li> <li>Ongoing optimisation of the borefield by regular casing inspection and general testing for iron bacteria.</li> <li>Ongoing implementation of the Seepage Mitigation Project:</li> <li>An ArrowMag geophysical survey was undertaken during September 2024 and combined with previous electromagnetic and structural data to identify new groundwater targets north and south of the TSF.</li> <li>The survey was followed by the drilling of 16 groundwater exploration holes at 5 locations during October 2024. All holes were drilled to a depth of ~ 100 m, with airlift yields ranging from negligible up to 17 m<sup>3</sup>/hr.</li> <li>As such, 3 holes were selected for reaming and installation of permanent monitoring bores. Bore TSFMB067s was constructed with 50 mm casing to a depth of 24m. Neighbour TSFMB067_deep reaches a depth of 53m. TSFMB099 was initially intended to be a production bore, but due to its low yields, it was setup as a 200 mm monitoring bore, to a depth of 100m.</li> <li>Production bore TSFRB087 was installed on the southern side of the TSF to intercept seepage. The bore is planned to be equipped and connected to the dewatering network by mid-2025.</li> <li>Planning and organisation of permits is planned during 2025 for future groundwater exploration and additional drilling at the Kamikaze borefield.</li> <li>AGAA tailings experts will undertake a review of the TSF liner integrity in 2025.</li> </ul>
