Annual Audit Compliance Report Form

Section A – Licence details			
Licence number:	L8676/2012/1	Licence file number:	2012/002666-3
Licence holder name:	AngloGold Ashanti Australia Limited		
Trading as:	N/A		
ACN:	008 737 424		
Registered business address:	Level 10 140 St Georges Terrace PERTH WA 6000		
Reporting period:	01/01/2022 to 31/12/2022

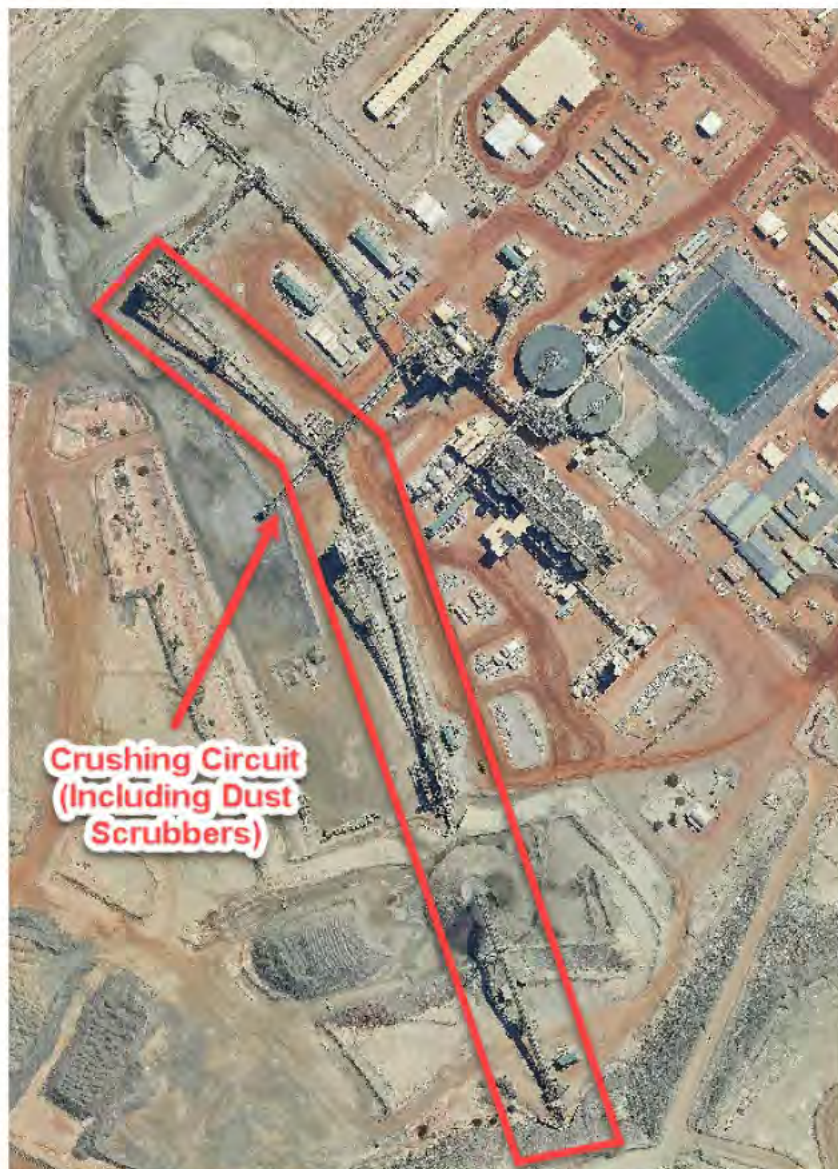
Figure 1 Location of Dust Scrubbers within the TGM Processing Plant

- Due to the physical location of this infrastructure within the broader disturbed footprint, there has been no observable impact on any environmental receptors, including vegetation (Figure 1).

- The unexpected downtime for the dust scrubbers was due to mechanical faults induced by material buildup on the fan blades.

- A review of the Scrubber system by a third-party contractor established items to reduce downtime.
- Items identified by the review have been implemented, and continued monitoring will establish the efficiency of the improvements;
 - Increased inspection regime,
 - Servicing and repairs to crushing and screening areas to reduce material build-up.

These reviews occurred during Q1 and Q2 of 2022, and Q4 saw a significant increase in Dust Scrubber Reliability.

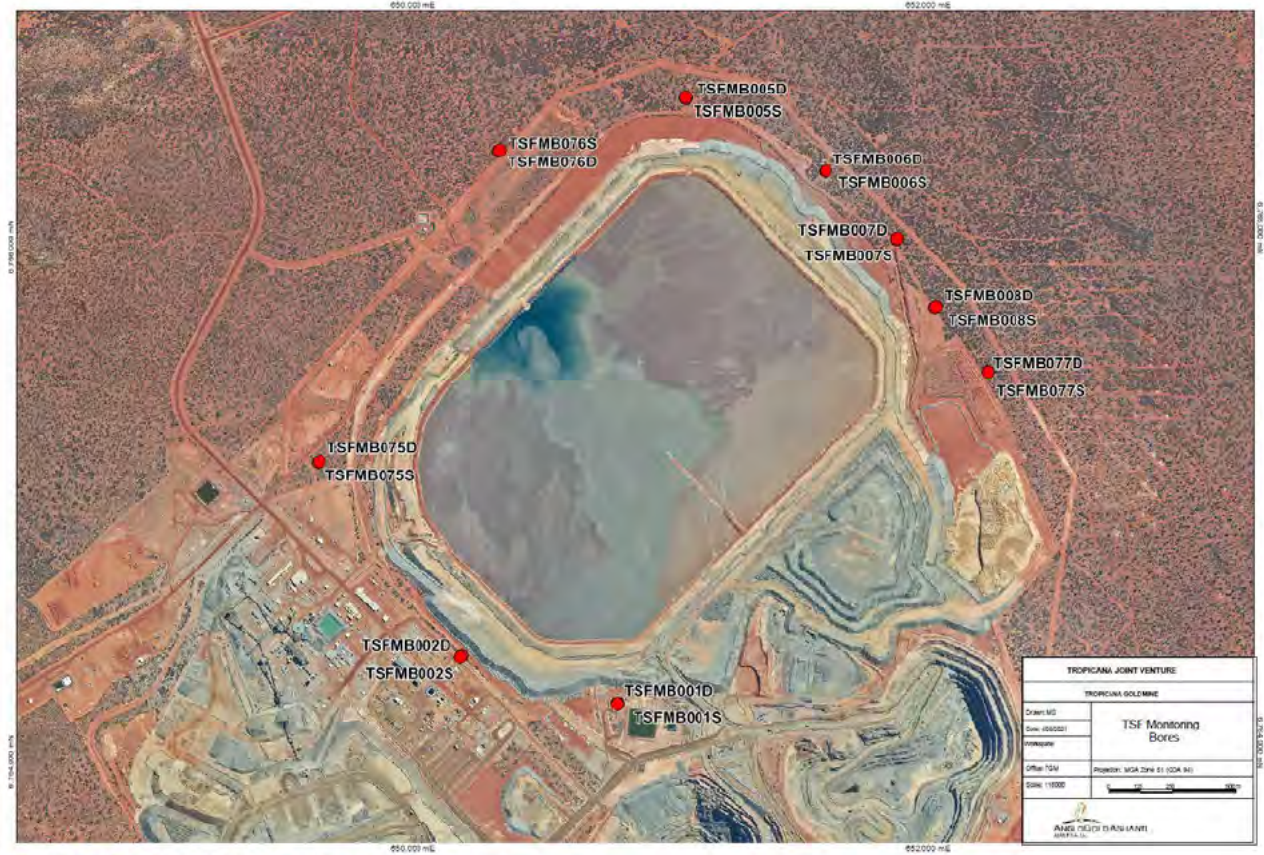
Figure 2 TSF Monitoring Bore Locations

- Localised changes in groundwater quality are not considered to have had any detrimental impact to environmental values. The existing groundwater environment is typically saline to hypersaline and has no known beneficial users.
- Groundwater levels surrounding the TSF were observed to stabilise and/or decline during the reporting period due to the ongoing implementation of the TGM Seepage Mitigation Project. The current groundwater levels were not observed to have any impacts on environmental receptors, including vegetation.
 - Monitoring of vegetation condition in proximity to operational areas has not identified any impacts to vegetation health associated with changes in groundwater quality or groundwater levels.

- The cause/s of the localised change in groundwater levels and quality from the TSF have been attributed to the hydraulic head within the TSF and suspected increased permeability of the compacted clay liner compared to design.

- Ongoing groundwater monitoring of water levels and water quality around the TSF.
- Ongoing implementation of the Seepage Mitigation Project. At the end of 2022, 29 groundwater recovery bores were in operation around the perimeter of the TSF.

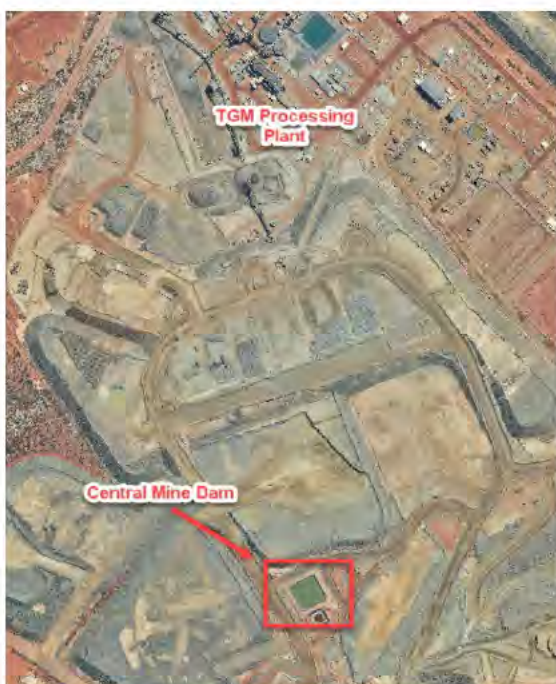
Figure 3 Central Mine Dam

- The Central Mine Dam overtopped on 2nd June 2022, releasing saline/hypersaline water to previously disturbed land within the active mining area. The release was contained and immediately cleaned up after the incident.

No adverse environmental effects have resulted from the operational freeboard non-compliance. The Central Mine Dam shown in Figure 3, lies within the active mine area, due to the physical location of this infrastructure within the broader disturbed footprint, there has been no observable impact to any environmental receptors.

Section E – Details of non-compliance with licence condition	
Cause (or suspected cause) of non-compliance:	
<p>The cause of the overtopping event at the Central Mine Water Dam (CMD) has been attributed to Operator Error and a malfunction of the auto-valve linked to high level alarms and sensors on the dam:</p> <ul style="list-style-type: none"> • High saline water level alarms were acknowledged by Mill control however were not escalated to the department responsible for maintaining the CMD. • The auto valve linked to the high-level alarms attempted to close but faulted and did not close, allowing water to keep flowing into the CMD. 	
Action taken to mitigate any adverse effects of non-compliance and prevent recurrence of the non-compliance:	
<p>Actions completed during the 2022 reporting period include:</p> <ul style="list-style-type: none"> • Faulty Auto valve replaced. • Revised the procedure for the escalation process from mill control to the dewatering team when the high saline water level alarm initiates. • Implementation of the Dewatering team conducting monthly inspections on the Mine water dams and valves.
