Annual Audit Compliance Report Form

Environmental Protection Act 1986, Part V

Section A – Licence Details			
Licence number:	L9036/2017/1	Licence file number:	DER2017/000279
Licence holder:	Pilgangoora Operations Pty Ltd		
Trading as:	Pilbara Minerals Limited		
ACN:	095 384 491		
Registered address:	Level 2, 146 Colin St., West Perth, WA 6005		
Reporting period:	01/01/2024 to 31/12/2024

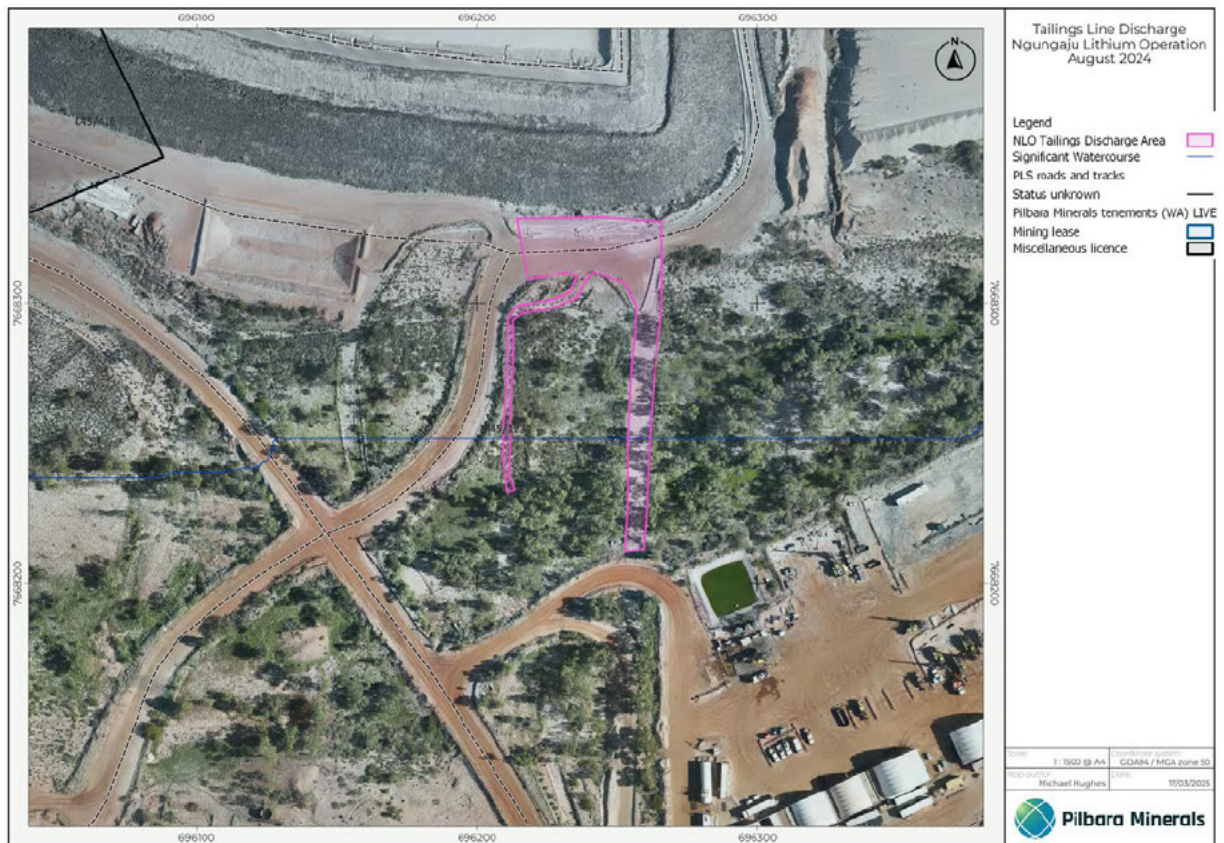
Section E – Details of Non-Compliance with Licence Condition			
Please use a separate page for each condition with which the licence holder was non-compliant at a time during the reporting period.			
Condition no:	1	Date(s) of non-compliance:	05/08/2024
Details of non-compliance:			
<p>Unauthorised discharge from NLO tailings pipeline</p> <p>A newly installed valve on the Tailings Storage Facility (TSF) pipeline developed a pinhole, which worsened over time, leading to a complete failure of the valve.</p> <p>Tails slurry began to escape from the pipeline at approximately 1200hrs and discharged into the surrounding area until the release was discovered at around 0400hrs by the Control room operator, who noted and reacted to the leak detection pressure differential alert.</p> <p>Upon investigation, the spill had followed the contour of the road, breached a gap in the windrow and discharged into the surrounding environment.</p>

What was the actual (or suspected) environmental impact of the non-compliance? NOTE – please attach maps or diagrams to provide insight into the precise location of where the non-compliance took place.			
No environmental impact – The spilled tailings reached the Southern Creek drainage line; however, water samples were sent to the lab, with laboratory results indicating compliance against the ANZECC guidelines. Vegetation has been monitored since the spill and has shown no sign of impact from the event.

- Flange bolt on pipeline valve was not tight enough
- Limited bunding along the pipeline corridor, allowed the spill to reach surrounding areas
- On Duty-Control room operator failed to adequately recognise the pressure drop alert within the process control system and did not respond in a timely manner.

- Water samples taken - laboratory results confirmed to be compliant against relevant guidelines
- Improvements to daily TSF inspection reports
- TSF tailings line and containment trench upgrades to be completed prior to NLO plant restart
- Upgrade of the leak-detection system to include an additional flowmeter installed on the end of the tails pipeline as well as the start of the line, in addition to the pump pressure system which is linked to the Control room with audible and visual alarms to identify differential changes
- Control room operator training
- Ongoing vegetation monitoring
