## Annual Audit Compliance Report Form

Section A – Licence details			
Licence number:	L9056/2017/1	Licence file number:	DER2017/000318
Licence holder name:	Pilgangoora Operations Pty Ltd		
Trading as:	Pilbara Minerals Pty Ltd		
ACN:	616 560 395		
Registered business address:	Level 2, 146 Colin Street, WEST PERTH WA 6005		
Reporting period:	01 / 07 / 23 to 30 / 06 / 24

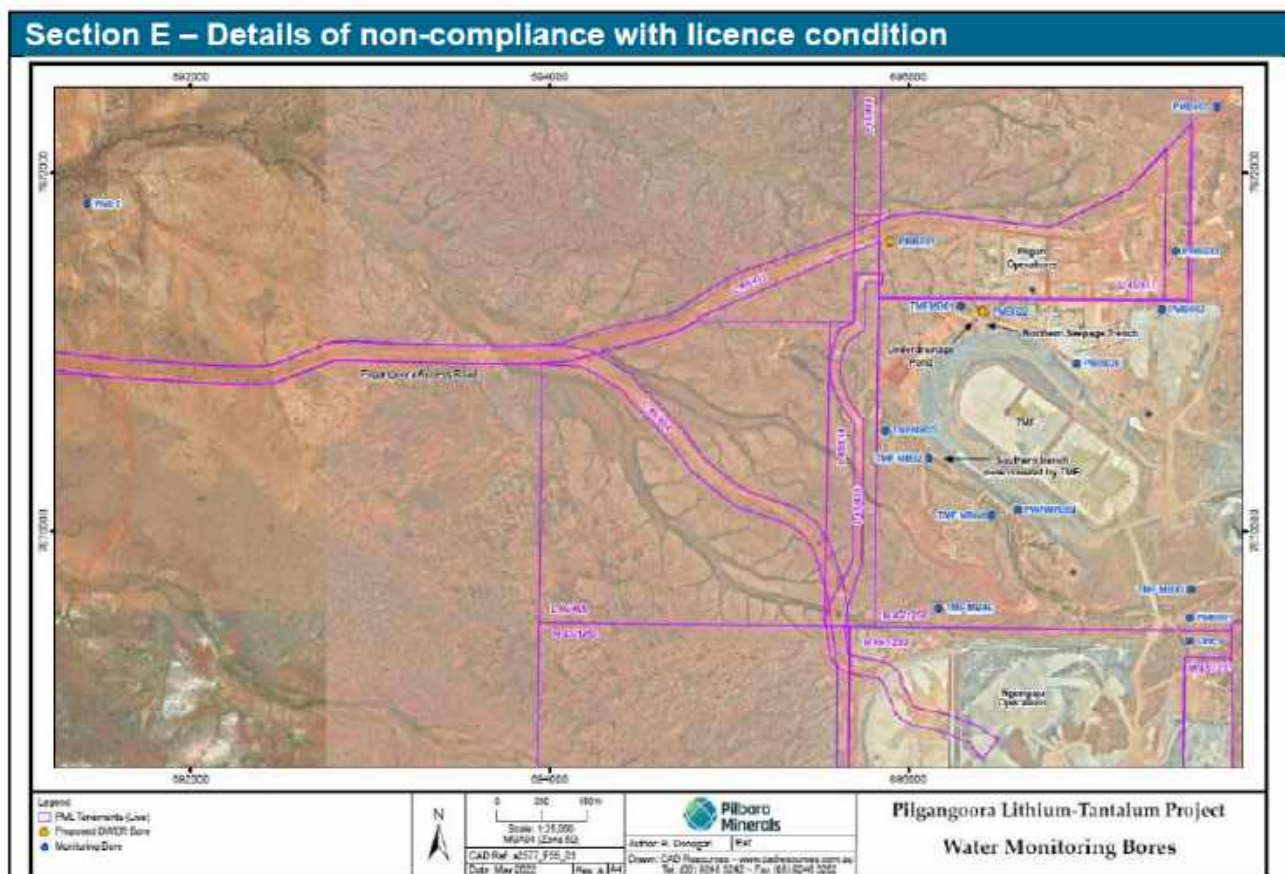
Figure 6: Location of TMF monitoring bores

Section E – Details of non-compliance with licence condition			
Please use a separate page for each condition with which the licence holder was non-compliant at a time during the reporting period.			
Condition no:	1	Date(s) of non-compliance:	Multiple
Details of non-compliance:			
<p>Standing Water Levels (SWL) for the Ambient groundwater monitoring bores TMFMB01, TMFMB02, TMFMB04, TMFMB05, PMB001 and PMB002 are at/or above the limit and trigger levels for operating licence L9056/2017/1.</p> <ul style="list-style-type: none"> <li>• <b>TMFMB01</b> has recorded a reading of 4.96mbgl for the month of April, 4.84mbgl for the month of May and 4.62mbgl for the month of June 2024, all exceeding the licence limit of 5mbgl.</li> <li>• <b>TMFMB02</b> has recorded multiple readings throughout the 2023 / 2024 reporting period, all exceeding the licence limit of 5mbgl (as per attachment 4 Condition 12 Ambient groundwater)</li> <li>• <b>TMFMB04</b> has recorded multiple readings throughout the 2023 / 2024 reporting period, all exceeding the licence trigger level of 5mbgl. (as per attachment 4 Condition 12 Ambient groundwater)</li> <li>• <b>TMFMB05</b> has recorded a reading of 3.26mbgl for the month of March, 4.29mbgl for the month of April and 3.48mbgl for the month of June 2024, all exceeding the licence trigger threshold of 5mbgl.</li> <li>• <b>PMB021</b> has recorded a reading of 4.80mbgl for the month of June, exceeding the licence limit of 5mbgl.</li> <li>• <b>PMB022</b> has recorded a reading of 4.65mbgl for the month of July (2023), 2.86mbgl for the month of March, 2.78mbgl for the months of April / May and 2.49mbgl for the month of June, all exceeding the licence limit of 5mbgl.</li> </ul> <p>Hydrographs for all trigger levels and quality exceedances are provided in Appendix 1. Refer to Attachment 4 Condition 12-Ambient Groundwater</p>

What was the actual (or suspected) environmental impact of the non-compliance?			
<p><b>NOTE</b> – please attach maps or diagrams to provide insight into the precise location of where the non-compliance took place.</p>			
No environmental impact has resulted from these elevations in groundwater.

Seepage from the Pilgan Tailings Management Facility (TMF) has resulted in mounding within close proximity to the facility. SWL fluctuations vary depending on which cell is receiving tailings, with levels increasing more in areas nearer to the active cell. Additionally, SWL is significantly affected by rainfall recharge, typically rising during the wet season and falling during the dry months. This combination of factors has led to SWL exceeding the established licence limits and trigger levels.

- Four new seepage recovery bores were drilled in September 2024 (servicing the Pilgan Tailings Management Facility) and are currently being pump tested.
- Approvals for the new Tailing Storage Facility (TSF) 3 and 16 associated facility monitoring bores obtained
- Construction of new TSF3 commenced. Facility scheduled to be commissioned Quarter 1 of 2026
- Transition of the Pilbara Minerals Limited water database from **InViron** to **Preserve (INX)**, commenced May 2024
- Tailings Deposition and Decant Return Improvement Projects undertaken during the 2024 financial year
- Seepage Modelling and Draft Seepage Recovery Plan, scheduled for Quarter 4 of 2024; and

Section E – Details of non-compliance with licence condition	
<ul style="list-style-type: none"> <li>• Pumping out clay lined Sediment Pond West and returning water back into the processing circuit</li> <li>• Review of DWER operating licence triggers and limits as set by L9056/2017/1, scheduled for Quarter 4 of 2024 (post submission of 2024 AER)</li> </ul>	
Was this non-compliance previously reported to DWER?	
<input checked="" type="checkbox"/> Yes, and	
<input type="checkbox"/> Reported to DWER verbally	Date: / /
<input checked="" type="checkbox"/> Reported to DWER in writing	Date: 17 / 06 / 24

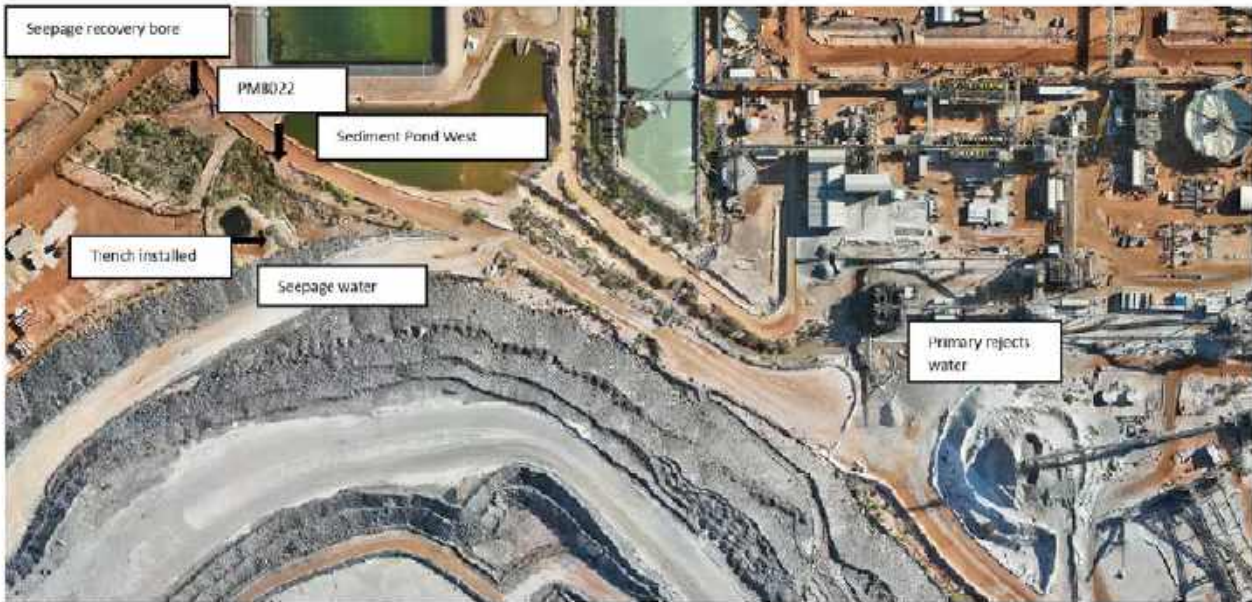
Section E – Details of non-compliance with licence condition			
Please use a separate page for each condition with which the licence holder was non-compliant at a time during the reporting period.			
Condition no:	1	Date(s) of non-compliance:	9 <sup>th</sup> June 2024
Details of non-compliance:			
Ambient groundwater monitoring bore PMB022 returned a Total Dissolved Solids (TDS) result, exceeding the operating licence L9056/2017/1 limit.			
<ul style="list-style-type: none"> <li>PMB022 has recorded a TDS reading of 4140mg/L for the month of June 2024, exceeding the licence limit of 4000mg/L.</li> </ul>			
What was the actual (or suspected) environmental impact of the non-compliance?			
<b>NOTE</b> – please attach maps or diagrams to provide insight into the precise location of where the non-compliance took place.			
No environmental impact has resulted from this elevation in groundwater quality.

Cause (or suspected cause) of non-compliance:			
The cause of the elevated levels are due to evapo-concentration of run-off from the primary rejects contained at the Sediment Pond West, and seepage water from tailings water from the Pilgan Tailings Management Facility (TMF).			
Action taken to mitigate any adverse effects of non-compliance and prevent recurrence of the non-compliance:

Section E – Details of non-compliance with licence condition	
<ul style="list-style-type: none"> <li>Installation of sump and pump at Primary Rejects area to prevent water entering Sediment Pond West, which is adjacent to bore PMB022.</li> <li>Installation of a 'seepage' trench at the Pilgan TMF</li> <li>Improving tailings densities as per licence limits</li> <li>Four new seepage recovery bores were drilled in September 2024 (servicing the Pilgan Tailings Management Facility) and are currently being pump tested.</li> </ul>	
Was this non-compliance previously reported to DWER?	
<input checked="" type="checkbox"/> Yes, and	
<input type="checkbox"/> Reported to DWER verbally	Date: / /
<input checked="" type="checkbox"/> Reported to DWER in writing	Date: 26 / 06 / 24

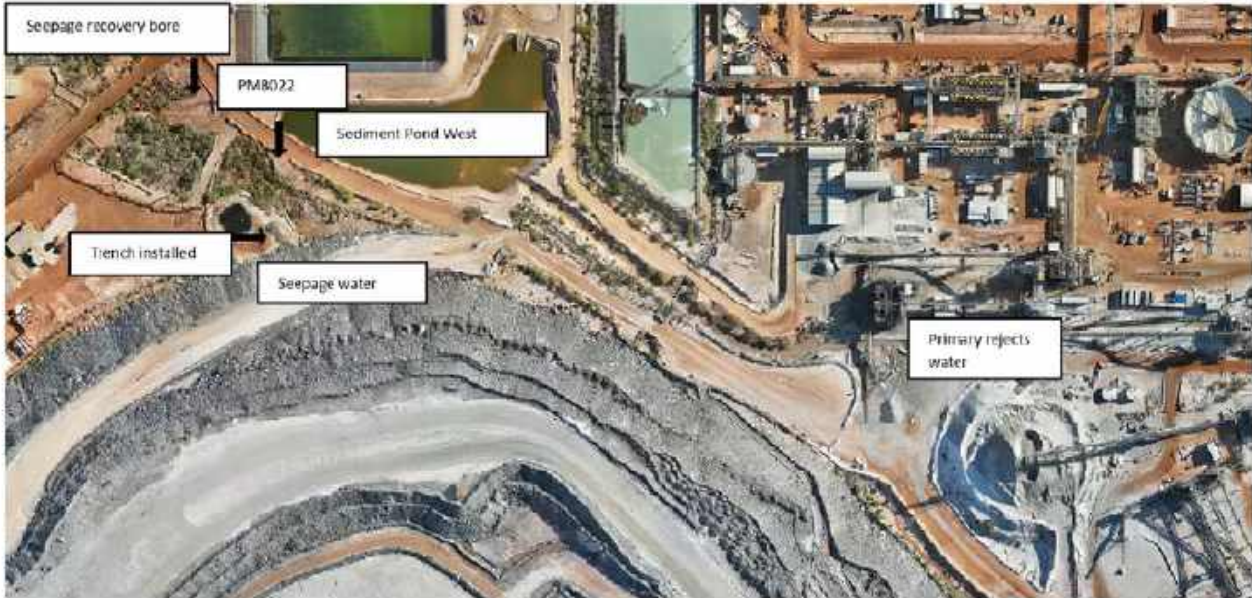
Section E – Details of non-compliance with licence condition			
Please use a separate page for each condition with which the licence holder was non-compliant at a time during the reporting period.			
Condition no:	1	Date(s) of non-compliance:	23 <sup>rd</sup> May 2024
Details of non-compliance:			
Ambient groundwater monitoring bore PMB022 returned both Fluoride and Vanadium results, exceeding the operating licence L9056/2017/1 limits.			
<ul style="list-style-type: none"> <li>PMB022 has recorded a Fluoride result of 7mg/L for the month of May 2024, exceeding the licence limit of 2mg/L.</li> <li>PMB022 has recorded a Vanadium result of 0.29mg/L for the month of May 2024, exceeding the licence limit of 0.2mg/L.</li> </ul>			
What was the actual (or suspected) environmental impact of the non-compliance?			
NOTE – please attach maps or diagrams to provide insight into the precise location of where the non-compliance took place.

No environmental impact has resulted from this elevation in groundwater.

Cause (or suspected cause) of non-compliance:			
The elevations are believed to be as a result of evapo-concentration of run-off from the primary rejects stockpile contained at the Sediment Pond West, and seepage of tails water at the Pilgan TMF.			
Action taken to mitigate any adverse effects of non-compliance and prevent recurrence of the non-compliance:

Section E – Details of non-compliance with licence condition	
<ul style="list-style-type: none"> <li>Installation of sump and pump at Primary Rejects area to prevent water entering Sediment Pond West, which is adjacent to bore PMB022.</li> <li>Installation of a 'seepage' trench at the Pilgan TMF</li> <li>Improving tailings densities as per licence limits</li> <li>Four new seepage recovery bores were drilled in September 2024 (servicing the Pilgan Tailings Management Facility) and are currently being pump tested.</li> </ul>	
Was this non-compliance previously reported to DWER?	
<input checked="" type="checkbox"/> Yes, and	
<input type="checkbox"/> Reported to DWER verbally	Date: / /
<input checked="" type="checkbox"/> Reported to DWER in writing	Date: 30 /05 / 24

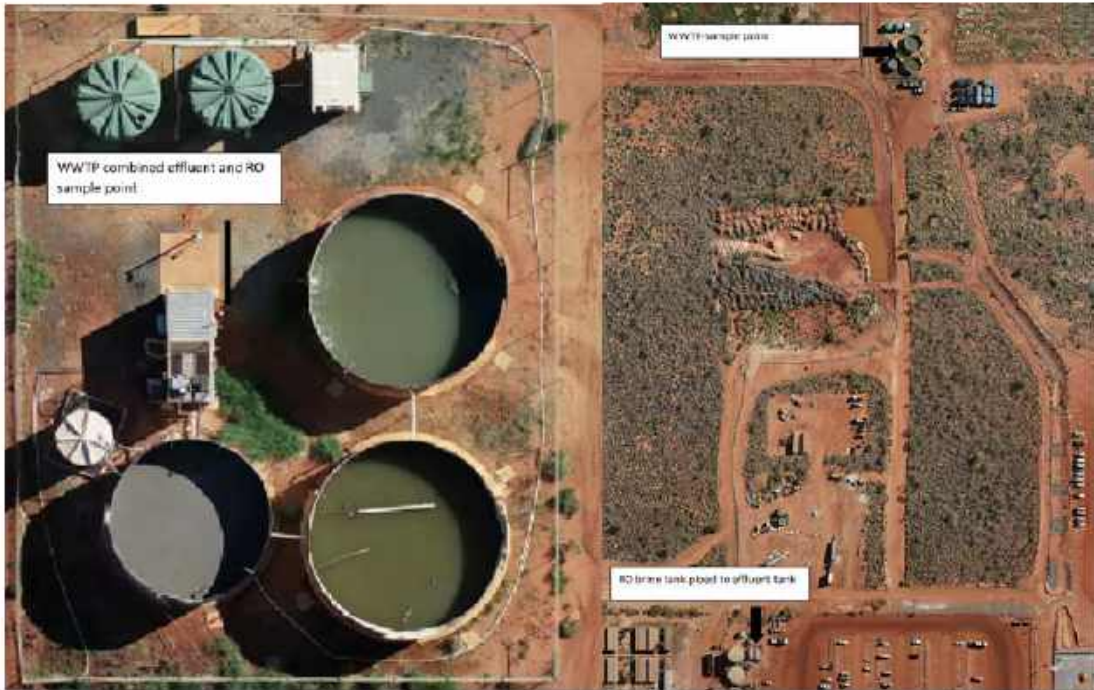
Section E – Details of non-compliance with licence condition			
Please use a separate page for each condition with which the licence holder was non-compliant at a time during the reporting period.			
Condition no:	3	Date(s) of non-compliance:	6 <sup>th</sup> April 2024
Details of non-compliance:			
<p>Waste Water discharge point from combined effluent and RO Brine mixing tank(Carlindi Camp) returned a Total Dissolved Solids(TDS) result, exceeding the operating licence L9056/2017/1 limit.</p> <ul style="list-style-type: none"> <li>• WWTP has recorded a TDS result of 4640mg/L for the month of April 2024, exceeding the licence limit of 4000mg/L.</li> </ul>			
What was the actual (or suspected) environmental impact of the non-compliance?			
<p><b>NOTE</b> – please attach maps or diagrams to provide insight into the precise location of where the non-compliance took place.</p>			
<p>No environmental impact has resulted from this elevation in water quality as the area is confined to the sprayfield.</p>

Cause (or suspected cause) of non-compliance:			
<p>The elevated TDS levels are thought to be the result of excessive RO brine water, reporting to a low level effluent tank at the time of sampling. The low level of treated effluent was attributed to little to no inflow from the accommodation facility at the time of sampling. This led to the overall dilution rate being low in the effluent tank and therefore high TDS levels.</p>			
Action taken to mitigate any adverse effects of non-compliance and prevent recurrence of the non-compliance:

Section E – Details of non-compliance with licence condition	
<ul style="list-style-type: none"> <li>Rectified blending controls in the treated effluent storage facility prior to release of effluent</li> <li>Completing regular site-based testing of the blended effluent to ensure blending controls are working as designed</li> </ul>	
Was this non-compliance previously reported to DWER?	
<input checked="" type="checkbox"/> Yes, and	
<input type="checkbox"/> Reported to DWER verbally	Date: / /
<input checked="" type="checkbox"/> Reported to DWER in writing	Date: 01 /05 / 24

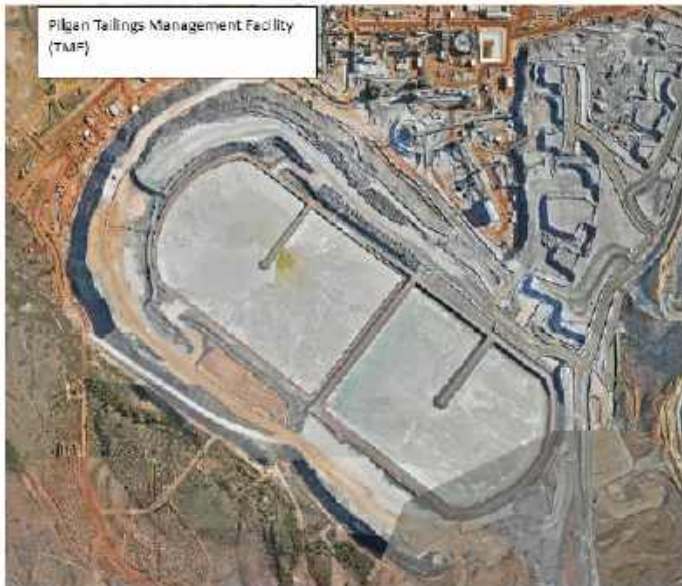
Section E – Details of non-compliance with licence condition			
Please use a separate page for each condition with which the licence holder was non-compliant at a time during the reporting period.			
Condition no:	5	Date(s) of non-compliance:	October, November 2022 April 2023
Details of non-compliance:			
<p>Discharge of tailings to the Pilgan Tailings Management Facility (TMF) below the minimum solids concentration rate as per operating licence L9056/2017/1.</p> <ul style="list-style-type: none"> <li>Tailings discharged at a density concentration of 45% October 2022</li> <li>Tailings discharged at a density concentration of 48% November 2022</li> <li>Tailings discharged at a density concentration of 49.4% April 2023</li> </ul> <p>Note: Although exceedances are outside of the reporting period, this has been added to this AACR as they were identified and reported to DWER in October 2023.</p>

What was the actual (or suspected) environmental impact of the non-compliance?			
<p><b>NOTE</b> – please attach maps or diagrams to provide insight into the precise location of where the non-compliance took place.</p> <p>The environmental impact was considered low as it was confined to the Pilgan Tailings Management Facility (TMF).</p>

Cause (or suspected cause) of non-compliance:			
<p>During operations multiple equipment (Filter Press 1 and 2, plant) were using excessive water. The excess water needed to be discharged and due to the Process Water Pond being at full capacity, the water was diverted to the tailings thickener, therefore compromising the tailings density to the Pilgan TMF.</p>			
Action taken to mitigate any adverse effects of non-compliance and prevent recurrence of the non-compliance:

Section E – Details of non-compliance with licence condition	
<ul style="list-style-type: none"> <li>Dedicated line installed and re-circulates excess water to feed the Filter Press, instead of Raw water therefore reducing the need to divert excess water to the tailings thickener</li> <li>Prepare additional filter cloth replacement parts, inspect and replace at regular basis intervals to be able to handle the processed water</li> <li>Process Water Pond dredging planned to increase capacity</li> <li>Removal of weeds in Process Water Pond planned to increase capacity</li> </ul>	
Was this non-compliance previously reported to DWER?	
<input checked="" type="checkbox"/> Yes, and	
<input type="checkbox"/> Reported to DWER verbally	Date: / /
<input checked="" type="checkbox"/> Reported to DWER in writing	Date: 31 /10 / 23

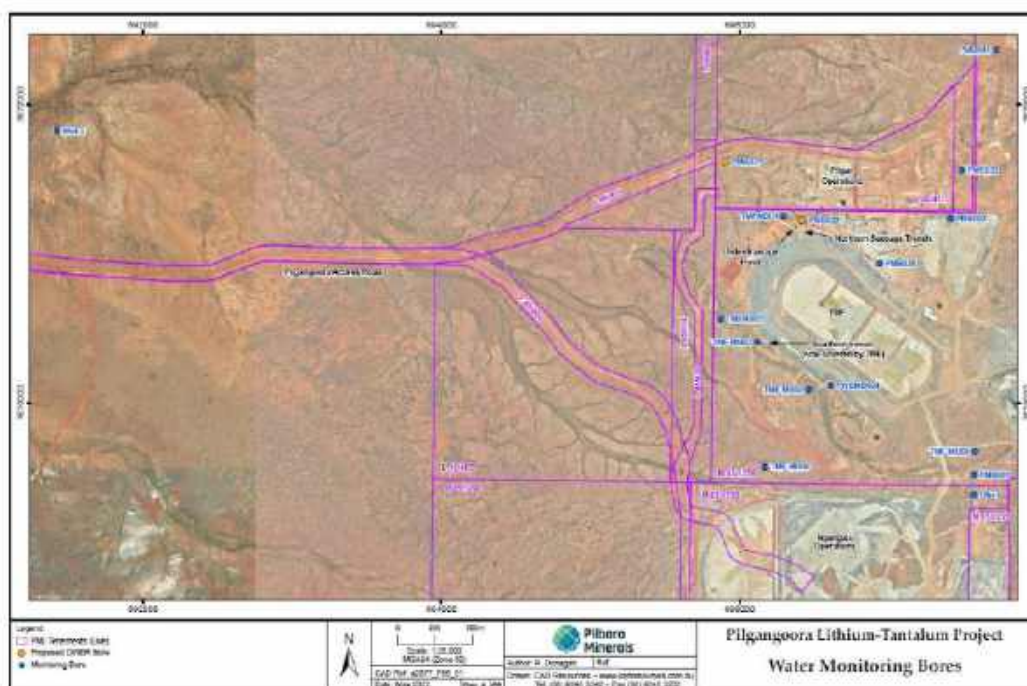
Figure 6: Location of TMF monitoring bores

Ambient groundwater monitoring bore PMB022 returned Sulfate, Fluoride and Vanadium results, exceeding the operating licence L9056/2017/1 limits and bore PWE033 returned Fluoride results exceeding the licence limit.

- PMB022 has recorded a Sulfate result of 1060mg/L for the month of November 2022, exceeding the licence limit of 1000mg/L.
- PMB022 has recorded a Fluoride result of 4.1mg/L for the month of May 2023, exceeding the licence limit of 2mg/L.
- PMB022 has recorded a Vanadium result of 0.24mg/L for the month of May 2023, exceeding the licence limit of 0.2mg/L.
- PWE033 has recorded a Fluoride result of 4.6mg/L for the month of Feb 2023, exceeding the licence limit of 2mg/L.

The environmental impact is considered low as the water quality is confined to the monitoring bore.

The elevations are believed to be as a result of evapo-concentration of run-off from the primary rejects stockpile contained at the Sediment Pond, and seepage of tails water at the Pilgan TMF.

A fluoride exceedance was detected in February 2023 for PWE033, however, further analysis showed that fluoride concentrations returned to baseline levels by the following quarter (May 2023). The cause of this isolated exceedance remains unknown, with the possibility of a sampling error. Regardless, Pilbara Minerals will continue to monitor and track fluoride levels to ensure there is no detrimental decline in water quality.

- Installation of sump and pump at Primary Rejects area to prevent water entering Sediment Pond West, which is adjacent to bore PMB022.
- Installation of a 'seepage' trench at the Pilgan TMF
- Improving tailings densities as per licence limits
- Four new seepage recovery bores were drilled in September 2024 (servicing the Pilgan Tailings Management Facility) and are currently being pump tested.
- Continual monitoring
- Transition of the environmental monitoring database from the previous INX-InViron to the new INX-Preserve.
