Annual Audit Compliance Report Form

Environmental Protection Act 1986, Part V

Section A – Licence Details			
Licence number:	L9056/2017/1	Licence file number:	DER2017/000318
Licence holder:	Pilgangoora Operations Pty Ltd		
Trading as:	PLS Ltd (formally Pilbara Minerals Pty Ltd)		
ACN:	616 560 395		
Registered address:	Level 2, 146 Colin Street, WEST PERTH WA 6005		
Reporting period:	01/07/2024 to 30/06/2025

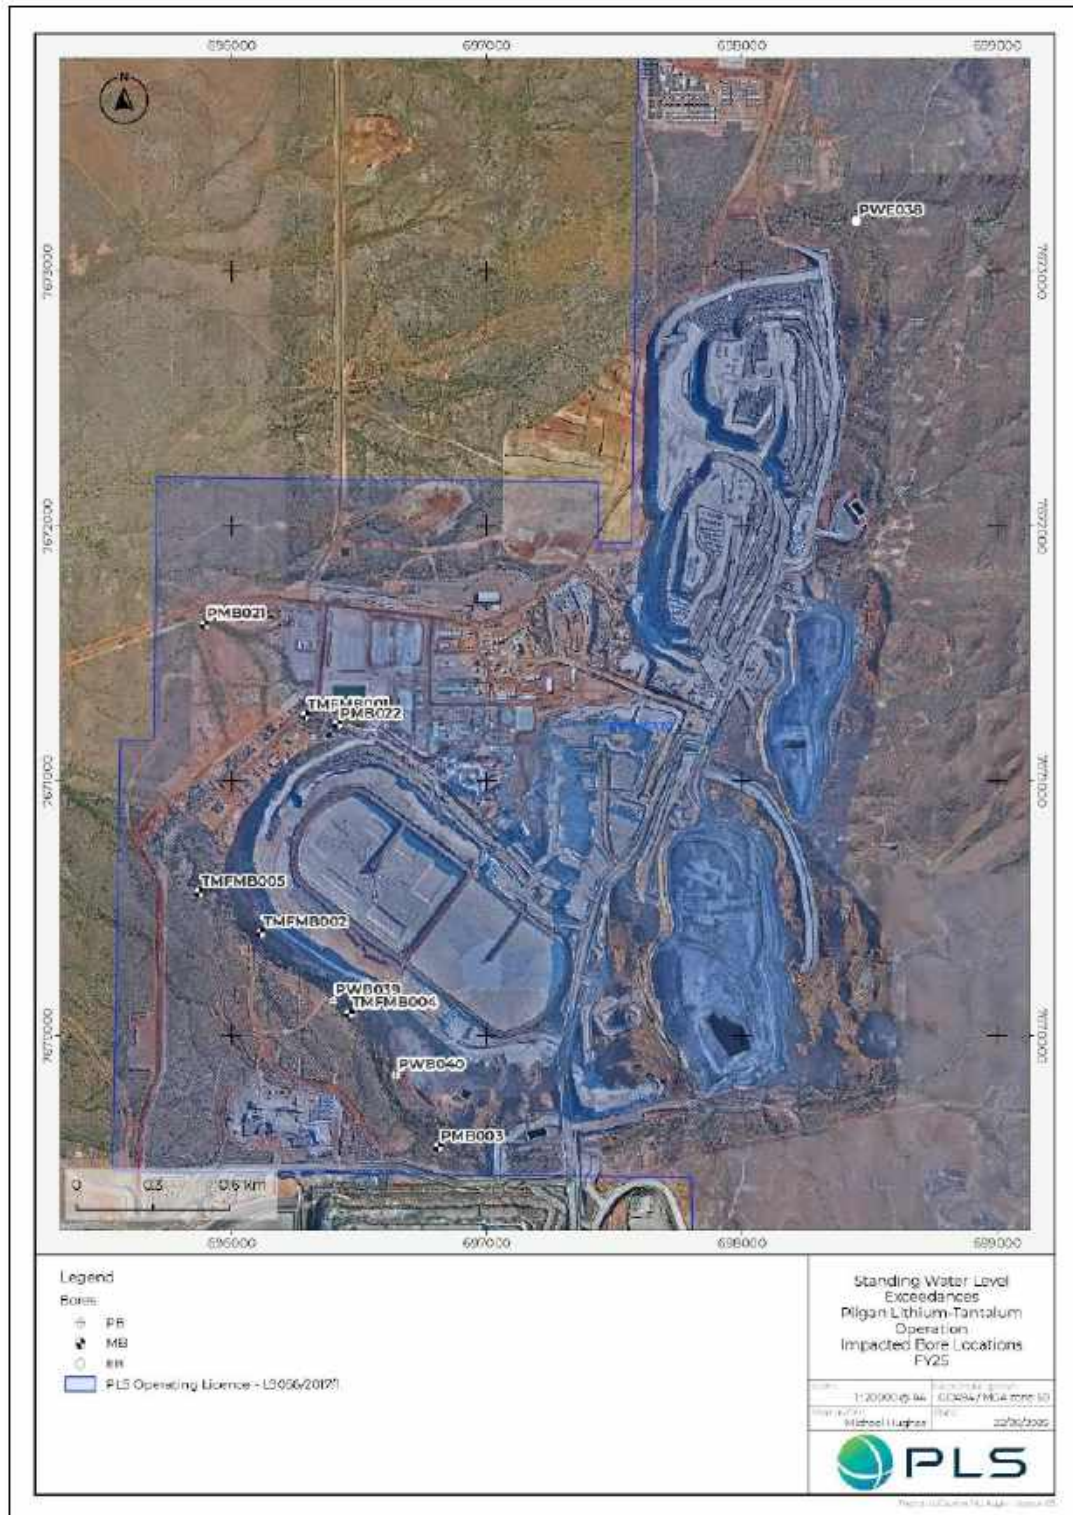
Section E – Details of Non-Compliance with Licence Condition			
Please use a separate page for each condition with which the licence holder was non-compliant at a time during the reporting period.			
Condition no:	Condition 12	Date(s) of non-compliance:	Multiple Dates
Details of non-compliance:			
<p>For each calendar month of the FY25 reporting period, numerous licensed monitoring bores exceeded either the licence trigger and / or licence limit for Standing Water Level (SWL). On regular occasions TMFMB004 and PWBMB004 exceeded the licence trigger value, whilst PWB038 exceeded SWL licence trigger value once only during June 2025. Again on regular occasions TMFMB001, TMFMB002, TMFMB005, PMB021, PMB022 exceeded the licence limit value for SWL, whilst PMB003, PWB039 and PWB040 exceeded the licence limit value for SWL only once during June 2025.</p>			
What was the actual (or suspected) environmental impact of the non-compliance?

<p>NOTE – please attach maps or diagrams to provide insight into the precise location of where the non-compliance took place.</p>			
No actual or suspected environmental impact associated with the non-compliance.			
Cause (or suspected cause) of non-compliance:			
<p>A combination of above average rainfall for the FY25 period and increased potential seepage from the Pilgan Tailings Management Facility (TMF) is believed to have caused the shallow SWLs for some monitoring bores located in close proximity of the Pilgan TMF.</p> <p>Total rainfall at Pilgan Operation during FY24 was 272 mm, whilst during the FY25 period the operation received a total of 483mm. The above average rainfall was largely the result of the impact of Cyclone Zelia which impacted the region mid-February 2025, please note the average rainfall for Port Hedland is 310mm.</p>			
Action taken to mitigate any adverse effects of non-compliance and prevent recurrence of the non-compliance:

Figure 1: Location Map detailing Monitoring Bores exceeding both SWL Licence trigger and limit thresholds.

<p>Several projects were undertaken by PLS once it was determined that there was an issue with shallow SWLs around the Pilgan TMF facility, some of these projects remain ongoing, in summary:</p> <ul style="list-style-type: none"> • A leach drain was constructed to direct recovered seepage water from the TMF into the lined underdrainage pond, where it is returned to the processing circuit. • Seepage recovery network involving the construction and commissioning of additional four recovery bores. In total PLS has five recovery bores operational with another one scheduled to start pumping during quarter three of 2025. • PLS has an ongoing project whereby the Site Processing Team are reviewing practices to determine how to maximise the density of the tailings liquor to minimise the amount of water being initially pumped into the TMF. • Finally, PLS is close to constructing Tailing Storage Facility 3 which is scheduled to receive tailings from the Pilgan Plant in January 2026.

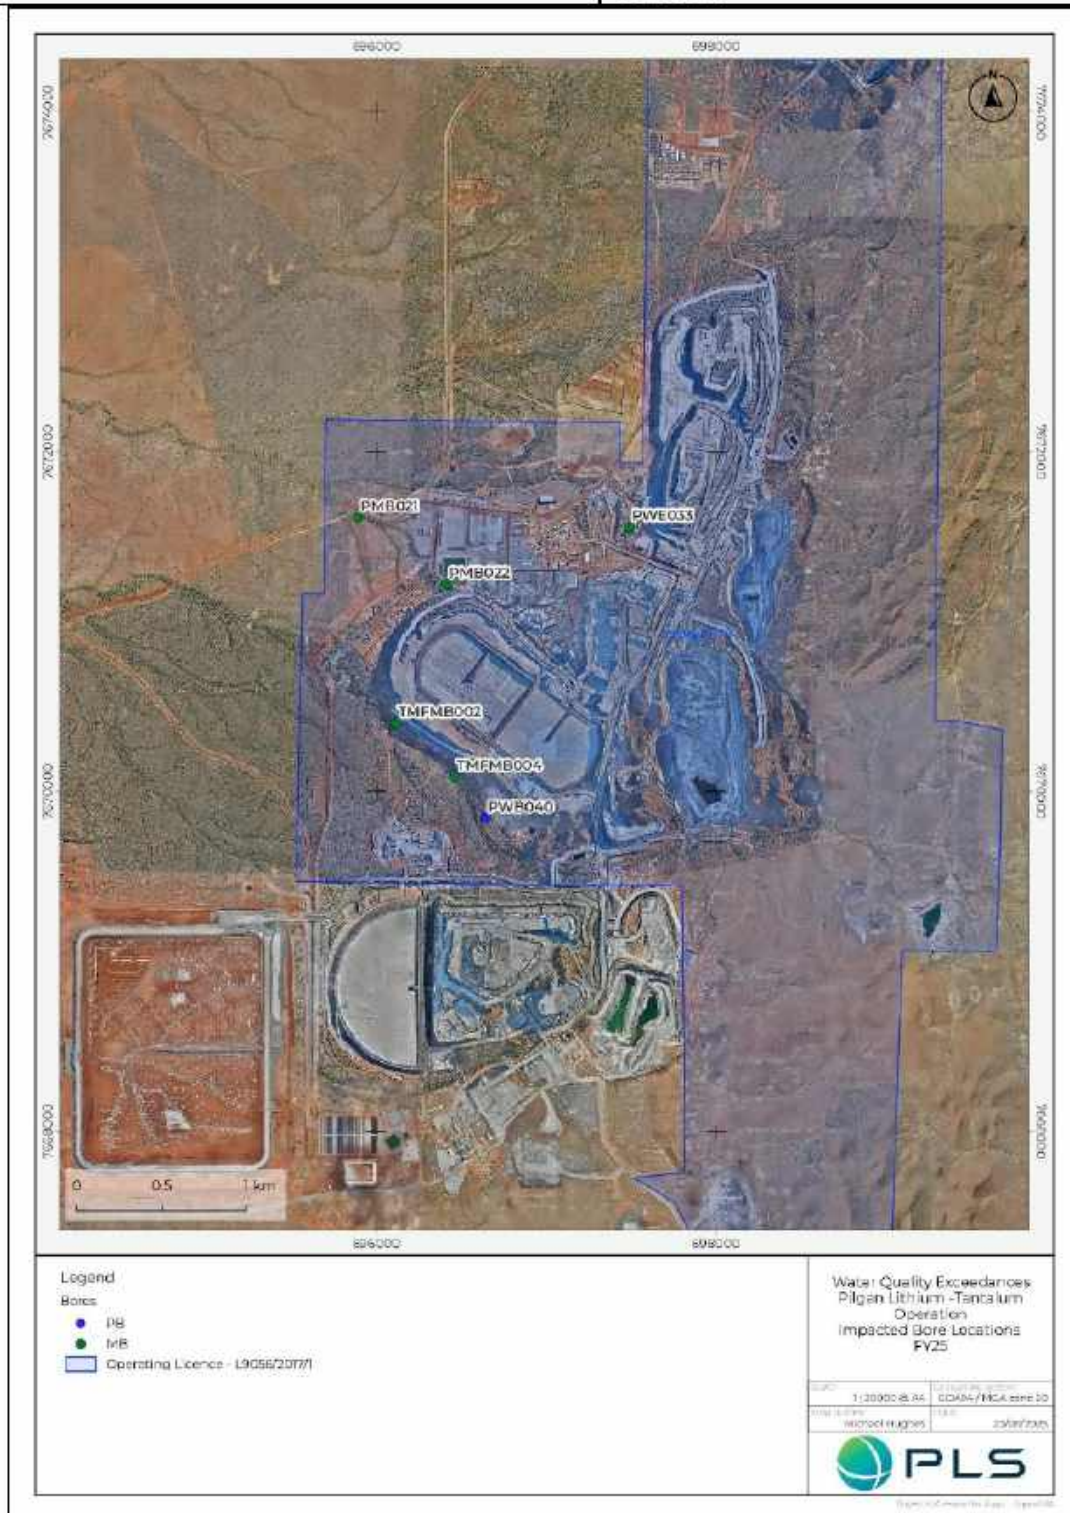
Section E – Details of Non-Compliance with Licence Condition			
Please use a separate page for each condition with which the licence holder was non-compliant at a time during the reporting period.			
Condition no:	Condition 12	Date(s) of non-compliance:	Multiple Dates
Details of non-compliance:			
For the majority of the calendar months of the FY25 reporting period, numerous licensed monitoring bores exceeded licence limits for groundwater quality. On regular occasions PMB021, PMB022, PWE033, PWB040, TMFMB002 and TMFMB004 exceeded the groundwater quality licence limits for Boron, Fluoride, Sulfate, Vanadium and Total Dissolved Solids.			
What was the actual (or suspected) environmental impact of the non-compliance?			
NOTE – please attach maps or diagrams to provide insight into the precise location of where the non-compliance took place.			
No actual or suspected environmental impact associated with the non-compliance.

Cause (or suspected cause) of non-compliance:			
The water quality non-conformances were the result of evapo-concentration of tailings water, interacting with groundwater as a result of TMF seepage.			
Action taken to mitigate any adverse effects of non-compliance and prevent recurrence of the non-compliance:			
<p>Several projects were undertaken by PLS once it was determined that there was an issue with water quality around the Pilgan TMF facility, some of these projects remain ongoing, in summary:</p> <ul style="list-style-type: none"> • A leach drain was constructed to direct recovered seepage water from the TMF into the lined underdrainage pond, where it is returned to the processing circuit. • Two lined catchment drains were installed downstream to the Primary Rejects stockpile to collect runoff (and return to processing) to minimise interaction with surrounding surface water drainage network. • Seepage recovery network involving the construction and commissioning of additional four recovery bores. In total PLS has five recovery bores operational with another one scheduled to start pumping during quarter three of 2025. • PLS has an ongoing project whereby the Site Processing Team are reviewing practices to determine how to maximise the density of the tailings liquor to minimise the amount of water being initially pumped into the TMF. • Finally, PLS is close to constructing Tailing Storage Facility 3 which is scheduled to receive tailings from the Pilgan Plant in January 2026.

Figure 2: Location Map detailing Monitoring Bores exceeding Water Quality Limits

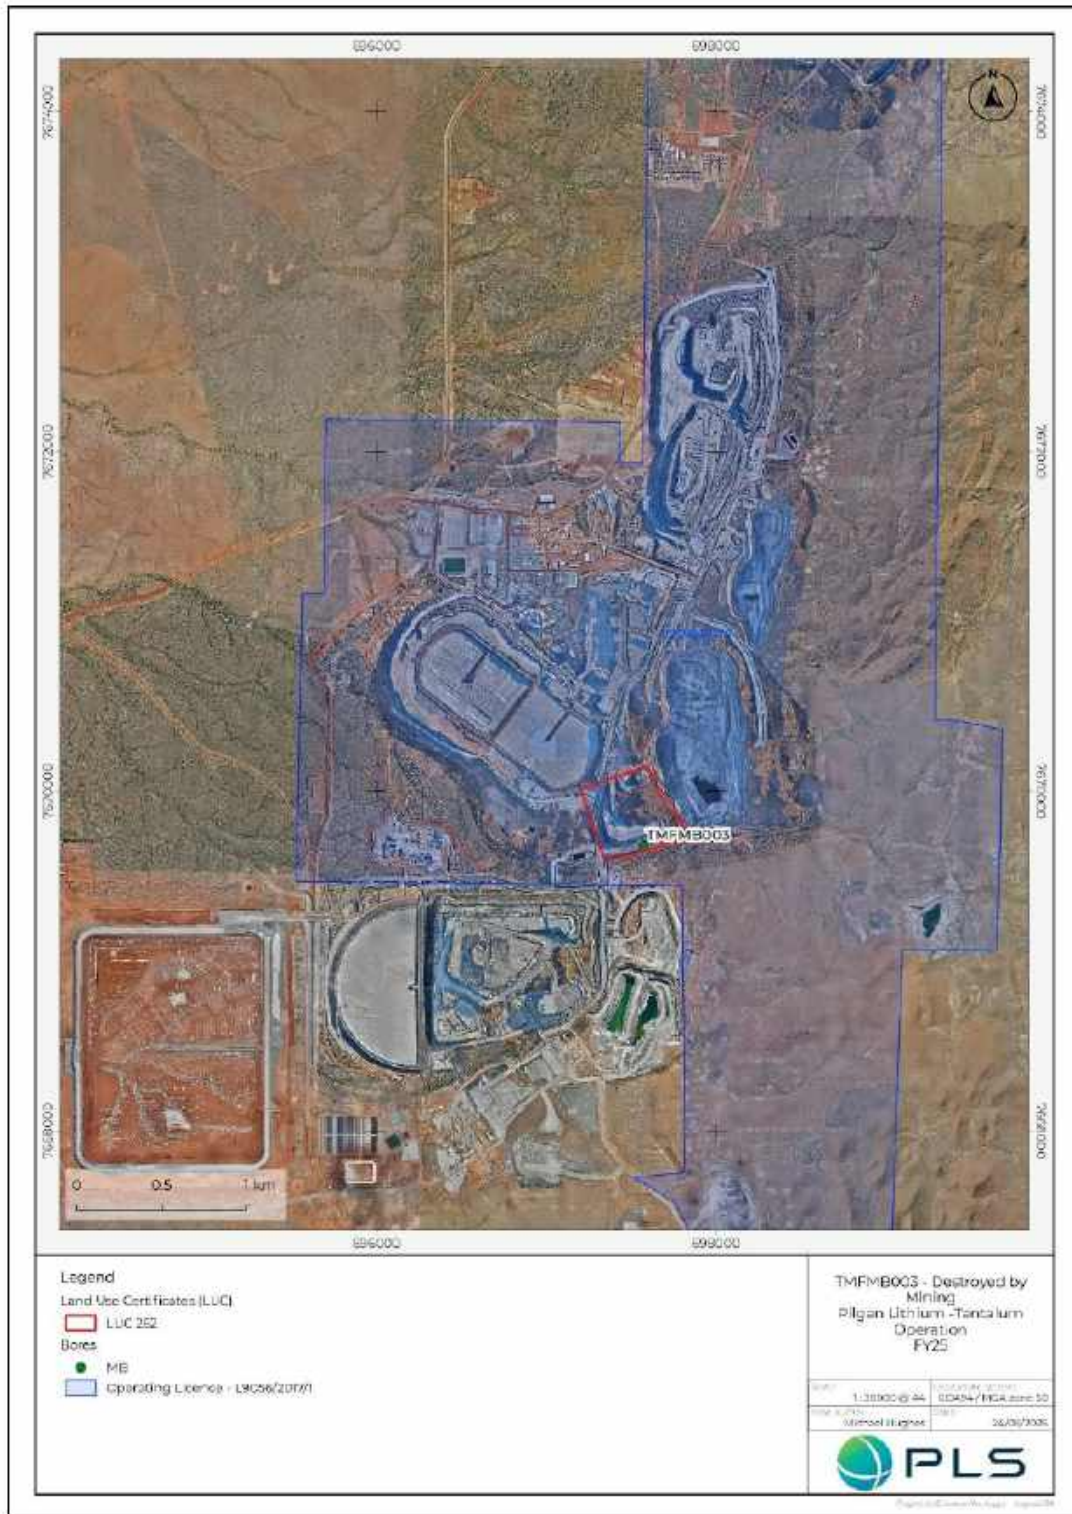
Section E – Details of Non-Compliance with Licence Condition			
Please use a separate page for each condition with which the licence holder was non-compliant at a time during the reporting period.			
Condition no:	Condition 12	Date(s) of non-compliance:	21/06/2025
Details of non-compliance:			
Licenced monitoring bore TMFMB03 was unintentionally decommissioned by mining activities.			
What was the actual (or suspected) environmental impact of the non-compliance?			
NOTE – please attach maps or diagrams to provide insight into the precise location of where the non-compliance took place.			
No actual or suspected environmental impact associated with the non-compliance.			
Cause (or suspected cause) of non-compliance:			
<p>Failure to adhere to the conditions of PLS internal Land Use Certificate (LUC262), as issued. LUC 262 had a nonstandard permit condition whereby TMFMB03 was not to be impacted. Contributing factors to the breach included:</p> <ul style="list-style-type: none"> • Four subsequent amendments to LUC262 conditions. • LUC / QGIS interface tool did not identify TMFMB03 existence within 'LUC checks'. • No updated LUC checklist issued with 'Version 04' of the LUC 262 map. • Bore not clearly delineated in the field. • Verbal approval to cover bore given, but not captured in formal work instructions. • Numerous dozer operators involved in the clearing of LUC 262.

Figure 3: Location Map of TMFMB003 – Destroyed by Mining

Action taken to mitigate any adverse effects of non-compliance and prevent recurrence of the non-compliance:			
<p>Revised LUC process (i.e. not allow subsequent/amended versions of a LUC, instead a new LUC is required for any amendment). LUC / QGIS interface tool now includes locations of production and monitoring bores, and 'flags' any overlap with LUC polygons. New software (Minestar Maps - Caterpillar Vehicle Guidance System) will also include environmental infrastructure (i.e. ground water bores), heritage and environmental monitoring sites as 'avoidance areas' thereby warning the mobile equipment operator of their existence and requirement to avoid.</p>

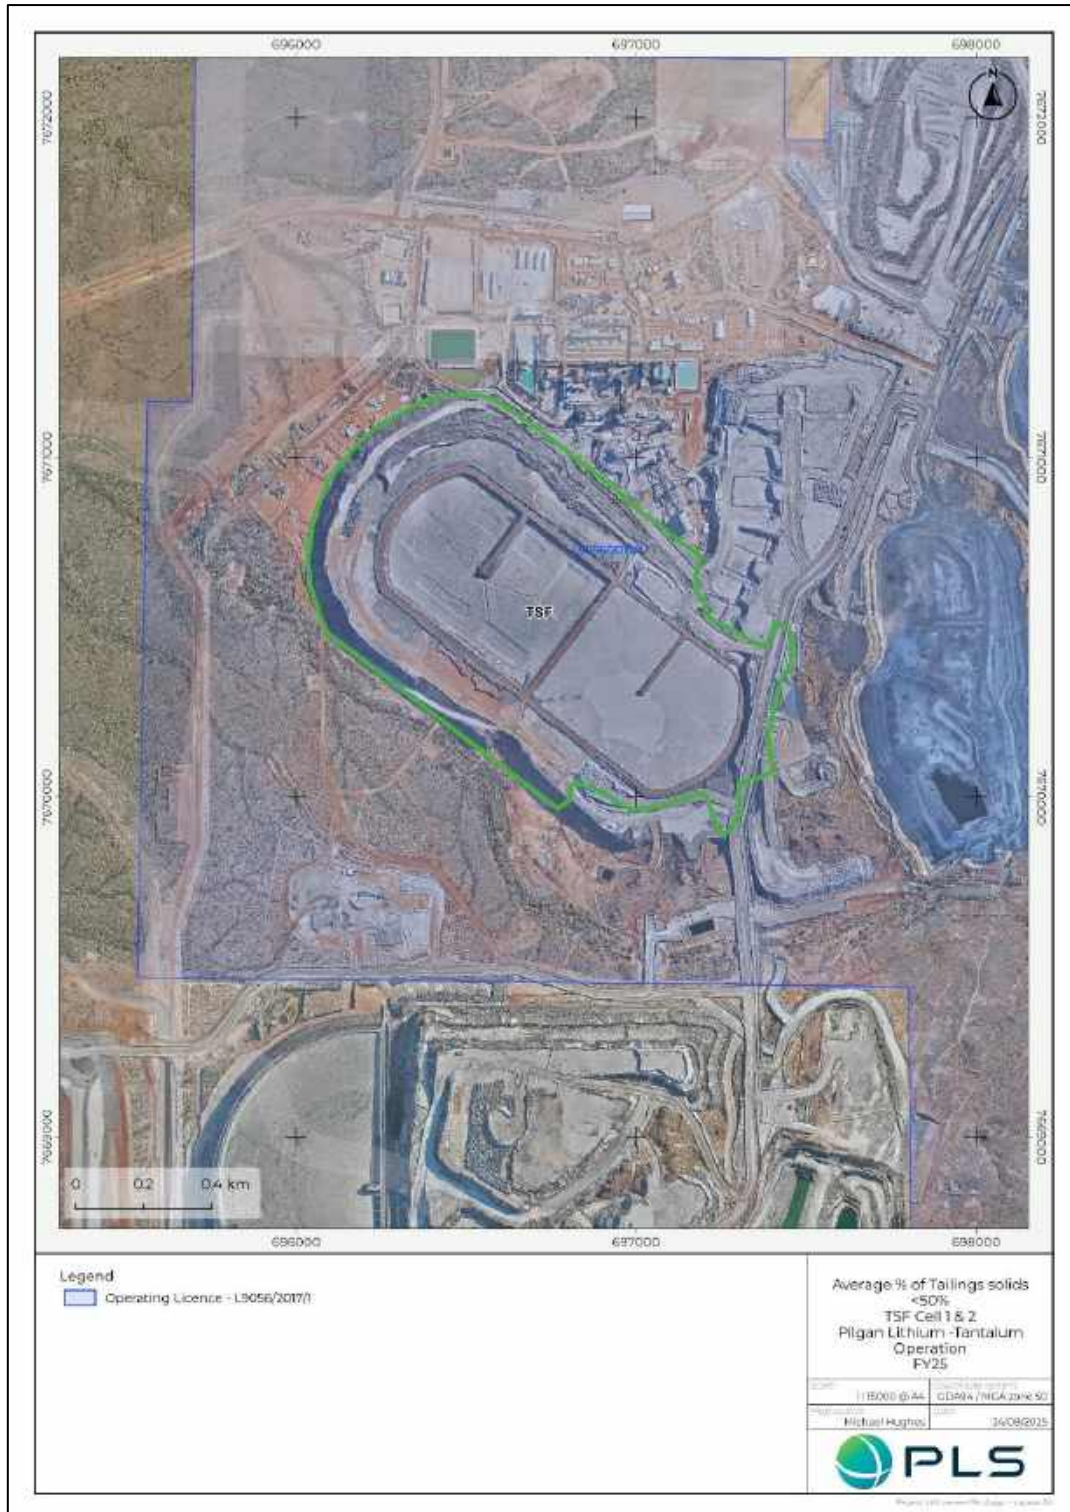
Section E – Details of Non-Compliance with Licence Condition			
Please use a separate page for each condition with which the licence holder was non-compliant at a time during the reporting period.			
Condition no:	Condition 5 (Table 6)	Date(s) of non-compliance:	7/02/25 & 8/05/25
Details of non-compliance:			
<p>Tailings discharged at Pilgan TMF below the minimum 50% solids concentration rate.</p> <p>Tailings discharges had an average percentage of solids of 48.4% for the period 24/01/25-03/02/25, and an average of 48.24 for the month of April 2025.</p>			
What was the actual (or suspected) environmental impact of the non-compliance?			
NOTE – please attach maps or diagrams to provide insight into the precise location of where the non-compliance took place.			
No actual or suspected environmental impact associated with the non-compliance.			
Cause (or suspected cause) of non-compliance:			
<p>The nonconformance for the period 24/01/25-03/02/25 was the result of the construction and initial commissioning of a second tailings thickener as part of Pilgangoora's P1000 Expansion Project. The upgrade resulted in the splitting of key ultrafine fraction of tailings (slimes) to the new Heavy Media Separation thickener, which has a significant larger diameter to accommodate the very low settling rate characteristics of this material. The result was that the material was settling and consolidating faster than anticipated, therefore the tailings bed did not build conventionally and 'flow' into the discharge cone.</p> <p>The nonconformance in April 2025 was the result of a significant throughput rate loss in lead up and after a scheduled major plant shutdown (i.e. when the plant is running at a reduced rate, or lines need to be flushed).</p>

Figure 4: PLO Tailings Management Facility (Cell 1 and 2) Location Map.

Action taken to mitigate any adverse effects of non-compliance and prevent recurrence of the non-compliance:	
<p>Nonconformance 1:</p> <ul style="list-style-type: none"> • Final tails tank autosampler has been diverted to send a portion of its stream to the flotation tails thickener. • Final tails tank receives flow from the thickened flotation tails thickener underflow and the HMS tails thickener underflow (which contains all the slimes). • This allows for some of the slimes from the HMS tails thickener to be bled into the flotation tails thickener. • Additionally, the reagent spillage pump was directed into the flotation tails thickener, this prevented direct dilution of thickened tailings. • These modifications have been successful in bringing the slurry rheology closer to what was occurring prior to P1000 i.e. greater than 50%. <p>Nonconformance 2:</p> <ul style="list-style-type: none"> • Processing Team now operates under an Operational Trigger Action Response Plan (TARP) that details different processing configurations that allow the Team to either increase or decrease tailings density as required to maintain compliant tailings densities. • During 'normal' operations i.e. between scheduled major plant shutdowns, the upgraded plant returns to and will continue to maintain average solids concentration levels above the operating licence threshold level.

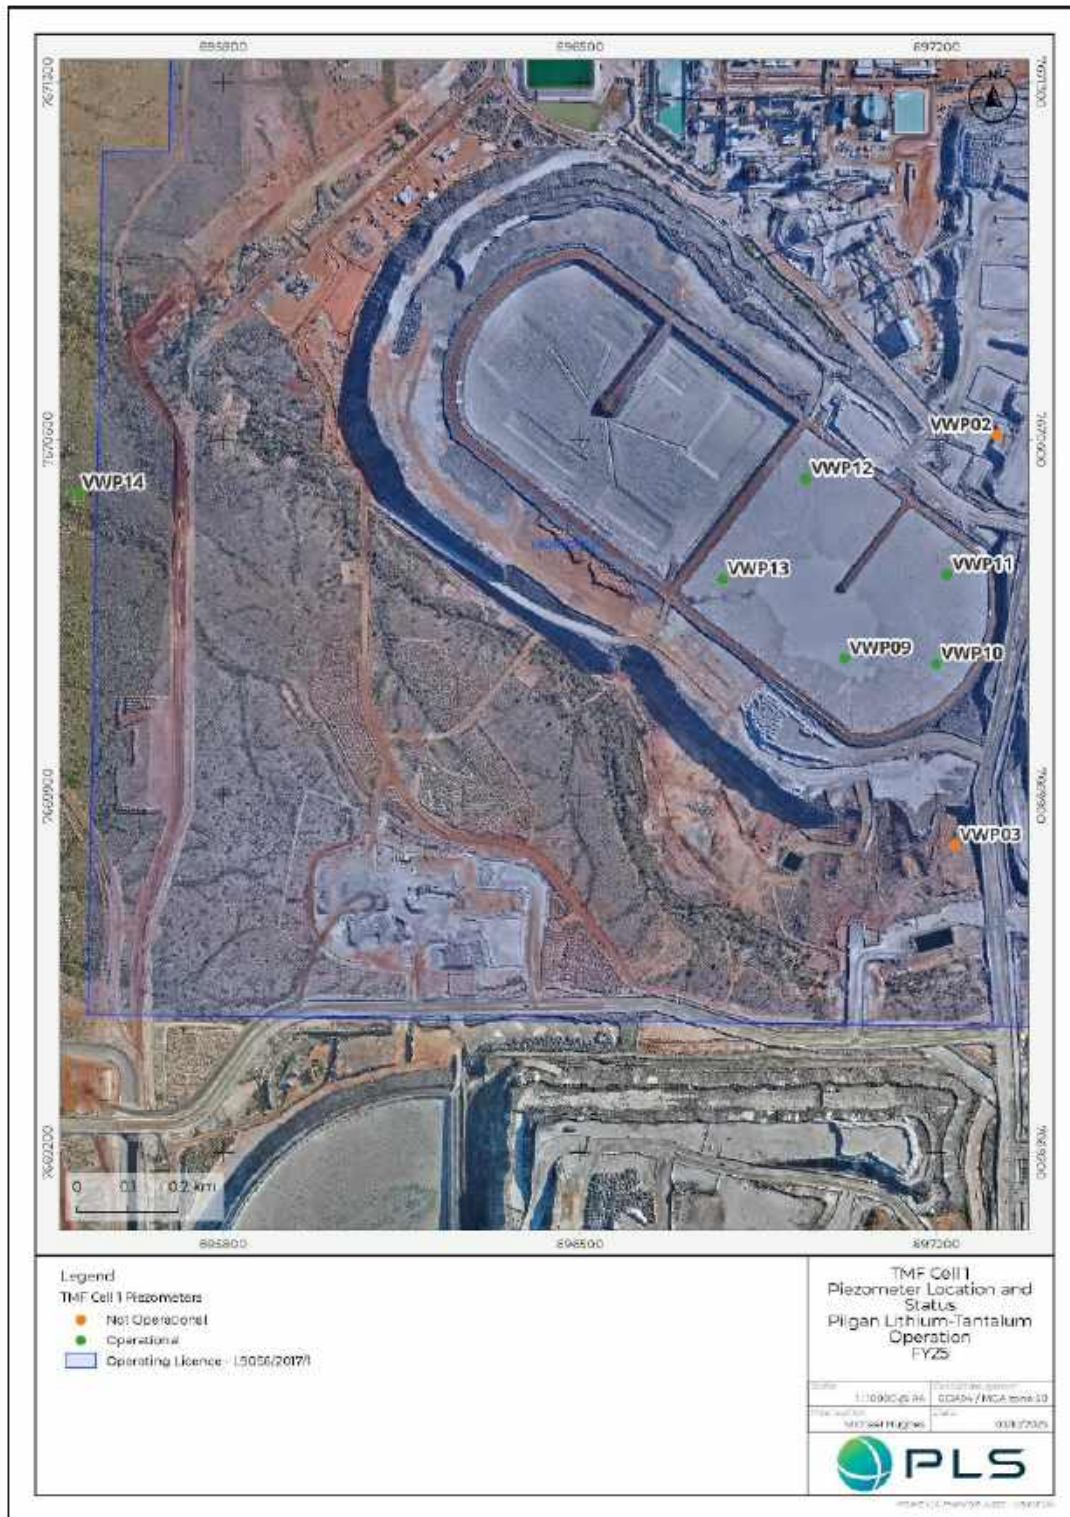
Section E – Details of Non-Compliance with Licence Condition			
Please use a separate page for each condition with which the licence holder was non-compliant at a time during the reporting period.			
Condition no:	Condition 5	Date(s) of non-compliance:	10/02/2025
Details of non-compliance:			
Following normal operational breakdowns, Cell 1 of the Pilgan Tailings Management Facility (TMF) currently has six functional piezometers to determine the phreatic surface within deposited tailings, instead of the eight piezometers that should be in place as indicated in Table 6 of Condition 5.			
What was the actual (or suspected) environmental impact of the non-compliance?			
NOTE – please attach maps or diagrams to provide insight into the precise location of where the non-compliance took place.			
No actual or suspected environmental impact associated with the non-compliance.			
Cause (or suspected cause) of non-compliance:

VWP2 sensor stopped responding due to a lost signal in mid-2023 whilst VWP3 sensor stopped responding due to a lost signal in late October 2024.			
Action taken to mitigate any adverse effects of non-compliance and prevent recurrence of the non-compliance:			
It was not feasible to reinstate either of VWP2 and VWP3 as they were buried within the tailings. Drilling was not an option, without the risk of breaking through the compacted clay base liner of the TMF, which would have potentially compromised the integrity of Cell 1. It was confirmed by the PLS registered tailings engineer that the tailings phreatic surface at TMF Cell 1 can still be monitored with the remaining six operational piezometers. In Q3 2025 PLS will amend L9056/2017/1 to reflect the current number of operational piezometers.

Figure 5: Location and status of TMF Cell 1 Piezometers.

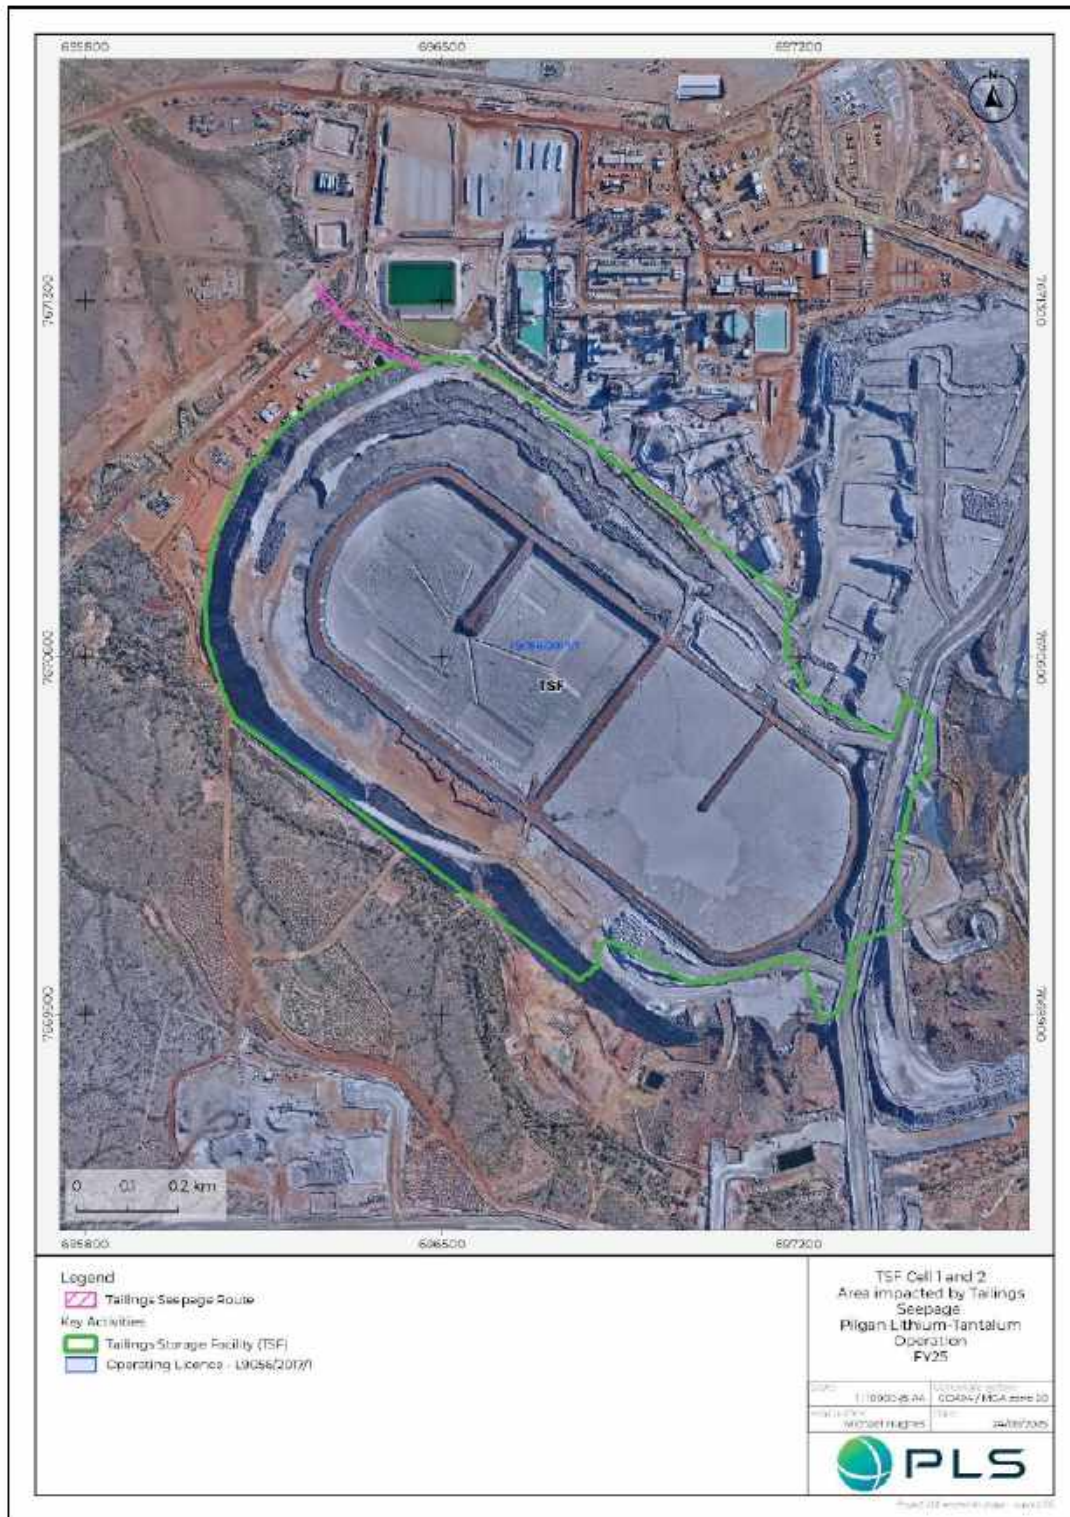
Section E – Details of Non-Compliance with Licence Condition			
Please use a separate page for each condition with which the licence holder was non-compliant at a time during the reporting period.			
Condition no:	Condition 1	Date(s) of non-compliance:	20/07/2024
Details of non-compliance:			
Water was found pooling against the northwest corner toe of Cell 2 of the Pilgan Tailings Management Facility (TMF). The suspected seepage water from the TMF facility continued to flow a further 250 metres downstream along a neighbouring minor ephemeral stream.			
What was the actual (or suspected) environmental impact of the non-compliance?			
NOTE – please attach maps or diagrams to provide insight into the precise location of where the non-compliance took place.			
No actual or suspected environmental impact associated with the non-compliance, as the results of associated water samples were all below the licence limits for ambient groundwater monitoring.

Cause (or suspected cause) of non-compliance:			
Tailings water from TMF Cell 2 seeping through the wall and/or floor of the facility. A contributing factor was a neighbouring unlined Sediment Pond which was at near capacity due to a recent rainfall event and stormwater runoff from the Plant.			
Action taken to mitigate any adverse effects of non-compliance and prevent recurrence of the non-compliance:			
<ul style="list-style-type: none"> • Installation of a 'French Drain' to intercept the tailings seepage water, which is now re-directed into the lined TMF underdrainage dam, from where it is pumped back into the processing pond/circuit. • Improved TMF daily inspection templates to prompt review for any Tailings facility seepage. • Improved TMF seepage recovery network involving the construction and commissioning of additional four recovery bores. In total PLS has five recovery bores operational with another one scheduled to start pumping during quarter three of 2025.

Figure 6: Area impacted by tailings seepage from TMF Cell 2.

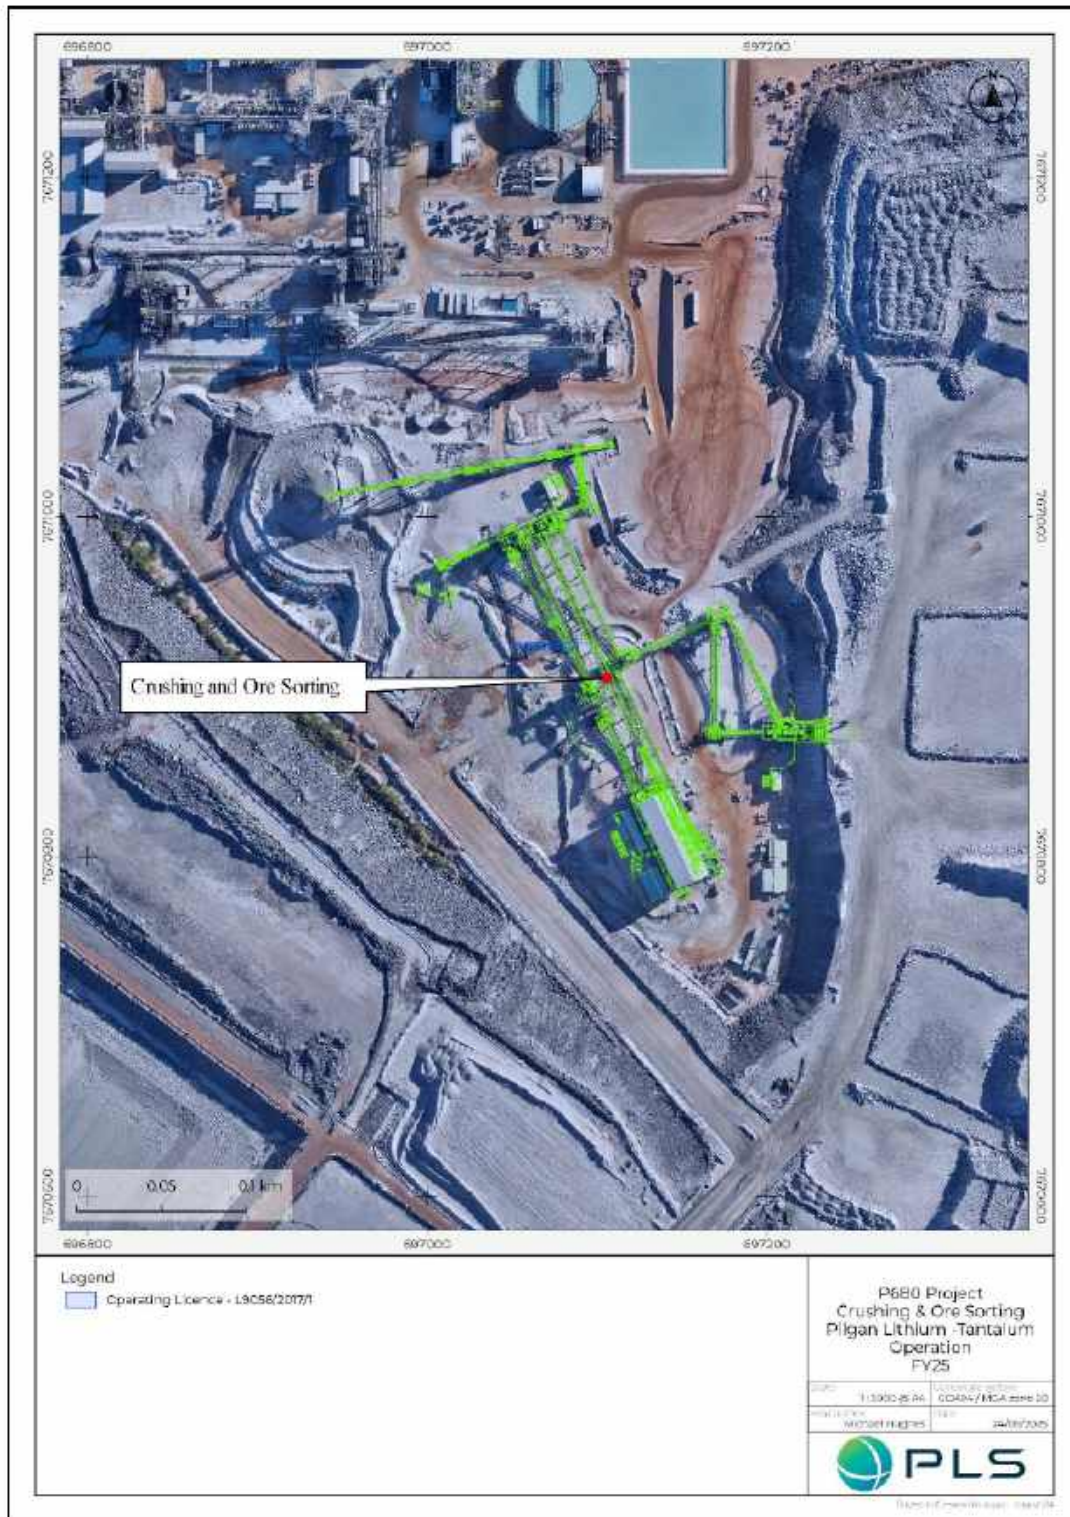
Section E – Details of Non-Compliance with Licence Condition			
Please use a separate page for each condition with which the licence holder was non-compliant at a time during the reporting period.			
Condition no:	Condition 5	Date(s) of non-compliance:	18/07/2024 and 05/05/2025
Details of non-compliance:			
<p>Two administrative non-compliances with Works Approval conditions, due to failure to procure an amendment of Licence L9056 incorporating recently constructed facilities within the specified 180 days of Time Limited Operation (TLO):</p> <ul style="list-style-type: none"> • Incident 1: associated with operation of <i>Stage 2 Heavy Media Separation and Primary Rejection facility</i>. • Incident 2: associated with operation of <i>P680 Crushing and Ore Sorting plant</i> 			
What was the actual (or suspected) environmental impact of the non-compliance?			
<p>NOTE – please attach maps or diagrams to provide insight into the precise location of where the non-compliance took place.</p>

No actual or suspected environmental impact associated with the non-compliances.			
Cause (or suspected cause) of non-compliance:			
<p>Incident 1:</p> <ul style="list-style-type: none"> • A written request to extend TLO was sent to DWER in July 2024. DWER advised that a TLO extension required a Works Approval amendment; however, given that an Operating Licence amendment had already been lodged (earlier in July 2024), DWER's preference was to progress the assessment of the Licence amendment instead of working on an additional Works Approval amendment. <p>Incident 2:</p> <ul style="list-style-type: none"> • The Operating Licence amendment to incorporate the recently constructed P680 Crushing and Ore Sorting plant was not finalised within approved timeframe for TLO (180 days). During this time PLS omitted to apply for a Works Approval amendment to extend TLO, and instead progressed with the application to amend the Operating Licence (L9056).

Figure 8: Compliance Issue 2: Pilgan P680 Crushing and Ore Sorting Facility

Following both events and meetings held with DWER, it was agreed that PLS would report both incidents as administrative non-compliance in the FY25 AACR.

If in the future the assessment timeframes of licence amendments looked like they are going to extend beyond approved Time Limited Operations (usually 180 days), it was agreed that meetings would be organised between PLS and DWER to discuss the best path forward.
