Annual Audit Compliance Report Form

Section A – Licence details			
Licence number:	L9362/2022/1	Licence file number:	DER2022/000510
Licence holder name:	Norton Gold Fields Pty Limited		
Trading as:			
ACN:	112 287 797		
Registered business address:	Paddington Site Menzie Highway Kalgoorlie WA		
Reporting period:	01/01/2023 to 31/12/2023

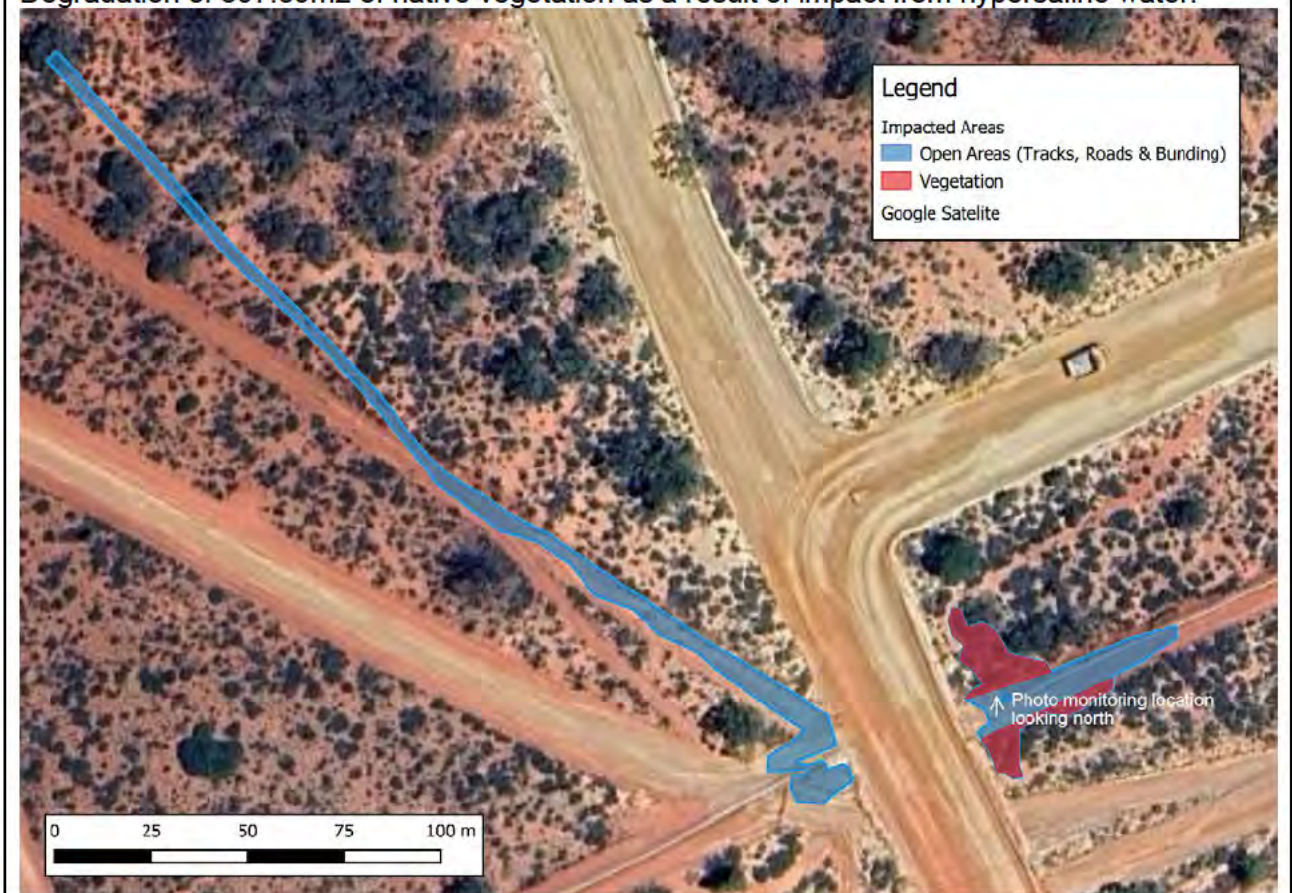
Section E – Details of non-compliance with licence condition			
Please use a separate page for each condition with which the licence holder was non-compliant at a time during the reporting period.			
Condition no:	2c	Date(s) of non-compliance:	14/10/2023
Details of non-compliance:			
Failure of pipeline bund. Failure of automatic shut-off logic.			
What was the actual (or suspected) environmental impact of the non-compliance?			
NOTE – please attach maps or diagrams to provide insight into the precise location of where the non-compliance took place.

Degradation of 397.89m² of native vegetation as a result of impact from hypersaline water.

Section E – Details of non-compliance with licence condition	
Cause (or suspected cause) of non-compliance:	
<p>Mining contractor Terra Mining were undertaken routine maintenance on an adjacent haul road. The grading works had resulted in the formation of a windrow obstructing the entrance of the pipeline inspection track. A decision was made by the operator to use the grader to clear the windrow. In doing so, the grader blade nicked the pipeline causing it to split. The pipeline was buried beneath the haulage road and visibility of the pipe was obscured as it exited the ground.</p> <p>The pipeline, where not buried was contained within a bund. At the exit point it appears the pipeline was covered with material (expected to be the bund), likely a result of recent storm activities, increased use of the track and nearby maintenance work. This gave the pipeline the appearance of being buried however was insubstantial at containing the discharge.</p> <p>The pipeline is fitted with flow meters and telemetry providing an automatic shut-off functionality. Given the length of the pipeline, distance between communication towers and properties of the water a tolerance logic (which utilizes an averaging timeframe) was applied to the program during the commissioning phase to allow the pipeline to continue operating when experiencing 'normal' operational fluctuations. The pulsating and slow release of the water was not detected as a result of the length of the averaging period utilized and therefore the automatic shut-off did not engage. A breakdown in communication between departments meant it took 45 minutes to shut-off the discharge.</p>

Action taken to mitigate any adverse effects of non-compliance and prevent recurrence of the non-compliance:	
<p>The pipeline has been lowered a further 300mm into the ground by trenching beneath it and the material used to raise the surrounding bunding. This has increased the height and strength of the bunds. This was completed on the 17/10/2023 and the pipeline put back into service.</p> <p>The tolerance of the automatic shut-off has been reduced by changing the logic to a 3-minute average moving flow as opposed to the 15-minute average previously used. This change has been applied and the system tested.</p> <p>Monthly photo monitoring of the impacted vegetation is underway. See AER.</p>	
Was this non-compliance previously reported to DWER?	
<input checked="" type="checkbox"/> Yes, and	
<input checked="" type="checkbox"/> Reported to DWER verbally	Date: 15/10/2023
<input checked="" type="checkbox"/> Reported to DWER in writing	Date: 17/10/2023
