Annual Audit Compliance Report Form
Environmental Protection Act 1986, Part V

Section A – Licence Details			
Licence number:	L4597/1988/14	Licence file number:	DER2014/000887
Licence holder:	[REDACTED]		
Trading as:			
ACN:			
Registered address:			
Reporting period:	01 /10 / 2020	to	31 /09 / 2021

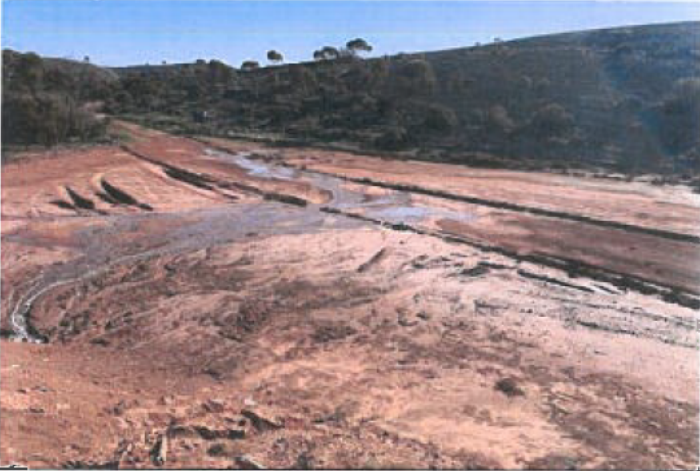
Section E – Details of Non-Compliance with Licence Condition			
Please use a separate page for each condition with which the licence holder was non-compliant at a time during the reporting period.			
Condition no:	1.2.1 & 1.2.4	Date(s) of non-compliance:	13/09/2021
Details of non-compliance:			
The silver pit pump was not turned off on night shift and pit water was pumping into the Nevoria T/N dam overnight which caused an overflow. Water has pooled in a cleared area between dam and waste dump (as per Photo) where no vegetation is present.			
What was the actual (or suspected) environmental impact of the non-compliance?			
NOTE – please attach maps or diagrams to provide insight into the precise location of where the non-compliance took place.			
Approximately 20,000 litres of Hypersaline water TDS @ ~200,000mg/L was released, and the water has pooled in a cleared area between dam and waste dump where no vegetation is present.

Cause (or suspected cause) of non-compliance:			
During the night of the 12/9/21, the night shift supervisor did not turn the Silver pit pumps off, which caused the Nevoria Turkey Nest dam to overflow. The supervisor is a new employee and was not aware that the Nevoria Turkey Nest dam water level must be monitored during the night to check the levels.			
Action taken to mitigate any adverse effects of non-compliance and prevent recurrence of the non-compliance:			
Upon initial assessment the below actions have been identified:			
<ol style="list-style-type: none"> 1. Stopping pit water into the Turkeys Nest dam. 2. Repair any erosion damage caused to the dam wall. 3. Review the current system of dewatering induction and ensure that shift supervisors are aware of procedure. 4. Installation of high-water alarm and flashing light. 			
Was this non-compliance previously reported to DWER?			
Yes

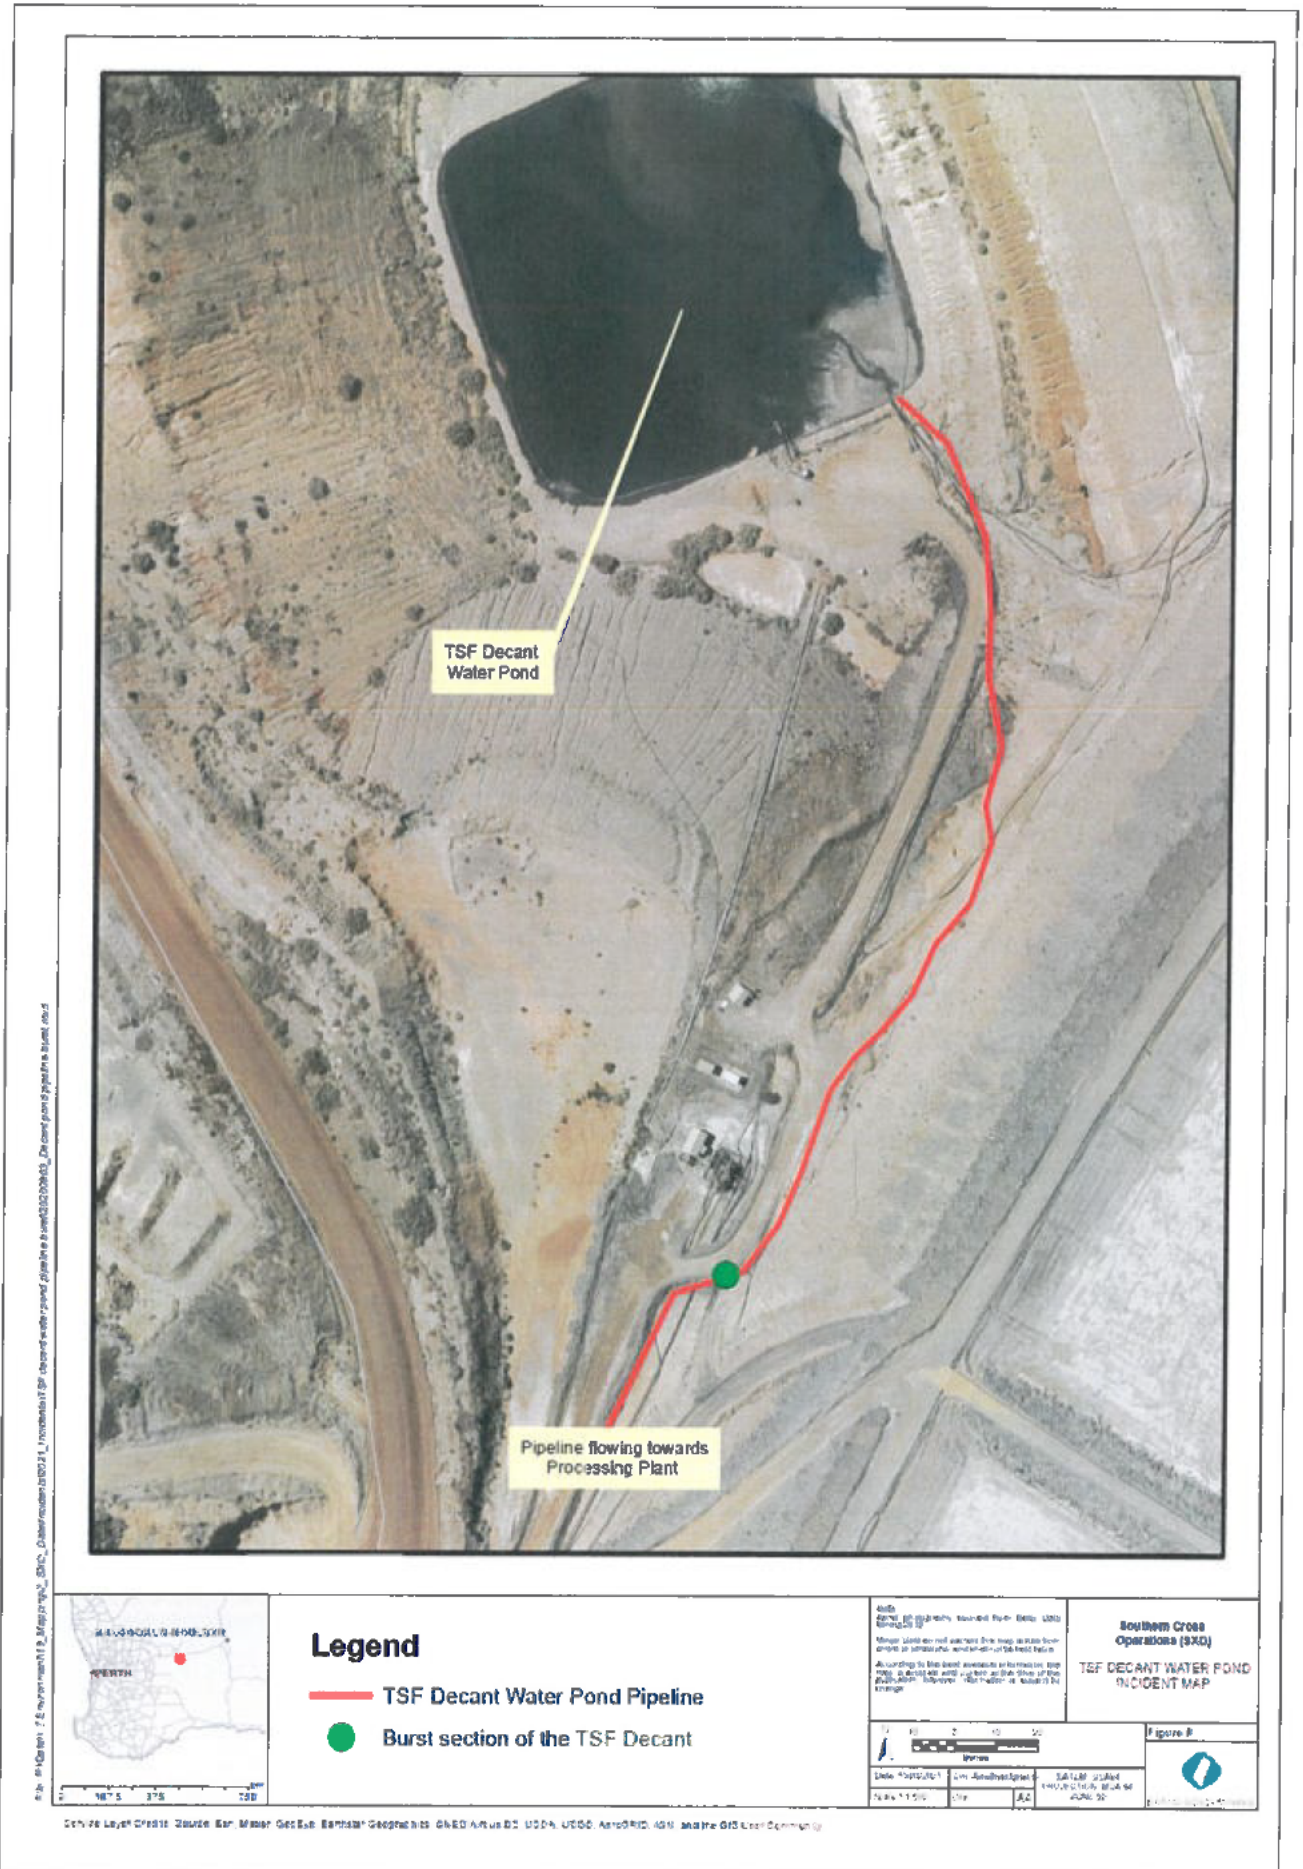
A section of decant pond to process plant pipeline at the west side of the TSF 1 & 2, has cracked at the top of pipe, releasing TSF decant water into the designed catchment bund. The pipe returns water from the TSF decant pond to the Processing Plant.

The location of the split was fully bunded, capturing the water released from the pipe. It is also within the disturbance footprint of the TSF, adjacent to the access road down the decant pond, where surface water flow would terminate. The location had been holding water at the time of the incident due to heavy rainfall in the days prior. A total volume of the spill is difficult to calculate due to the existing rainwater and the split being on top of the pipe, releasing only a proportion of the pipes throughput. Estimates are of approximately 50 – 100m³.

Samples were taken of the water within the bund, which returned values of 7.45 pH; 64,640 ppm TDS and 0.00 ppm CN. The salinity would equate to approximately half the level of the raw water, so there is some dilution with rainwater, however the lack of residual cyanide shows it was not a significant proportion.

Cause (or suspected cause) of non-compliance:
The cause of the fractured pipeline appears due to a weak point developing on top of the pipeline as it crosses the roadside bund. Periodic use of the pipeline and high temperatures have caused it to repeatedly flatten, creating a weak point where the fracture has occurred.
Action taken to mitigate any adverse effects of non-compliance and prevent recurrence of the non-compliance:
The section of pipeline has been replaced.
Was this non-compliance previously reported to DWER?
<input checked="" type="checkbox"/> Yes
