Rhodes Ridge Construction Camp – Geotechnical and Environmental Report

COPP210911-REP-G-001

Project Name:	Rhodes Ridge Construction Camp				
Project Number:	COPP210911 / P-0325003				
Client:	Rio Tinto Iron Ore				
Document No:	COPP210911-REP-G-001	Rev:	B	Rev Date:	11/03/2024

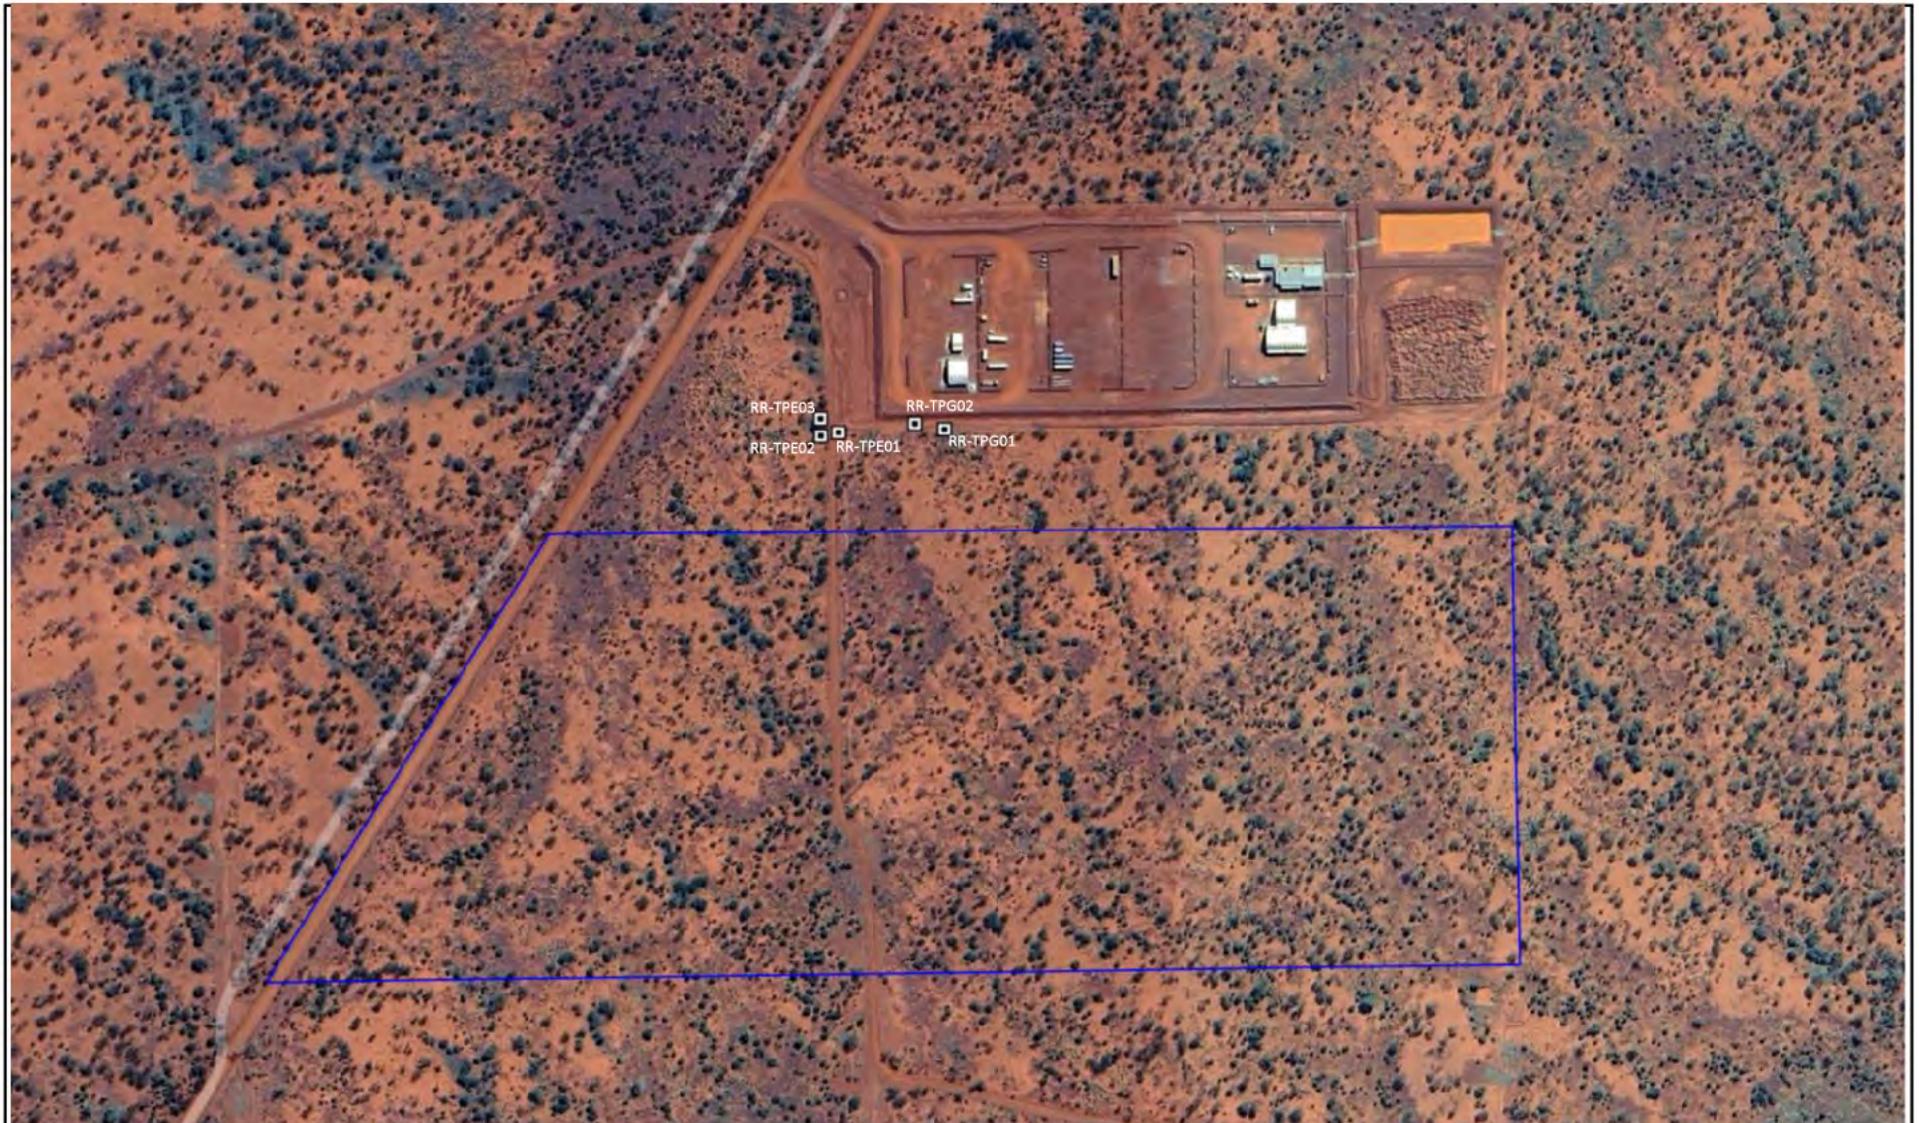
Test Pit Location	Map data: Google Maxar Technologies	CLIENT RIO TINTO IRON ORE	SCALE Not to Scale			
		PROJECT RHODES RIDGE CONSTRUCTION CAMP	DRAWN WP	DATE 6/03/2024		
		TITLE TEST PIT LOCATIONS	CHECKED BL	DATE 6/03/2024		
		JOB No COPP210911	Figure 1

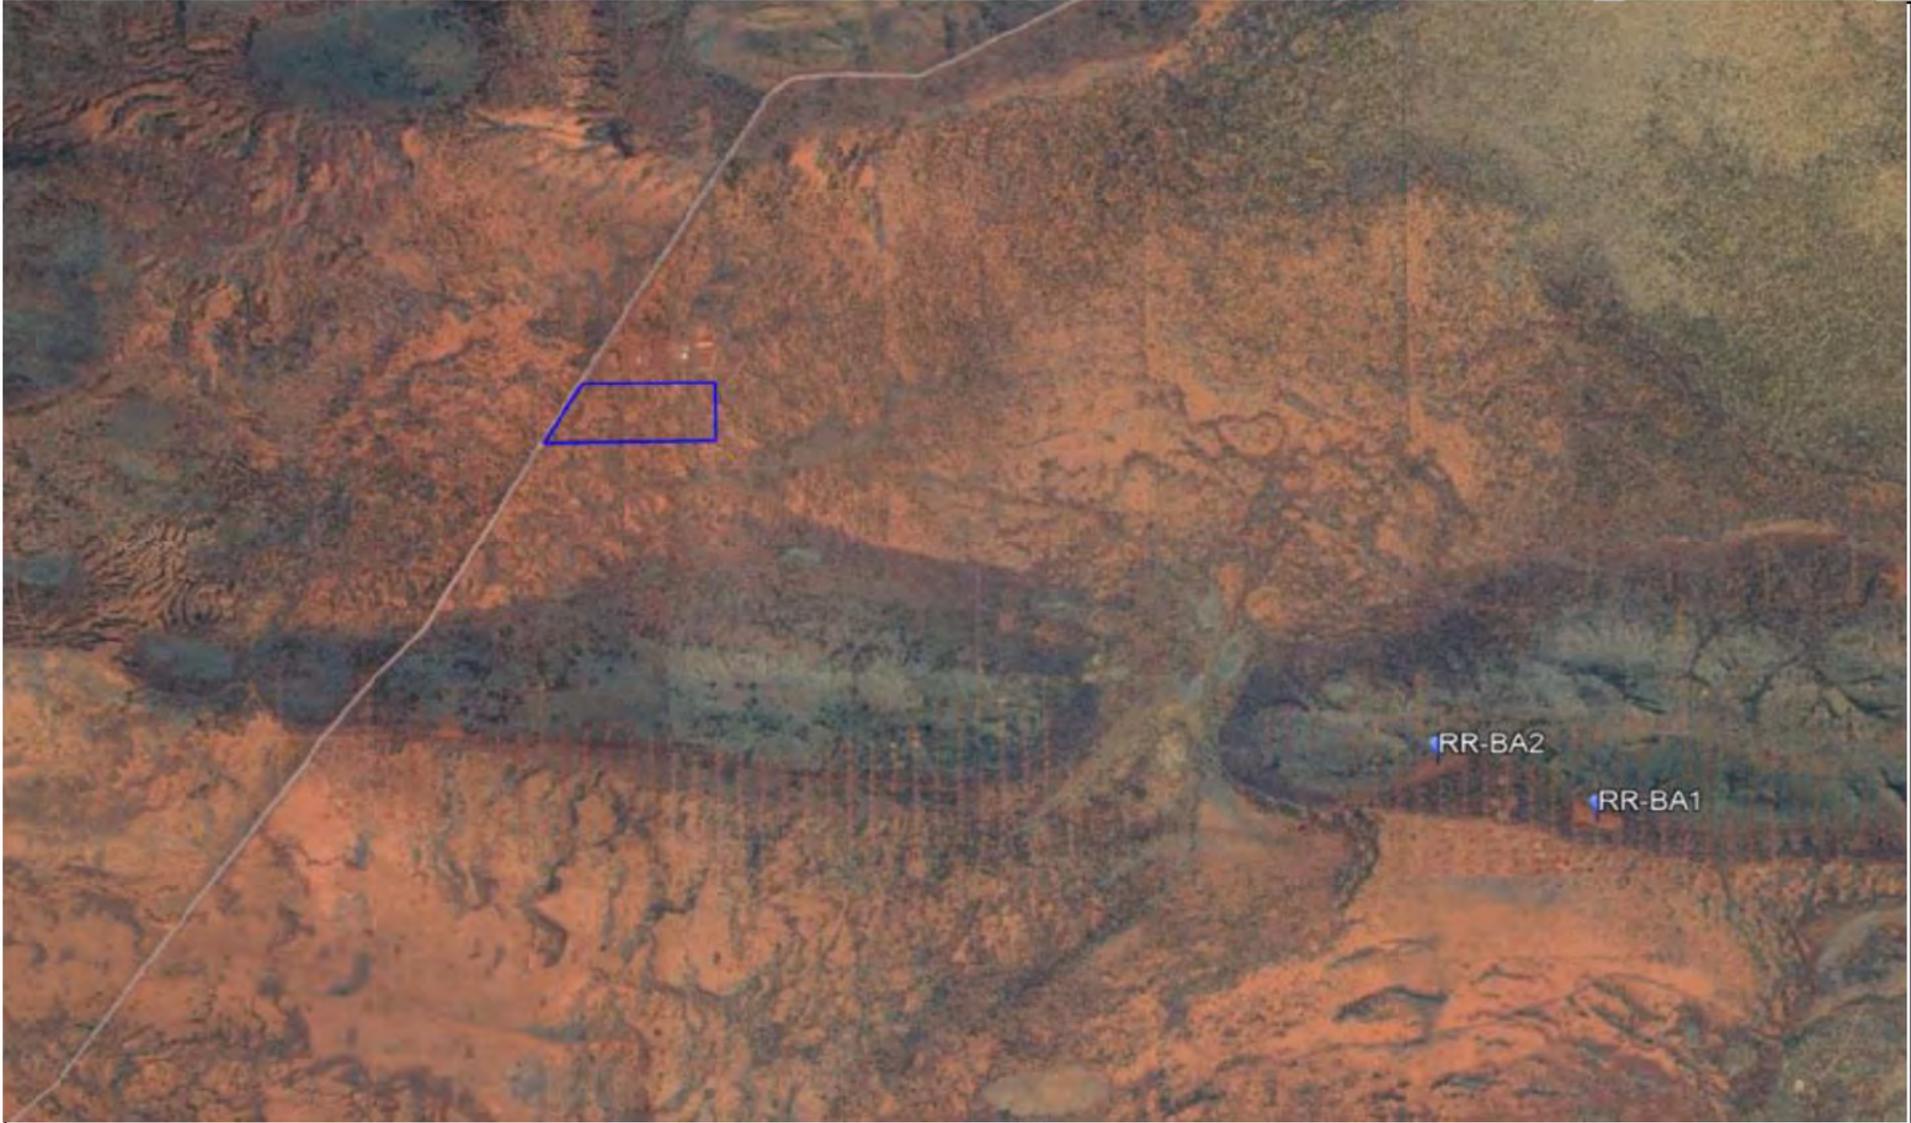
Proposed Site	Map data: Google Maxar Technologies	CLIENT	RIO TINTO IRON ORE	SCALE	Not to Scale		
		PROJECT	RHODES RIDGE CONSTRUCTION CAMP	DRAWN	WP	DATE	11/03/2024
				CHECKED	BL	DATE	11/03/2024
		TITLE	BORROW AREA LOCATIONS	Figure 2			
		JOB No	COPP210911

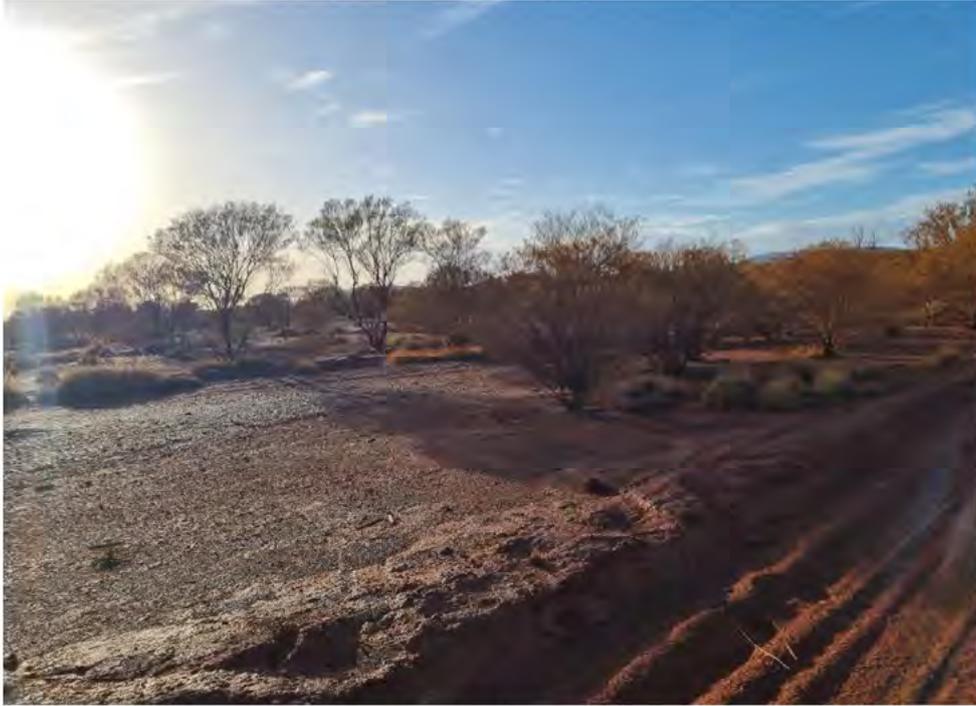
RR-TPE01 Before Disturbance

CLIENT	RTIO	SCALE	N.T.S	
PROJECT	Rhodes Ridge Construction Camp	DRAWN	WP	DATE 5/03/2024
		CHECKED	BL	DATE 6/03/2024
TITLE	Test Pit Photos	RR-TPE01 Before and After		
JOB No	COPP210911

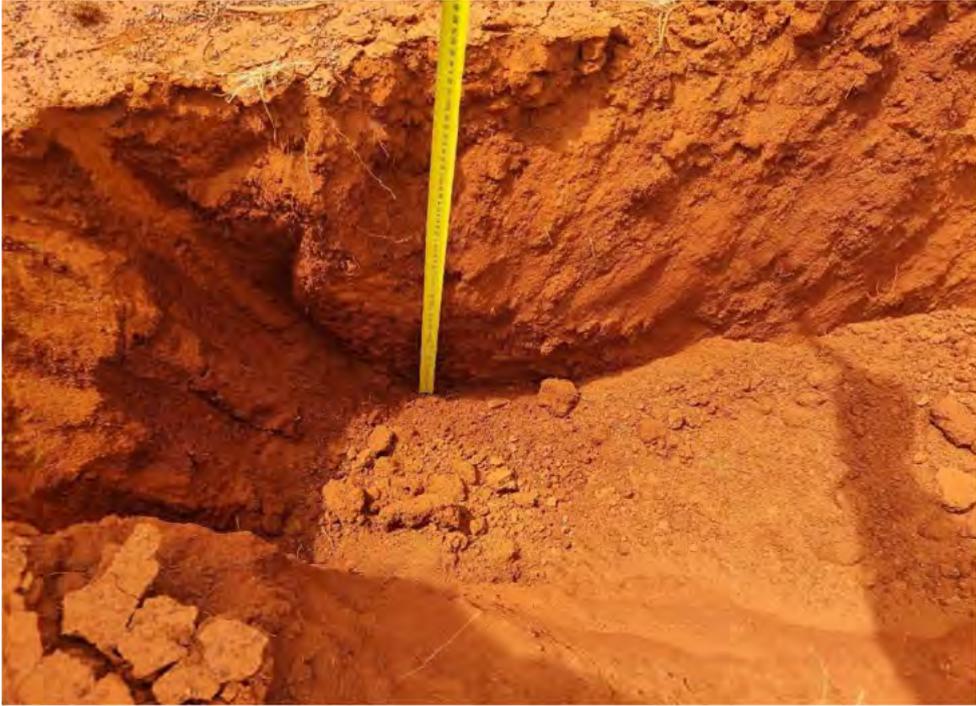
CLIENT	RTIO	SCALE	N.T.S	
PROJECT	Rhodes Ridge Construction Camp	DRAWN	WP	DATE 5/03/2024
		CHECKED	BL	DATE 6/03/2024
TITLE	Test Pit Photos	RR-TPE01 Excavation and Spoil		
JOB No	COPP210911
