16 August 2012

Document Ref. 2013-0007AC

RE: GEOTECHNICAL STABILITY REVIEW, OPAL VALE LANDFILL, CHITTY ROAD, TOODYAY, WA

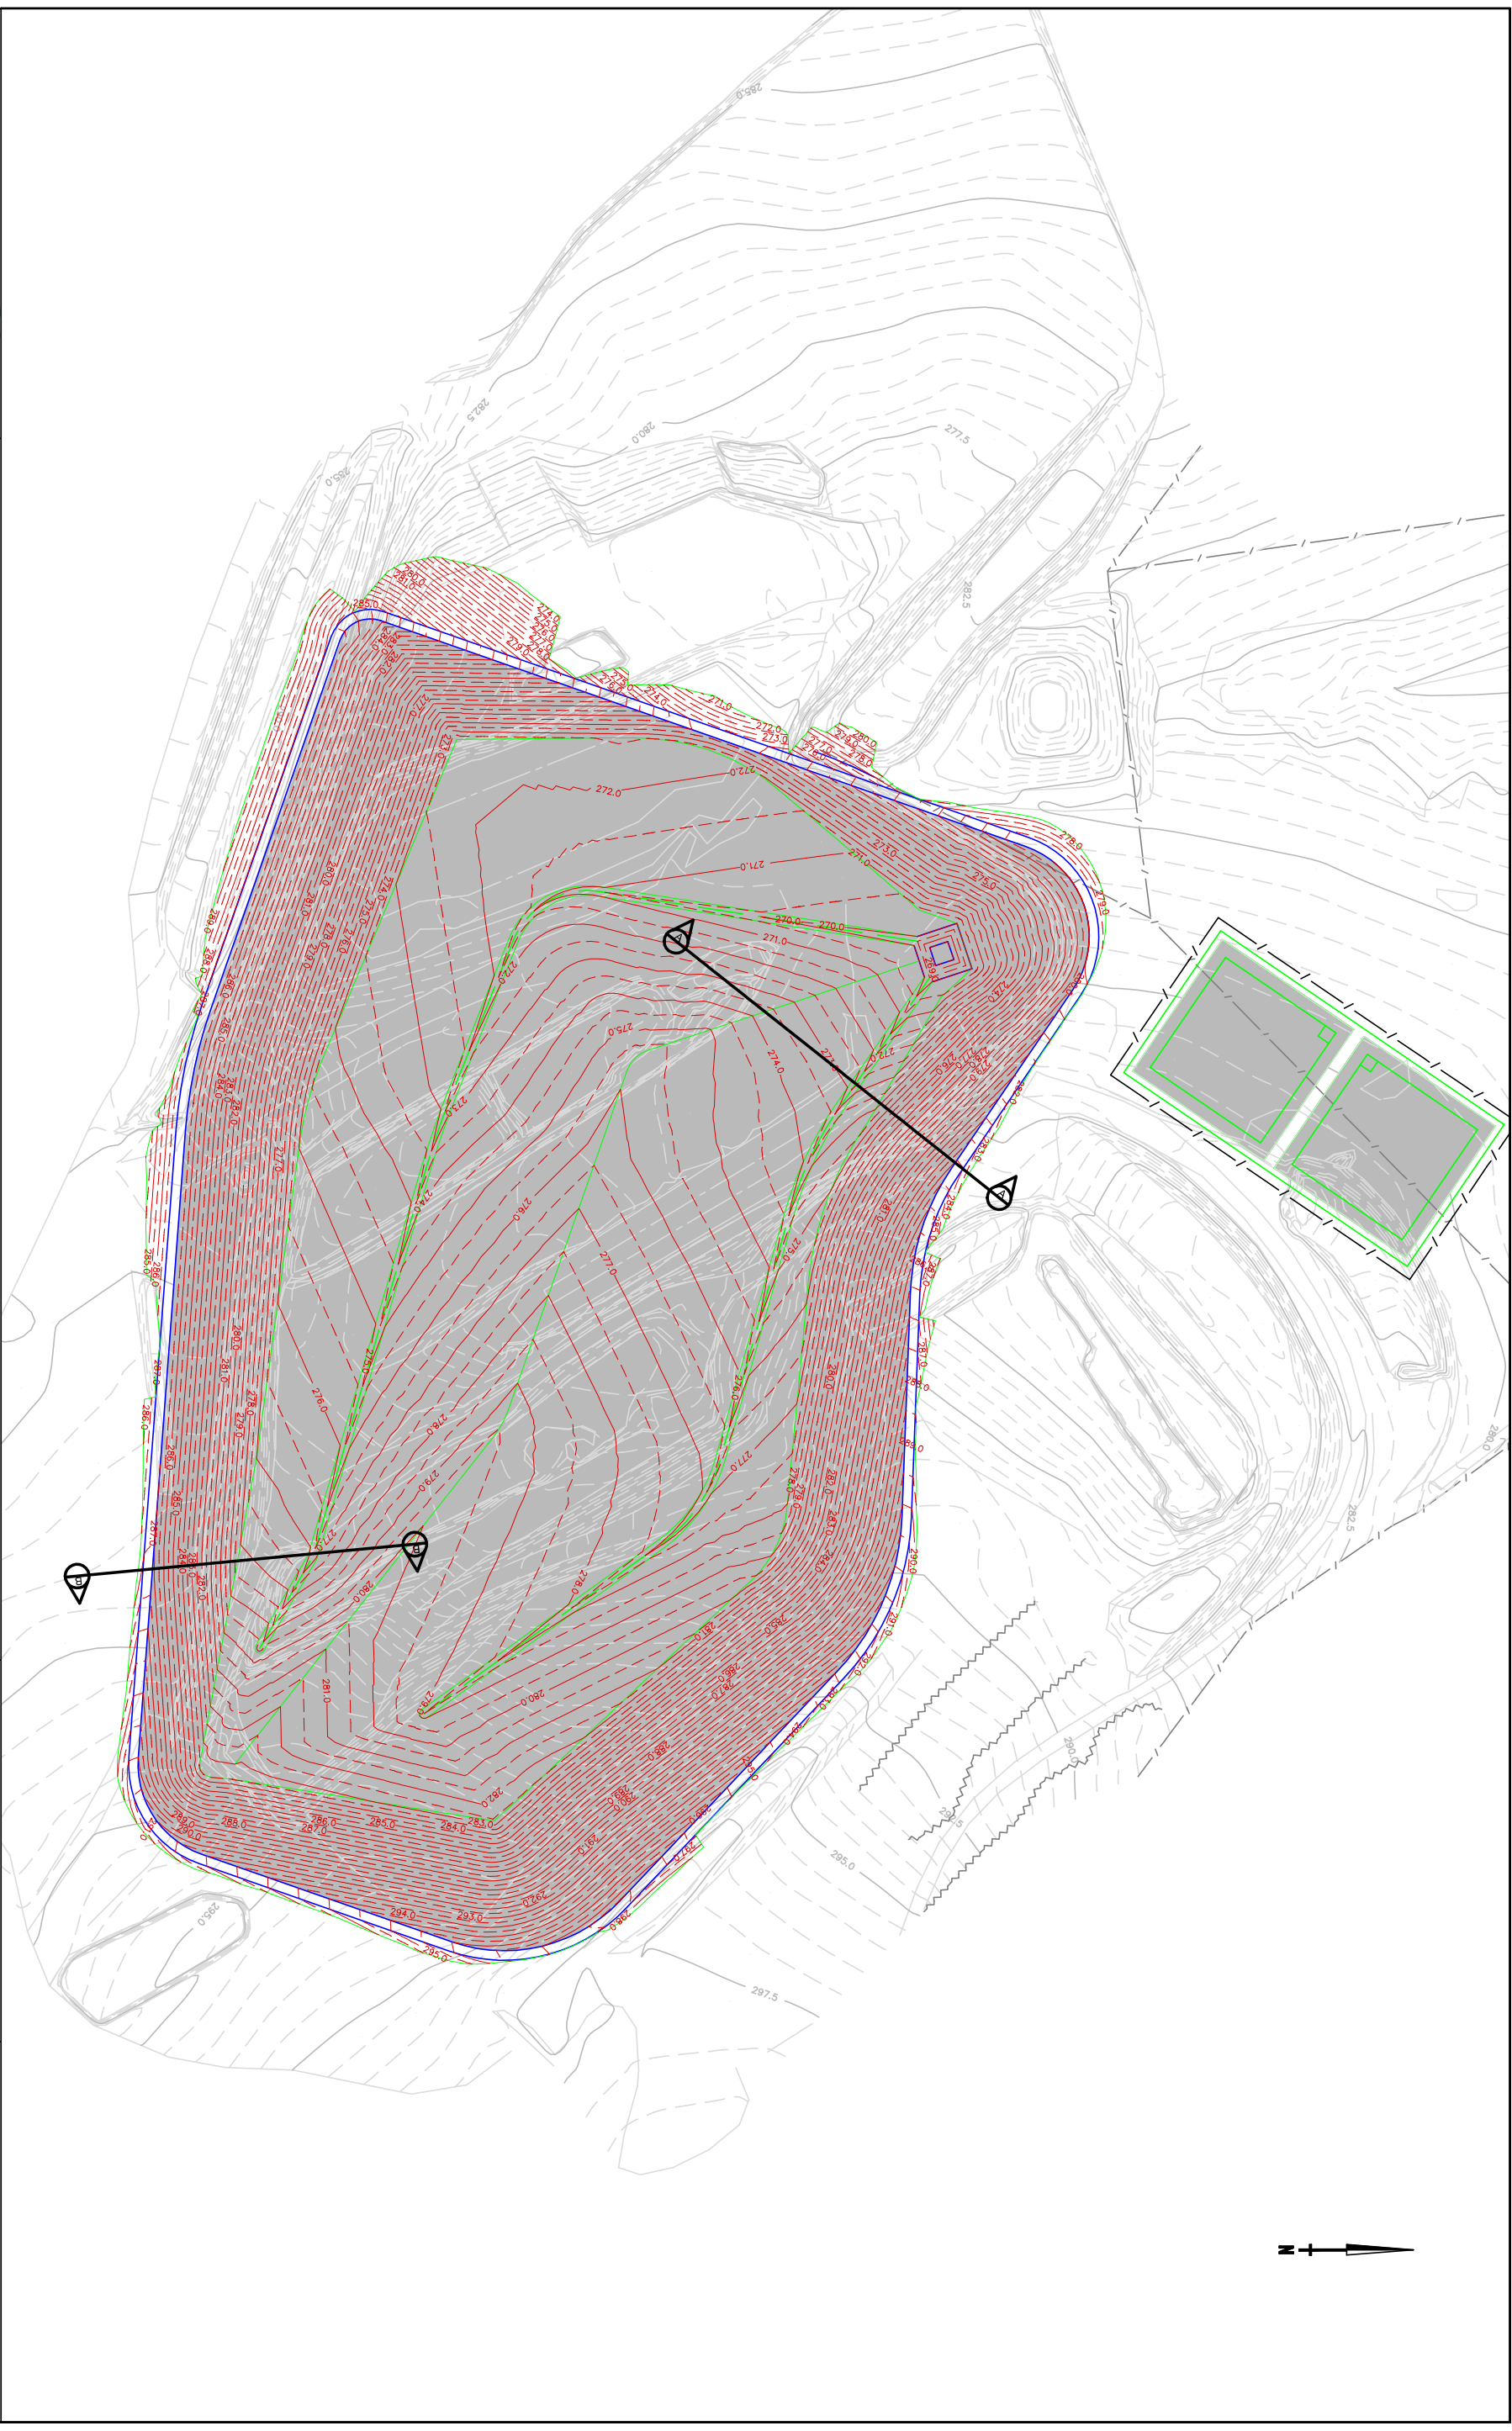
TITLE: **SITE PLAN**

Cross sections were drawn through strategic areas of the project where shown on the appended site plan. These sections were selected as being the most appropriate for computer stability analyses because the slopes were the steepest and the before and after earthworks profiles are significantly different. The cross-sections were analysed for deep seated circular slips. The slope stability software program used was SLIDE version 6.0.

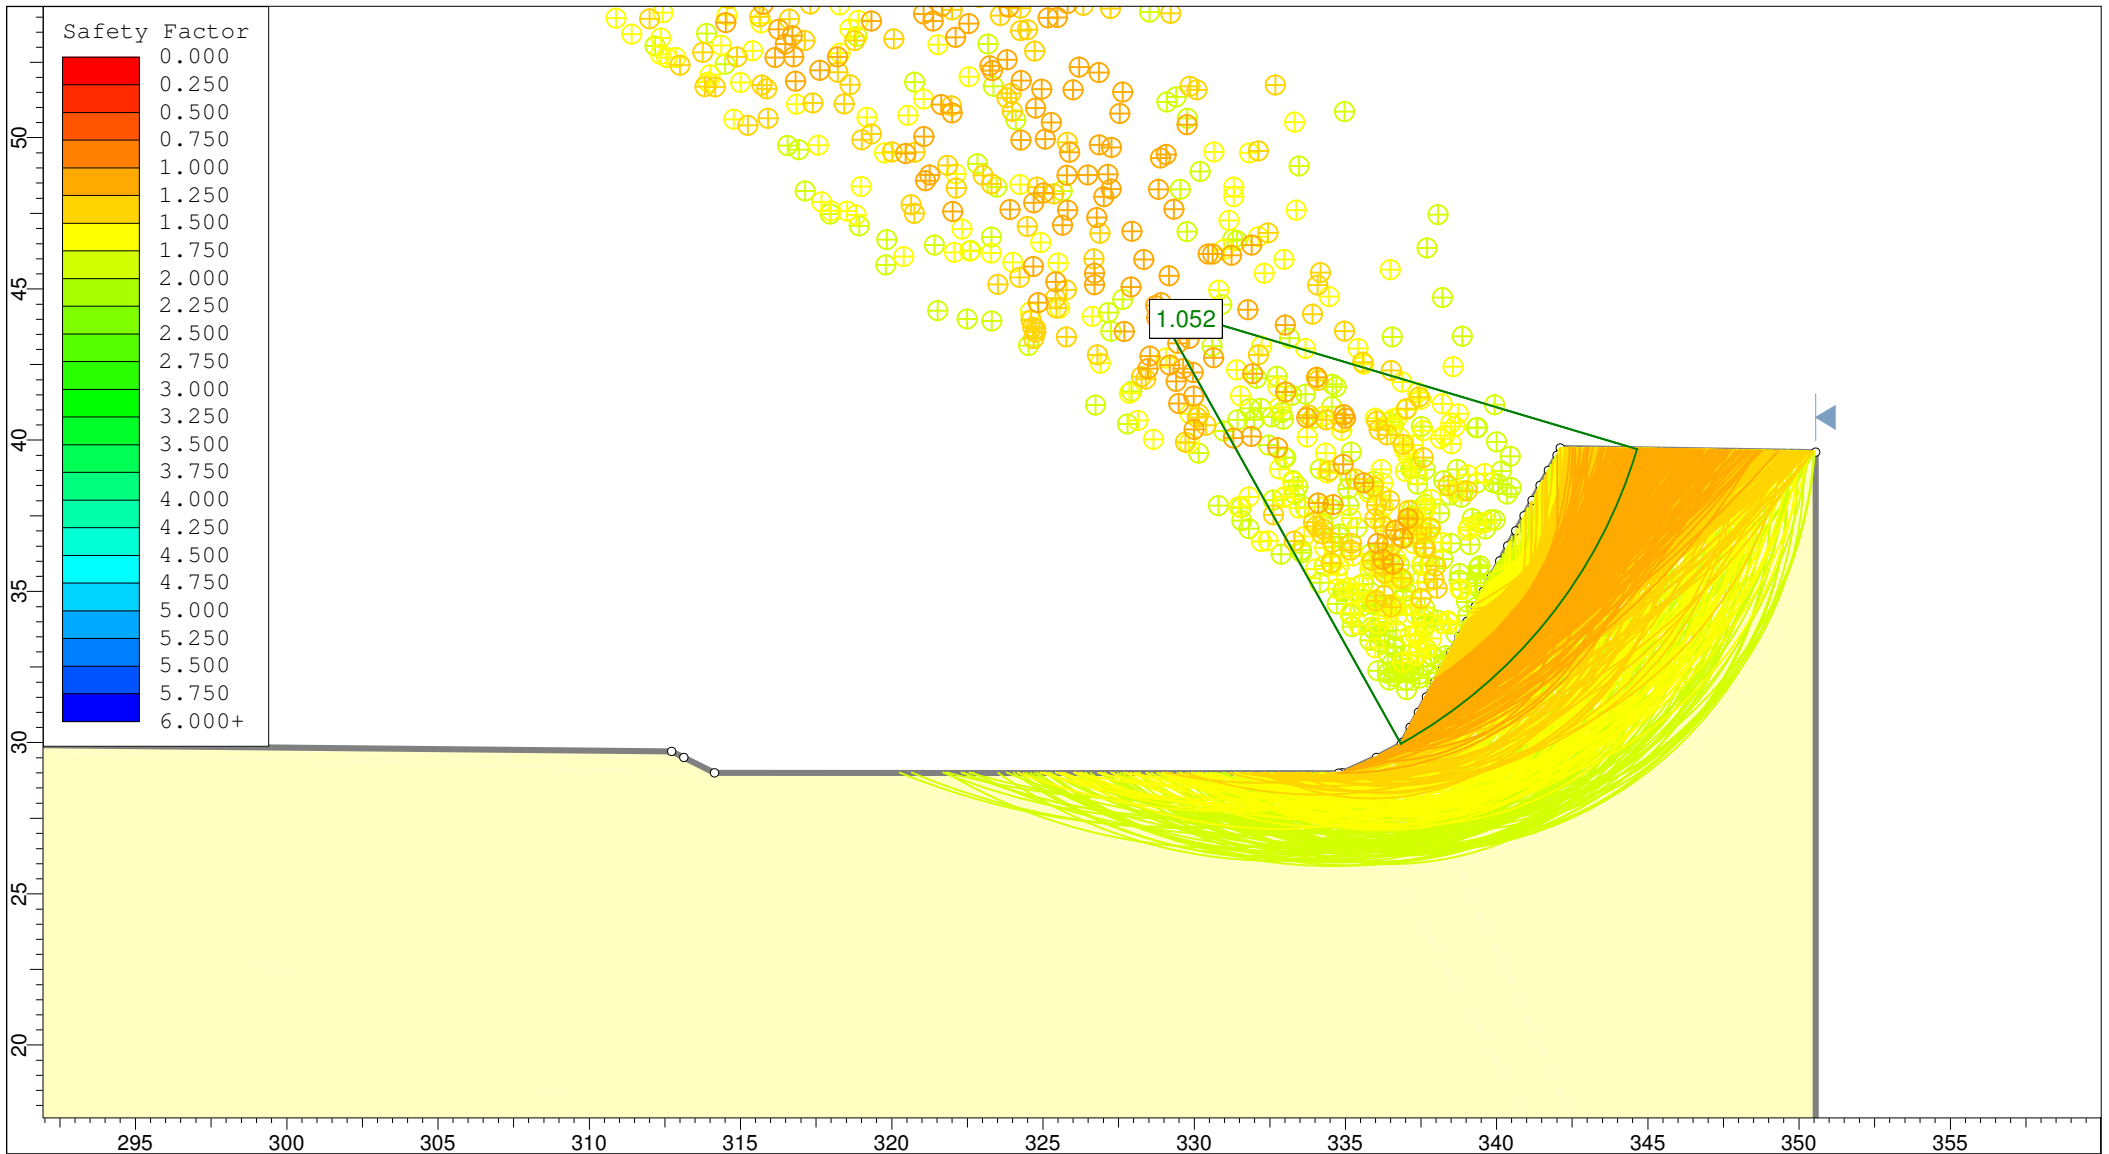
Project		OPAL VALE LANDFILL	
Slope stability analysis condition			
Existing Slope Height and Angle (70 Deg) with no ground conditions - drained soil shear strength parameters			
Drawn By	PDC	Scale	1:250
Date	2/08/2012, 1:04:52 PM	File Name	Existing Slope noGW NON SEISMIC.slim

As can be seen from the above results, with drained soil shear strength parameters, the cross-section was found to have a minimum factor of safety of 0.9 for an overburden slip extending approximately 3 metres back from the crest of the slope. This factor is for 'worst case' highly saturated ground conditions, which should not occur on the site other than during temporary extreme storm conditions and accordingly the result is considered to be satisfactory. The analysis of a dry slope with drained soil strength parameters produced a factor of safety of 1.1.

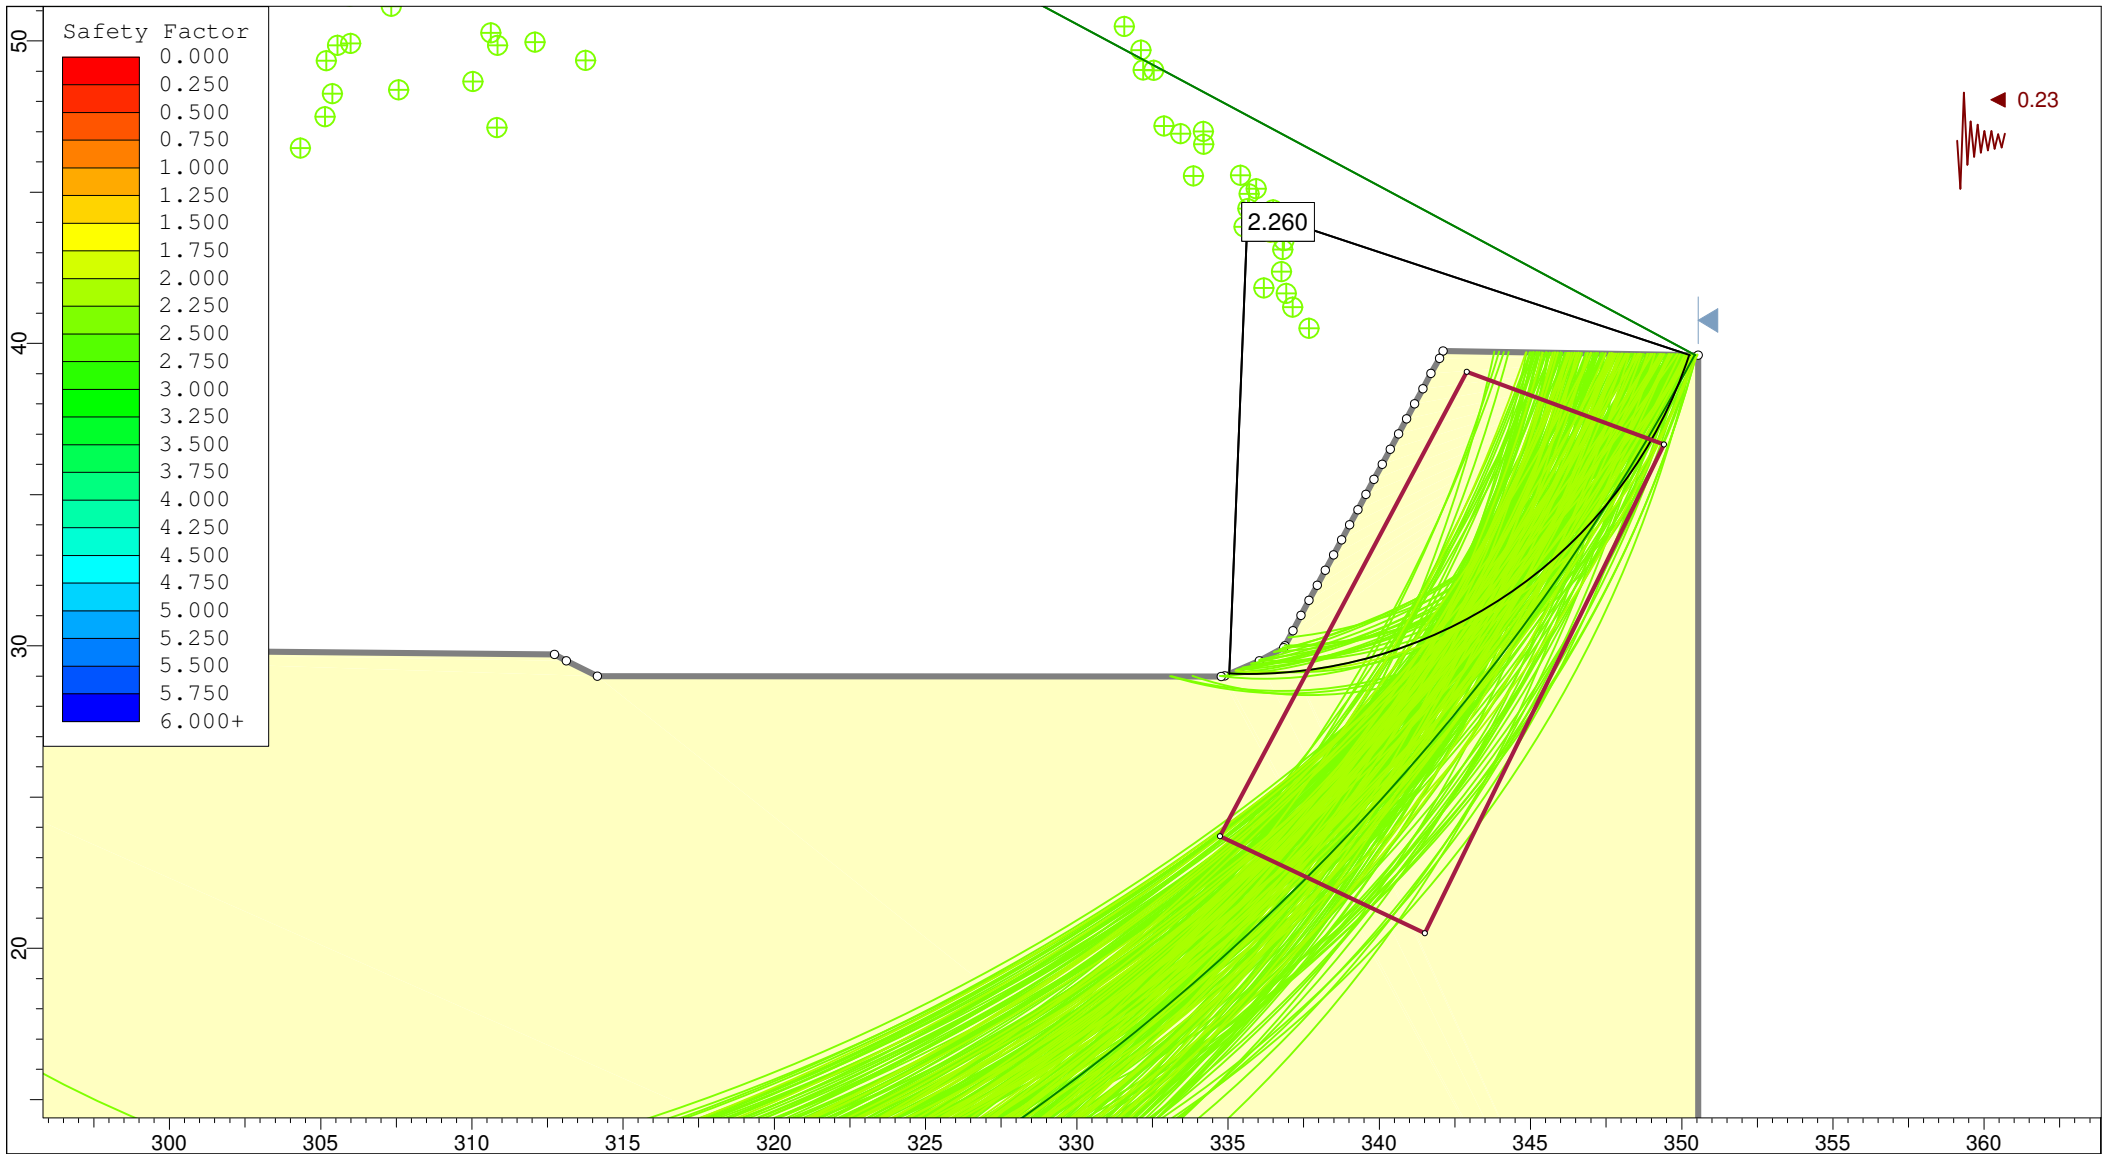
<i>Project</i>	OPAL VALE LANDFILL	
<i>Slope stability analysis condition</i>	Existing slope height and angle with Seismic Load - horizontal ground acceleration 0.23 (70 deg) (Su > 100kPa)	
<i>Drawn By</i>	PDC	<i>Scale</i> 1:250
<i>Date</i>	2/08/2012, 1:04:52 PM	<i>File Name</i> Existing Slope UNDRAINED SEISMIC 0.23.slim

Using undrained soil shear strength parameters the factor of safety was 2.9. Then using conservative undrained soil strength parameters under pseudo-static loading produced a factor of safety in excess of 2. The slope was then analysed at proposed angles of 1V:3H (18 degrees) with minor cuts at the crest and bulk filling placed and compacted at the toe of the slope. This produced a factor of safety in excess of 2 for a high phreatic surface while a factor of safety of 1.5 using undrained soil shear strength parameters under pseudo-static loading was determined.

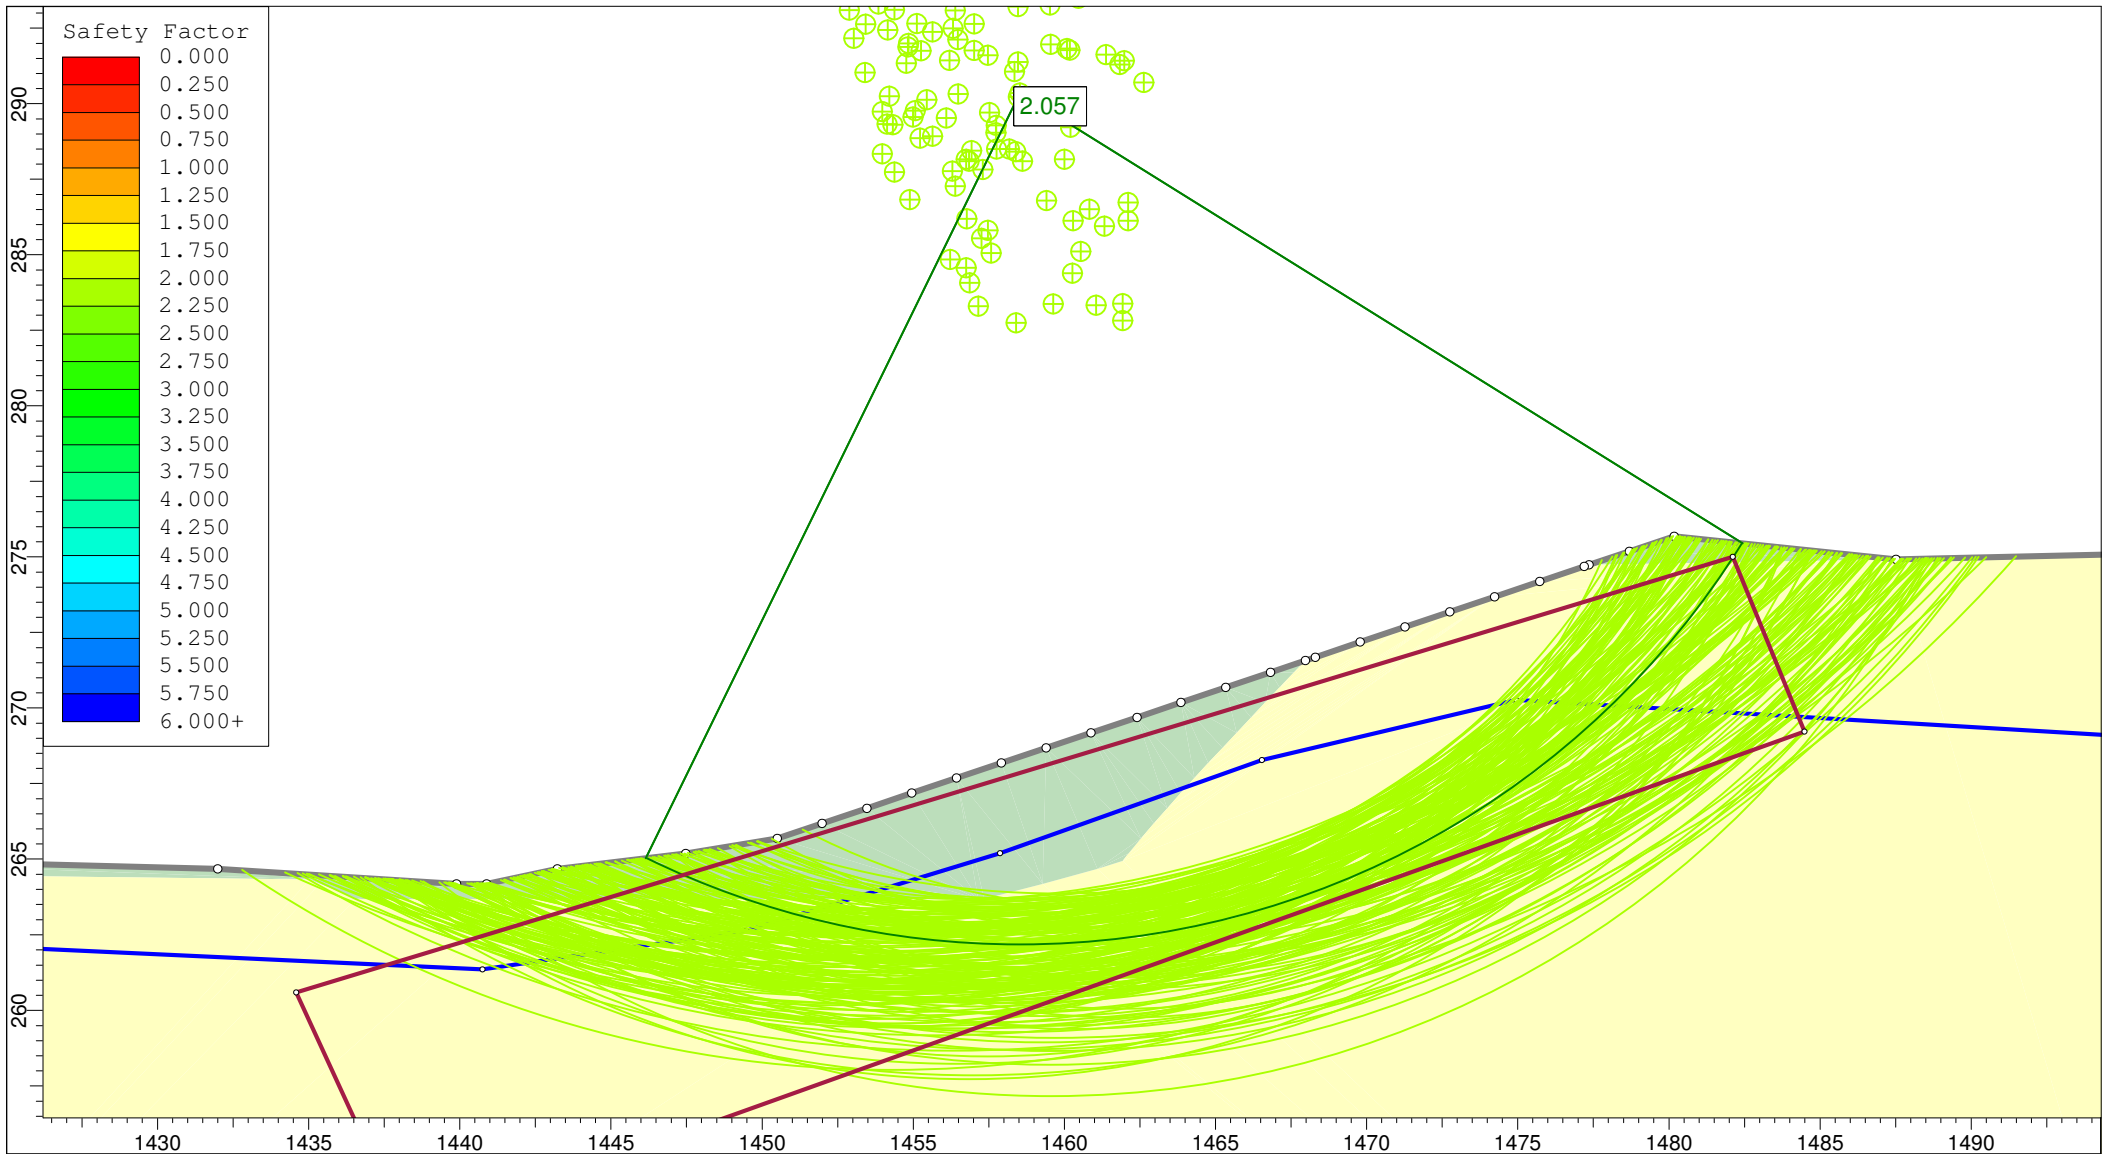
<i>Project</i>	OPAL VALE LANDFILL		
<i>Slope stability analysis condition</i>	Proposed slope angle (1V:3H) with highly saturated ground conditions		
<i>Drawn By</i>	PDC	<i>Scale</i>	1:250
<i>Date</i>	7/08/2012, 10:06:38 AM	<i>File Name</i>	Proposed Slope HIGHGW non seismic.slim

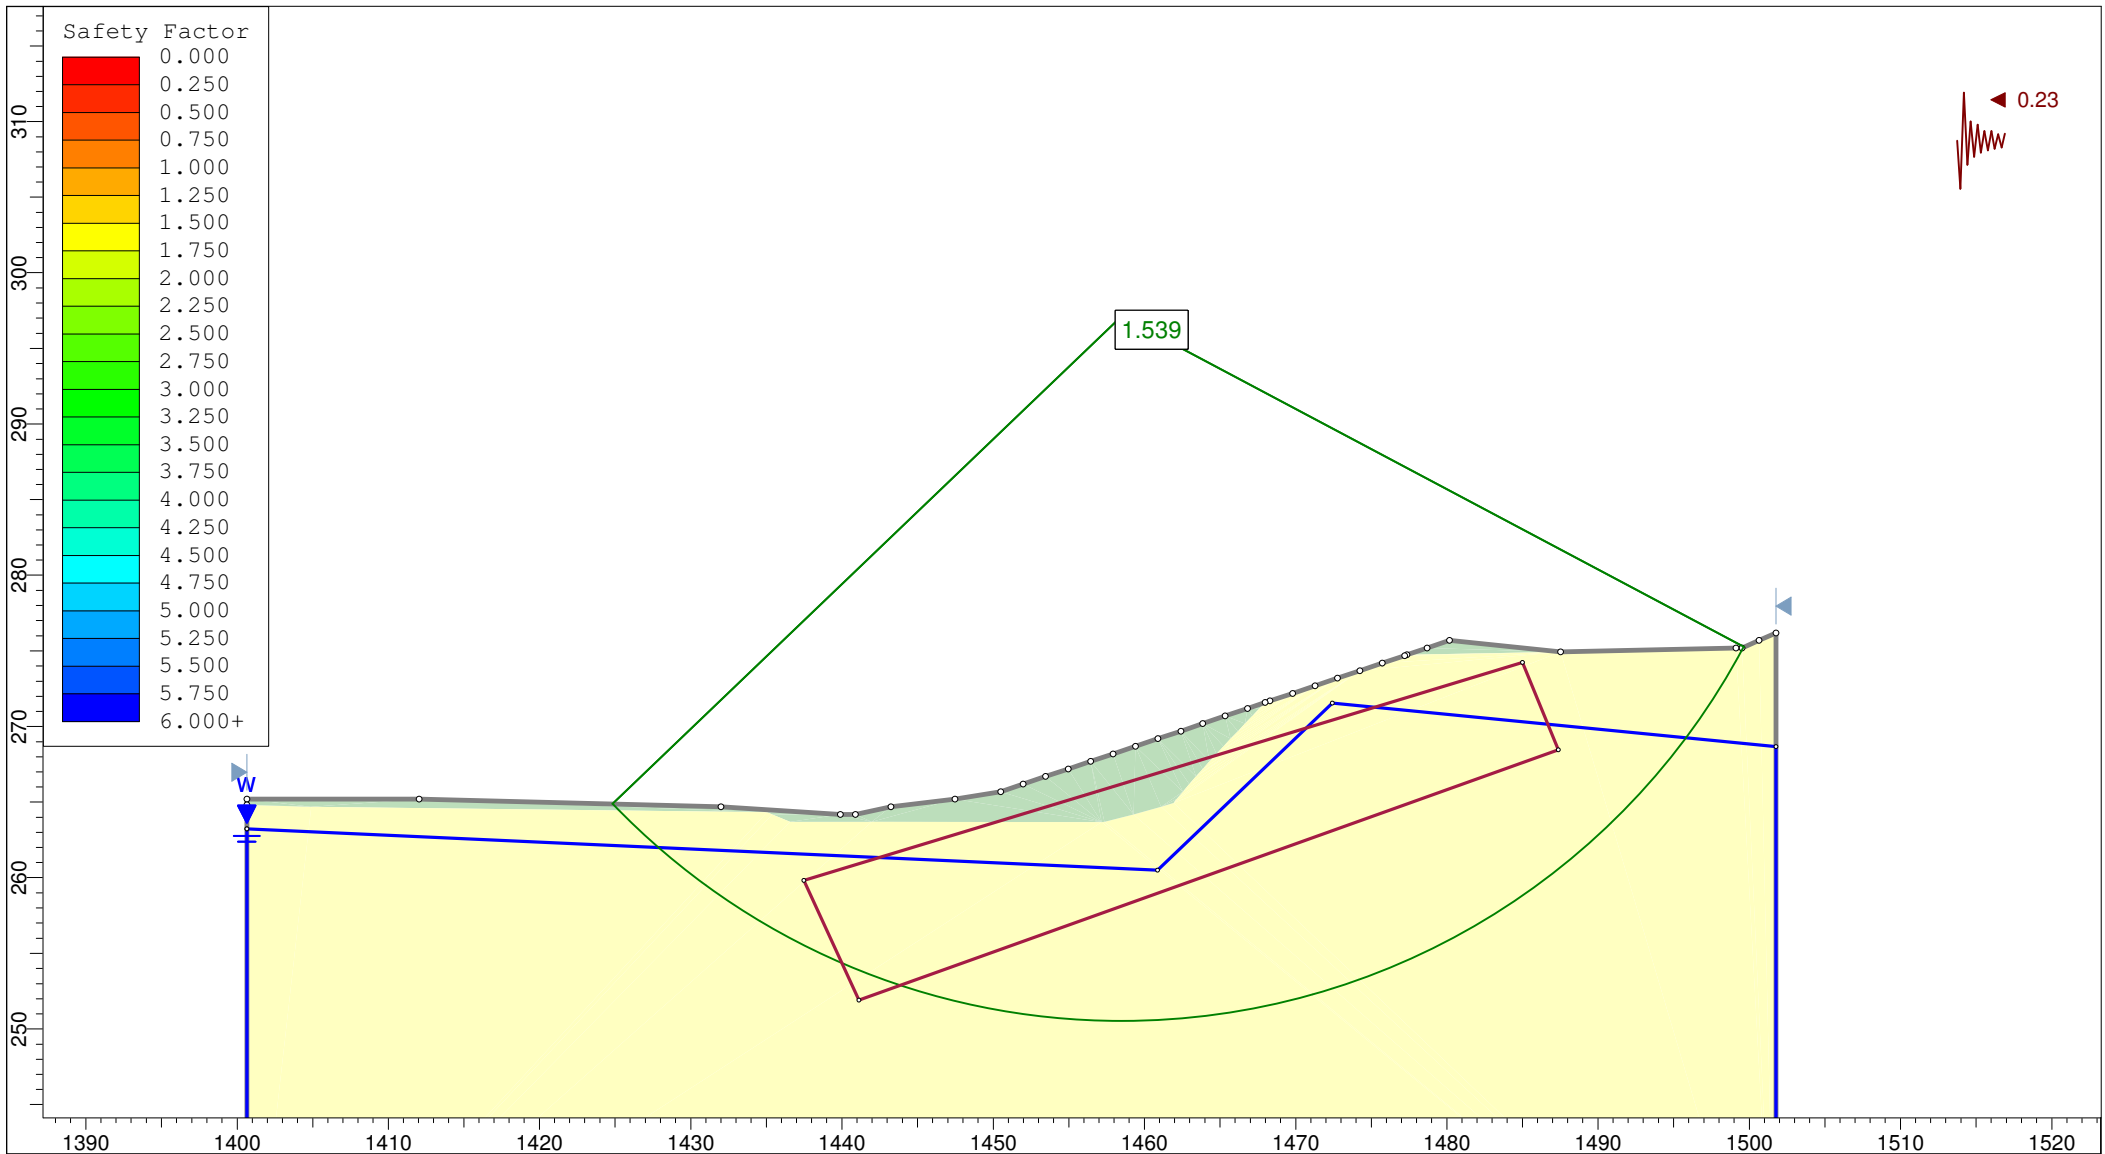
<i>Project</i>	OPAL VALE LANDFILL	
<i>Slope stability analysis condition</i>	Cell One Completed with Seismic Load - Horizontal ground acceleration 0.23	
<i>Drawn By</i>	PDC	<i>Scale</i> 1:500
<i>Date</i>	7/08/2012, 10:06:38 AM	<i>File Name</i> Proposed Slope SIEMIC LOAD 0 23 grid.slim

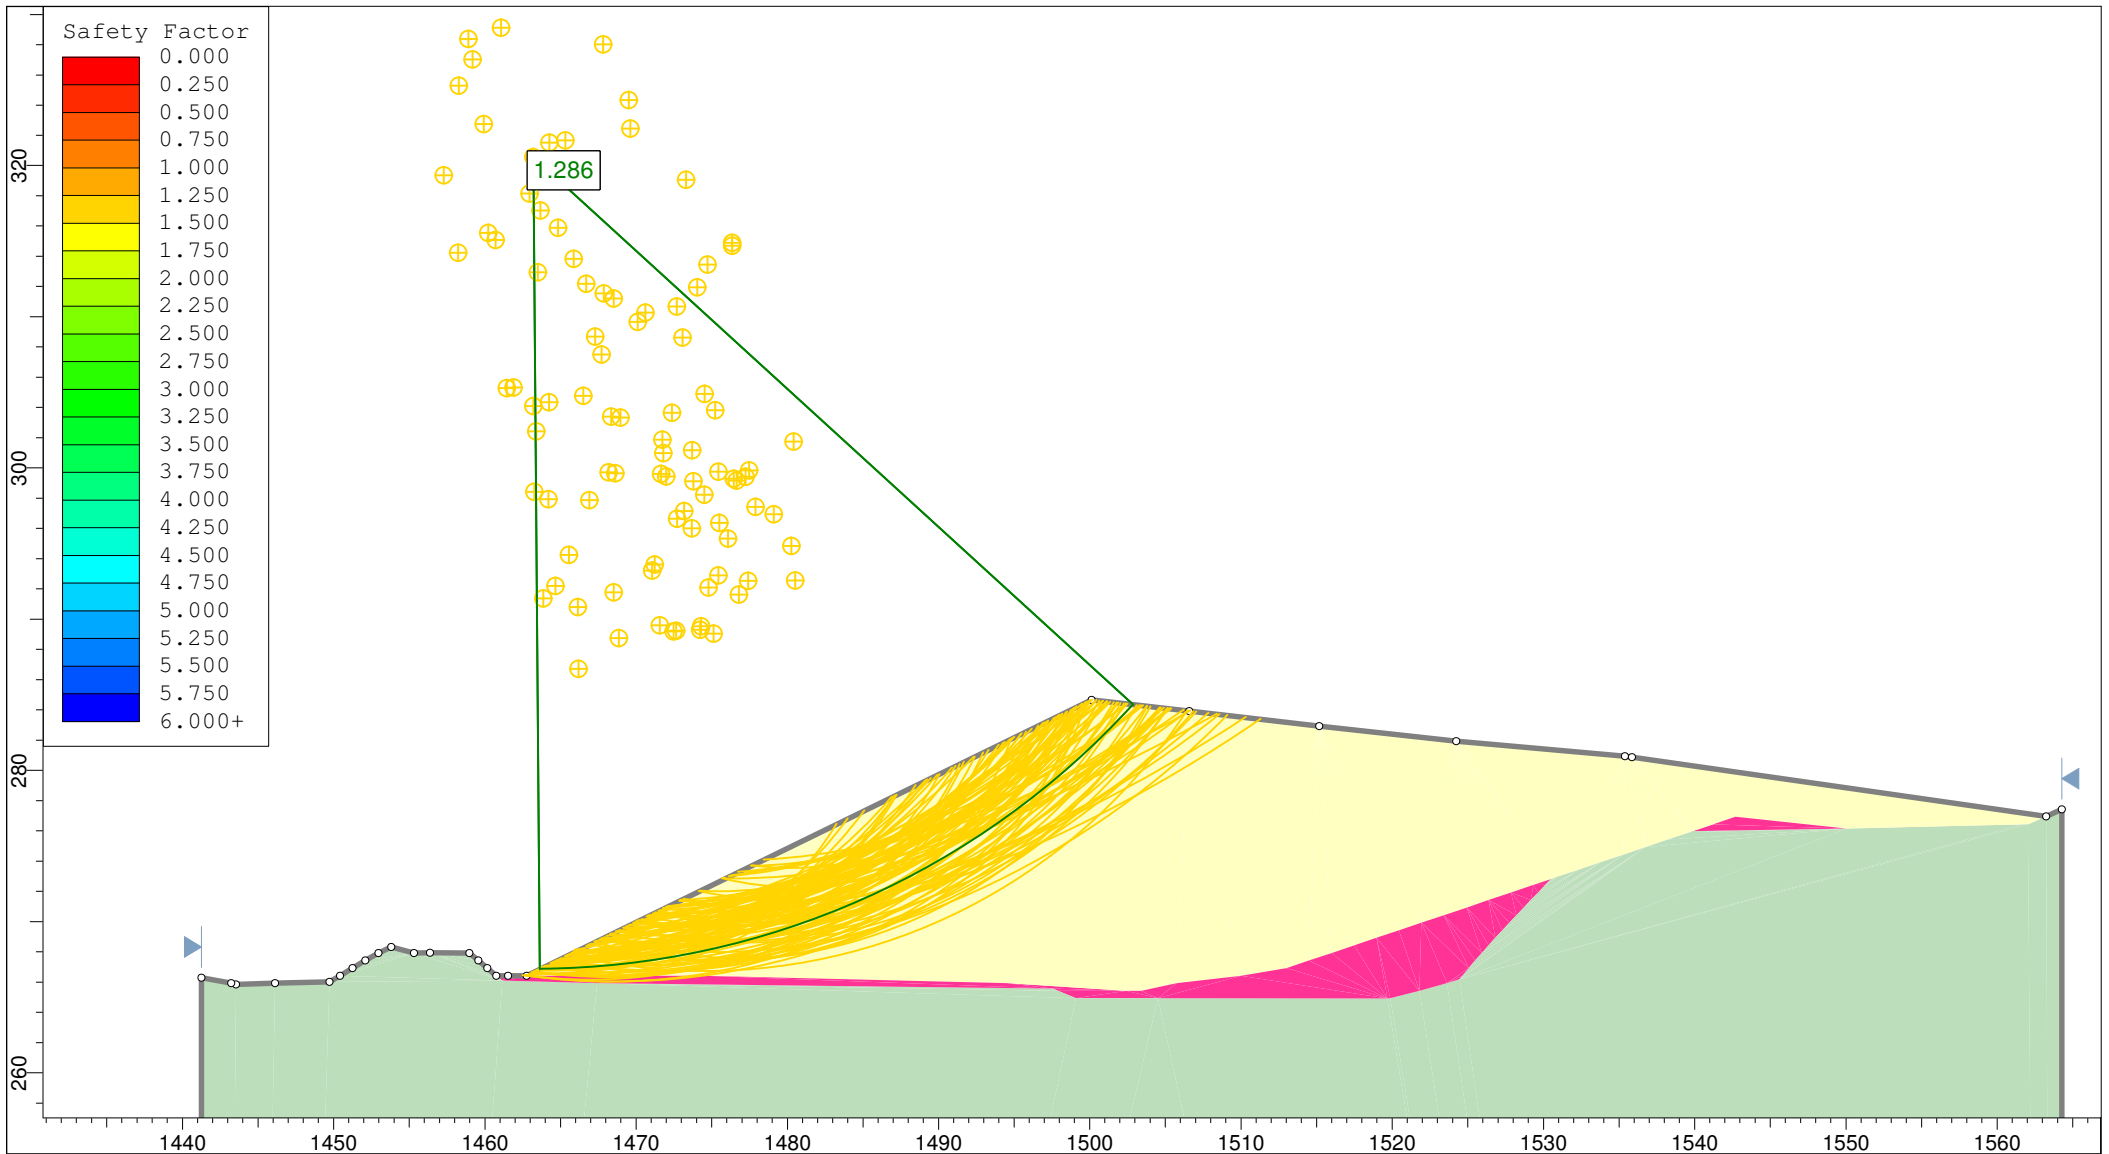
Project		OPAL VALE LANDFILL	
Slope stability analysis condition		Cell One Completed without Seismic Load	
Drawn By	PDC	Scale	1:500
Date	20/08/2012, 10:37:58 AM	File Name	Cell One Completed NON SEISMIC ver2.slim
