**ASPHALTECH**

## **LICENCE APPLICATION**

Part Lot 55 Sutherland Way, Picton, WA, 6229, Dec 2024

### **ODOUR RISK ASSESSMENT**

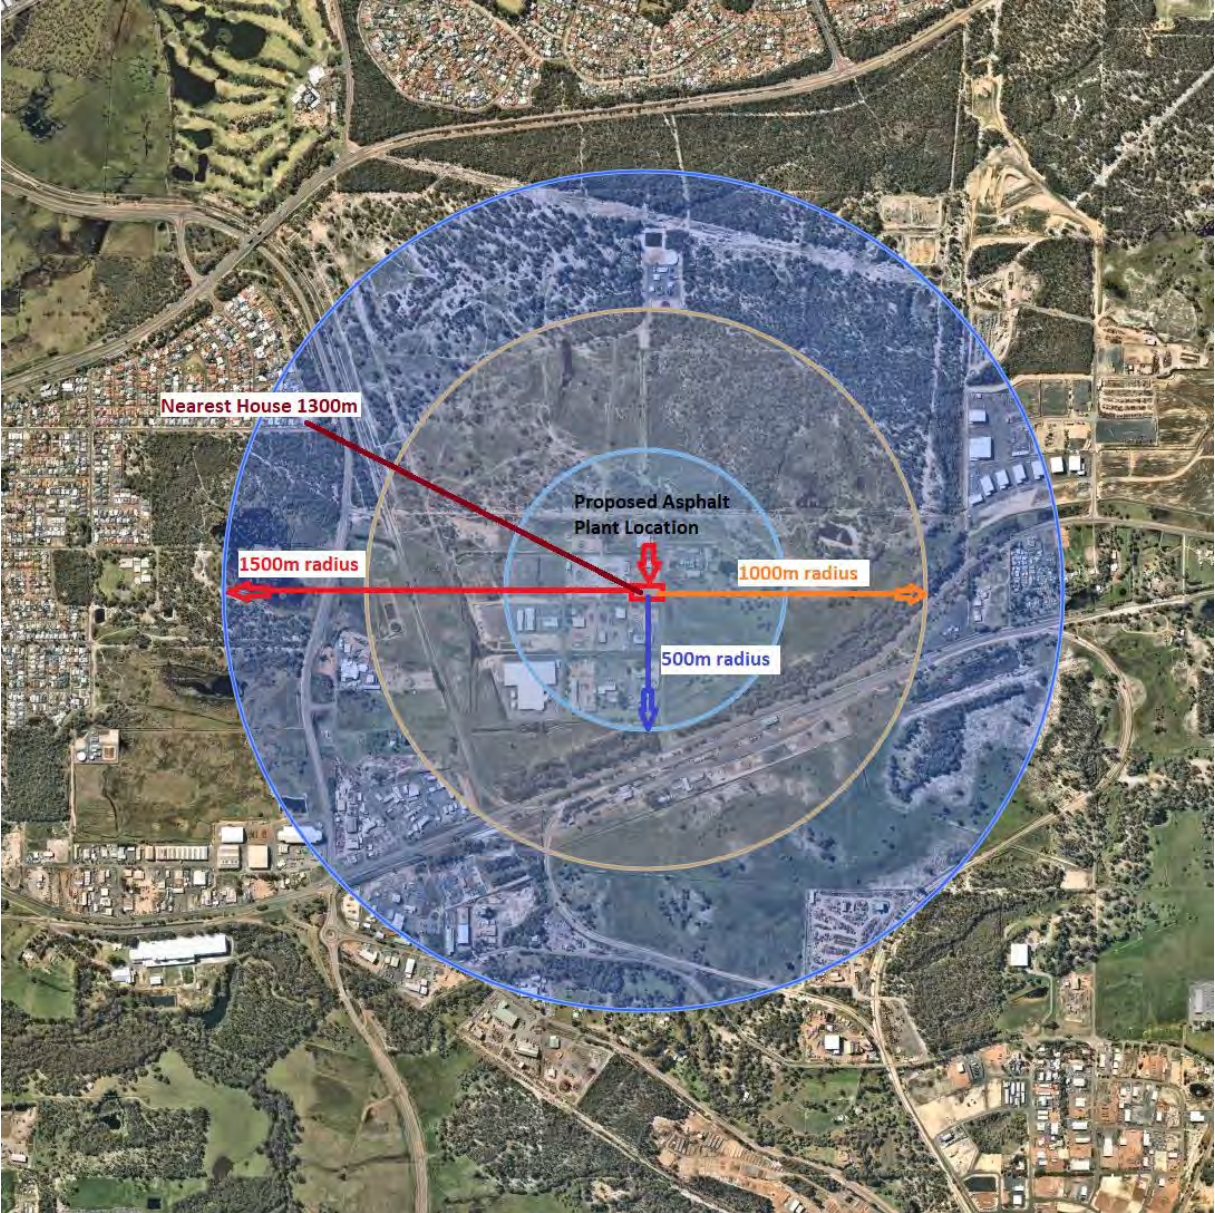
Figure OD6 Separation distances

Figure 6 shows the proposed plant location at Picton Site with a circle showing the radius of the nearest residence, together with a 500m radius, a 1000m radius and a 1500m radius

The distance to the nearest sensitive receptor (residential) is 1300m which complies with EPA Guidance for the Assessment of Environmental Factors 2005.

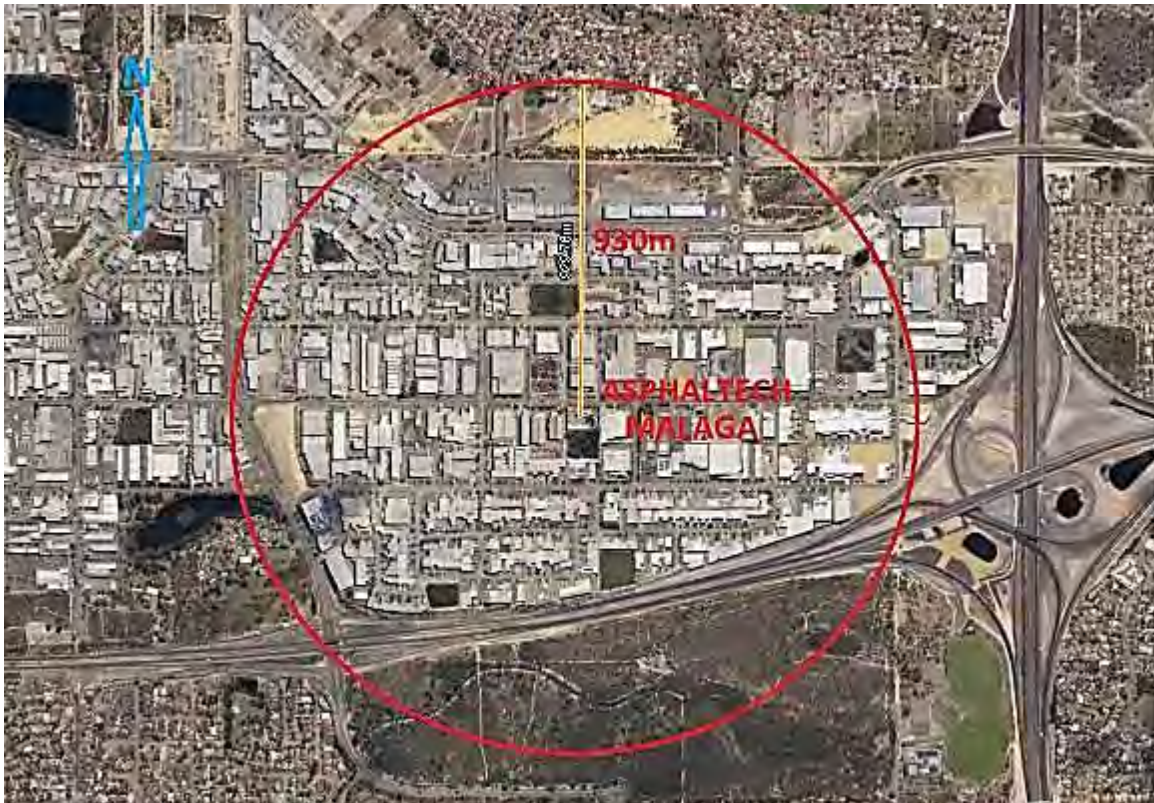
Figure OD8 Location of the Victoria Road Asphalt plant at Malaga where the plant operated.

The Malaga site at which the plant operated is shown below. The closest dwelling was at a distance of 930 metres to the north with extensive and intensive light industrial and other activities, offices, commercial and people working in close proximity to that Malaga plant. See Figure 8.

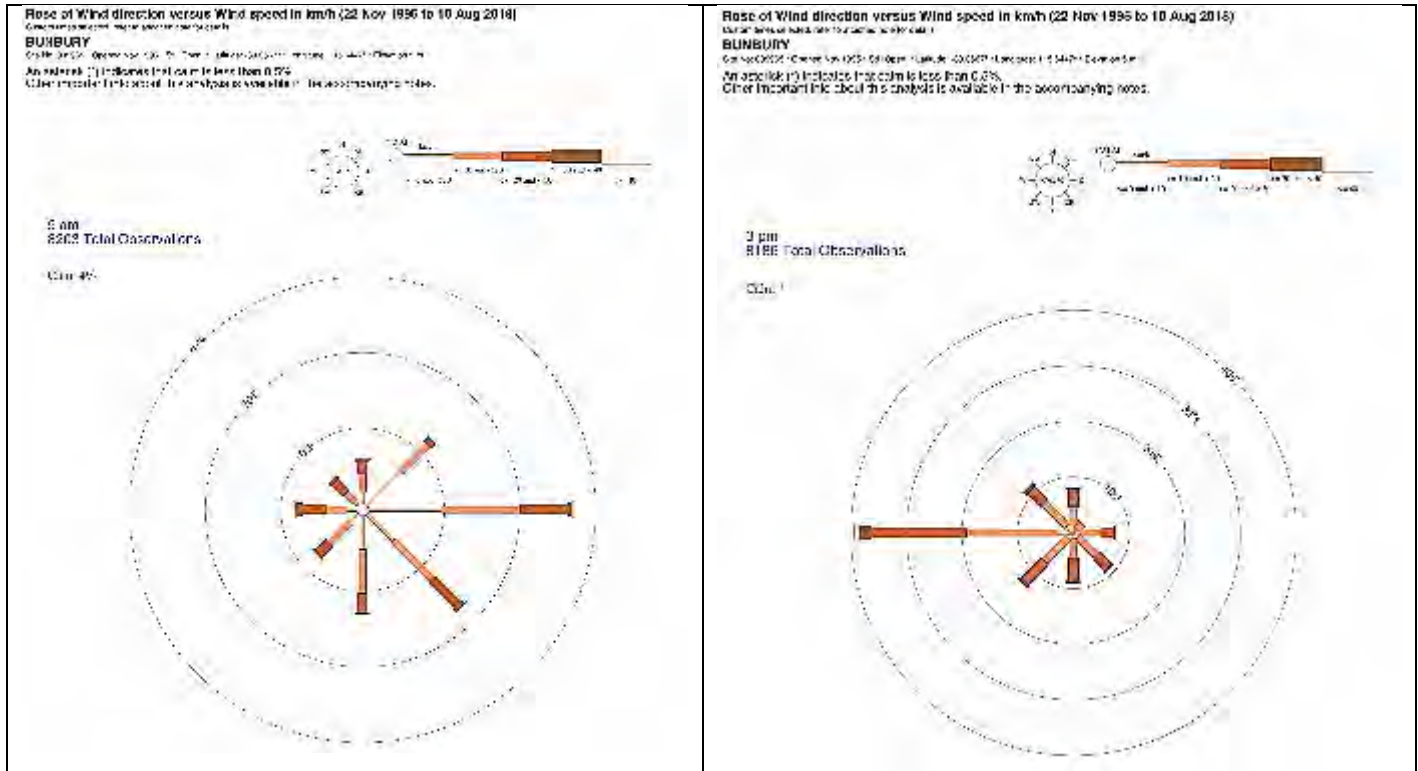
Figure OD15 Yearly Wind Data Bunbury

Wind data shows a predominantly easterly and westerly trend.

Summer winds at 9.00 am are predominantly light to moderate from the east – south east (>60%) with speeds less than 20 kph on 75% of the mornings. At 3.00 pm the winds are stronger from the west and southwest for over 65% of the time.

For odour the worst time is normally on still winter mornings when there is little turbulence to disperse any odour. Overall, the number of calm days is low with just 4% at 9.00 am and no significant occasions at 3.00 pm.
