Report on  
Geotechnical Investigation

Proposed Development  
The Landing Precinct  
Lots 2 and 3 Great Northern Highway, Port Hedland

Prepared for  
Port Village Accommodation Pty Ltd

Project 76319  
March 2012

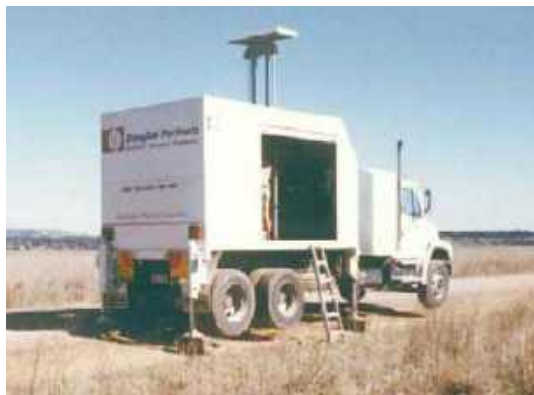
Figure 2: Purpose built CPT rig

The cone is thrust into the ground at a steady rate of about 20 mm/sec, usually using the hydraulic rams of a purpose built CPT rig, or a drilling rig. The testing is carried out in accordance with the Australian Standard AS1289 Test 6.5.1.
