Environmental Assessment and Management Plan

Warmun Landfill Development

Prepared for Department of Communities

April 2025

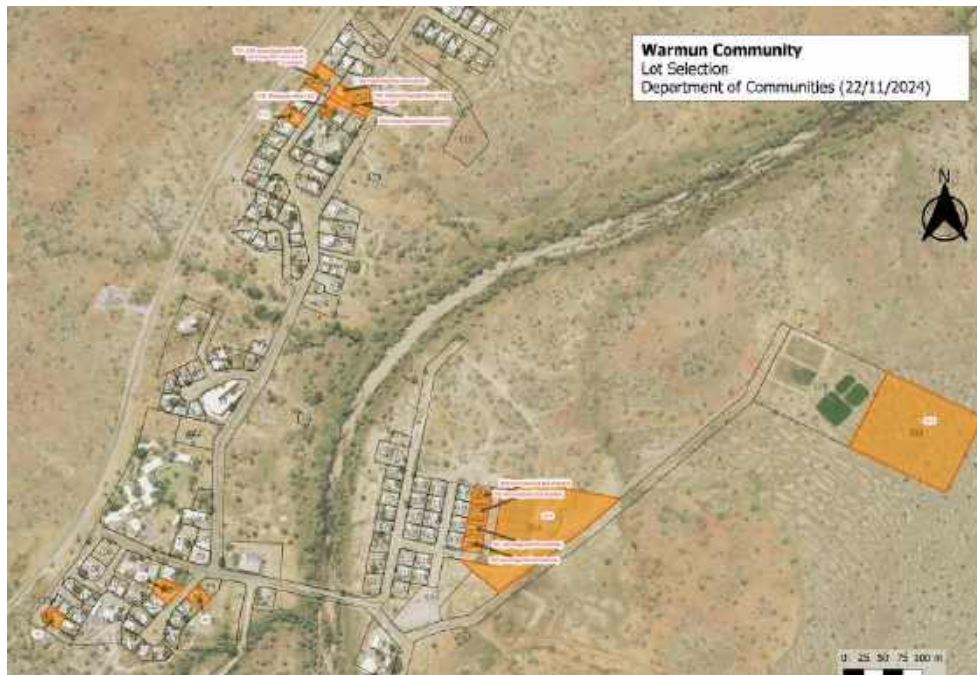
Figure 1. Aerial view of the site location (Source: Landgate Map)

Department of Communities commissioned Local Geotechnics (LG) to prepare a geotechnical site classification report for 17 Lots at Warmun Community, WA (the project). The site location is shown in Figure 1, with the tested areas highlighted in orange.

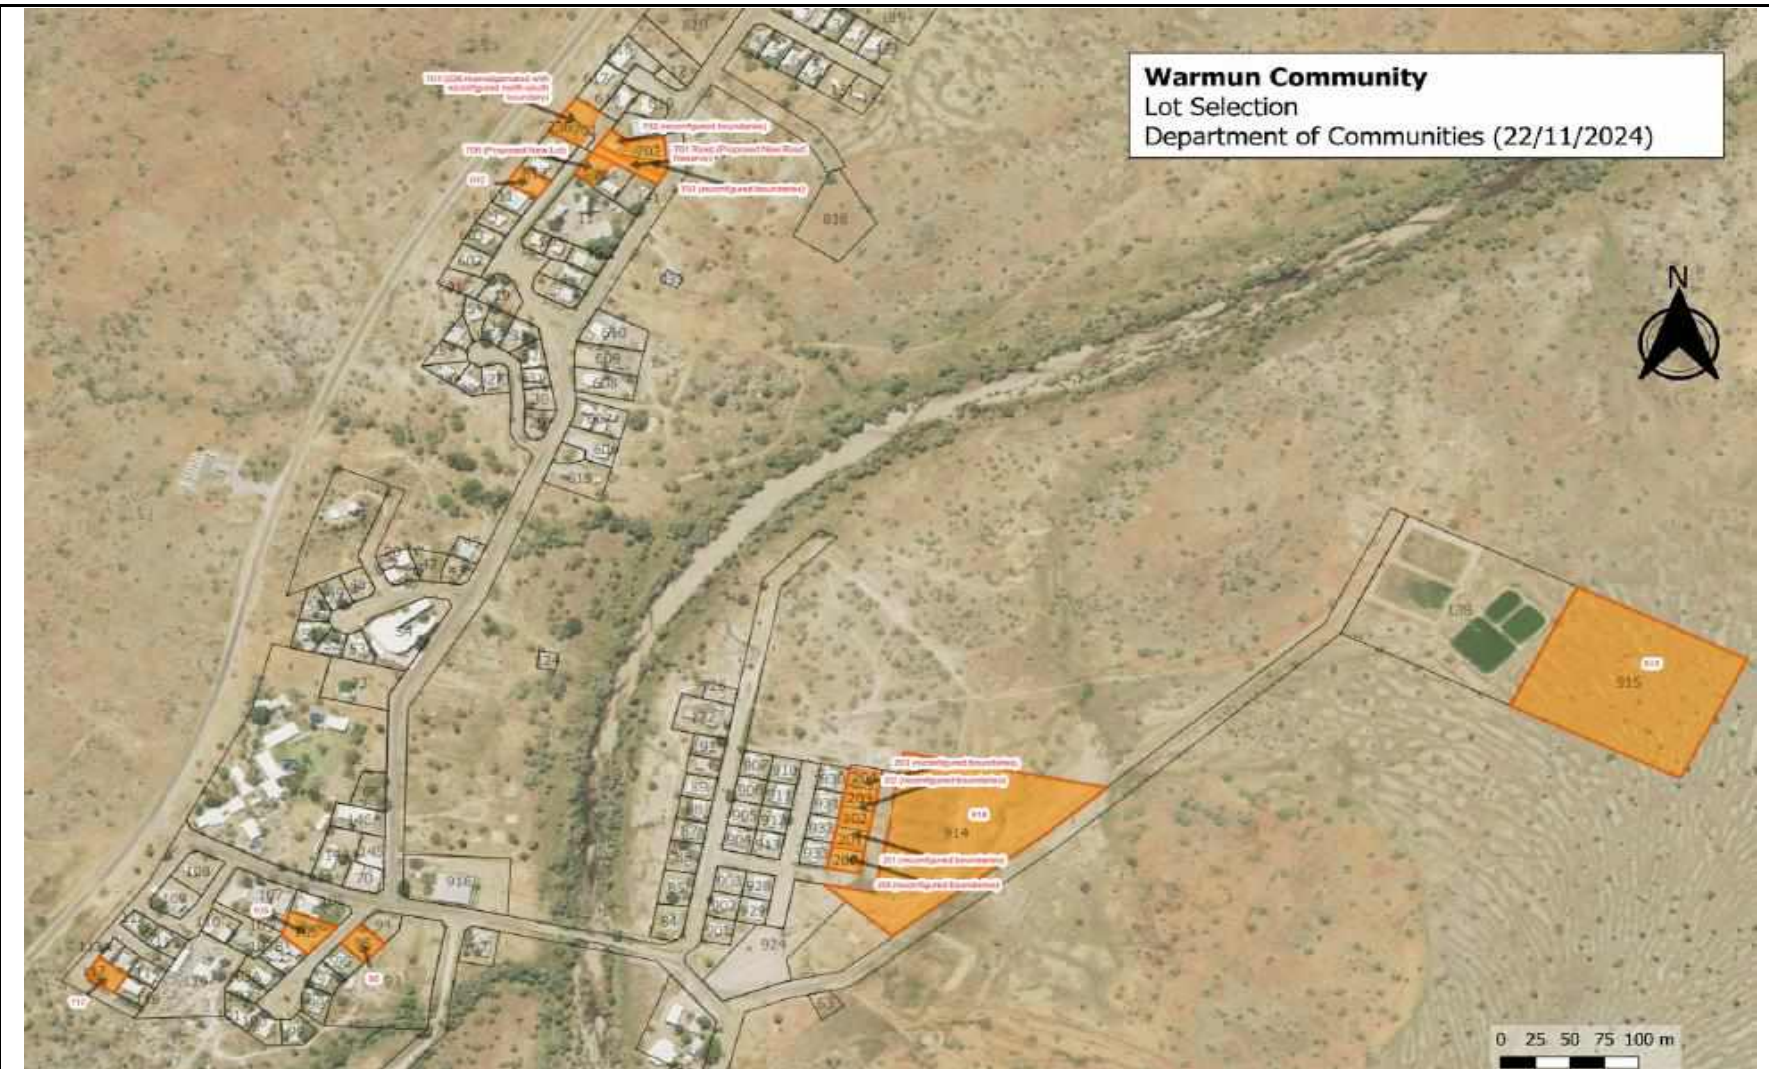
Site Sketch : Overview of Test Locations across Various Lots

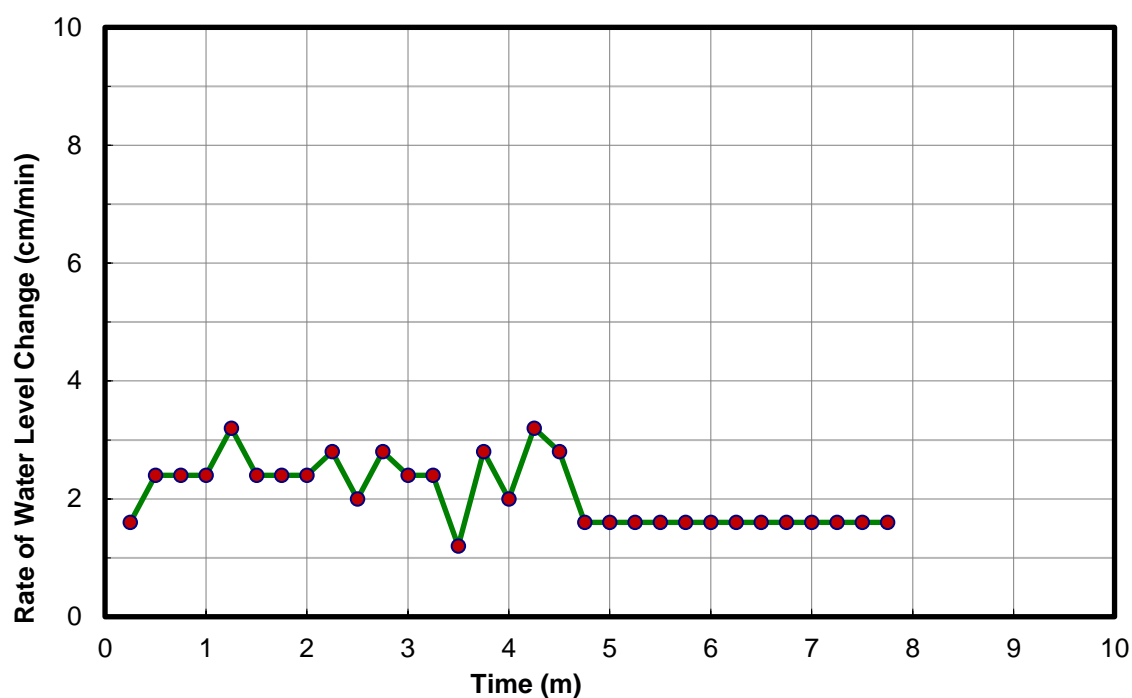
Notes: Test was conducted at a depth of 0.45 m from the existing surface level

Water Hydraulic conductivity K_{fs} : **3.0E-06** m/sec
2.6E-01 m/day

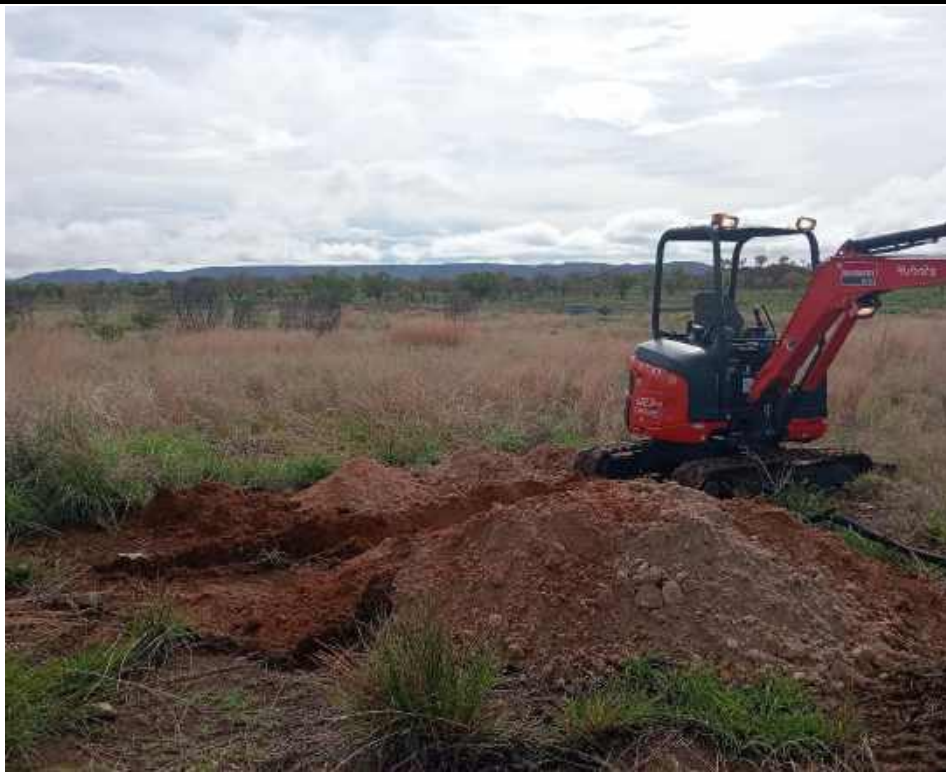
Photo 2. Test Location 01 (TP1), Sub-surface Probing by Using an Excavator

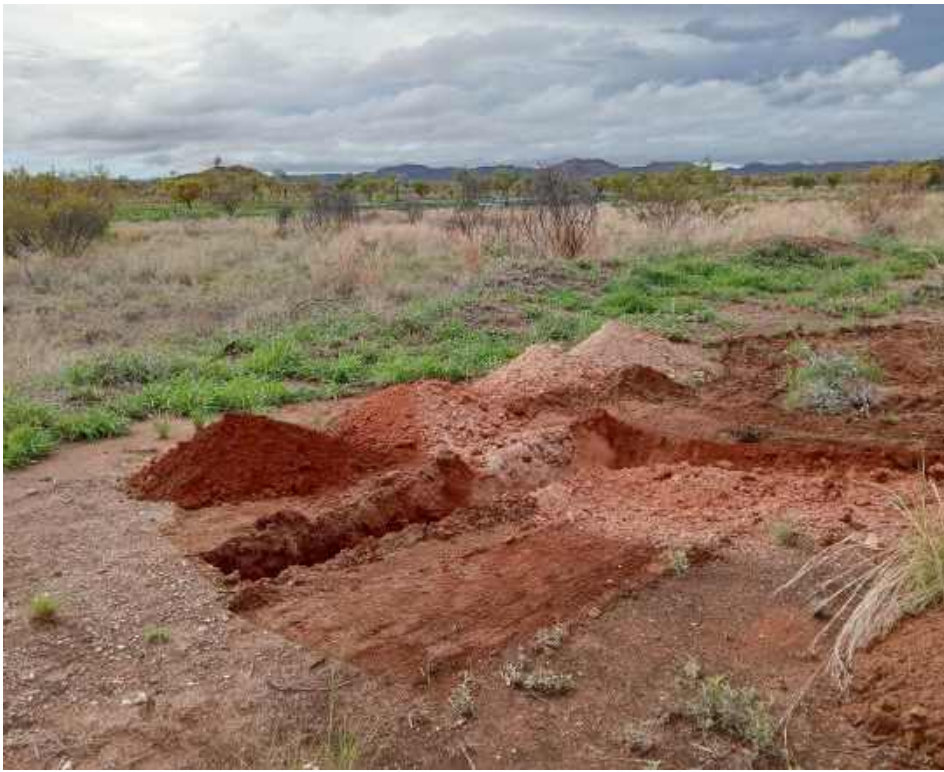
Photo 3. Soil from Test Location 01 (TP1)

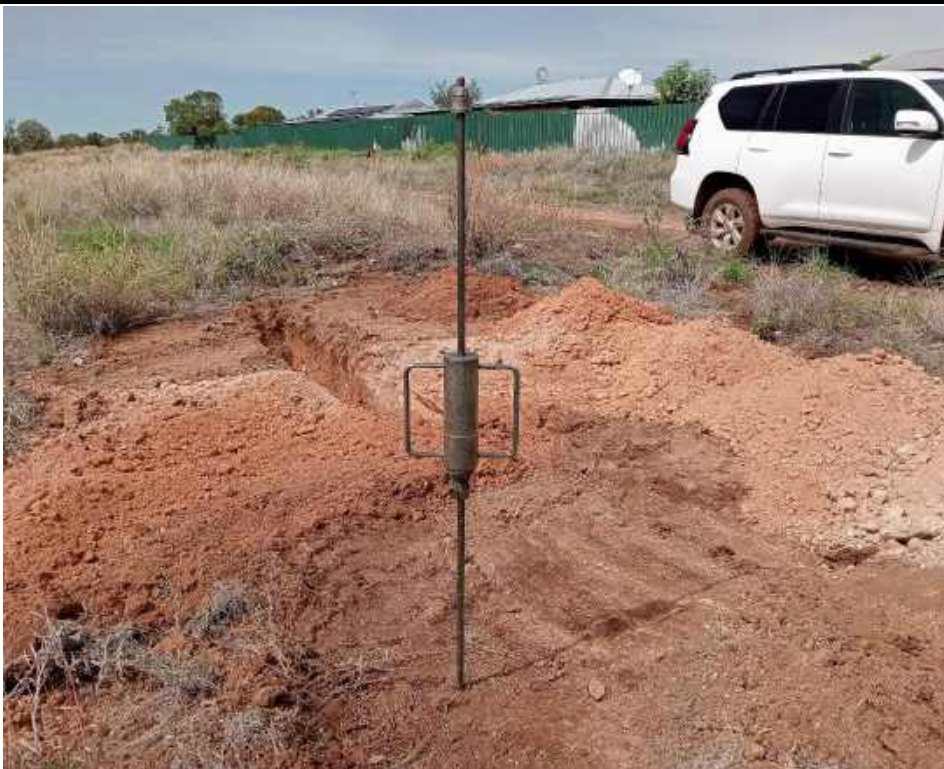
Photo 4. Test Location 09 (DCP9), Testing by using a Dynamic Cone Penetrometer

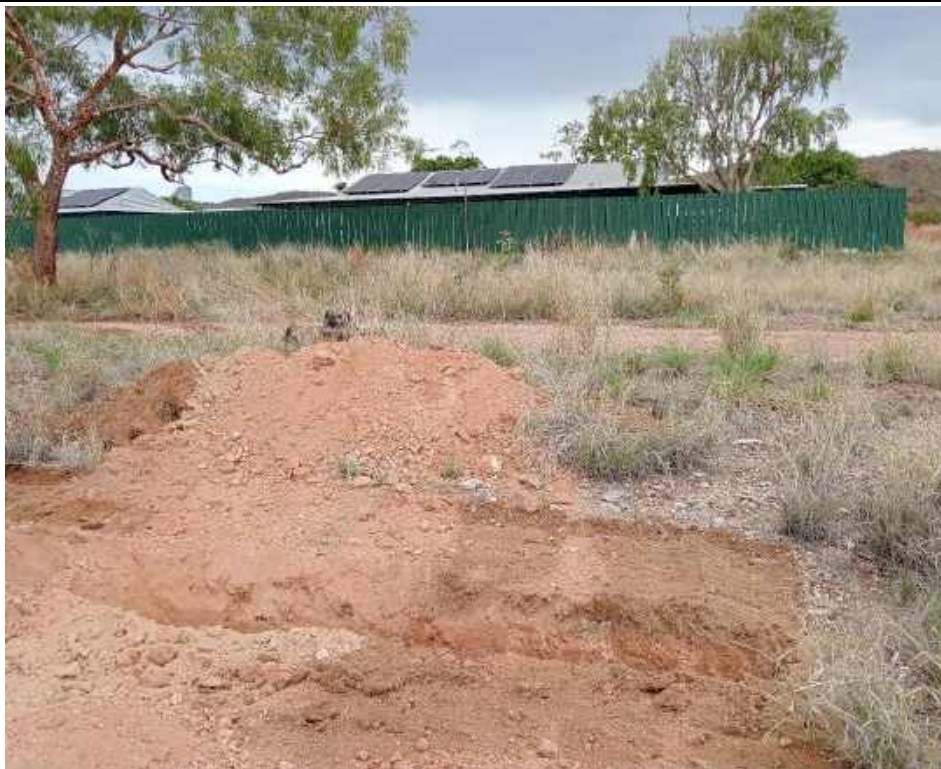
Photo 5. Soil from Test Location 11 (TP11)

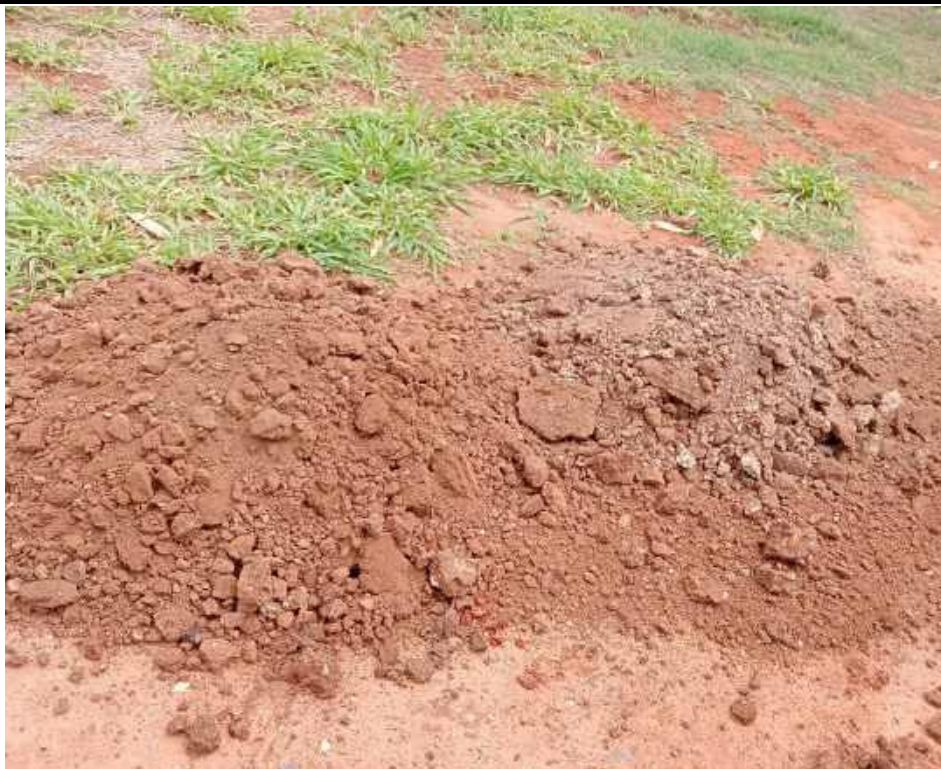
Photo 8. Soil from Test Location 22 (TP22)

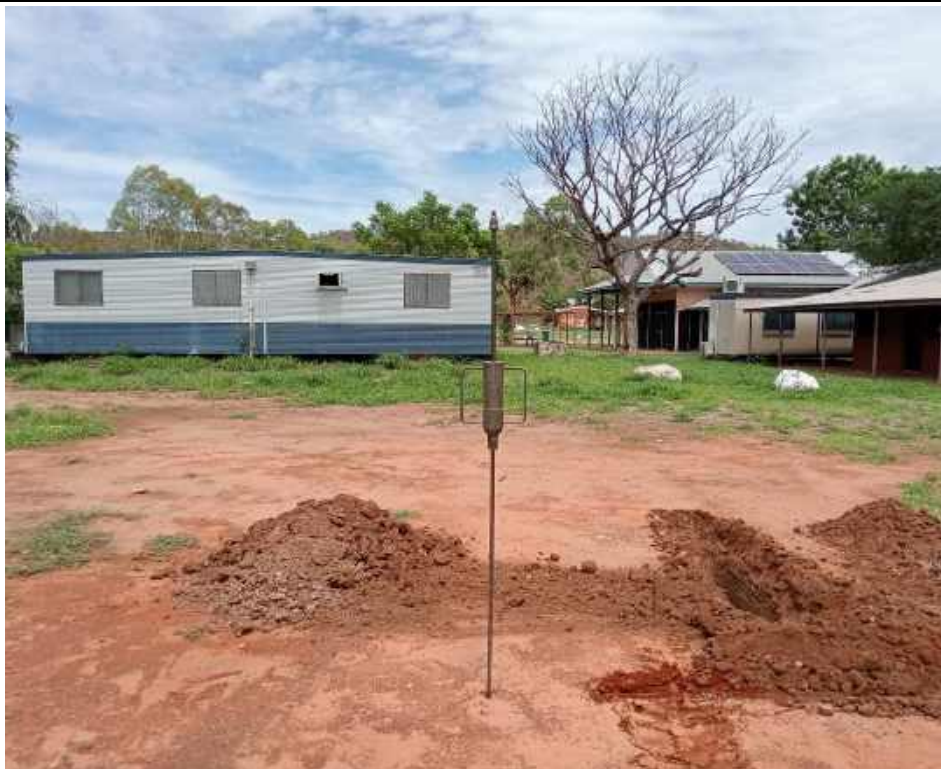
Photo 9. Test Location 22 (DCP22), Testing by Using a Dynamic Cone Penetrometer

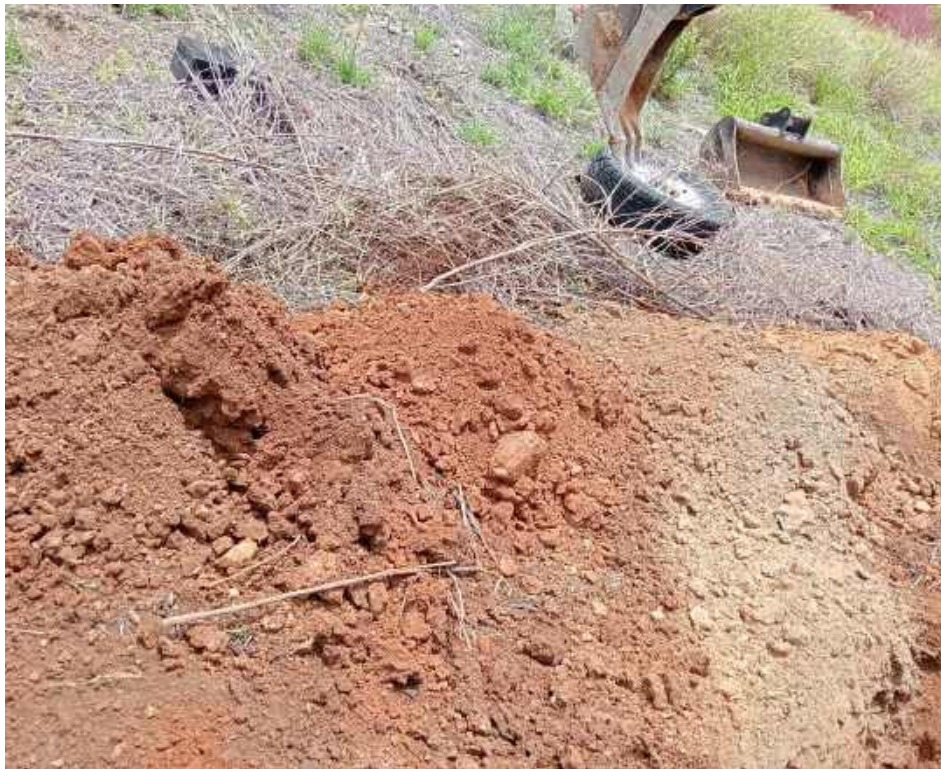
Photo 11. Soil from Test Location 49 (TP49)

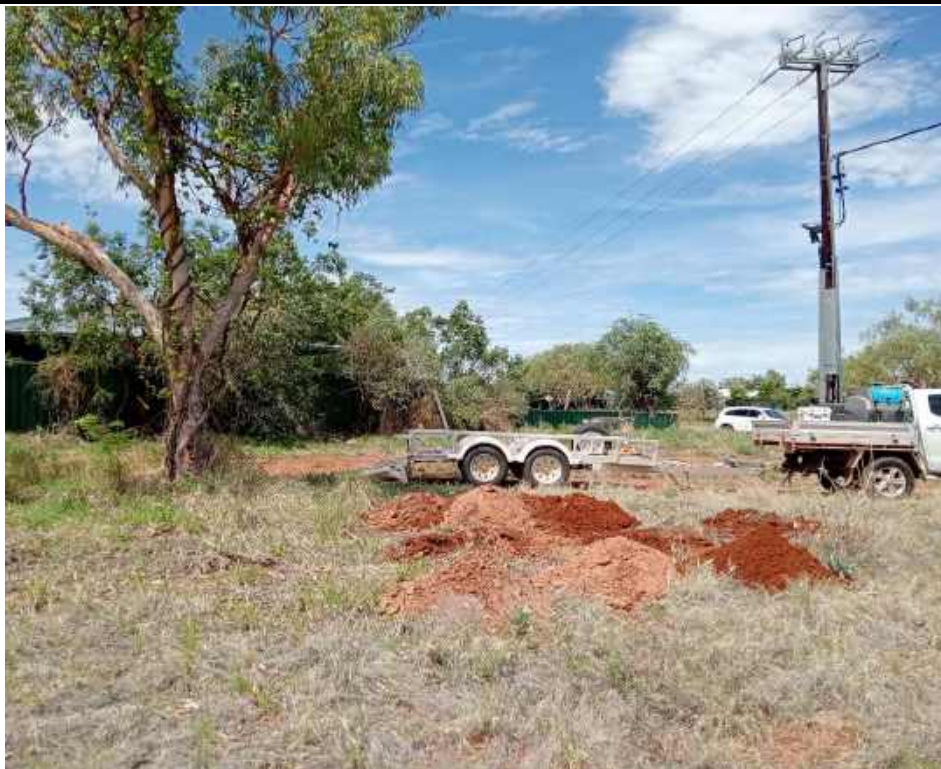
Photo 12. Soil from Test Location 53 (TP53)

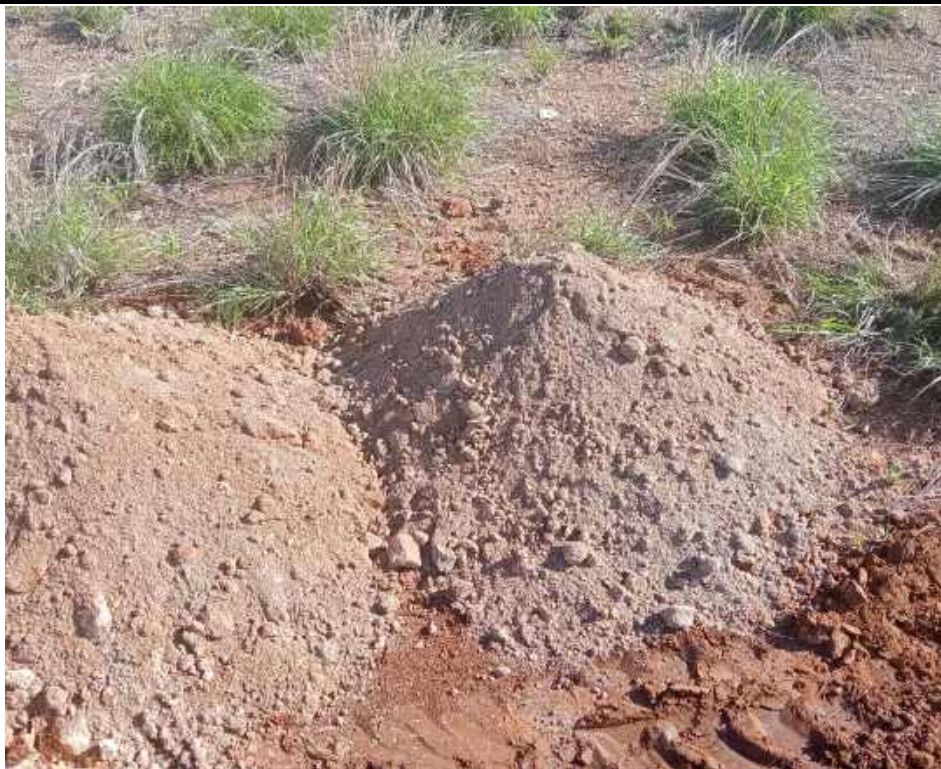
Photo 14. Soil from Test Location 68 (TP68)

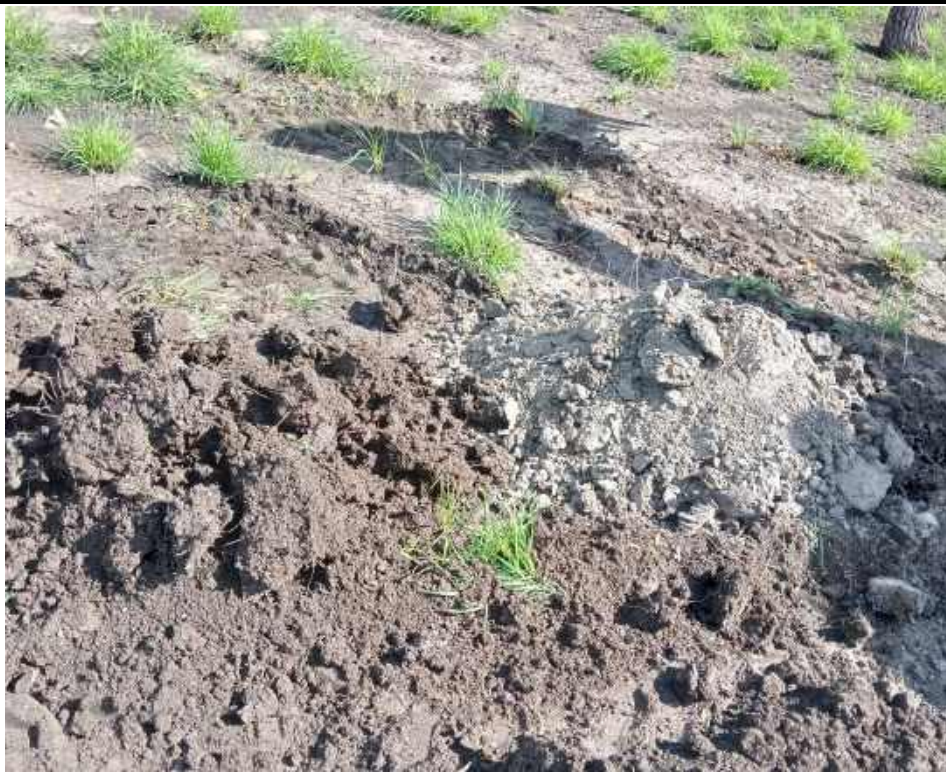
Photo 16. Soil from Test Location 91 (TP91)
