Talis Consultants

**Wangara Waste Transfer  
Station Modification and  
Addition Works**

Geotechnical Investigation

March 2025

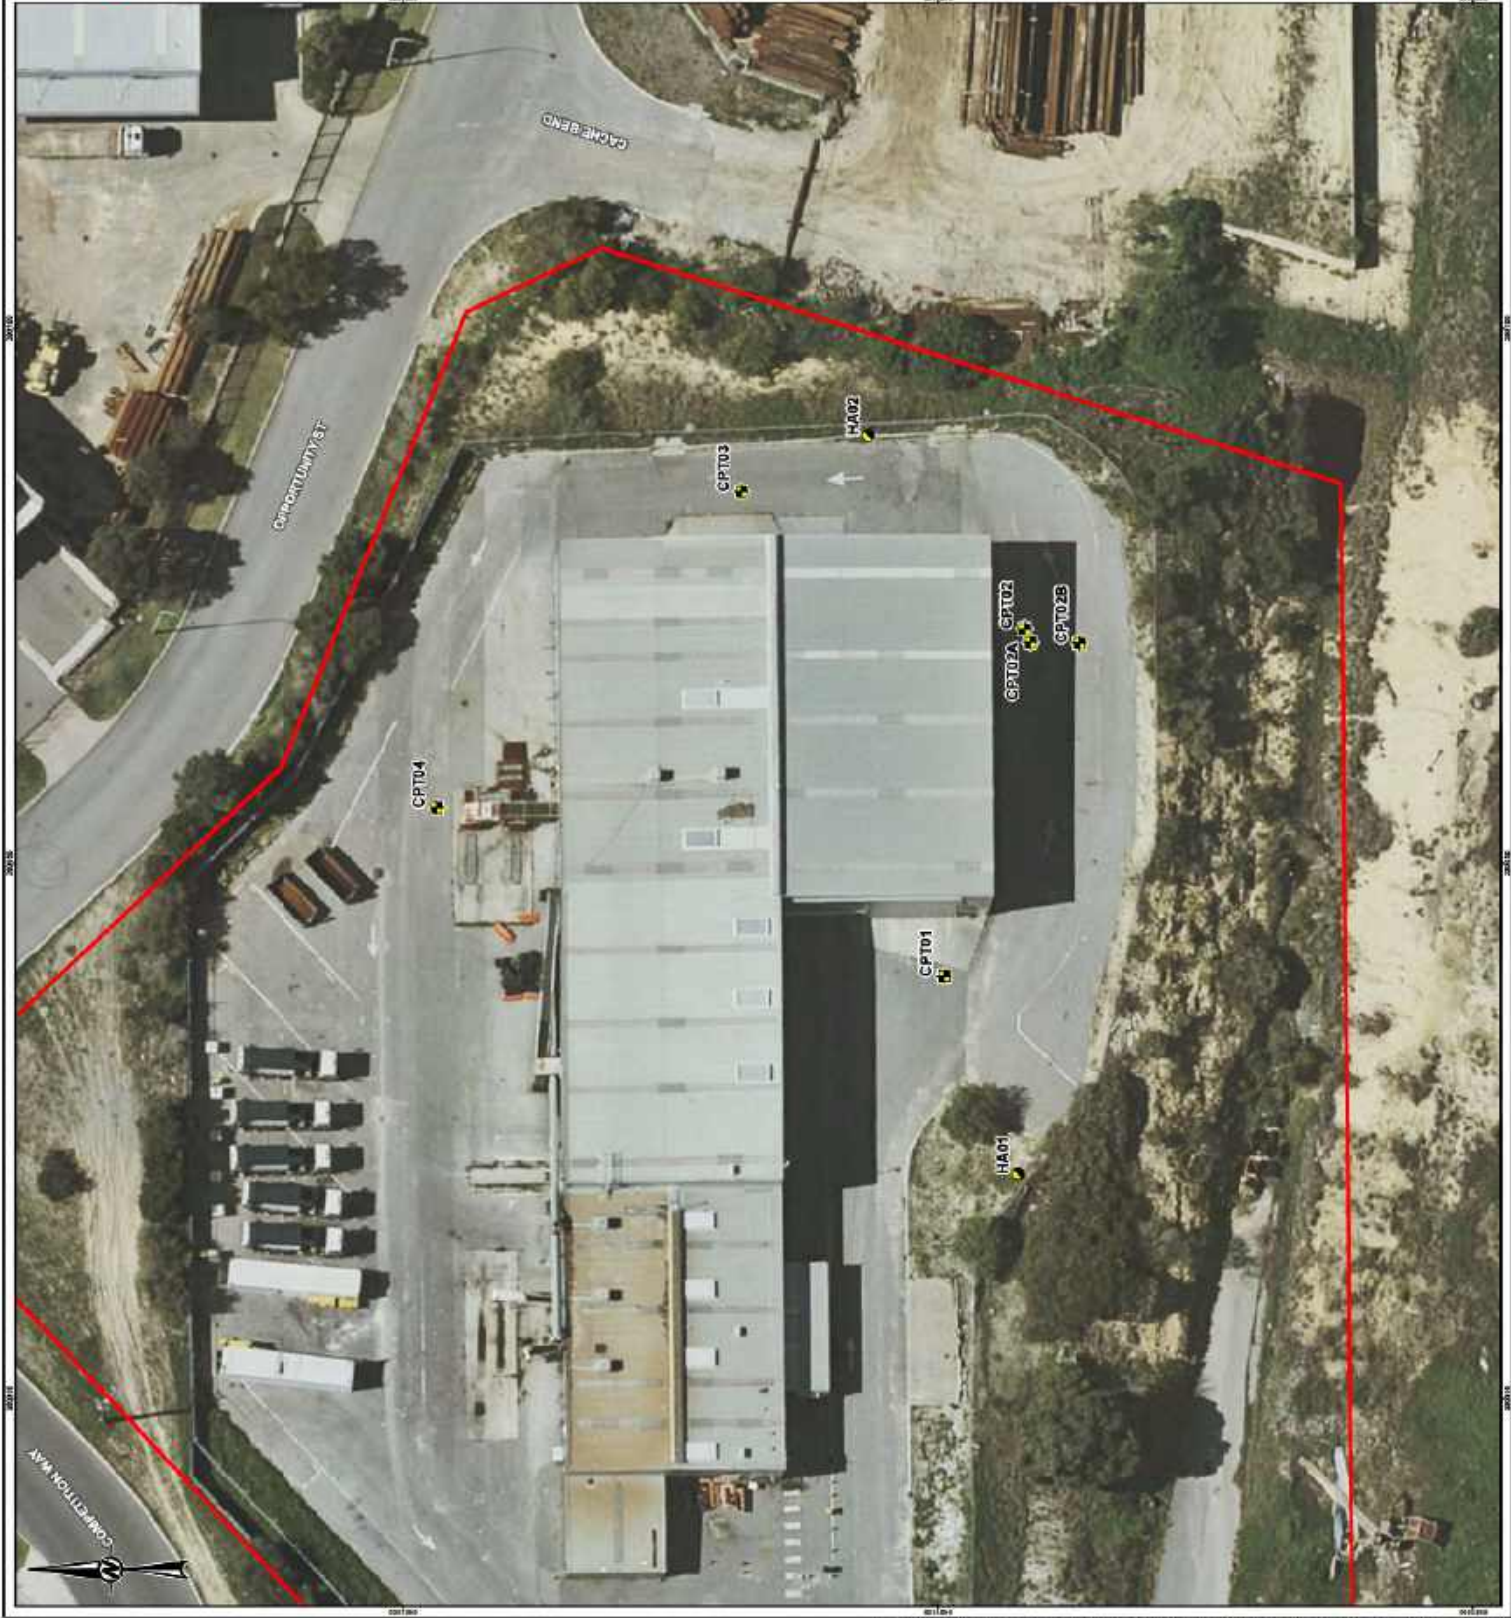
- LEGEND**
- SITE INVESTIGATION**
  - CONE PENETRATION TEST
  - HAND AUGER
  - SITE BOUNDARY

The test locations are shown on Figure 2 – Site Plan. A summary of test details is presented in Table 3.1.

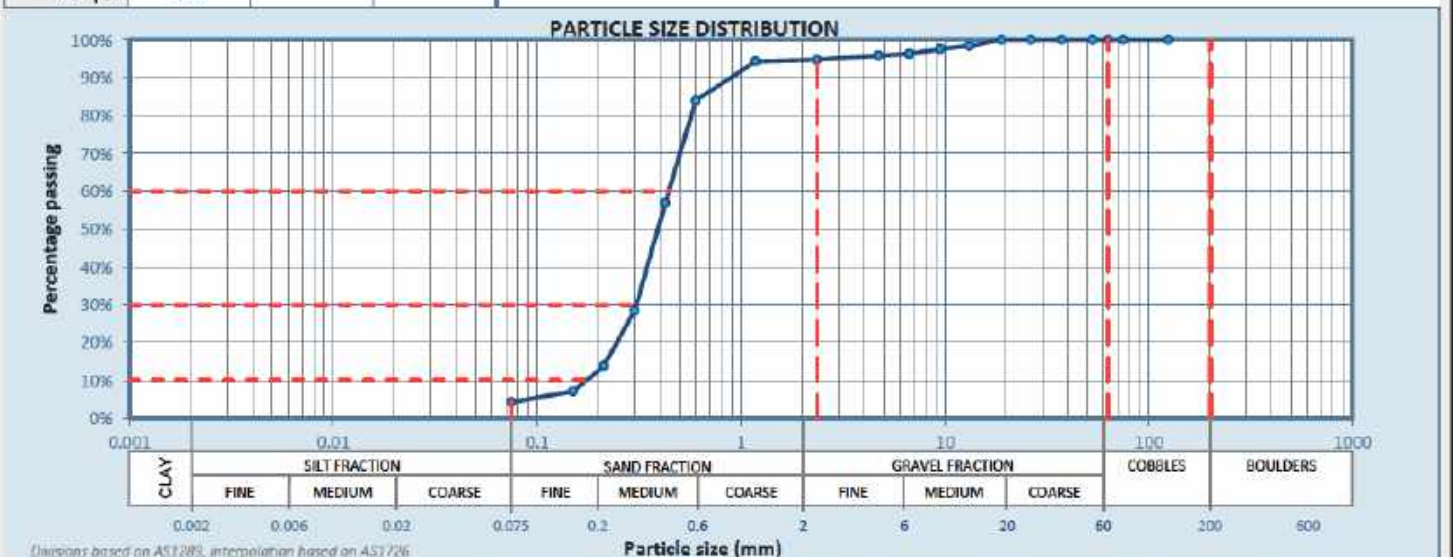
Specimen description: (Based on visual and tactile assessment)				Sampling:				Tested as received													
PARTICLE SIZE DISTRIBUTION AS 1289.3.6.1				(SP) SAND, fine to coarse grained, grey, trace of fines, trace of fine to medium gravel.				Easting (m)		Northing (m)		Level (m)									
Sieve Size		Passing		LB S		UB S															
125 mm	100%							Method:		AS 1289.2.1.1		AS 1289.3.1.2		AS 1289.3.2.1		AS 1289.3.3.1		AS 1289.3.4.1			
75 mm	100%									Moisture content		1 point Liquid limit		Plastic limit		Plasticity index		Linear shrinkage		Curling/ Crumbling/ Cracking	
63 mm	100%									Result:		10.7% As Rcvd.									
53 mm	100%									LB S:										-

2.36 mm	95%									4.3%		90.4%		5.3%		0.0%					
1.18 mm	94%									*Proportions based on guidance in AS1726-2017 Section 6.1.4.2											
600 µm	84%																				
425 µm	57%																				
300 µm	28%																				
212 µm	14%																				
150 µm	7%																				
75 µm	4%

Sample Location	Depth (m)	AS 1726 Soil Description	Particle Size Distribution (% Passing)		
			Fines	Sand	Gravel
HA01	0.3 – 0.5	(SP) SAND, fine to coarse grained, grey, trace fines, trace fine to medium gravel	2.6	95.1	2.3
	0.7 – 1.0	(SP) SAND, fine to coarse grained grey, trace fines, trace fine to medium gravel	2.5	89.3	8.2
HA02	1.0 – 1.3	(SP) SAND, fine to coarse grained, grey, trace fines, trace fine to medium gravel	4.3	90.4	5.3
