**RE: 766 King Road, Oldbury: Additional Main Stockpile Assessment**

Aurora Environmental (Aurora) was commissioned by Hope Valley Wood Waste Pty Ltd to undertake an additional investigation of the Main Stockpile at 766 King Road, Oldbury (the Site) and prepare this addendum letter report.

The objective of the additional investigation was to further assess the central and lower middle portions of the main stockpile to clarify its contamination status and evaluate its suitability for on-Site crushing and re-use as hardstand.

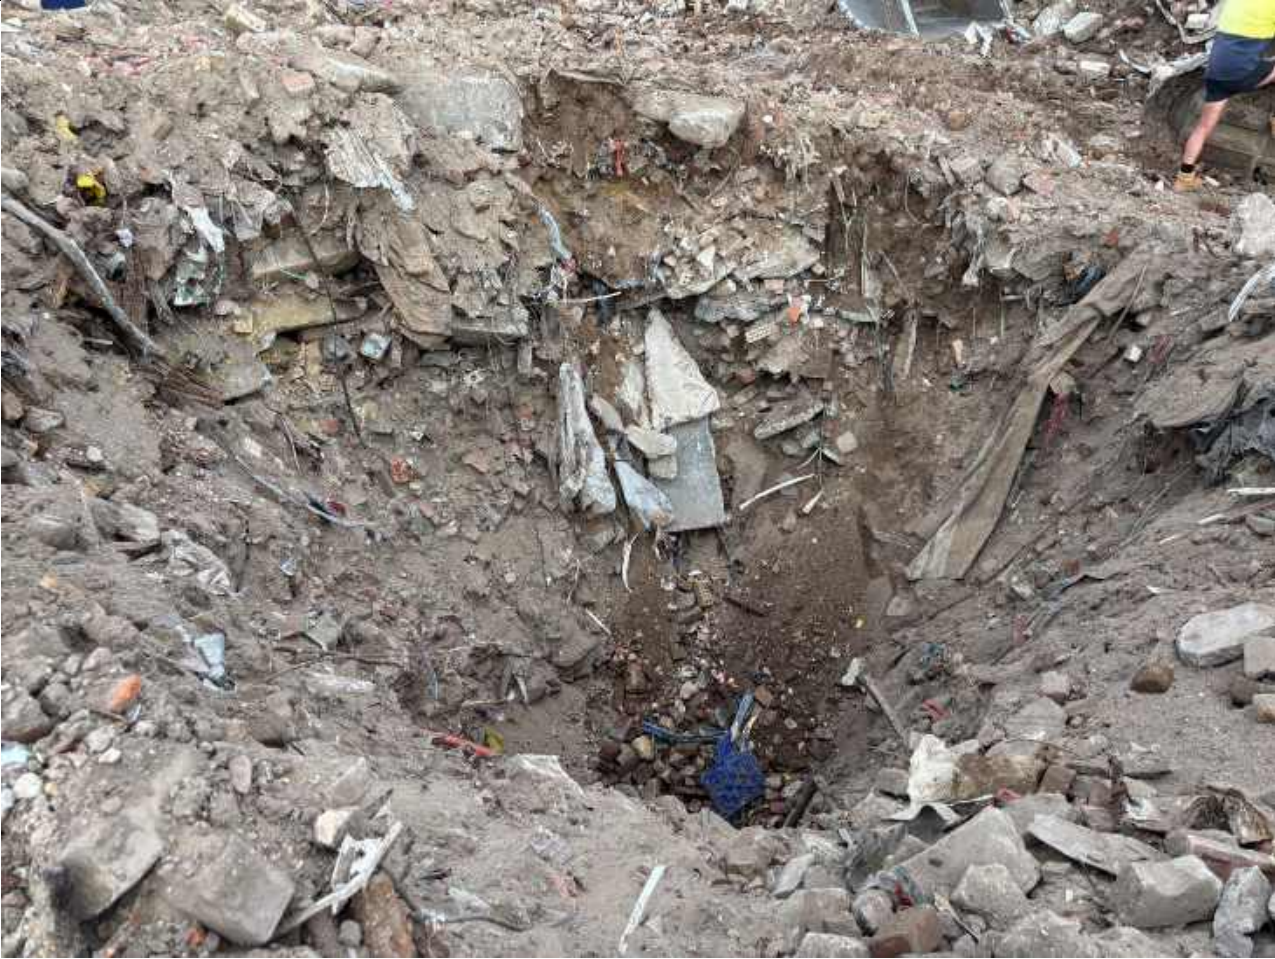
| <b>Test Pit No: 31</b> | | | | |
|---|---|---|---|---|
| 0-6.5 | FILL | SAND – Grey to brown, fine to coarse grained, poorly graded, dry.<br><br>50–70% construction and demolition waste including: brick; concrete (slabs and fragments); metal sheeting; timber; geofabric; plastic; PVC; cables; electronic circuit boards. | TP31 0-0.1<br>TP31 1.9-2.0<br>TP31 3.9-4.0<br>TP31 5.9-6.0 | PACM1 identified at 5.0-6.0m bgl.<br>1x fibre cement fragment in good, bonded condition.<br>3g.<br><br>No stains or odours. |

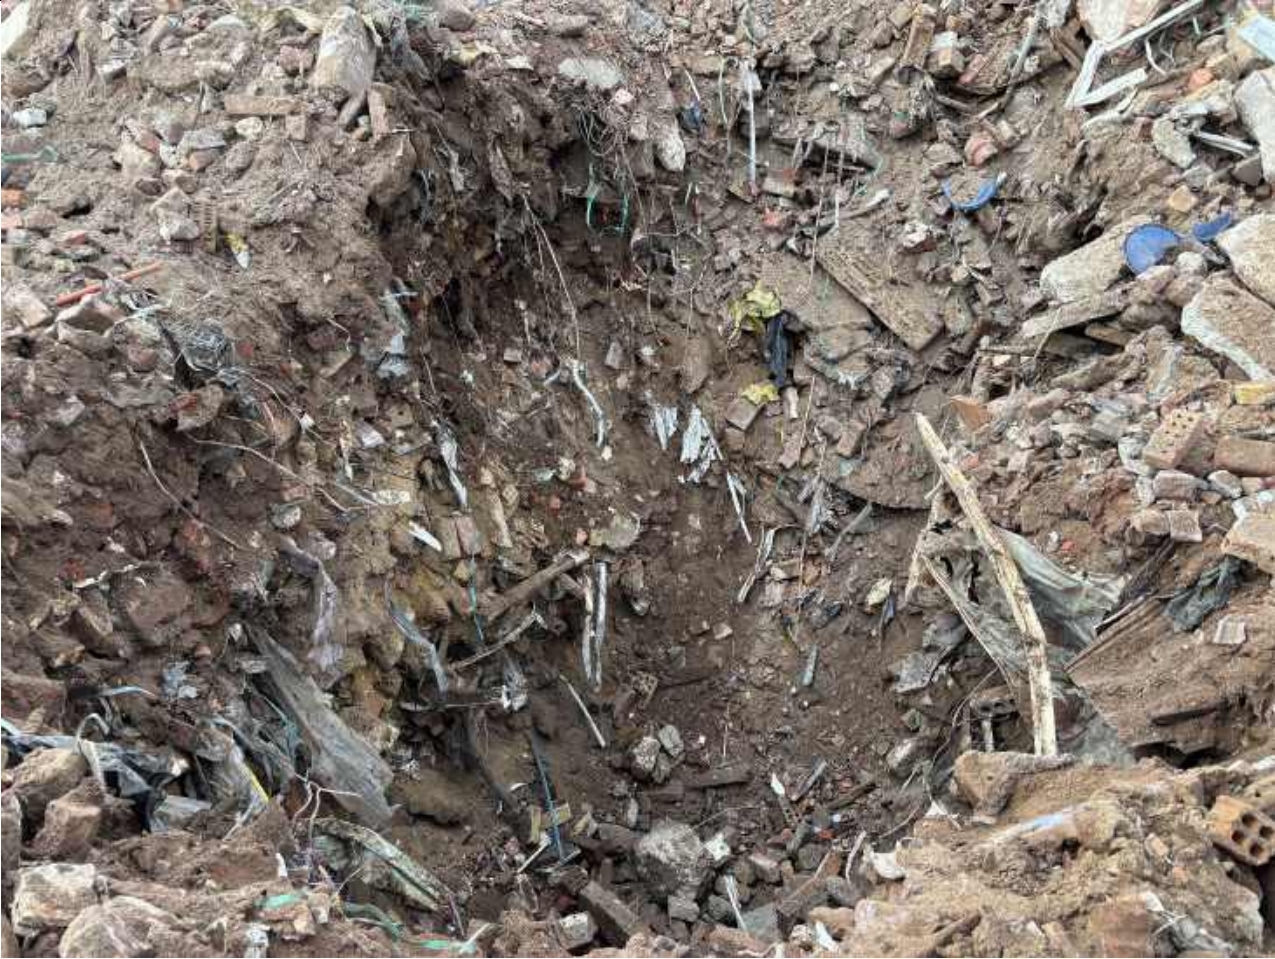
| <b>Test Pit No: 32</b> | | | | |
|---|---|---|---|---|
| 0-6.5 | FILL | SAND – Grey to brown, fine to coarse grained, poorly graded, dry.<br><br>50–70% construction and demolition waste including: brick; concrete (slabs and fragments); metal sheeting; timber; geofabric; plastic; PVC; cables; electronic circuit boards. | TP32 0.5-0.6<br>TP32 0.9-1.0<br>TP32 3.9-4.0<br>TP32 6.4-6.5 | No PACM identified.<br><br>No stains or odours. |

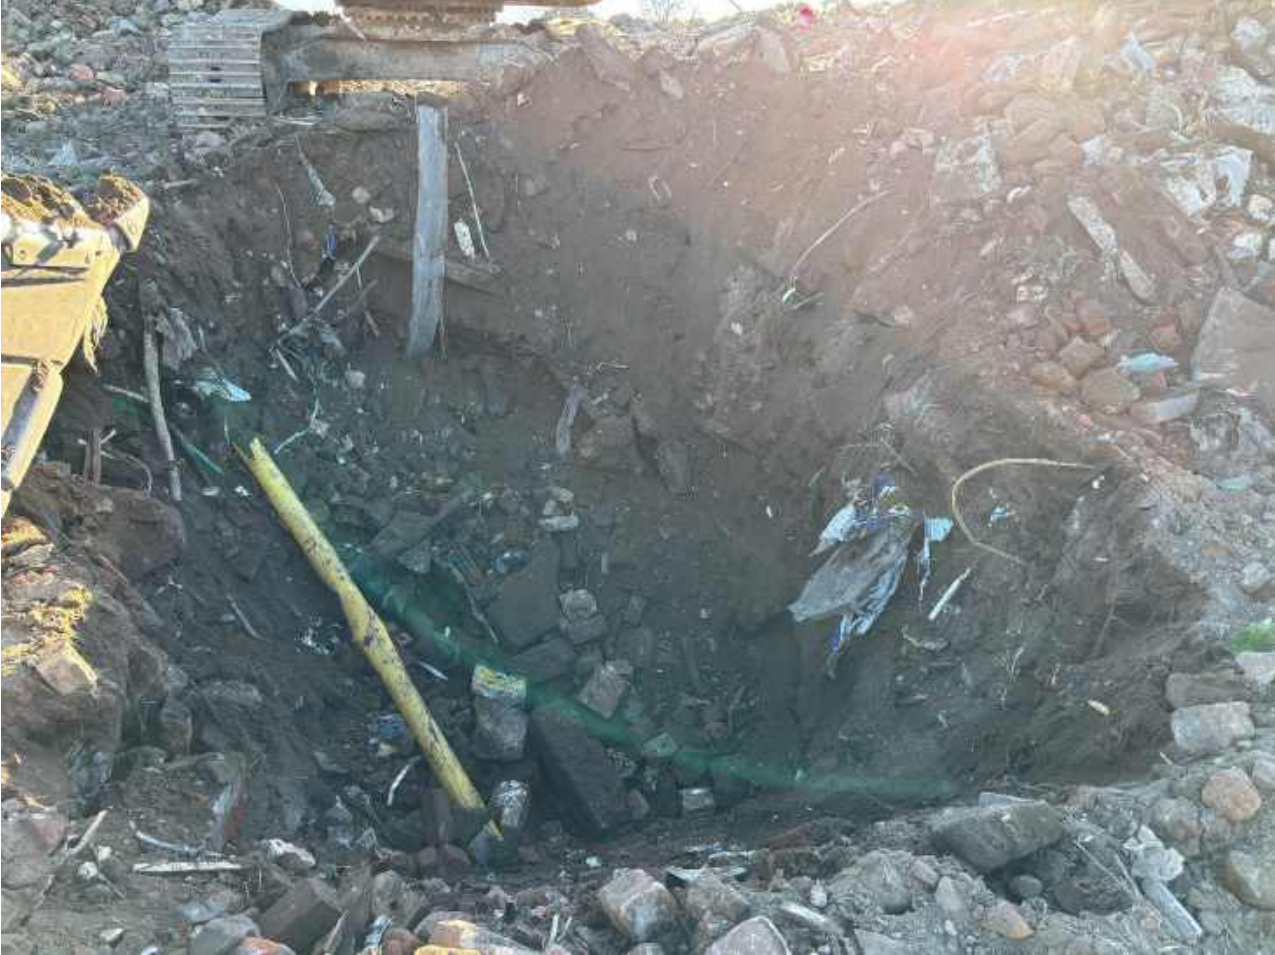
| <b>Test Pit No: 33</b> | | | | |
|---|---|---|---|---|
| 0-5.5 | FILL | SAND – Grey to brown, fine to coarse grained, poorly graded, dry.<br><br>50–70% construction and demolition waste including: brick; concrete (slabs and fragments); metal sheeting; timber; geofabric; plastic; PVC; cables. | TP33 0.5-0.6<br>TP33 1.9-2.0<br>TP33 2.9-3.0<br>TP33 3.9-4.0<br>TP33 4.9-5.0 | PACM2 identified at 2.0-3.0m bgl.<br>2x fibre cement fragments in good, bonded condition.<br>23g.<br><br>No stains or odours. |

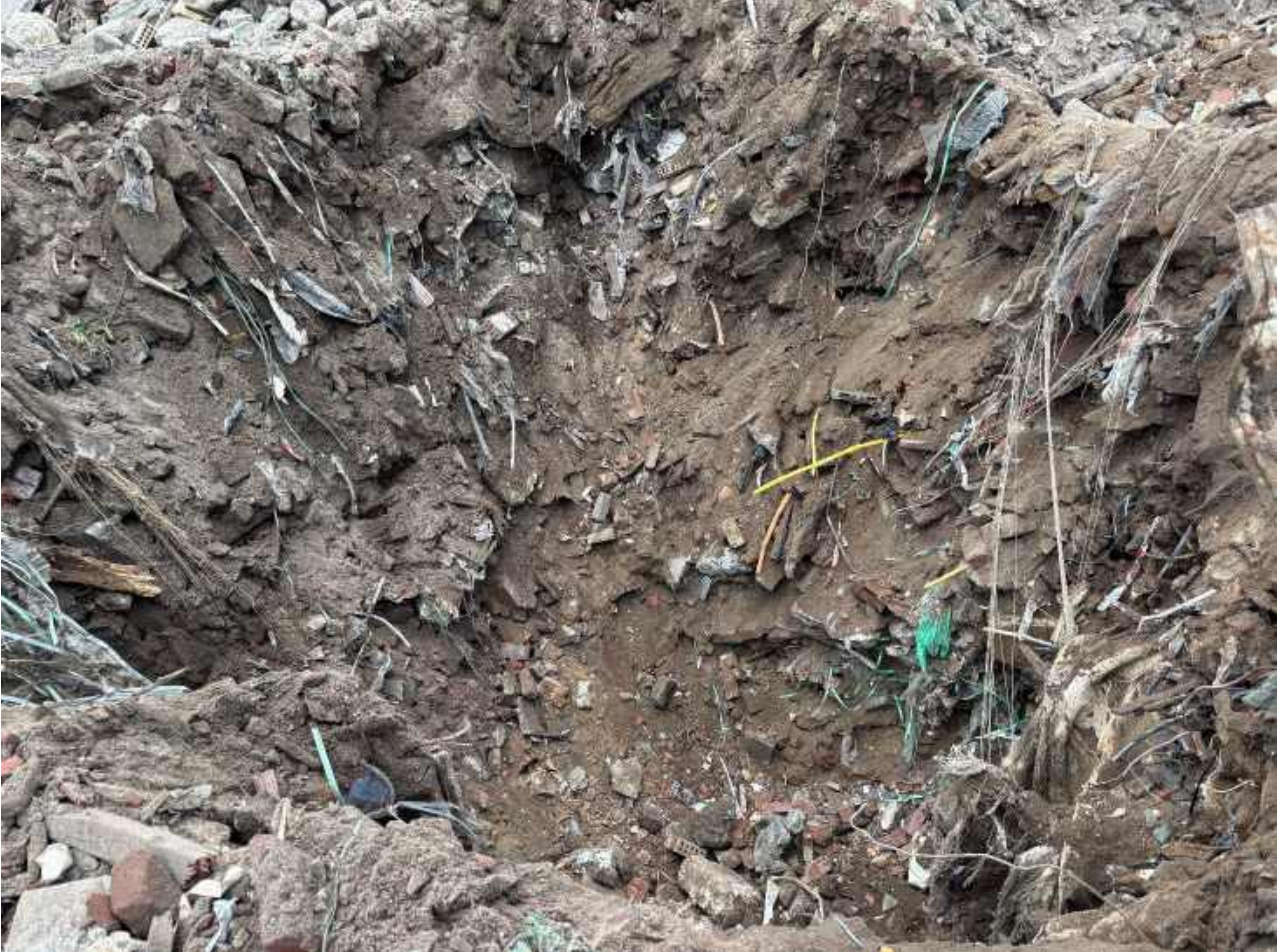
| <b>Test Pit No: 34</b> | | | | |
|---|---|---|---|---|
| 0-7.0 | FILL | SAND – Grey to brown, fine to coarse grained, poorly graded, dry.<br><br>50–70% construction and demolition waste including: brick; concrete (slabs and fragments); metal sheeting; timber; geofabric; plastic; PVC; cables. | TP34 0.9-1.0<br>TP34 2.9-3.0<br>TP34 4.9-5.0<br>TP34 6.9-7.0 | PACM3 identified at 0-1.0m bgl.<br>1x fibre cement fragment in good, bonded condition.<br>15g.<br><br>No stains or odours. |

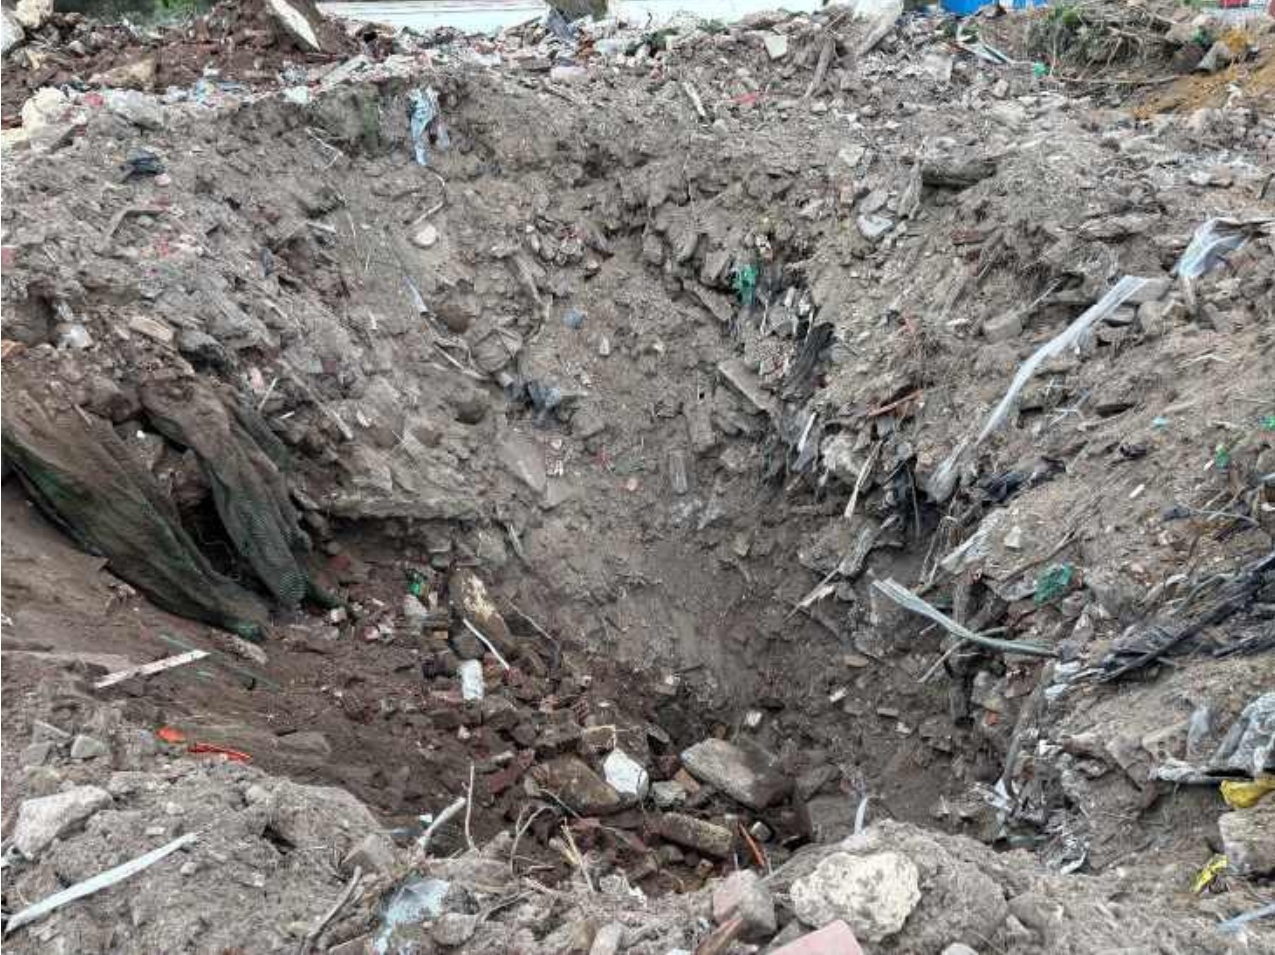
| <b>Test Pit No: 35</b> | | | | |
|---|---|---|---|---|
| 0-7.0 | FILL | SAND – Grey to brown, fine to coarse grained, poorly graded, dry.<br><br>50–70% construction and demolition waste including: brick; concrete (slabs and fragments); metal sheeting; timber; geofabric; plastic; PVC; cables. | TP35 0-0.1<br>TP35 0.9-1.0<br>TP35 2.9-3.0<br>TP35 4.9-5.0<br>TP35 6.9-7.0 | No PACM identified.<br><br>No stains or odours. |

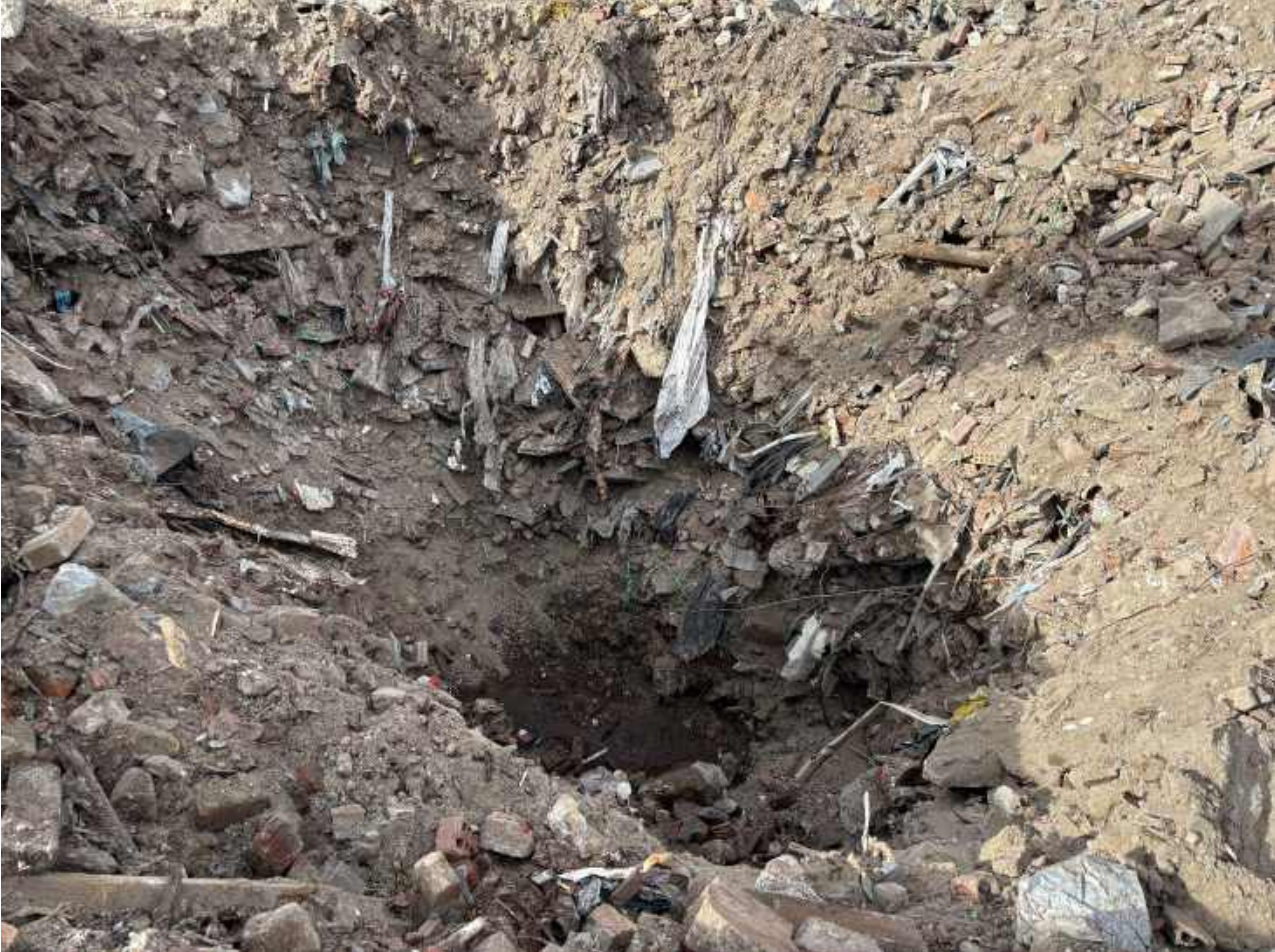
| <b>Test Pit No: 36</b> | | | | |
|---|---|---|---|---|
| 0-7.0 | FILL | SAND – Grey to brown, fine to coarse grained, poorly graded, dry.<br><br>50–70% construction and demolition waste including: brick; concrete (slabs and fragments); metal sheeting; timber; geofabric; plastic; PVC; cables. | TP36 0-0.1<br>TP36 0.9-1.0<br>TP36 2.9-3.0<br>TP36 4.9-5.0<br>TP36 6.9-7.0 | No PACM identified.<br><br>No stains or odours. |

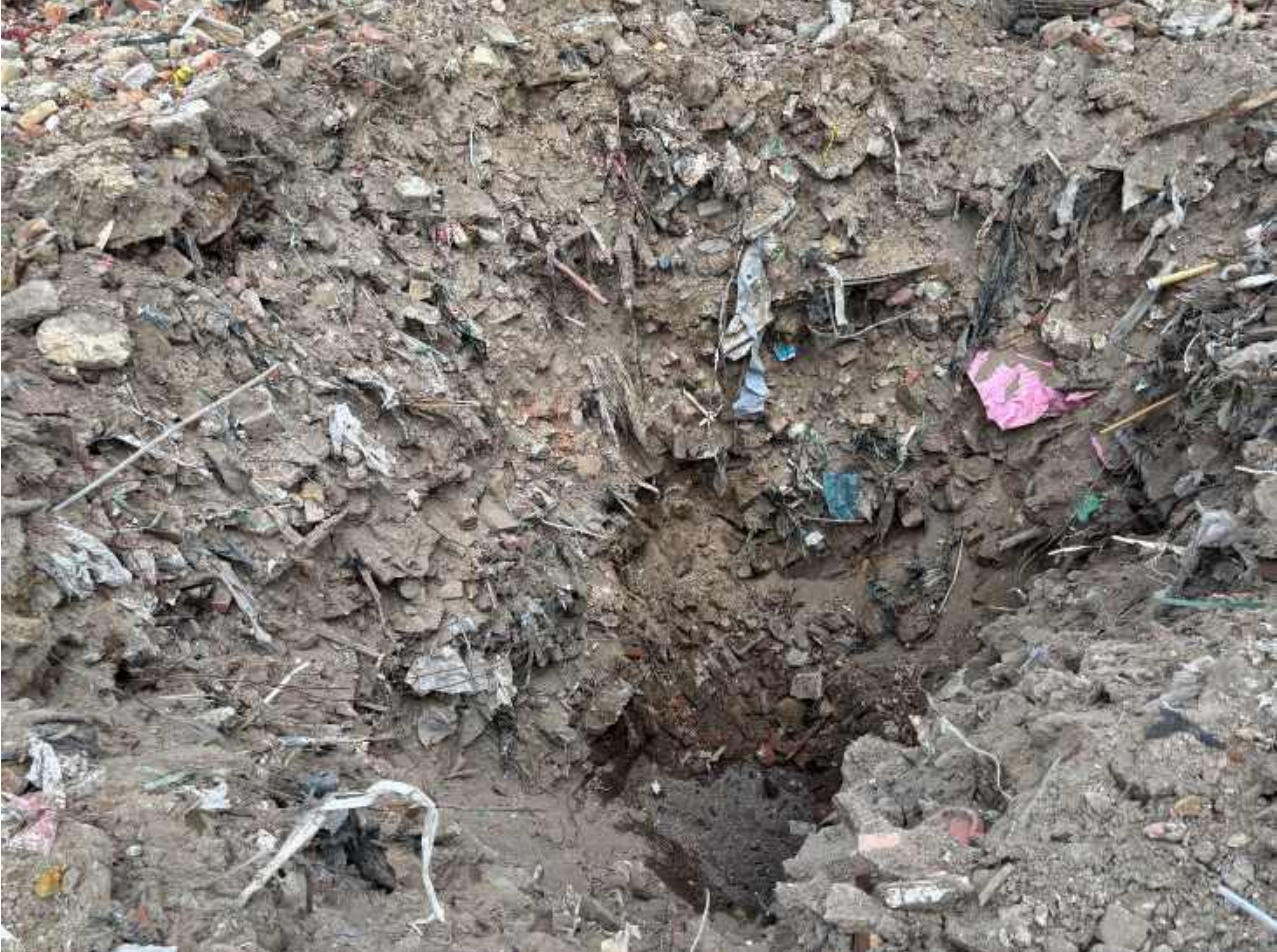
| <b>Test Pit No: 37</b> | | | | |
|---|---|---|---|---|
| 0-7.0 | FILL | SAND – Grey to brown, fine to coarse grained, poorly graded, dry.<br><br>50–70% construction and demolition waste including: brick; concrete (slabs and fragments); metal sheeting; timber; geofabric; plastic; PVC; cables. | TP37 0-0.1<br>TP37 1.9-2.0<br>TP37 3.9-4.0<br>TP37 5.9-6.0<br>TP37 6.9-7.0 | No PACM identified.<br><br>No stains or odours. |

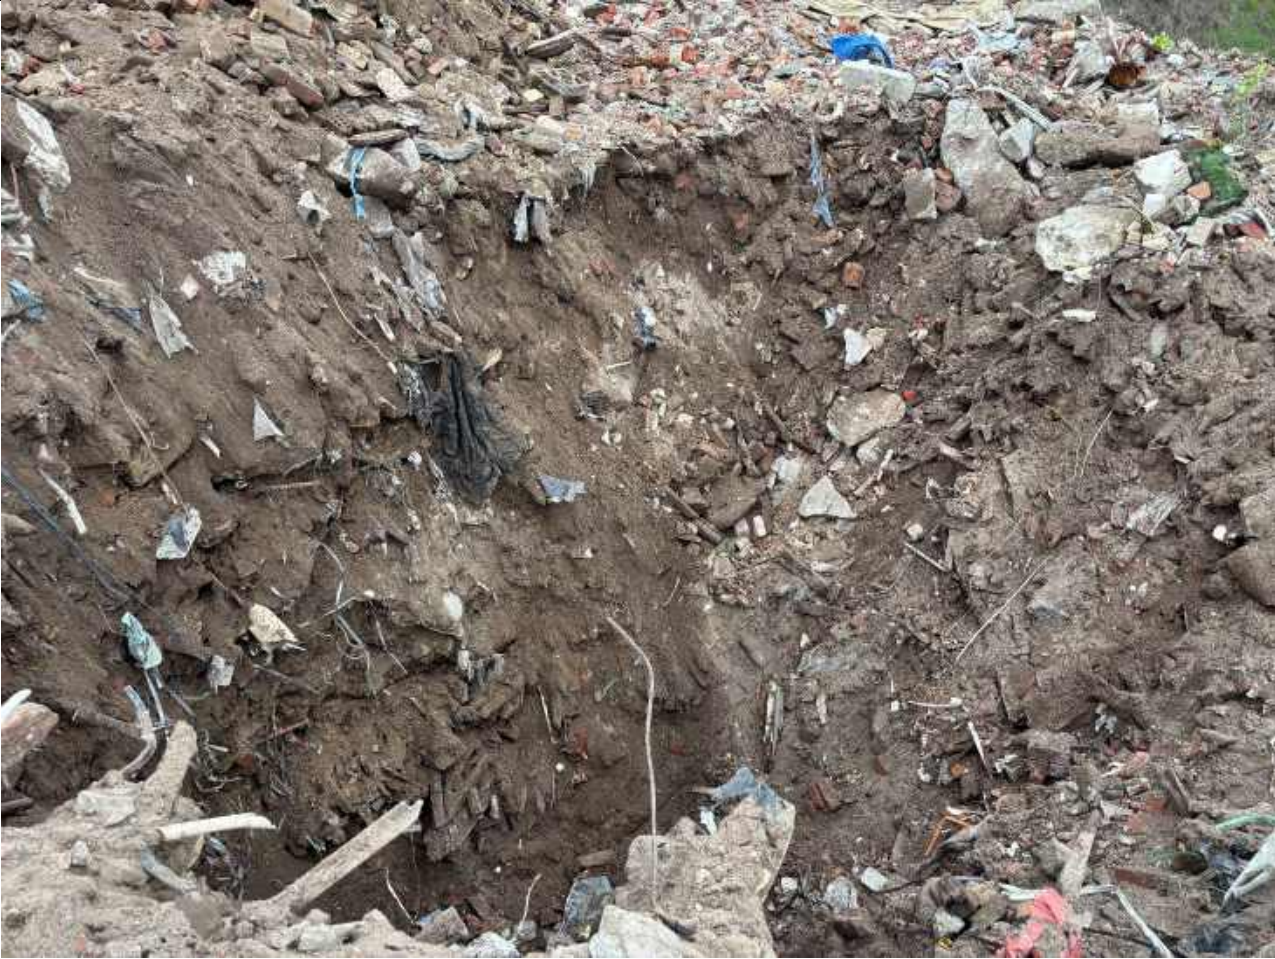
| <b>Test Pit No: 38</b> | | | | |
|---|---|---|---|---|
| 0-7.0 | FILL | SAND – Grey to brown, fine to coarse grained, poorly graded, dry.<br><br>50–70% construction and demolition waste including: brick; concrete (slabs and fragments); metal sheeting; timber; geofabric; plastic; PVC; cables; electronic circuit boards. | TP38 0-0.1<br>TP38 0.9-1.0<br>TP38 3.9-4.0<br>TP38 5.5-6.0<br>TP38 6.9-7.0 | QC1 is duplicate of TP38 5.5-6.0.<br><br>No PACM identified.<br><br>No stains or odours. |

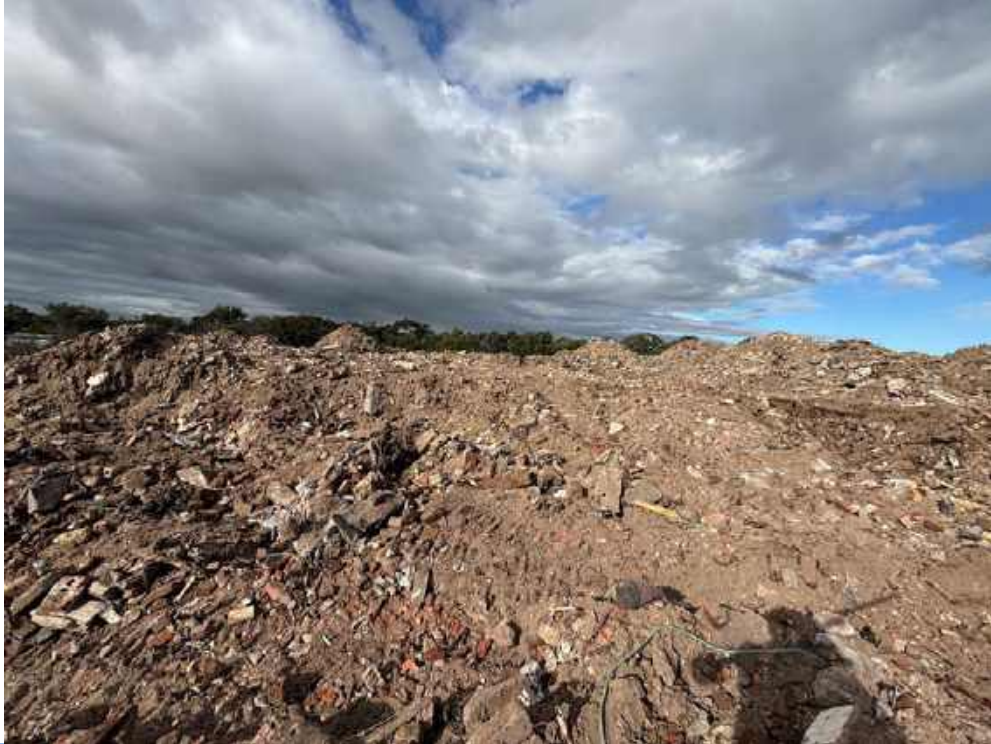
A photograph log showing Site conditions and materials in the Main Stockpile is presented in Attachment 3. The Main Stockpile was comprised of fine to coarse grained sand and inert C&D wastes (concrete, brick, metal, wood, tile, PVC, electronic cables, and assorted plastics) and other waste, such as textiles (Attachment 3 – 1 and 2). Other wastes noted in the inspection included isolated fragments of fibre cement PACM and consequently representative samples were collected (Attachment 3 – 3). All of the fibre cement PACM was in good, bonded condition and fragment sizes ranged from 3 x 1cm to 15 x 8cm (see Table A for details). Fibre cement PACM was mostly flat, except for the largest fragment, which was curved and appeared to be from a pipe. No staining or odours indicating

**Photograph 1:** Surface conditions of the Main Stockpile.

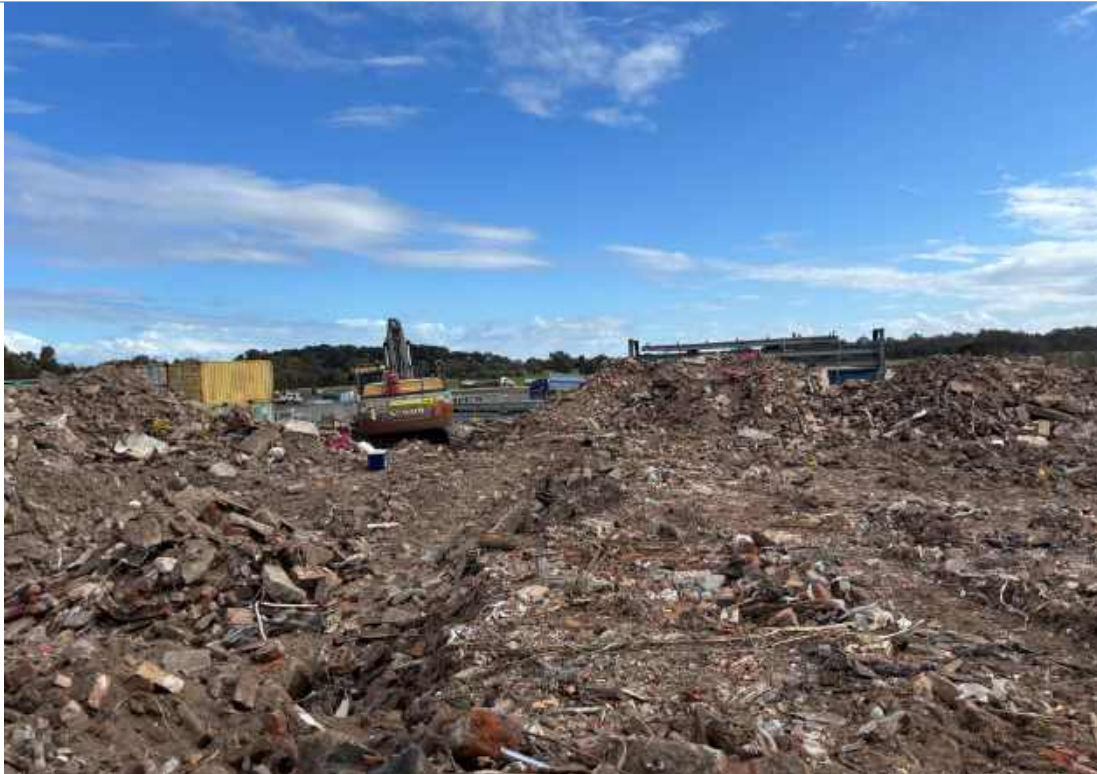
**Photograph 2:** Surface conditions of the Main Stockpile, note 20t excavator in background.

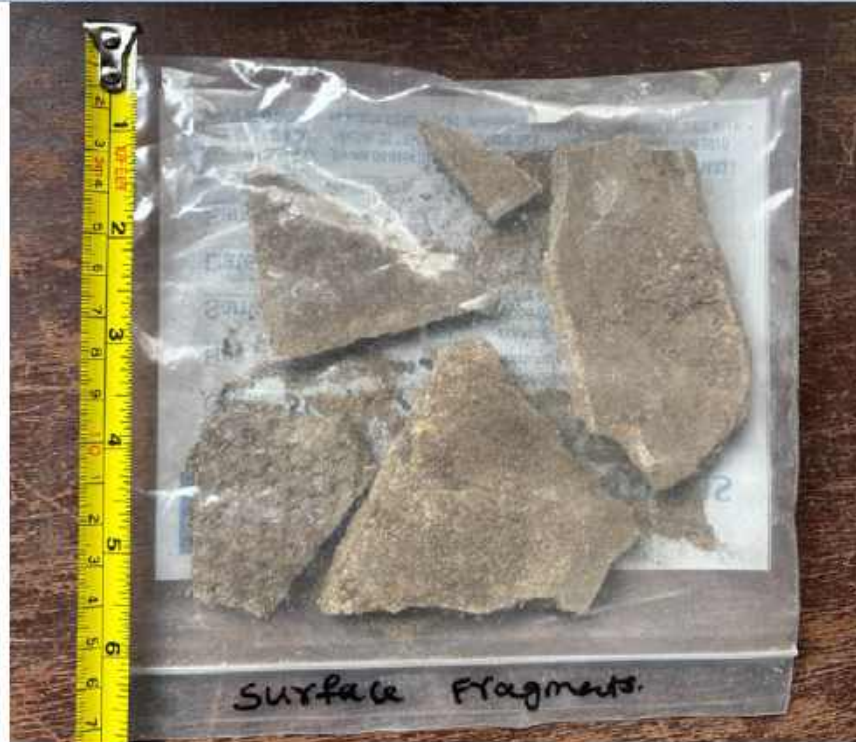
| SAMPLE ID | LOCATION | DEPTH (m bgl) | DESCRIPTION | WEIGHT (G) |
|---|---|---|---|---|
| PACM4 | Stockpile Surface | Surface | 5x bonded fragments in good condition.<br>3 x 1cm to 15 x 8cm | 118 |

All suspected ACM fragments were collected during the walkover and while sampling test pit spoil. These materials were removed from Site and confirmed to contain asbestos by an accredited laboratory (Lifetree Environmental). The fibre cement fragments that were found were in good, bonded condition and there was no evidence of bulk asbestos wastes, such as stacks of fence sheeting, pipes or building cladding. The total mass of ACM recovered was approximately 152g (Attachment 5).

**Photograph 3: Surface PACM fragments, identified during stockpile walkover.**

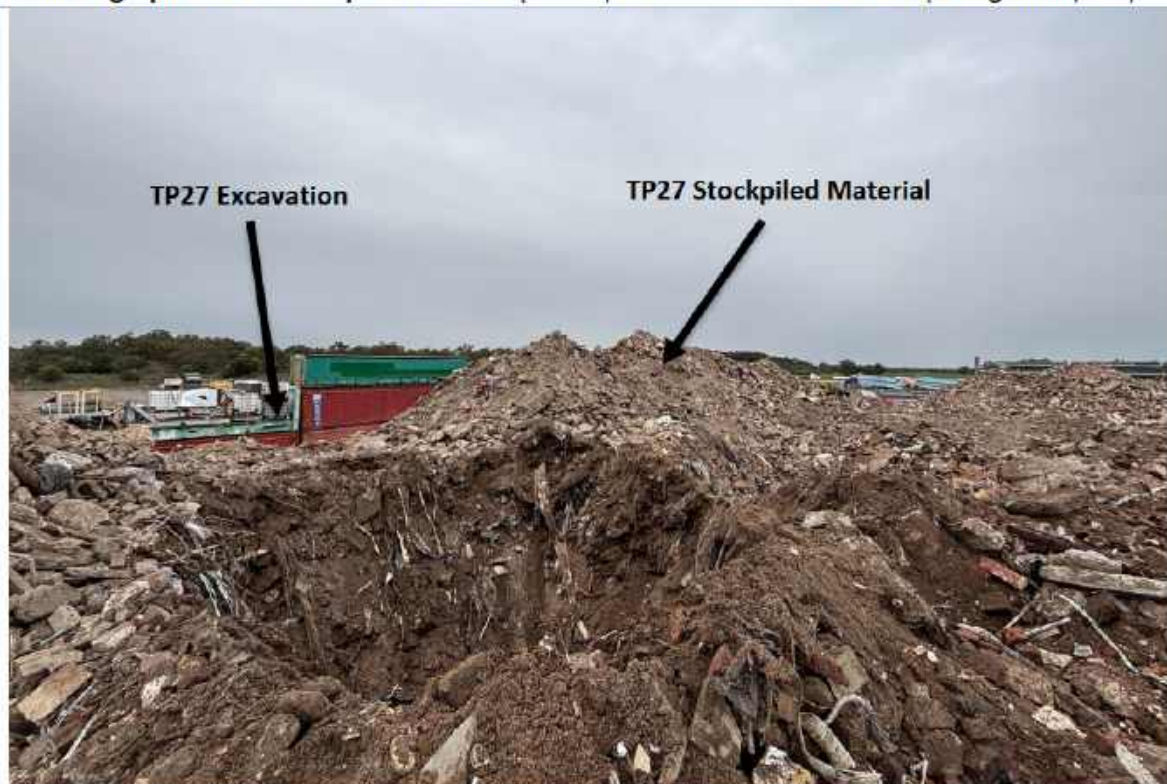
The stockpiled material previously excavated from the TP27 area was situated on top of the main stockpile (Attachment 3 – 4). The base and walls of the excavation around TP27 was situated on the southern side of the main stockpile (Attachment 3 – 4). Additionally, timber was noted to be present throughout the Main Stockpile and in the vicinity of the TP27 excavated area (Attachment 3 – 5).

**Photograph 4: TP27 stockpiled material (centre) and TP27 excavated area (background, left).**

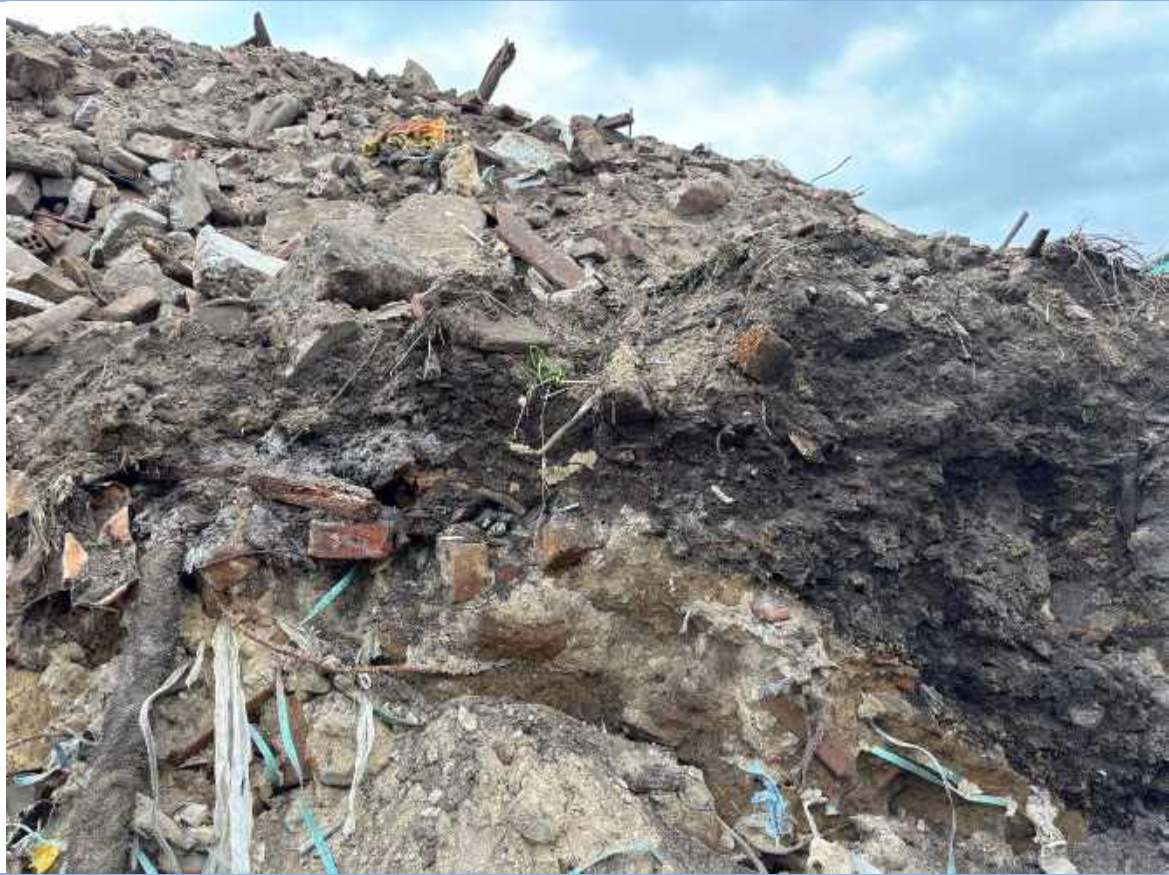
**Photograph 5:** TP27-V2 location, showing timber within Main Stockpile and in vicinity of TP27 excavated area.
