**MSP ENGINEERING PTY LTD**

**WHITE WELL PROJECT  
TAILINGS STORAGE FACILITY  
GEOTECHNICAL ASSESSMENT REPORT**

**REF: 036400REP01\_REV0**

**18 JANUARY 2016**

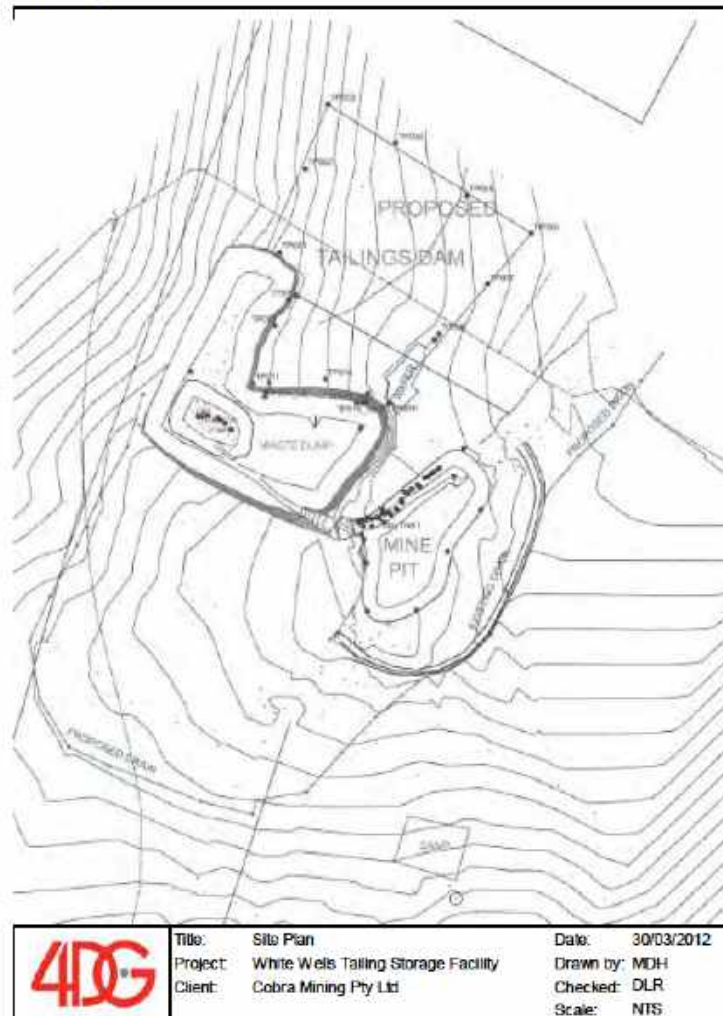
White Well TSF Site Plan

Twelve (12) test pits were located on the perimeter of the proposed TSF and were excavated to depths ranging from 0.1m to 1.0m, typically refusing on the top of the Ferricrete (also referred to as hard pan in the Dames & Moore report). The 30 tonne excavator could not penetrate the Ferricrete in the test pits, however, a trial was conducted where there was a free face on the existing pit where the excavator could excavate the laterised zone with difficulty.

Three (3) test pits were excavated within the face of the existing waste dump to depths ranging from 3.3m to 4.0m.

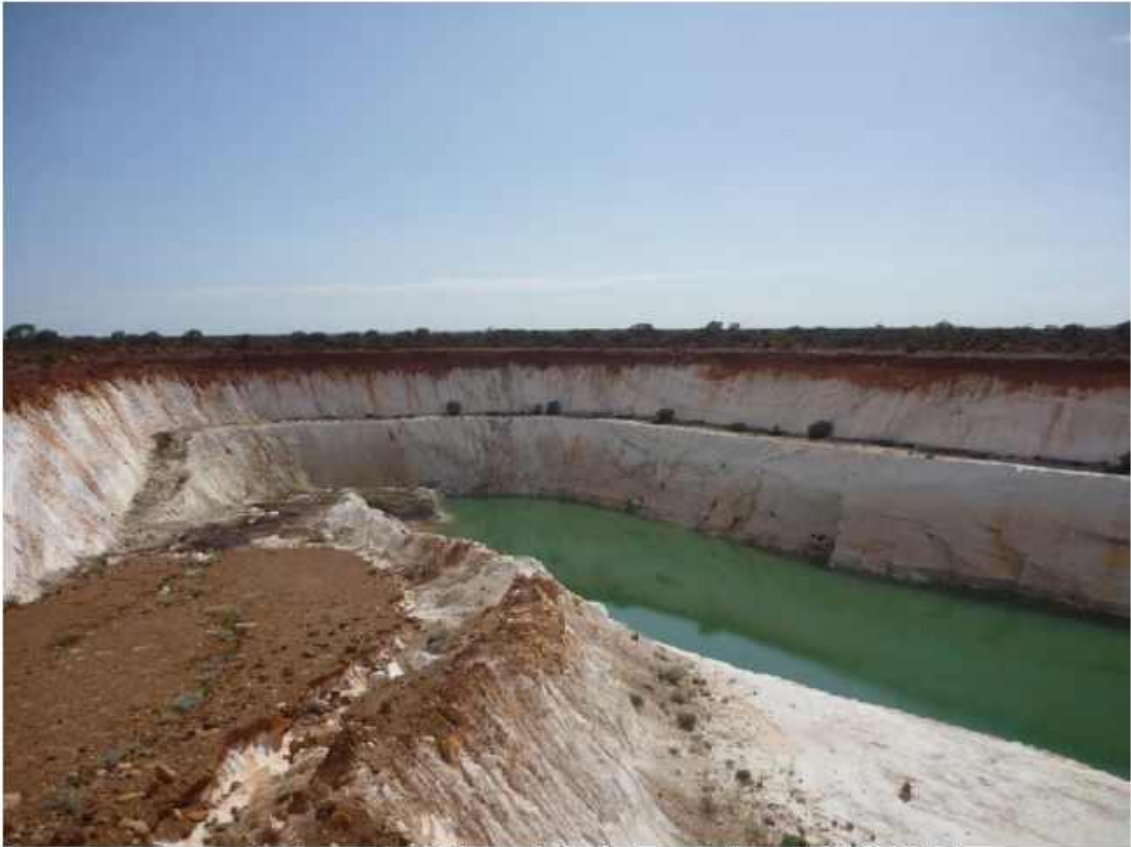
**Photograph 1:** View of pit (facing northeast, 2/02/2012).

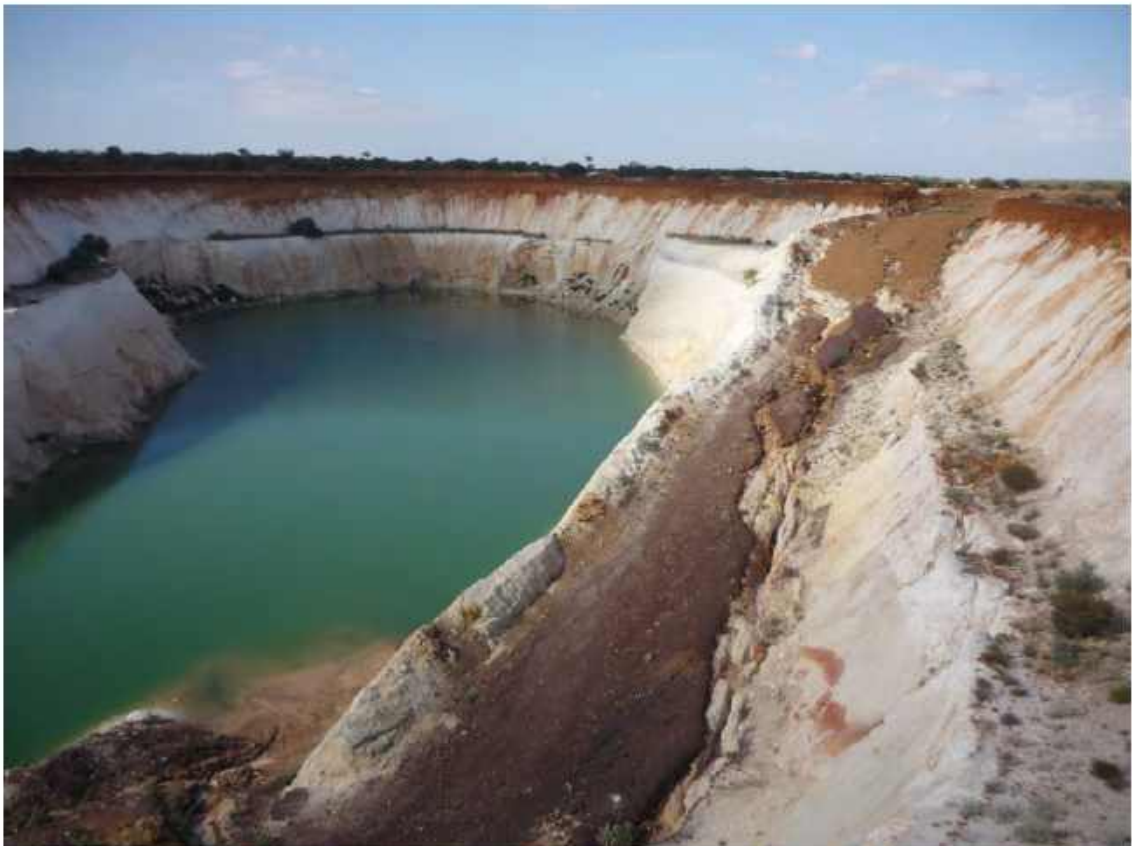
**Photograph 2:** View of pit (facing south, 2/02/2012).

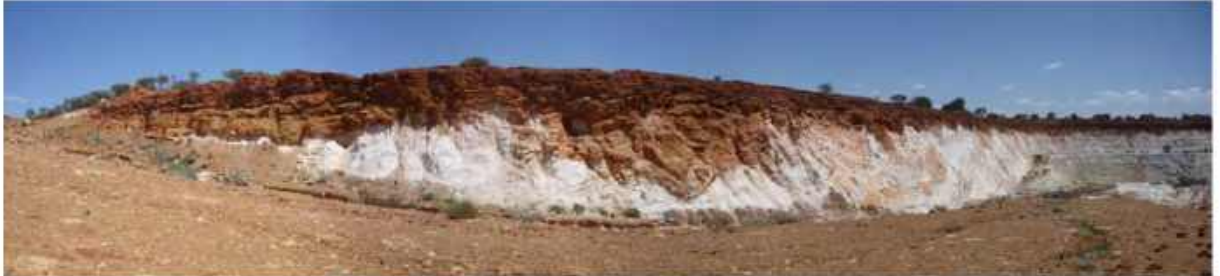
**Photograph 3:** View of starter pit wall (facing northwest, 2/02/2012).

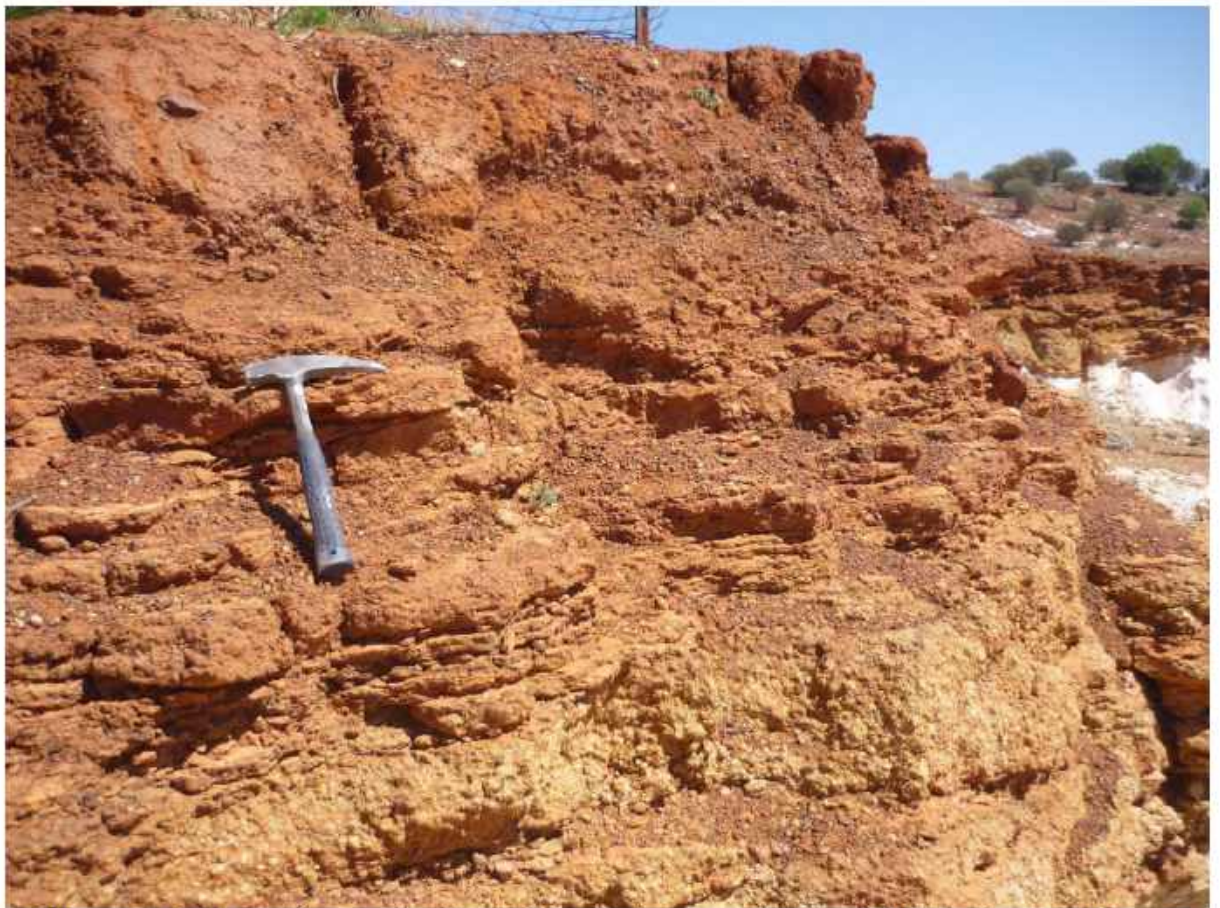
**Photograph 4:** Sandy gravel soil overlying ferricrete, note two distinct ferricrete substrate (2/02/2012).

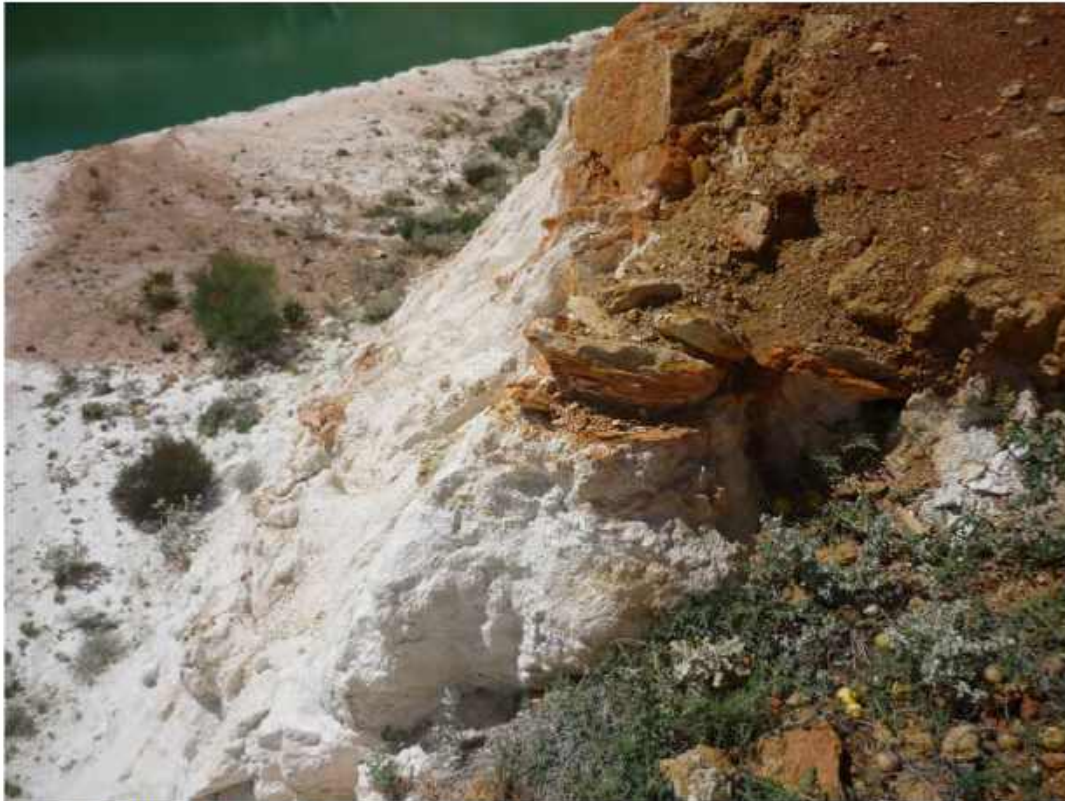
**Photograph 5:** Laterite zone underlain by pale grey stiff to very stiff clayey silt  
(2/02/2012)

- **Kaolin:** the kaolin is generally a clayey Silt to clayey silt/siltstone, stiff to very low strength, medium plasticity, dry to moist, pale greyish white with widely spaced steeply dipping defects (generally quartz veins and minor faults). The Dames & Moore 1991 report indicates that this unit is up to 75m deep below the TSF site.

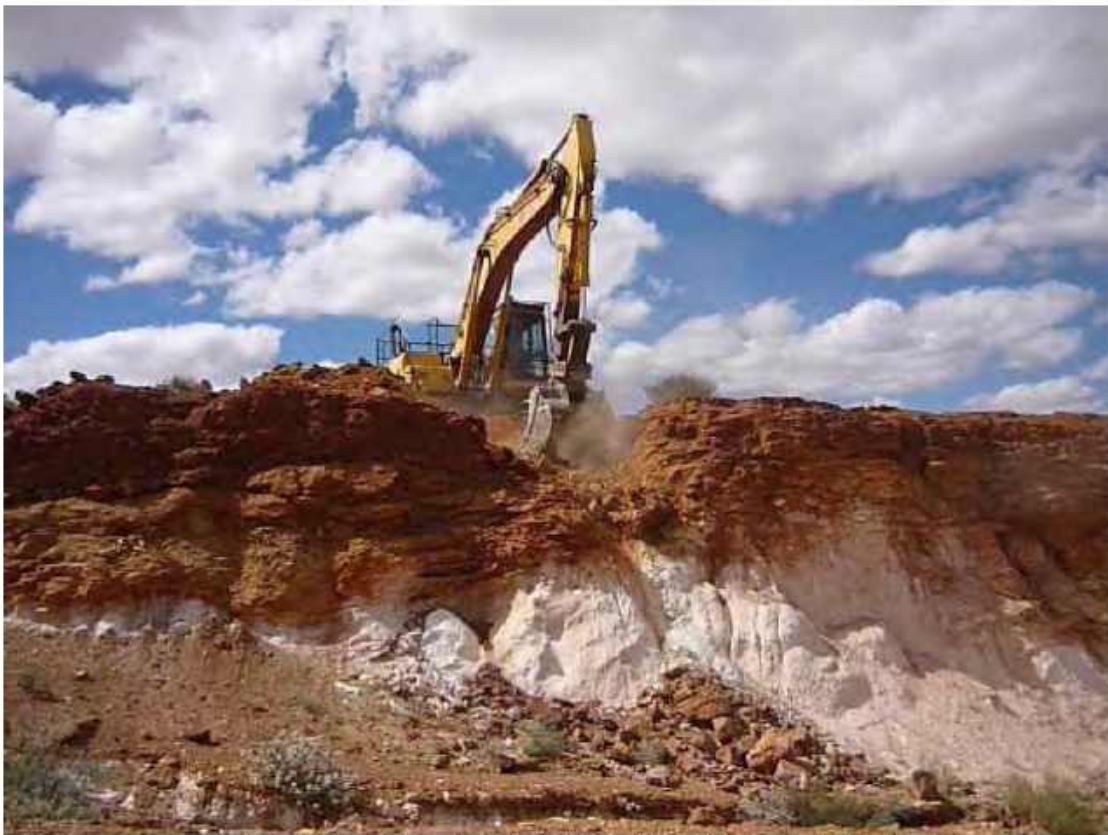
**Photograph 6:** Ripping trial of laterite zone (3/02/2012)

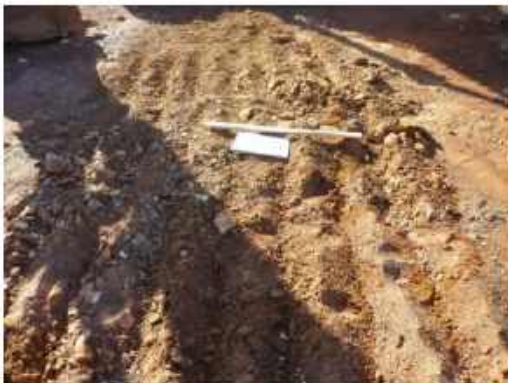
| Depth (m) | Graphic Log | Location: 617032 E 6970055 N RL: 483.5m<br>Equipment: 30T Excavator | Laboratory<br>Test Results | Date Logged: 2/02/2012<br>Logged By: MDH | TP No. TP001 |
|---|---|---|---|---|---|
| 0.0 | | FERRICRETE, very low strength, moderately cemented, red brown (iron cemented clayey sandy gravel)<br>EOP: 0.10 m (Refusal on ferricrete) | Not sampled | | |

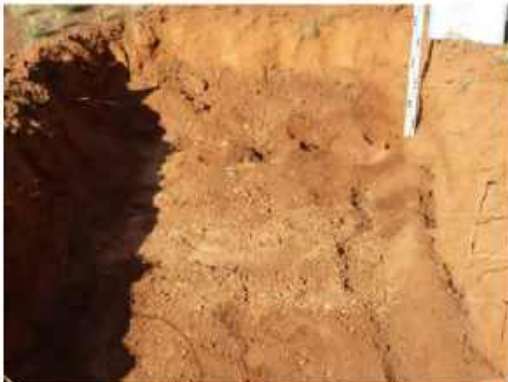
| Depth (m) | Graphic Log | Location: 617078 E 6970192 N RL: 483.0m<br>Equipment: 30T Excavator | Laboratory<br>Test Results | Date Logged: 2/02/2012<br>Logged By: MDH | TP No. TP002 |
|---|---|---|---|---|---|
| | | Clayey gravelly SILT (TOPSOIL): Low fines, dark red brown, moist, firm, homogeneous soil structure. | 0.00 - 0.50 m:<br>Sampled,(B) not tested | | |
| 1.0 | | Ferricrete, extremely weak, moderately cemented, red brown (iron cemented gravelly sand).<br>EOP: 0.60 m (Refusal on ferricrete) | | | |

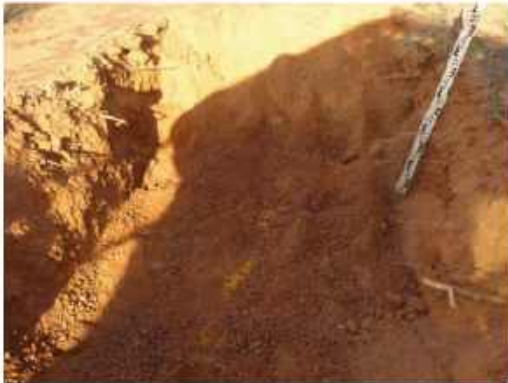
| Depth (m) | Graphic Log | Location: 617113 E 6970296 N RL: 483.0m<br>Equipment: 30T Excavator | Laboratory<br>Test Results | Date Logged: 2/02/2012<br>Logged By: MDH | TP No. TP003 |
|---|---|---|---|---|---|
| 0.00 - 0.60 m:<br>Sampled,(B) not tested | | Sandy silty GRAVEL (GC-GM): Fine to medium grained, rounded, low fines, dark red brown, dry, medium dense becoming very dense, homogeneous soil structure. Piscitic, non becoming weakly cemented.<br>EOP: 0.60 m (Refusal on cemented gravel) | | | |

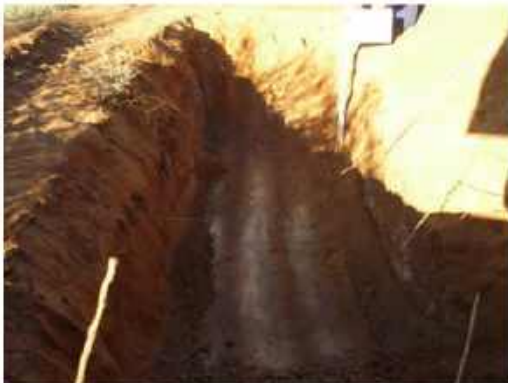
| Depth (m) | Graphic Log | Location: 617226 E 6970233 N RL: 481.0m<br>Equipment: 30T Excavator | Laboratory<br>Test Results | Date Logged: 2/02/2012<br>Logged By: MDH | TP No. TP004 |
|---|---|---|---|---|---|
| 0.0 | | <b>Sandy gravelly SILT (TOPSOIL):</b> Low fines, pale red brown, dry, soft, homogeneous soil structure. | 0.40 - 0.90 m:<br>Sampled,(B) not tested | | |
| | | <b>Silty sandy GRAVEL (GM):</b> Fine to medium grained, sub-angular to sub-rounded, low fines, red brown, dry, dense, homogeneous soil structure. Mottled pale grey. Weakly becoming moderately cemented.<br><br>EOP: 0.90 m (Refusal on cemented gravel) | | | |

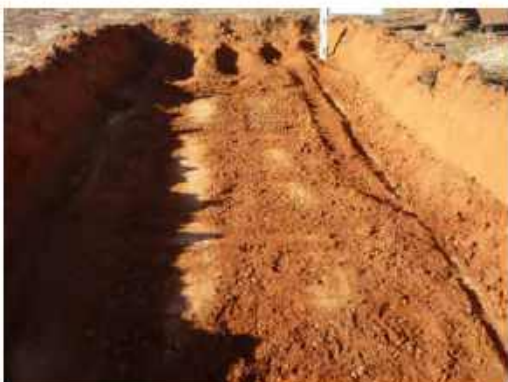
| Depth (m) | Graphic Log | Location: 617344 E 6970149 N RL: 480.0m<br>Equipment: 30T Excavator | Laboratory<br>Test Results | Date Logged: 3/02/2012<br>Logged By: MDH | TP No. TP005 |
|---|---|---|---|---|---|
| 0.0 | | Sandy gravelly SILT (TOPSOIL): Low fines, pale red brown, dry, soft, homogeneous soil structure. | Not sampled | | |
| 1.0 | | Ferricrete, very low strength, red brown mottled pale grey and purple, (iron cemented iron cemented sandy fine to medium GRAVEL, sub-angular to sub-rounded).<br>EOP: 0.30 m (Refusal on ferricrete) | | | |

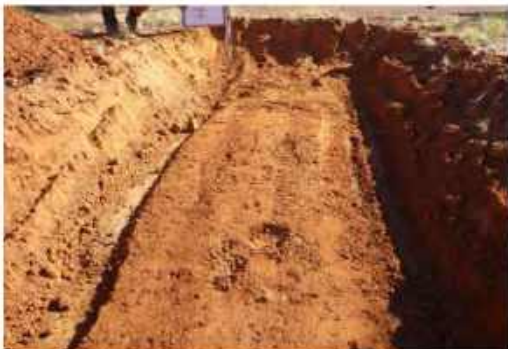
| Depth (m) | Graphic Log | Location: 617452 E 6970087 N RL: 479.0m<br>Equipment: 30T Excavator | Laboratory<br>Test Results | Date Logged: 3/02/2012<br>Logged By: MDH | TP No. TP006 |
|---|---|---|---|---|---|
| 0.0 | | Sandy gravelly SILT (TOPSOIL): Low fines, pale red brown, dry. | 0.20 - 0.30 m:<br>Sampled, (B) not tested | | |
| 1.0 | | Silty sandy GRAVEL (GM): Fine to medium grained, sub-angular to rounded, low fines, red brown, moist. Pisolithic.<br>EOP: 0.30 m (Refusal on cemented gravel) | | | |

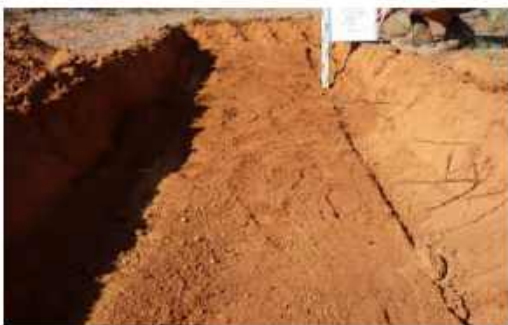
| Depth (m) | Graphic Log | Location: 617376 E 6970004 N RL: 480.0m<br>Equipment: 30T Excavator | Laboratory<br>Test Results | Date Logged: 3/02/2012<br>Logged By: MDH | TP No. TP007 |
|---|---|---|---|---|---|
| | | <b>Sandy gravelly SILT (TOPSOIL):</b> Low fines, pale red brown, dry. | Not sampled | | |
| 1.0 | | <b>Silty sandy GRAVEL (GM):</b> Fine to medium grained, sub-angular to rounded, low fines, red brown, moist.<br>EOP: 0.40 m (Refusal on cemented gravel) | | | |

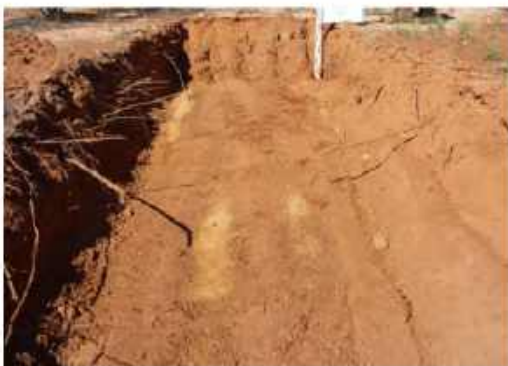
| Depth (m) | Graphic Log | Location: 617297 E 6969923 N RL: 480.5m<br>Equipment: 30T Excavator | Laboratory<br>Test Results | Date Logged: 3/02/2012<br>Logged By: MDH | TP No. TP008 |
|---|---|---|---|---|---|
| | | Sandy gravelly SILT (TOPSOIL): Low fines, pale red brown, dry. | 0.20 - 0.50 m:<br>Sampled,(B) not tested | | |
| 1.0 | | Silty sandy GRAVEL (GM): Fine to medium grained, sub-angular to rounded, low fines, red brown, moist.<br>EOP: 0.50 m (Refusal on cemented gravel) | | | |

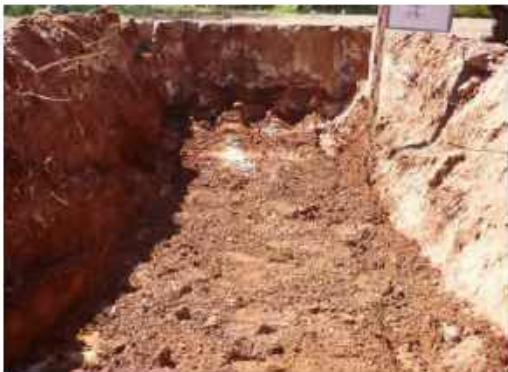
| Depth (m) | Graphic Log | Location: 617213 E 6969806 N RL: 480.5m<br>Equipment: 30T Excavator | Laboratory<br>Test Results | Date Logged: 3/02/2012<br>Logged By: MDH | TP No. TP009 |
|---|---|---|---|---|---|
| 0.0<br>1.0<br>2.0<br>3.0<br>4.0 | | Clayey gravelly SAND (FILL): Coarse to coarse grained, pale orangeish brown, m, medium dense, lensed soil structure. | 0.00 - 0.80 m:<br>Sampled, (B) not tested | | |
| | | Sandy silty GRAVEL (GC-GM): Fine to coarse grained, sub-angular to sub-rounded, low fines, reddish brown, w, very dense, homogeneous soil structure. Mottled yellow brown.<br>EOP: 0.90 m (Refusal on cemented gravel) | | | |

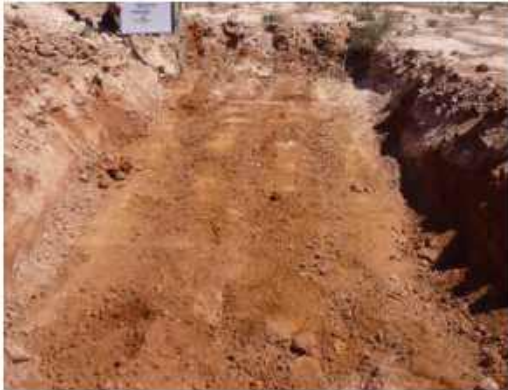
| Depth (m) | Graphic Log | Location: 617107 E 6969848 N RL: 482.0m<br>Equipment: 30T Excavator | Laboratory<br>Test Results | Date Logged: 3/02/2012<br>Logged By: MDH | TP No. TP010 |
|---|---|---|---|---|---|
| 0.0 | | <b>Sandy clayey GRAVEL with cobbles (FILL):</b> Fine to coarse grained, sub-angular, medium fines, pale pink brown, dry, dense, homogeneous soil structure. | Not sampled | | |
| 1.0 | | <b>Sandy cobbly GRAVEL with silt (GW):</b> Fine to coarse grained, sub-angular to rounded, low fines, red brown, dry, very dense, homogeneous soil structure. becoming weakly cemented. | | | |
| 2.0 | | <b>EOP: 0.50 m (Refusal on cemented gravel)</b> | | | |

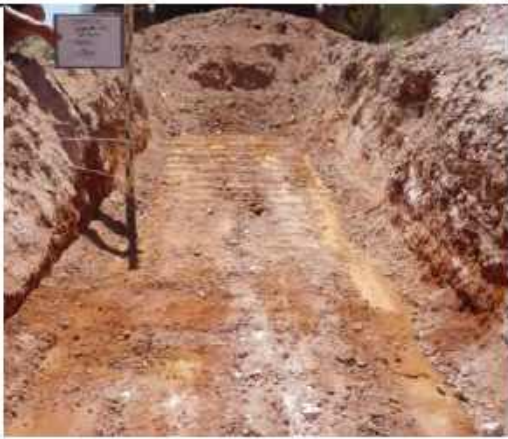
| Depth (m) | Graphic Log | Location: 616987 E 6969840 N RL: 483.5m<br>Equipment: 30T Excavator | Laboratory<br>Test Results | Date Logged: 3/02/2012<br>Logged By: MDH | TP No. TP011 |
|---|---|---|---|---|---|
| | | <b>Sandy clayey GRAVEL with cobbles (FILL):</b> Fine to coarse grained, angular to sub-angular, low fines, pale pink brown, dry, medium dense. | Not sampled | | |
| 1.0 | | <b>Gravelly sandy SILT with clay (FILL):</b> Medium fines, pale grey white, dry, firm. | | | |
| 2.0 | | <b>Sandy silty GRAVEL (GC-GM):</b> Sub-rounded to rounded, low fines, red brown, very dense, becoming moderately cemented. | | | |

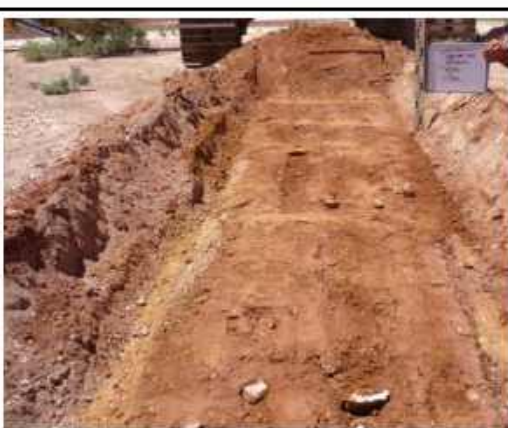
| Depth (m) | Graphic Log | Location: 617024 E 6969934 N RL: 483.0m<br>Equipment: 30T Excavator | Laboratory<br>Test Results | Date Logged: 3/02/2012<br>Logged By: MDH | TP No. TP012 |
|---|---|---|---|---|---|
| | | <b>Gravelly clayey SAND (FILL):</b> Fine to coarse grained, sub-angular, medium fines, pale pink brown, dry, medium dense, homogeneous soil structure. | Not sampled | | |
| 1.0 | | <b>Sandy silty GRAVEL (GC-GM):</b> Fine to medium grained, sub-angular to rounded, low fines, red brown, m, dense, homogeneous soil structure. Weakly becoming moderately cemented. | | | |
| 2.0 | | <b>EOP: 0.30 m (Refusal on cemented gravel)</b> | | | |

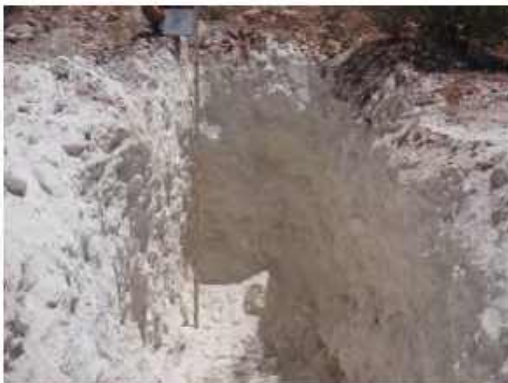
| Depth (m) | Graphic Log | Location: 617047 E 6969977 N RL: 484.5m<br>Equipment: 30T Excavator | Laboratory Test Results | Date Logged: 3/02/2012<br>Logged By: MDH | TP No. TP013 |
|---|---|---|---|---|---|
| 1.0 | | Clayey SILT with sand and gravel (FILL): Angular, medium to high fines, pale grey white, dry, soft, homogeneous soil structure. | 0.00 - 3.00 m:<br>LL=47%, PL=34%, P <sub>i</sub> =13%<br>LS = 2.5%<br>NMC = 2%<br>MMDD = 1.66m <sup>2</sup> OMC = 13%<br>% Passing 37.5mm: 100<br>% Passing 2.36mm: 94<br>% Passing 0.075mm: 83 | | |
| 2.0 | | FERRICRETE, very low strength, red brown, moderately cemented (iron cemented sandy silty GRAVEL). | | | |
| 3.0 | | EOP: 3.30 m (Refusal on ferricrete)<br>Site Description: Waste Dump. | | | |

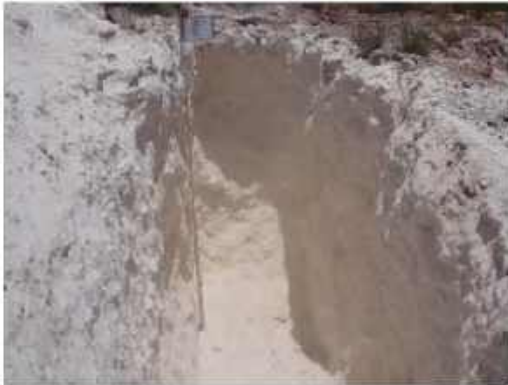
| Depth (m) | Graphic Log | Location: 617006 E 6969818 N RL: 485.0m<br>Equipment: 30T Excavator | Laboratory Test Results | Date Logged: 3/02/2012<br>Logged By: MDH | TP No. TP014 |
|---|---|---|---|---|---|
| 1.0 | | Clayey SILT with sand and trace gravel (FILL): Medium fines, pale grey white, dry, soft, homogeneous soil structure. | 0.00 - 3.80 m:<br>Sampled, (B) not tested | | |

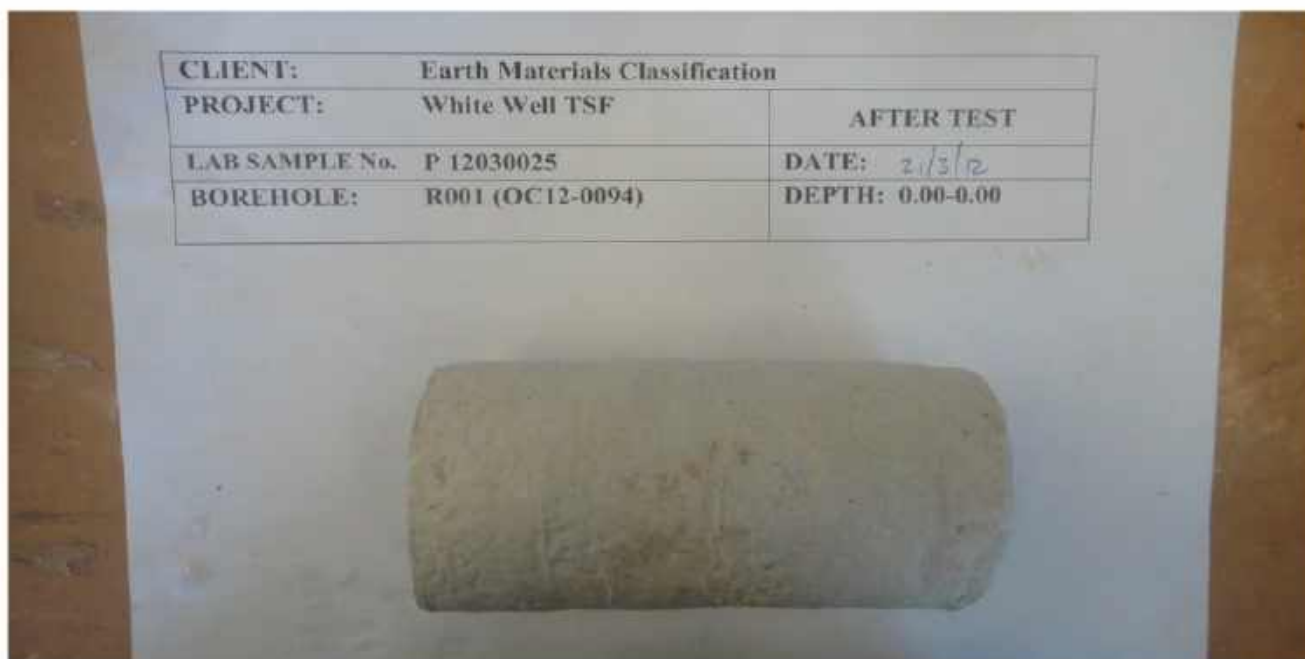
| <b>Description</b> CLAYEY SILT- pale grey | |

**Sample Type:** Single Individual Specimen remoulded at 98% of Modified Maximum Dry Density and Optimum Moisture Content

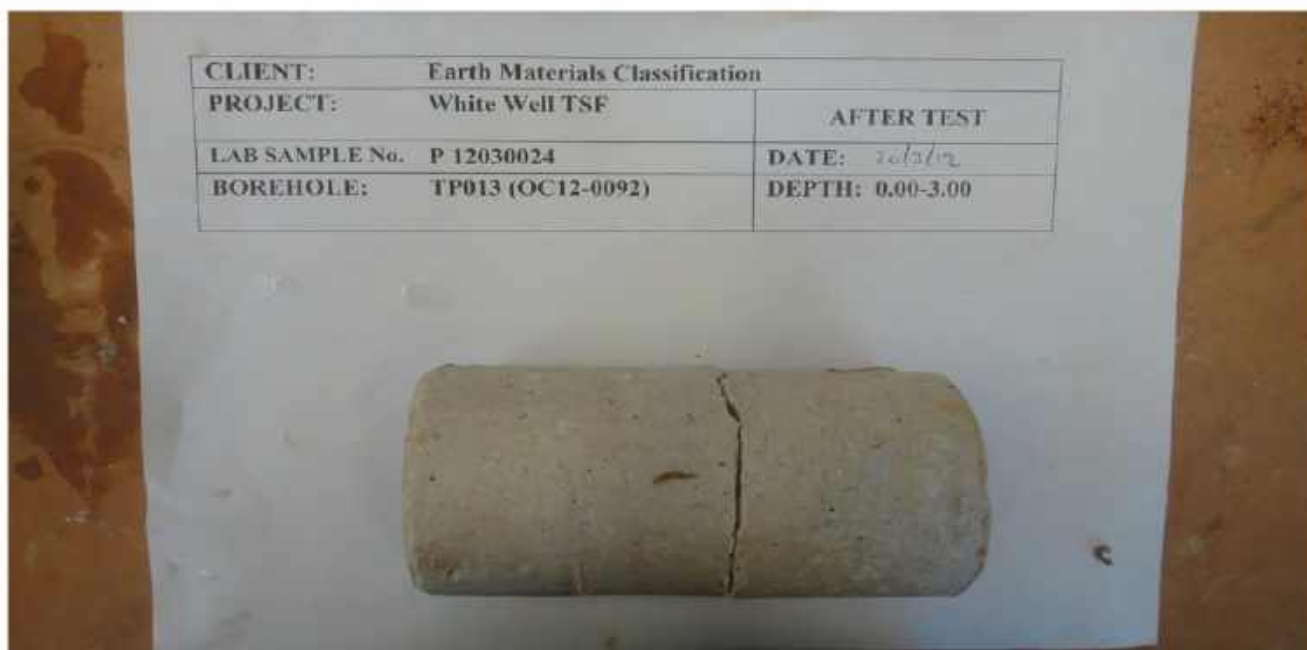
**Sample Type:** Single Individual Specimen remoulded at 98% of Modified Maximum Dry Density and Optimum Moisture Content
