# APPLICATION FOR WORKS APPROVAL AND OPERATING LICENCE

Iguana Mobile Crushing Plant

Beacon Mining Pty Ltd

Category 5 - Processing or beneficiation of metallic or non-metallic ore

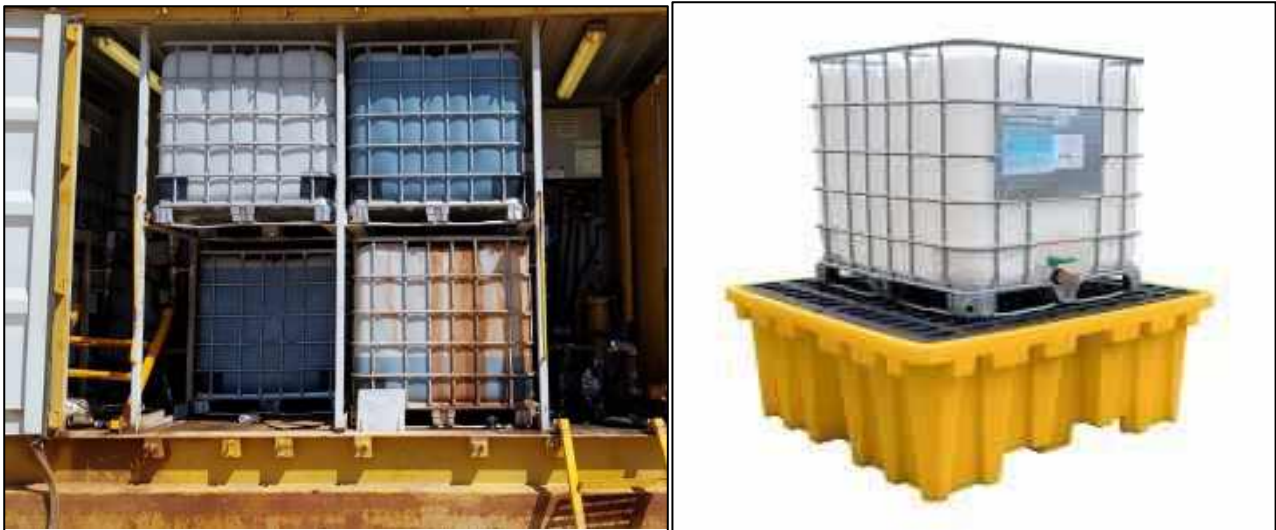
Plate 3: Example project hydrocarbon storage

Hydrocarbons will be managed and stored in self-bunding sea containers and portable bunding at an approved workshop at the Project (see example shown in Plate 3). No additional hydrocarbon storage is proposed for the mobile crushing plant development and operation.
